# MOUNTAINS TO SOUND HOME INSPECTION LLC

## HOME INSPECTION REPORT

3011 Deer Island Dr E  
Lake Tapps WA 98391

Nancy Juhlin  
FEBRUARY 3, 2020

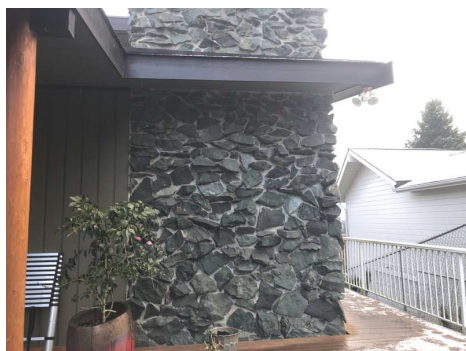
**Exterior Chimney: Serviceable Condition**

The exterior chimney was in serviceable condition. See additional notes in the roofing section of this report.

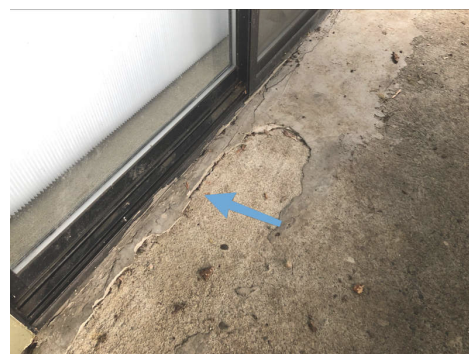
**PATIO FLOOR CRACKS**

There are cracks in the rear patio floor that you should view for yourself and correct as desired.

Contact a qualified concrete contractor.

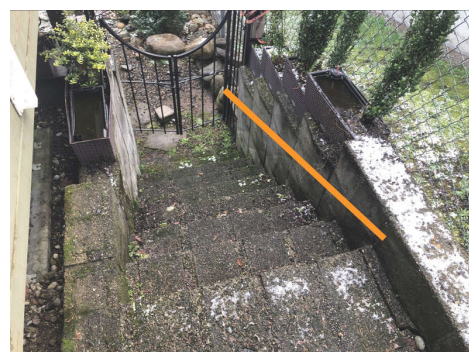
**MISSING RAIL**

The stairs are missing graspable rails. These are recommended on stairs where three or more risers are present. We recommend rail be installed.

Contact a qualified professional.

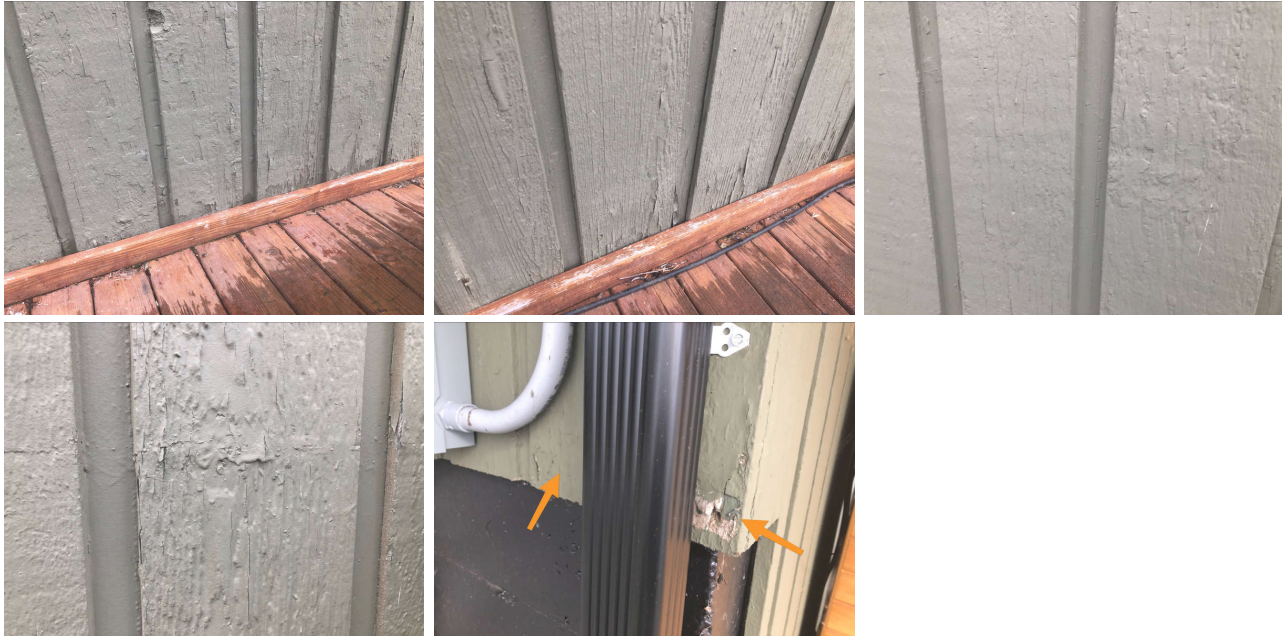
**WEATHERED SIDING**

The exterior siding is weathered. Maintenance, paint, and minor repairs are recommended.

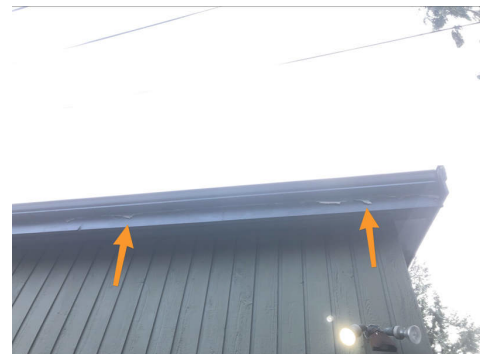
**SECTIONS OF FASCIA OR WOOD TRIM ARE WEATHERED**

Sections of the fascia board or wood trim around the residence are slightly weathered, and should be serviced as necessary to prevent further deterioration. Service such as scraping, repainting and sealing.

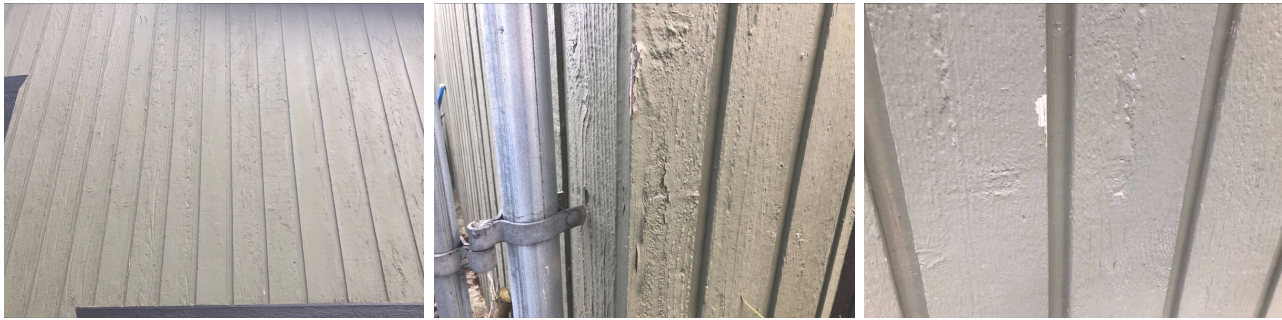
The exterior siding is weathered. Maintenance paint, and minor repairs are recommended.

Contact a qualified professional.

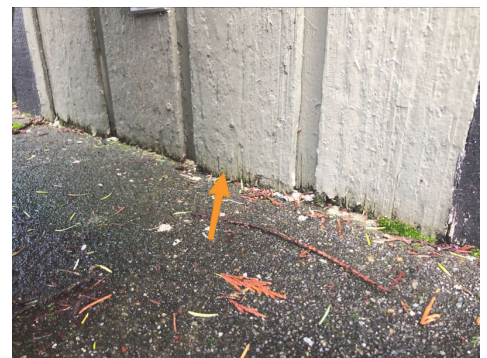
### **MOISTURE DAMAGED**

Portions of the wood siding are moisture damaged and should be further evaluated by a contractor and repaired.

Contact a qualified professional.

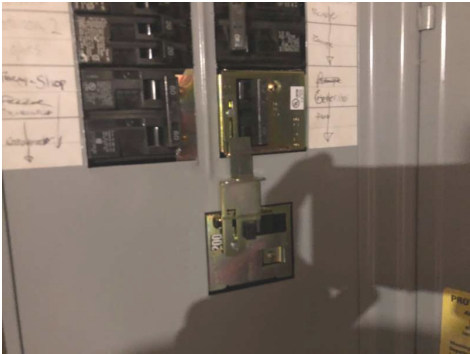
### OBSTRUCTED PANEL

Access to the electrical panel was obstructed by blockers. We were unable to access in the value at the electrical panel in detail.

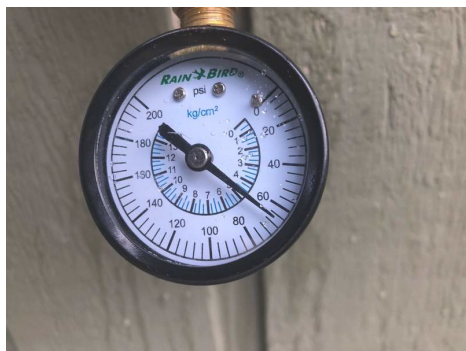
**Main Water Shut-Off, Distribution & Supply: House Pressure PICTURE-Acceptable**

The pressure at the street was within industry standards, between 40 and 80 and a regulator is not required on the plumbing system.

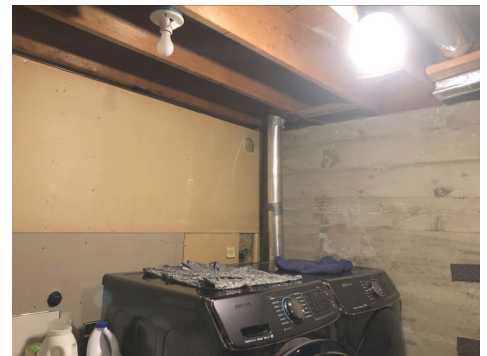
**NO EXHAUST FAN OR OPENABLE WINDOW**

There is not a laundry exhaust fan or openable window installed within this laundry room. Adding one is recommended and typically required to help disperse excessive moisture from the laundry room.
