# **OAKTREE HOME INSPECTIONS**

### RESIDENTIAL REPORT COPY

12345 Main Street NA, NA NA

Brandon Barkema JUNE 15, 2021

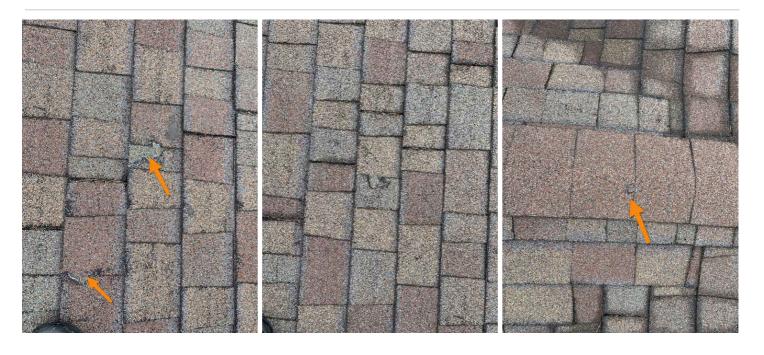
2.1.3 Coverings

#### **IMPROPER RIDGE CAP INSTALLATION**

Recommendation

Contact a qualified roofing professional.

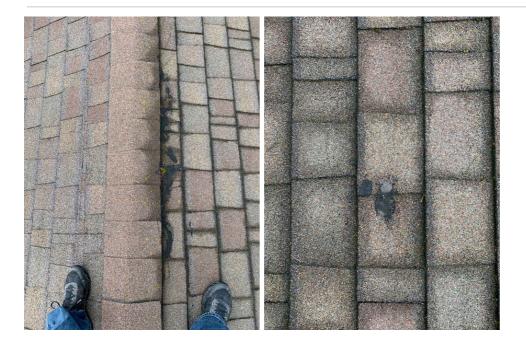
2.1.5 Coverings

#### **POWERWASHED**

The roof appeared to be power washed. power washing a roof can degrade the life of the roof significantly. Recommend a qualified roofer evaluate and repair damaged areas or the roof.

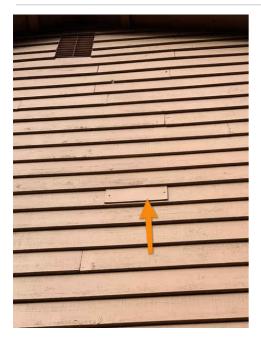
3.5.4 Siding, Flashing & Trim

No flashing noted at the time of the inspection in one or more areas. Recommend having a siding specialist come install flashing as needed to prevent moisture intrusion.

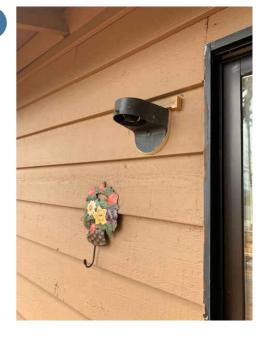
3.8.2 Lighting Fixtures, Switches & Receptacles

One or more light fixtures were missing a cover. Recommend replacing the cover to prevent moisture intrusion or shorting.

Contact a qualified professional.

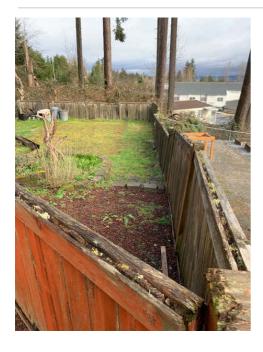
3.10.2 Fence & Retaining Walls

#### **ROTTED BOARDS**

One or more deck boards showed signs of rot. Recommend a qualified landscape professional evaluate and repair as needed.

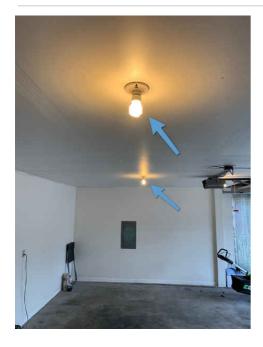
5.7.1 Garage Door

The auto reverse sensor was not responding at time of inspection. This is a safety hazard to children and pets. Recommend a qualified garage door contractor evaluate and repair/replace.

Contact a qualified garage door contractor.

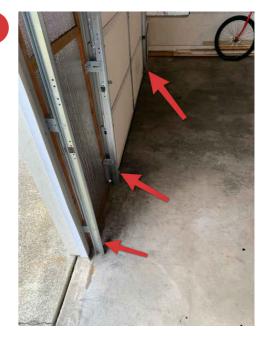
5.7.2 Garage Door

# CRUSH REVERSE NOT WORKING

Garage door openers have a sensor that will reverse if there is too much pressure to prevent the crushing of an object. The garage door did not reverse when pressure was applied to the door. Recommend having a qualified professional adjust the garage door opener to reverse properly.

Contact a qualified professional.

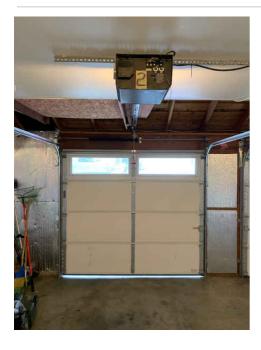
5.7.3 Garage Door

#### **RECOMMED REMOVING LOCK**

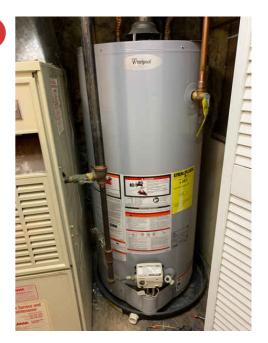
8.5.2 Hot Water Systems

#### **NO EXPANSION TANK**

Contact a qualified plumbing contractor.

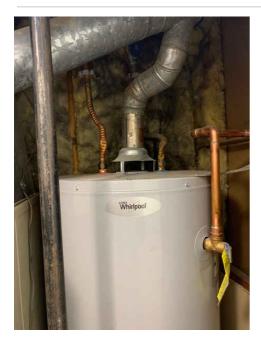
8.5.3 Hot Water Systems

### WATER TEMPERATURE TOO HIGH

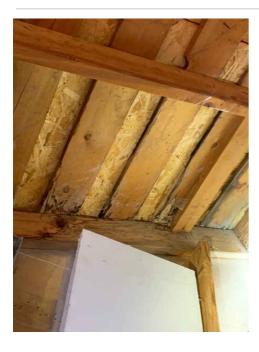
9.2.2 Roof Structure

## **MODIFIED TRUSSES**

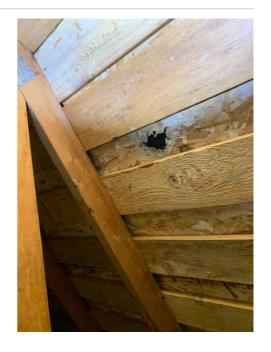
9.4.1 Ventilation

#### **GABLE VENT DAMAGED**

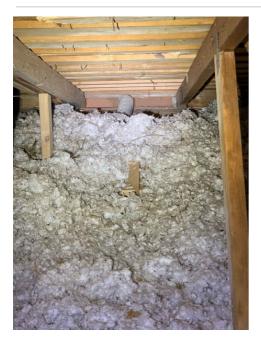
9.5.2 Exhaust Systems

Bathroom fan vents into the attic, which can cause moisture and mold. Recommend a qualified attic contractor property install exhaust fan to terminate to the exterior.

Contact a qualified professional.

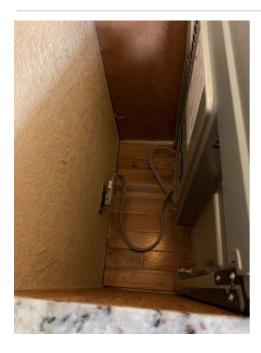
Range was not fastened to the floor. This poses a safety hazard to children. Recommend a qualified contractor secure range so it can't tip.

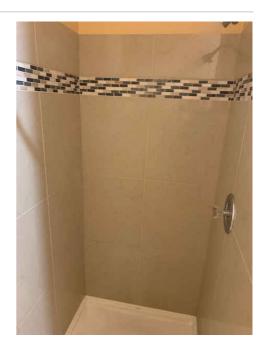
23.13.2 Tub/Shower

## **SHOWER HEAD LEAKS**

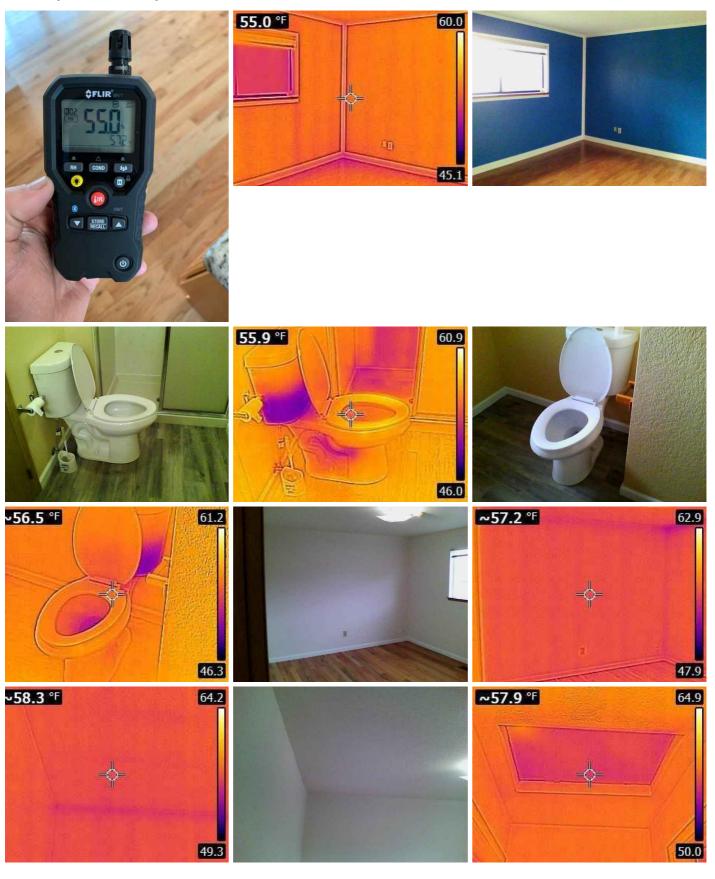
### **General: Flir Photos**

Here are the Flir (thermal camera) photos of the home for your records. They may not have issues in these photos and are for your records only.
