PROTECT PROPERTY INSPECTIONS RESIDENTIAL REPORT

13839 N 63Rd Pl
Scottsdale, AZ 85254

Larry Mesler
SEPTEMBER 23, 2020

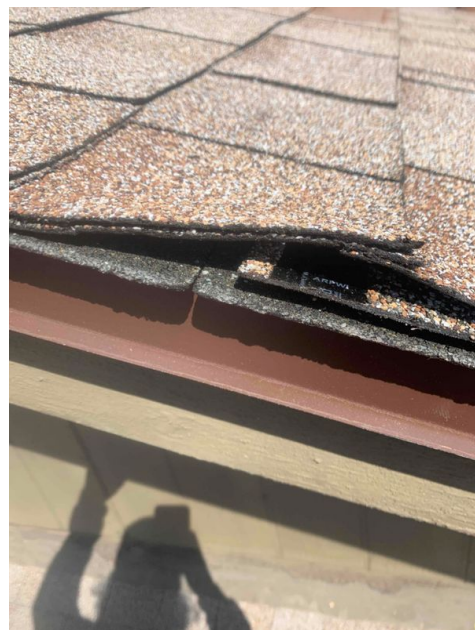
The roof had two existing layers of composition asphalt shingles installed at the time of the inspection. One layer is now the proffered amount of layers, but this condition is acceptable. This condition could result in the following:

- When new roofing is required, all layers will need to be removed. Whoever owns the home at the time of replacement will be required to pay for removal and disposal of the old shingles, and for materials and installation of the new roof-covering materials. This is much more expensive than simply adding another layer and you may wish to take this into account in your consideration of this property.
- Reduced asphalt shingle service-life of the existing shingle roof compared to similar shingles installed over a proper substrate.
- Any warranty offered for the shingles is possibly void. and
- Shingles will be more easily damaged by hail.

Contact a qualified professional.

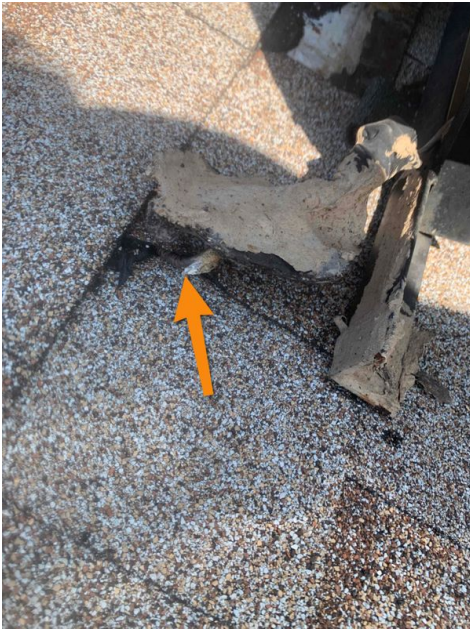
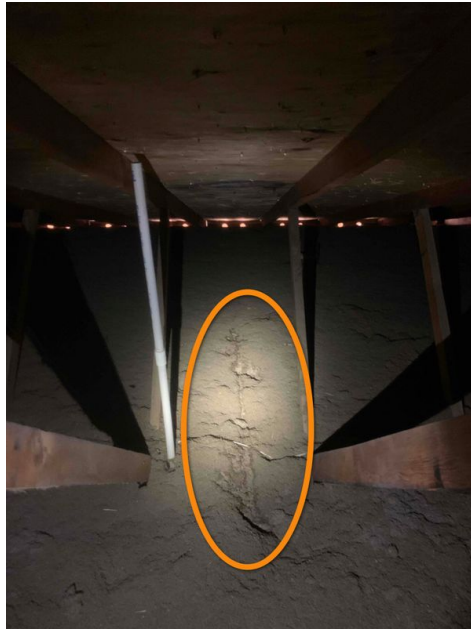
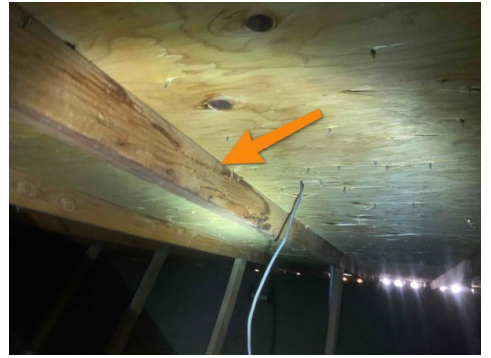
An opening was observed at a roof penetration. There appeared to also be signs of moisture intrusion near this area in the attic as well. Recommend sealing to prevent moisture intrusion.

Contact a qualified professional.

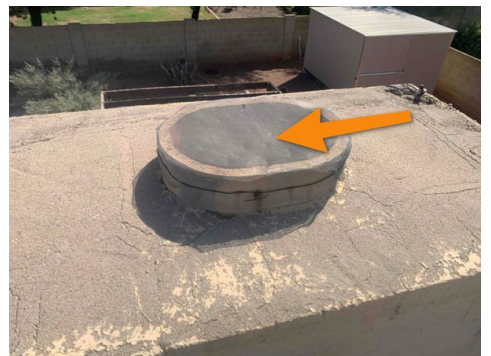
2.7.1 Chimneys at roof*

CHIMNEY CAP MISSING

No chimney cap was observed. This is important to protect from moisture intrusion and protect the chimney. Recommend a qualified roofer or chimney expert install.

Contact a qualified roofing professional.

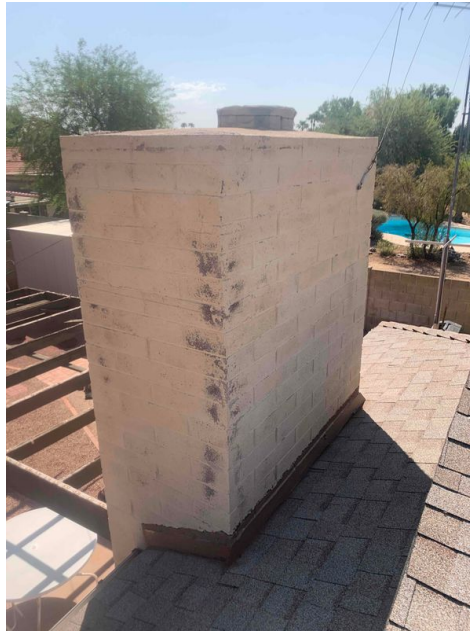
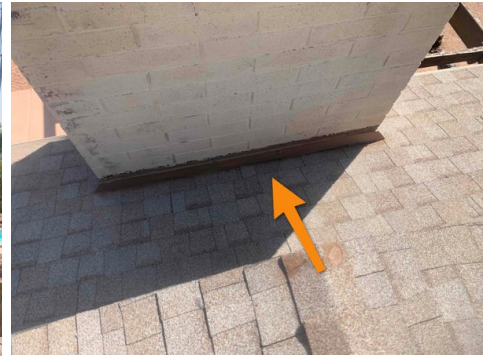
2.7.2 Chimneys at roof^{6*}**NO CRICKET, OVER 30"**

The chimney had no cricket. A cricket is a small roof built on the uphill side of the chimney to prevent roof drainage from pooling and causing damage from roof leakage. Crickets are recommended for chimneys measuring 30 inches or more in width (measured parallel to the eaves). This chimney measured more than 30 inches in width. Recommend Monitoring as this could lead to moisture intrusion.

Recommend monitoring.

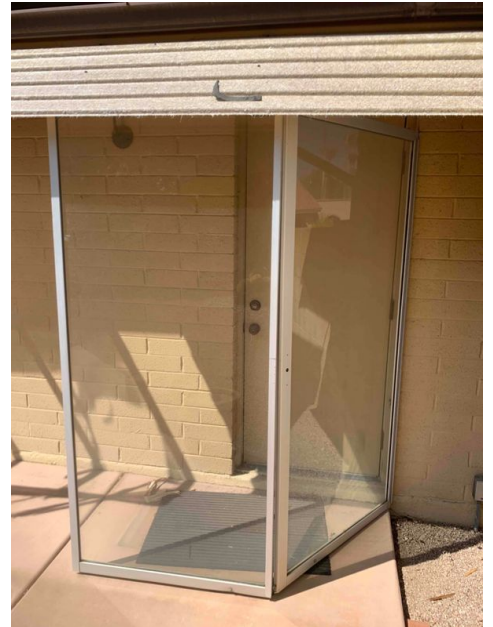
3.3.1 Wall Cladding

CRACKING AND IMPERFECTIONS - MINOR

The exterior wall cladding showed cracking, separations, prior repairs and/or opening in one or more places. This is commonly a result of temperature changes, and typical as homes age. Recommend monitoring and repairs where necessary.

Recommended DIY Project

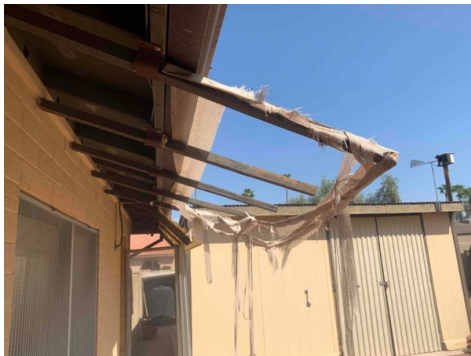
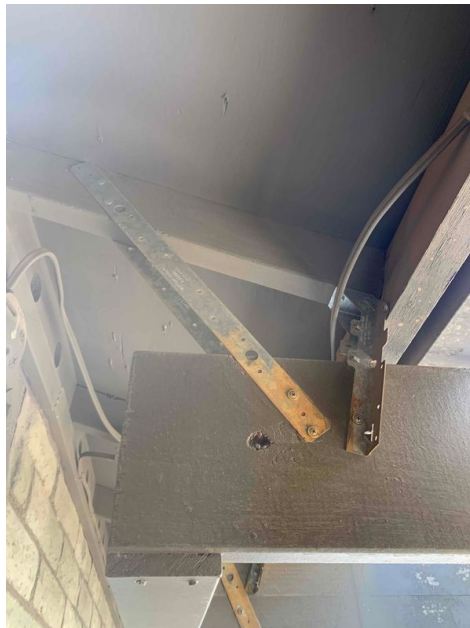
3.8.1 Patios, Decks, Porches, Balconies, Covers, Areaways, Railings & Stairs*

Wood a shade structures were observed on the rear and front of the home. Remnants of a cloth material shade was present, but mostly missing and damaged. The structures themselves appeared functional, but were unconventionally attaches to the home (screws used with straps and hangers) This does not appear to be causing an immediate issue, but we recommend having them reinforced properly by a qualified contractor. The wood used was also functional, but should be refinished for longevity.

Contact a qualified professional.

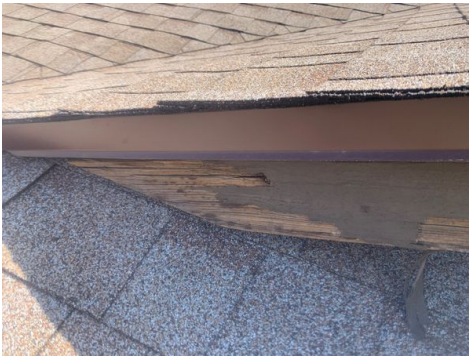
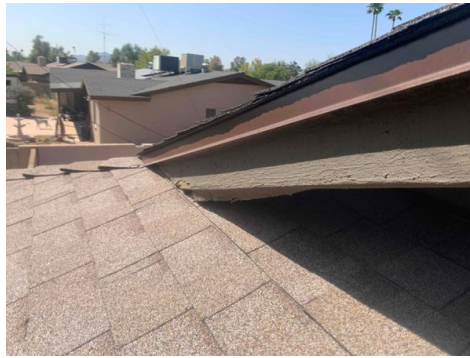
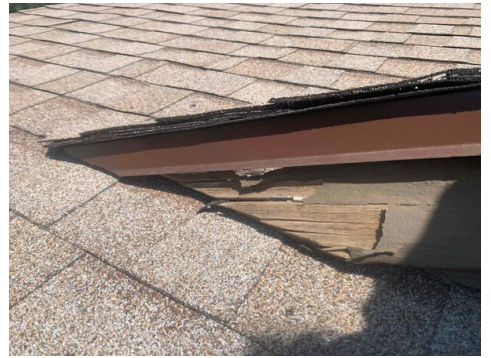
3.9.1 Trim, Eaves, Soffits, flashing & Fascia*

MINOR WEAR AND TEAR

Minor wear and tear are acceptable in these areas, but we do recommend monitoring them as deterioration or staining on these components could be signs of roof related defects.

Contact a qualified professional.

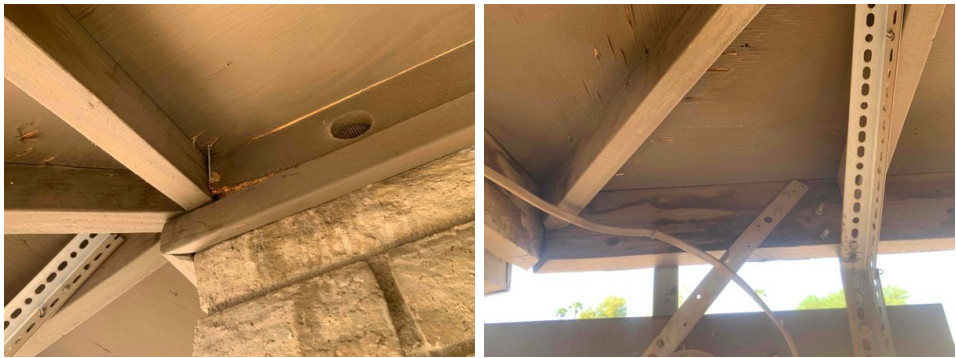
3.9.2 Trim, Eaves, Soffits, flashing & Fascia*

EAVES - WATER STAINS

Water stains were observed under the roof eaves. This may indicate a past roof leak, or be a common sign from previously installed roof. Recommend monitoring and qualified roofer evaluate as needed.

Contact a qualified roofing professional.

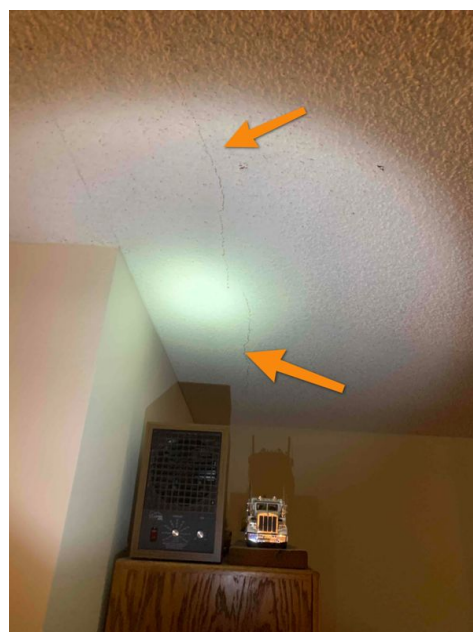
5.1.2 Ceilings

DRYWALL CRACKS

Contact a qualified professional.

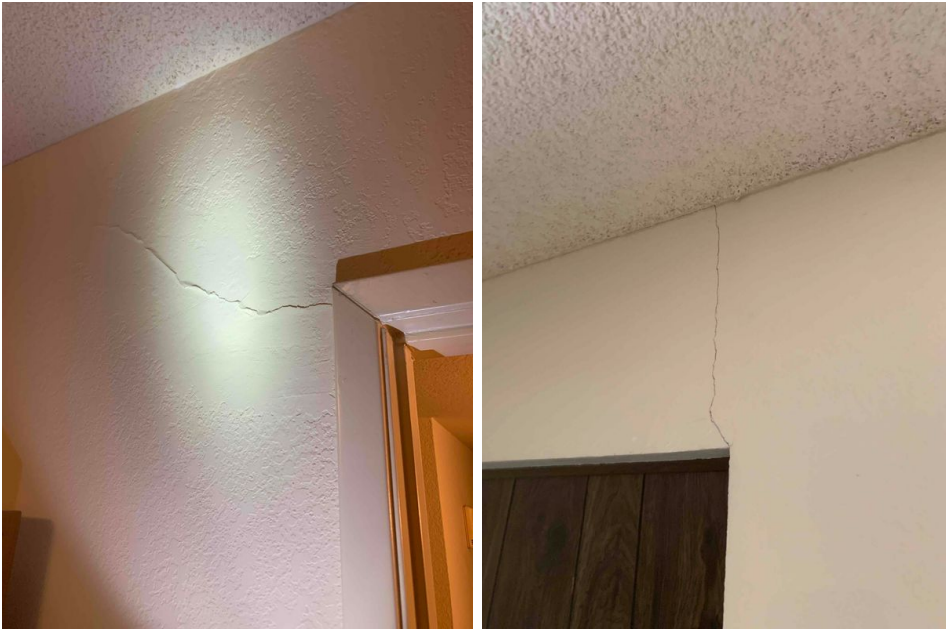
5.2.1 Walls

MINOR CRACKS

Contact a qualified professional.

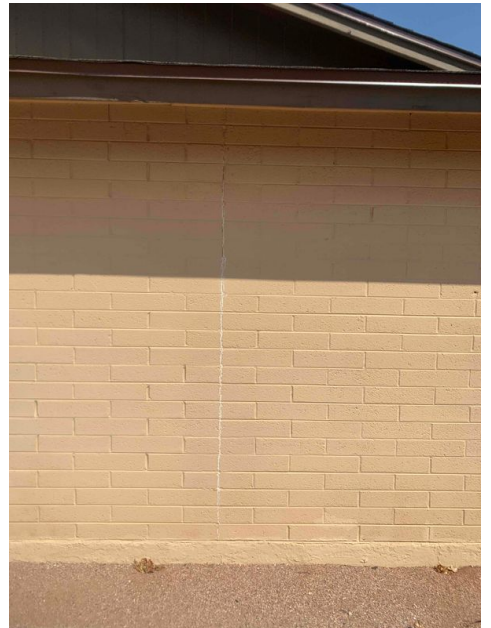
6.3.1 Wall Structure

CRACKS - MINOR

Recommend monitoring.

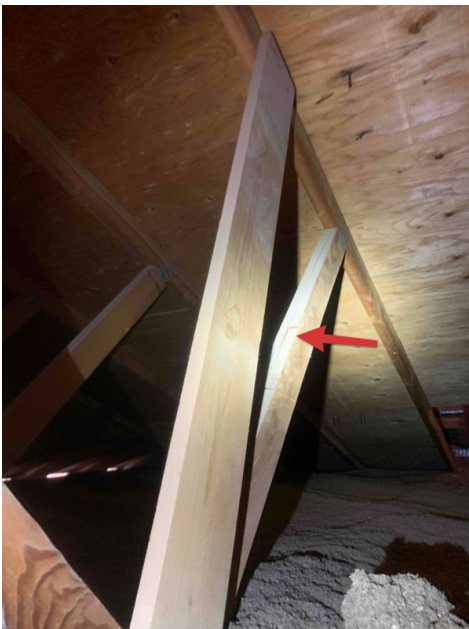
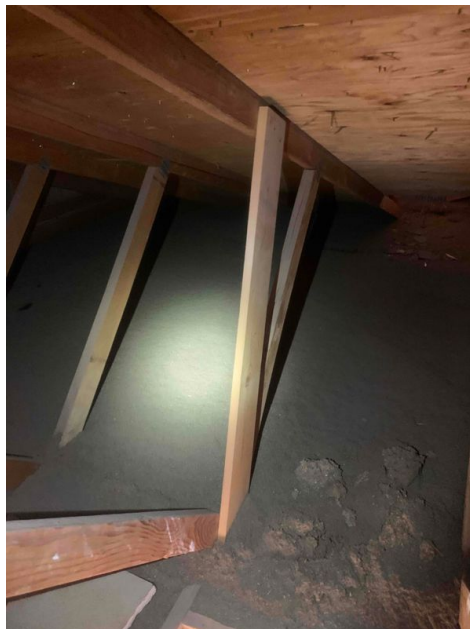
6.6.1 Roof Structure

CRACKED TRUSS - NO ENG REPORT

Contact a qualified structural engineer.

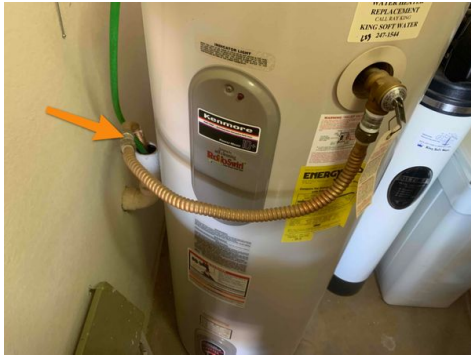
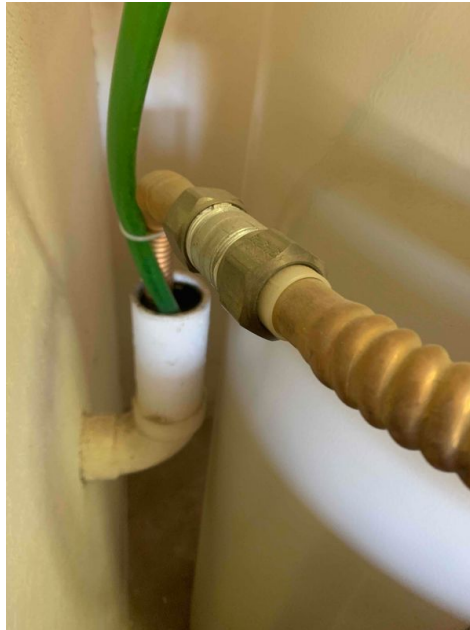
7.5.1 Hot Water Equipment and Operating Controls-Unit 1

NO DRIP PAN

Contact a qualified plumbing contractor.
