MICHAEL TOFANO PROPERTY AND HOME INSPECTIONS

NEW HOME WARRANTY RESIDENTIAL REPORT

205 Stillwater Crescent
Waterdown Ontario L0R 2H8

Samara Walorny
MAY 9, 2018

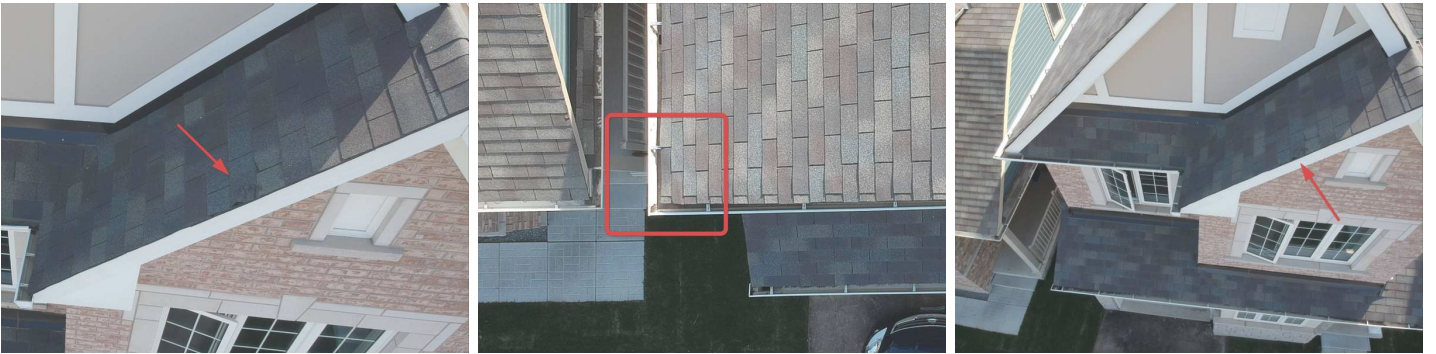
2.1.1 Coverings

DAMAGED (GENERAL)

Roof coverings showed moderate damage. Recommend a qualified roofing professional evaluate and repair.

Roof sheathing damage

Recommendation
Contact your builder.

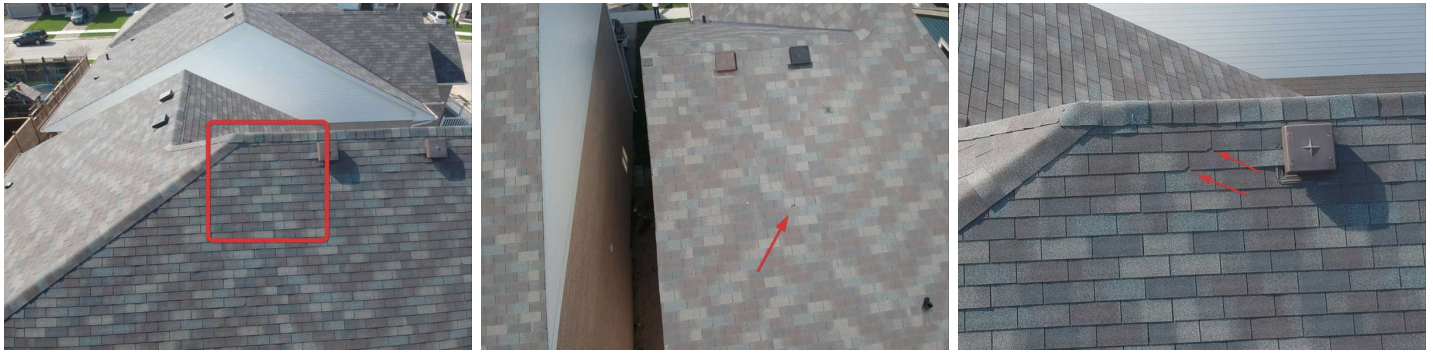
2.1.2 Coverings

SHINGLE CRACKED/BROKEN

Roof had cracked/broken tiles. Recommend a qualified roof contractor repair or replace to prevent moisture intrusion and/or mold.

Recommendation
Contact your builder.

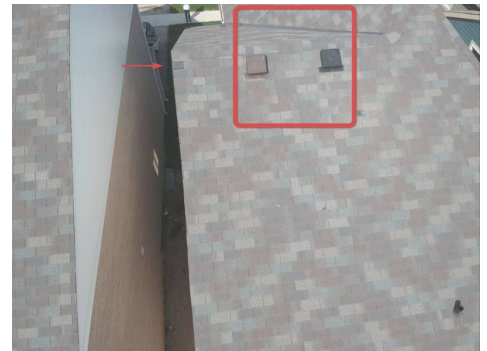
2.1.3 Coverings

SHINGLES MISSING

Observed areas that appeared to be missing sufficient coverings. Recommend qualified roofing contractor evaluate & repair.

2 different colour roof vents

Contact your builder.

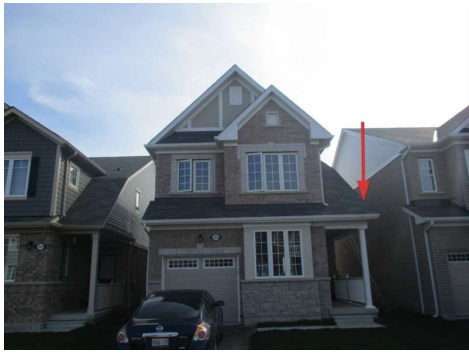
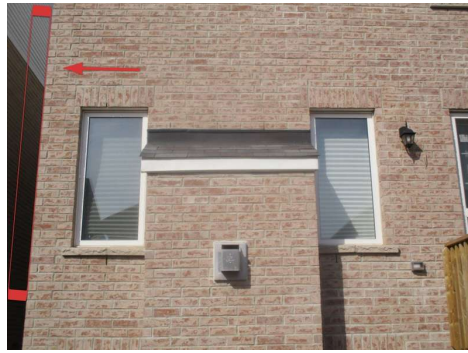
2.2.2 Roof Drainage Systems

DOWNSPOUTS MISSING

Home was missing downspouts in one or more areas. This can result in excessive moisture in the soil at the foundation, which can lead to foundation/structural movement. Recommend a qualified contractor install downspout extensions that drain at least 6 feet from the foundation.

Contact your builder.

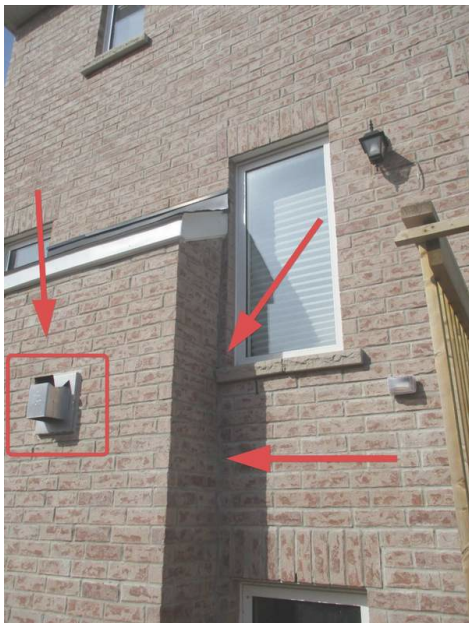
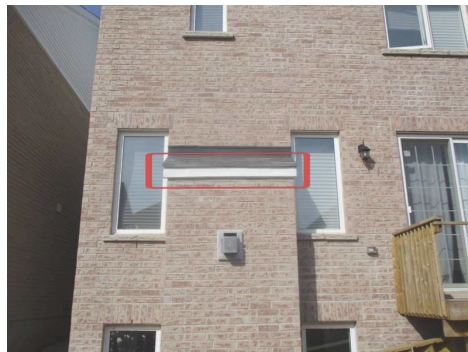
2.2.3 Roof Drainage Systems

GUTTERS MISSING

There are no gutters present on the structure. Gutters are recommended because they collect rain water from the roof and direct it away from the building.

Poor drainage at chimney capping.
Signs of water penetration at through
gas exterior venting.

Contact your builder.

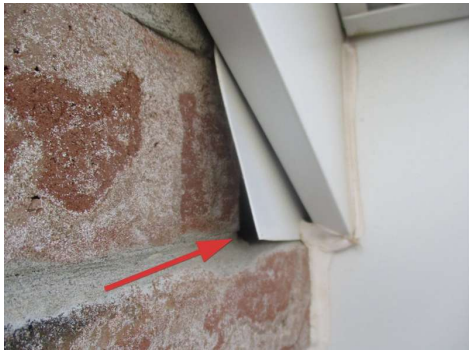
2.3.1 Flashings

LOOSE/SEPARATED

Flashings observed to be loose or separated, which can lead to water intrusion and/or mold. Recommend a qualified roofing contractor repair.

Area for water penetration and pests

Contact your builder.

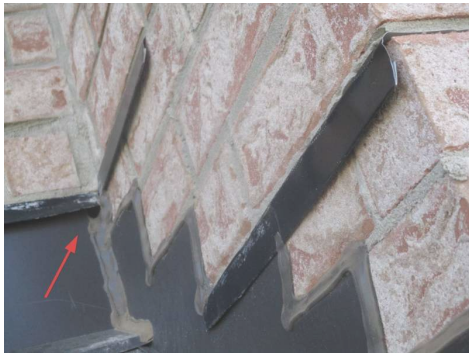
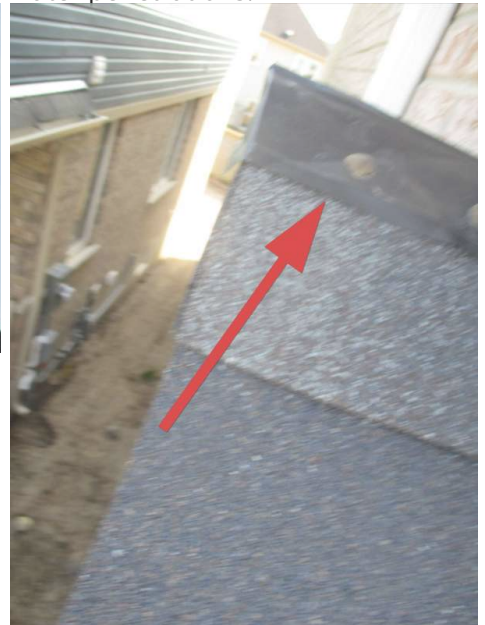
Poor workmanship multiple areas for water penetrations.

Exposed nails will rust and become point for water penetration.

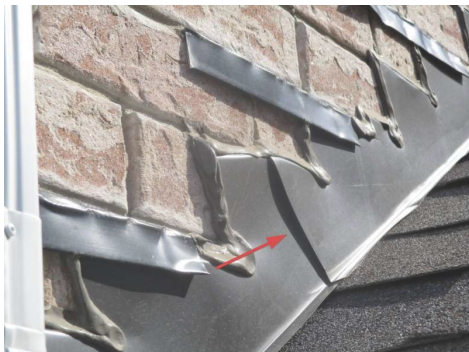
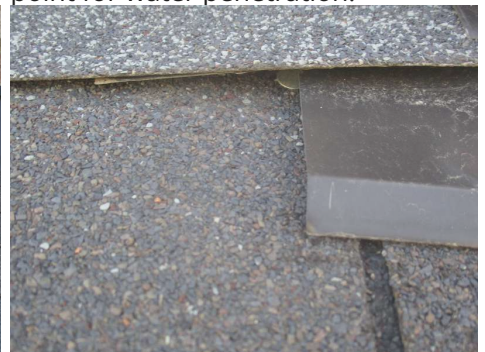
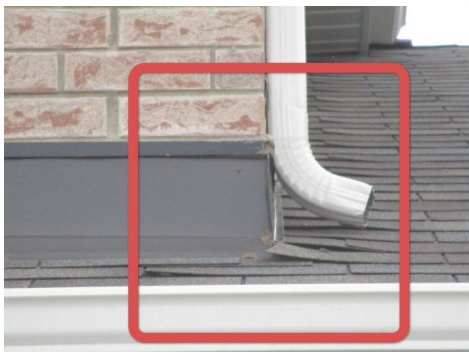
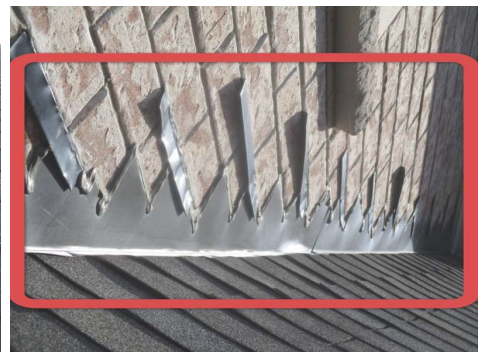
Poor workmanship multiple areas for water penetrations.

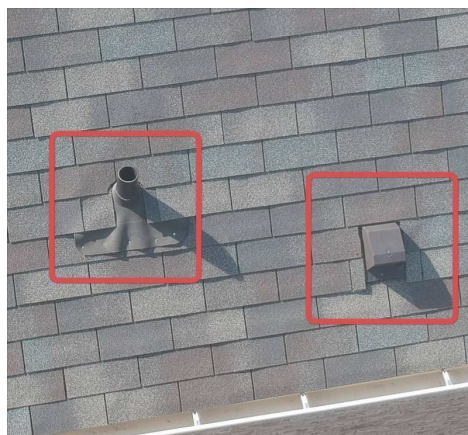
2.4.1 Skylights, Chimneys & Other Roof Penetrations

ROOF PENETRATION FLASHINGS

More than one or more roof vent flashings poorly or improperly installed during [roof installation](#). It is a vital element of the roofing system. It keeps your roof waterproof and airtight, sealing the outer envelope that protects the interior of your home from weather and other elements. Recommend a qualified roofing contractor to repair or replace.

Poor construction practices, multiple area for water penetrations and moisture damage.

Contact your builder.

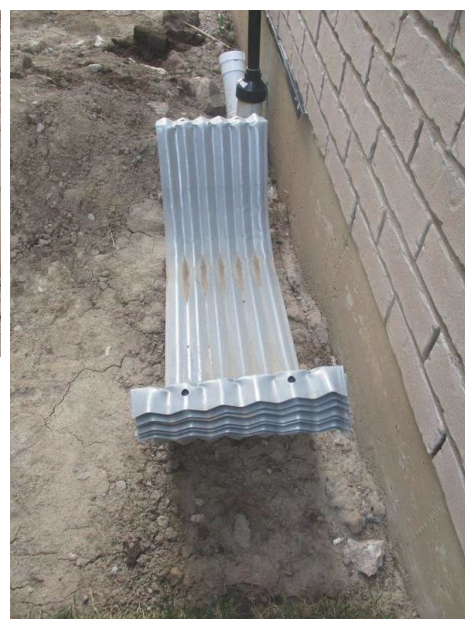
Basement slider window well and drainage systems missing at the time of the inspection. Recommend well and drainage to be installed immediately to prevent water and moisture penetration to the basement foundation.

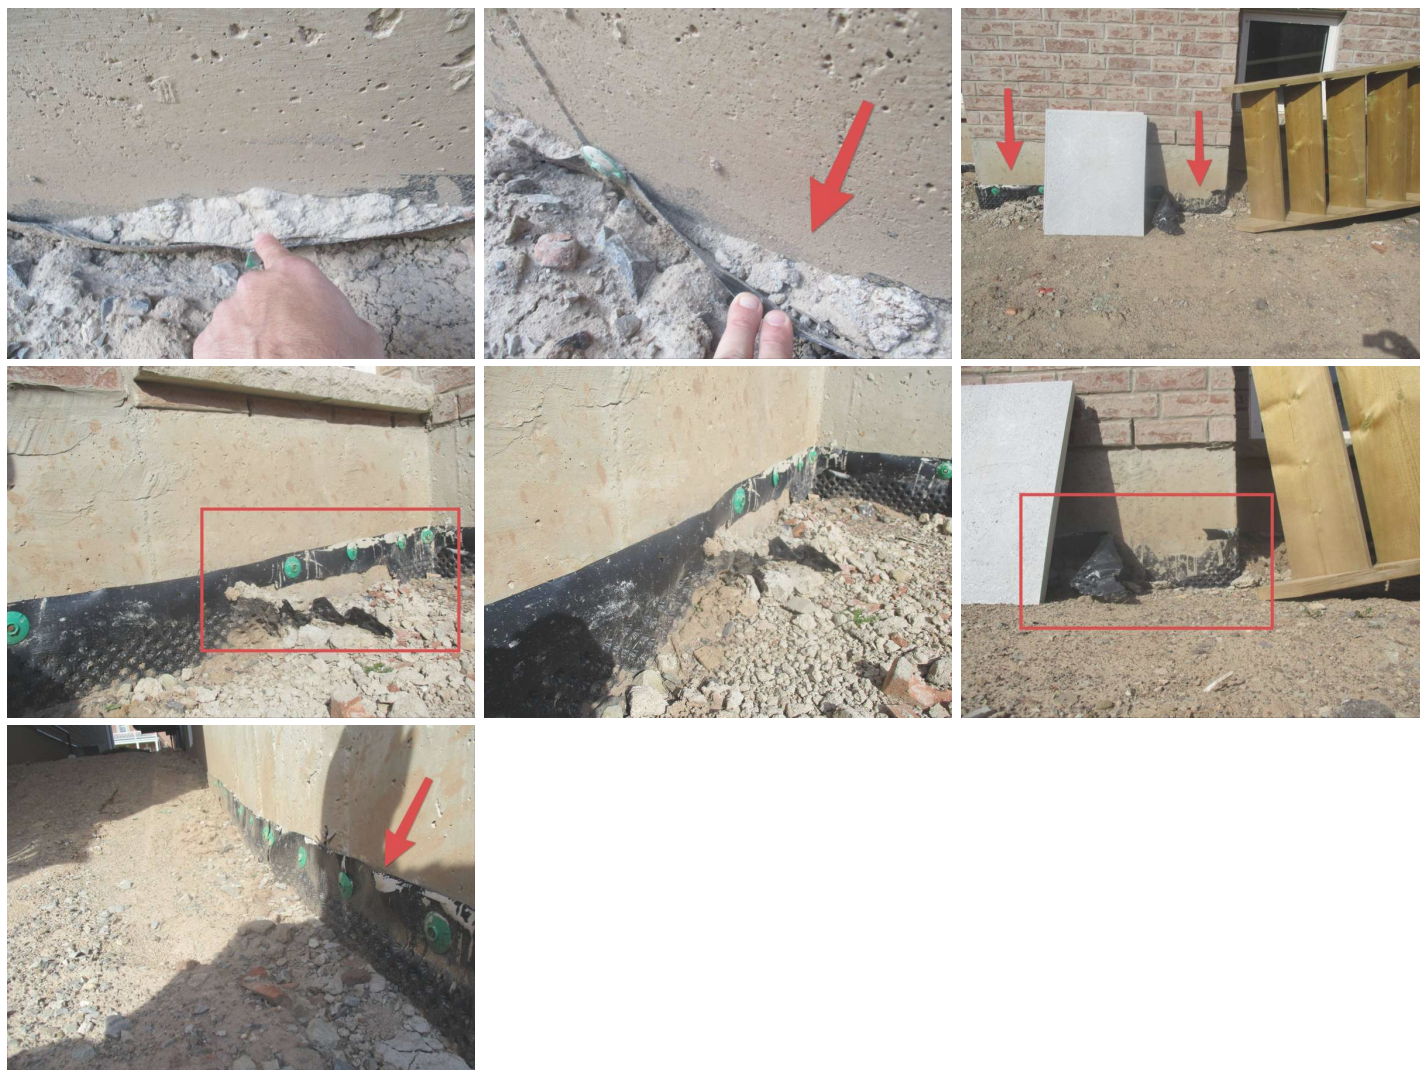
3.1.1 Foundation

IMPROPER CONSTRUCTION PRACTICES

Improper or sub-standard construction practices were noted at the foundation wall meeting waterproofing. Recommend a qualified contractor to evaluate and advise on how to bring the construction up to standards.

Missing waterproofing sealant

Contact your builder.

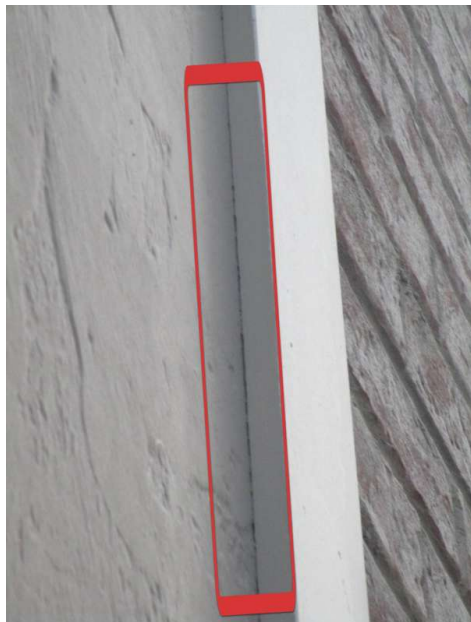
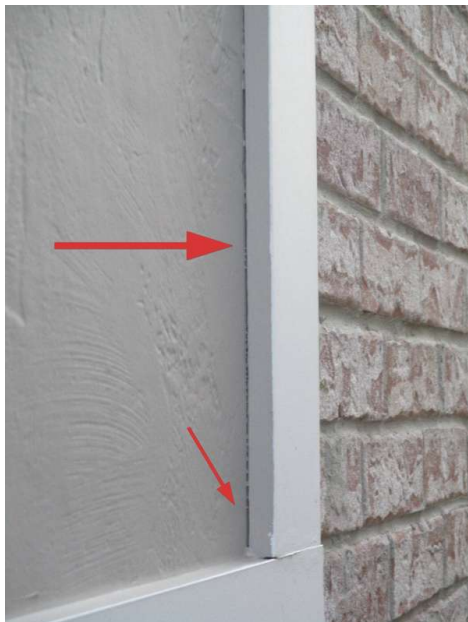
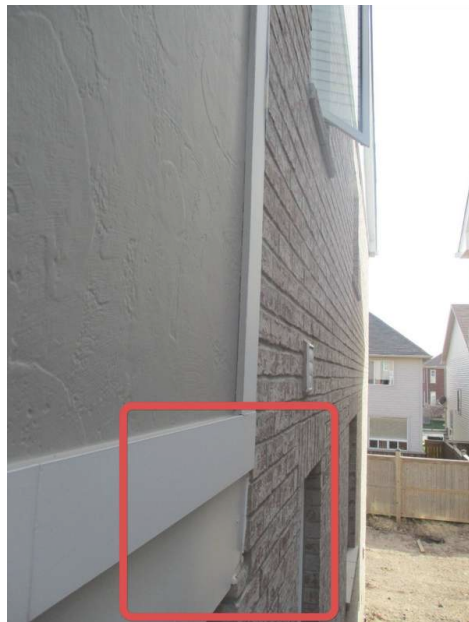
3.2.1 Siding, Flashing & Trim

EVIDENCE OF WATER INTRUSION

Exterior cladding/sidings showed signs of water intrusion. This could lead to further deterioration and/or mold or moisture damage. Flashing & trim pieces were improperly installed, which could result in moisture intrusion and damaging leaks. Recommend a qualified siding contractor evaluate and repair. Recommend a qualified contractor evaluate and repair or replace to prevent further damage to the home.

Multiple areas for water penetration and moisture damage.

Poor workmanship, missing flashings.

Contact your builder.

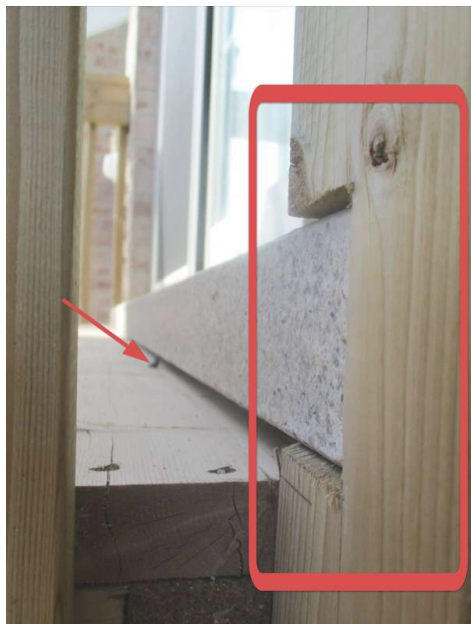
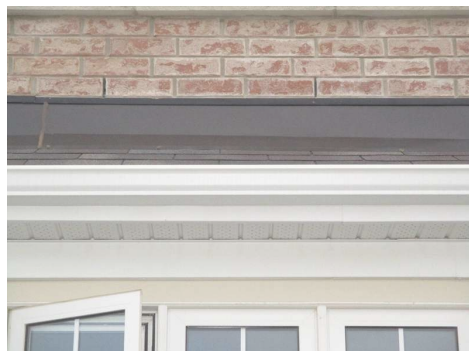
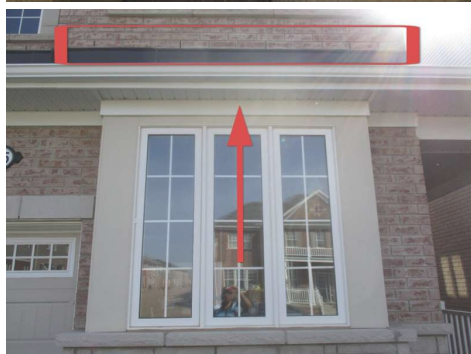
Poor drainage, interior areas showing sign of water damage at ceiling.

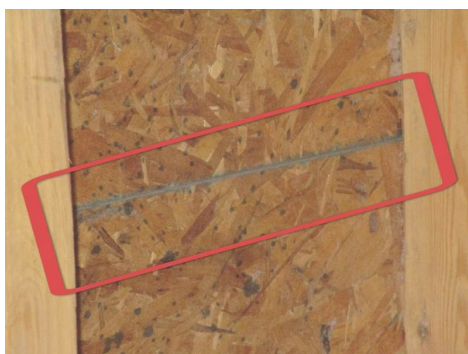
Signs of day light showing at attic cladding areas. Multiple areas of for water penetration and moisture damage. Missing waterproofing membrane, recommend repair or replace.

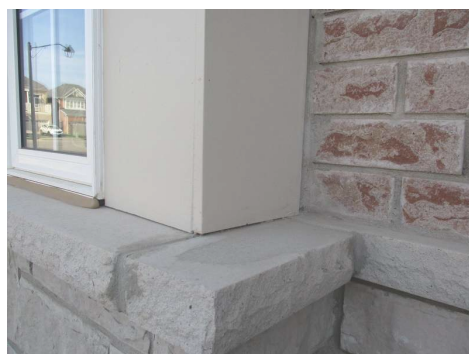
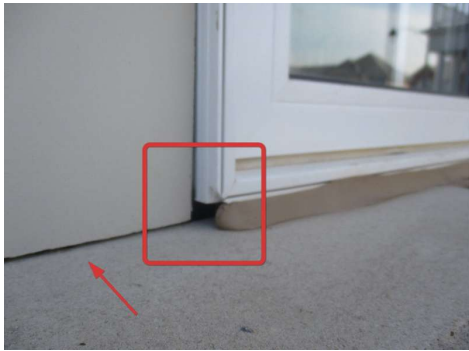
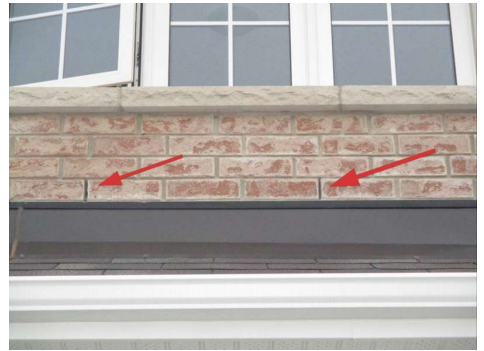
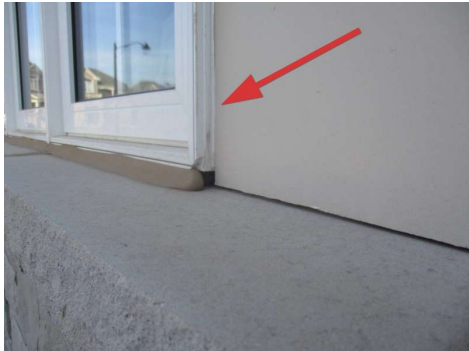
Poor constructions practices, one or more windows incorrectly installed.

Poor construction practices, multiple area for water penetration and moisture damage. Recommend repair or replace to prevent further damage.

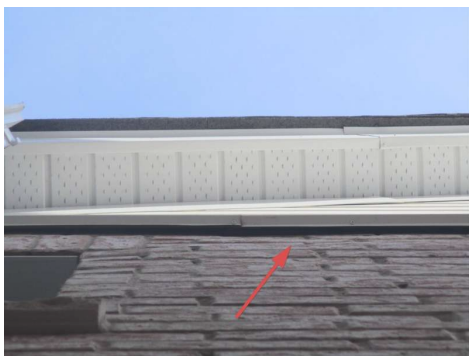
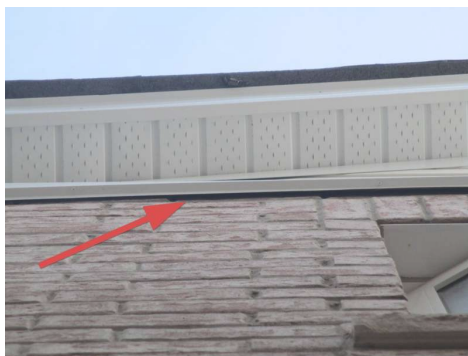
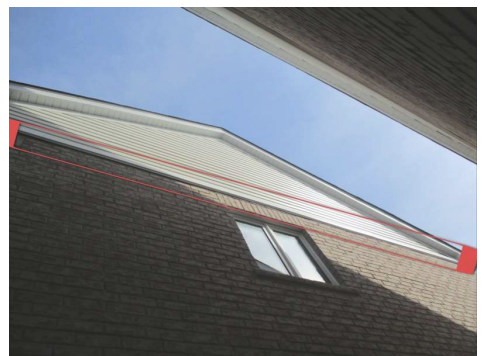
3.2.2 Siding, Flashing & Trim

WARPING/BUCKLING

Vinyl siding was warping or buckling in areas. This is often as a result of nailing siding boards to tight to the home, preventing expansion/contraction. Recommend a qualified siding contractor evaluate and repair.

Contact your builder.

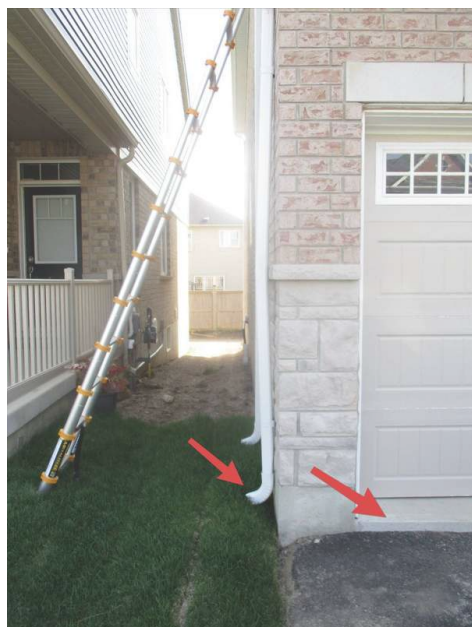
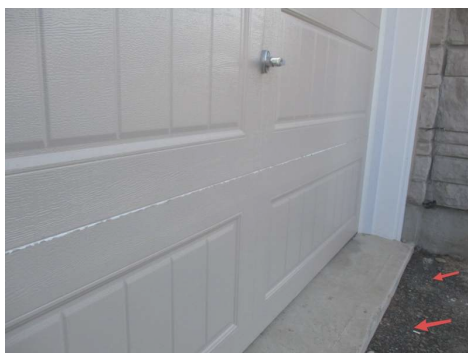
3.3.1 Walkways, Patios & Driveways

DRIVEWAY DRAINING TOWARDS HOME

The driveway has a negative slope and drains towards the structure. Recommend a driveway contractor evaluate and repair.

Contact your builder.

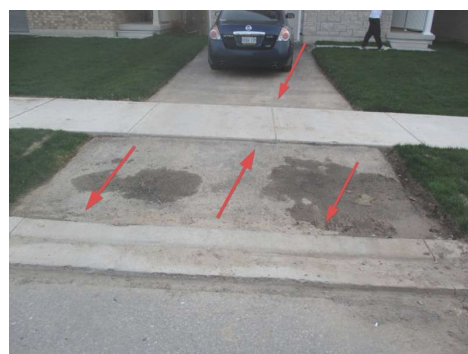
3.3.2 Walkways, Patios & Driveways

DRIVEWAY TRIP HAZARD

Ashphalt driveway showing sign of trip hazards located one or more areas. Client waiting for final asphalt installation.

Contact your builder.

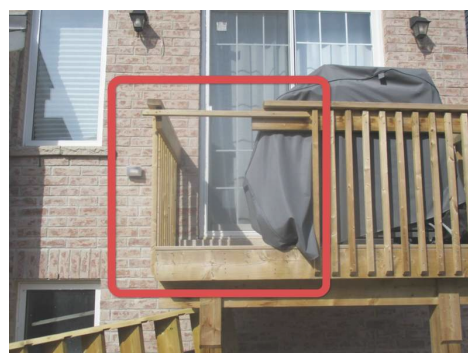
3.4.1 Decks, Balconies, Porches & Steps

RAILING UNSAFE

There is an unsafe opening in the railing. The spacing on the rail should not exceed 4". An opening greater than 4" is a serious safety hazard especially for children. Recommend repair or replacement to avoid serious injury.

Contact your builder.

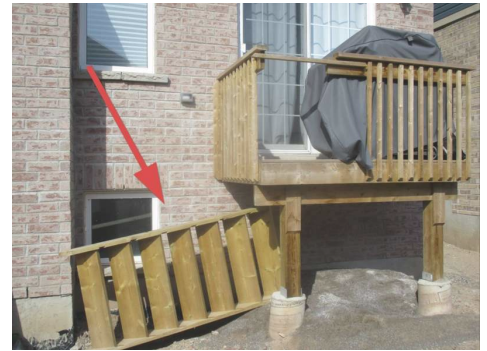
3.4.2 Decks, Balconies, Porches & Steps

STAIRS -MISSING

One or more sections of the exterior stairs are missing. Recommend qualified contractor evaluate & repair.

Contact your builder.

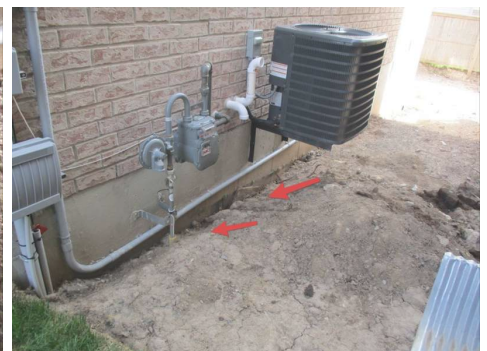
3.6.1 Vegetation, Grading, Drainage & Retaining Walls

NEGATIVE GRADING

Grading is sloping towards the home in some areas. This could lead to water intrusion and foundation issues. Recommend qualified landscaper or foundation contractor regrade so water flows away from home.

Contact your builder.

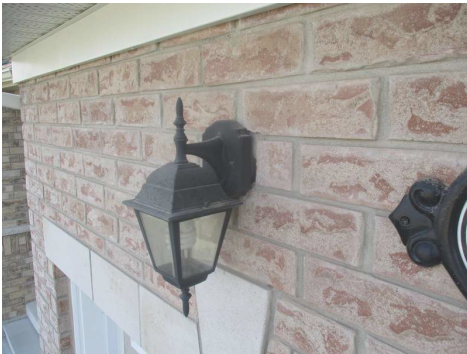
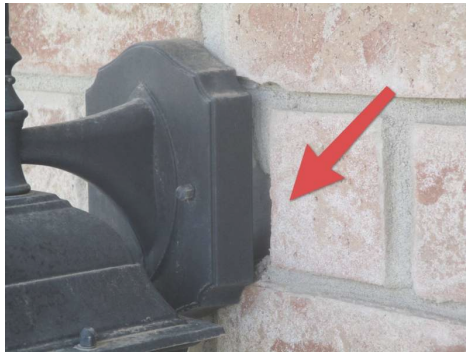
3.7.1 Lighting

WEATHERPROOFING

Improper construction practices, exterior light must be weather tight to prevent moisture damage. Recommend qualified professional to sealant/caulk areas where deficient.

Contact your builder.

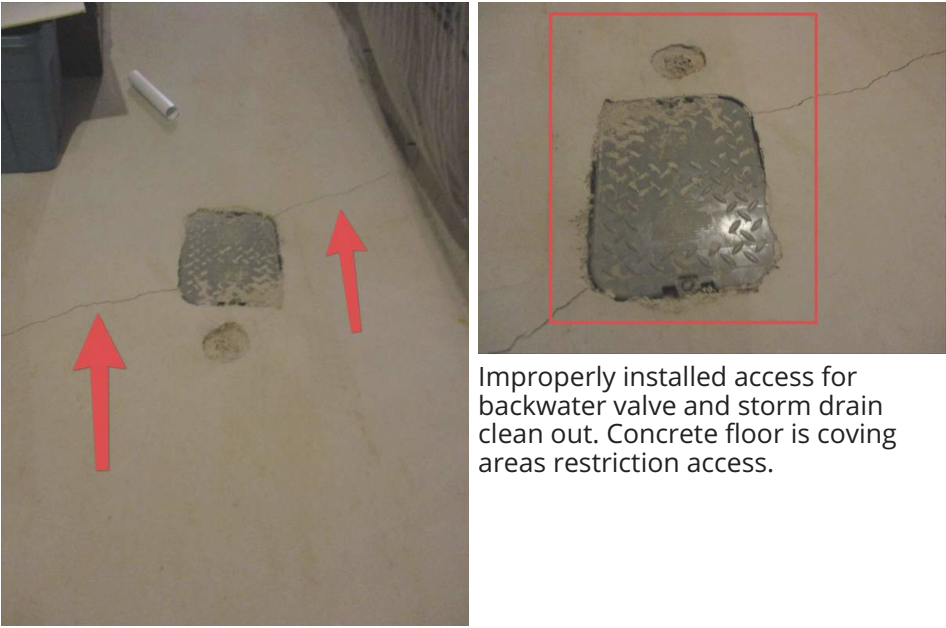
4.2.1 Floor Structure

CONCRETE SLAB SHIFTING/CRACKING

Concrete slab was found to be cracking at the floor around backwater valve and storm drain access. This can be caused by moisture intrusion and/or soil movement. Recommend a concrete contractor evaluate and repair to preserve integrity of the home.

Improperly installed access for backwater valve and storm drain clean out. Concrete floor is coving areas restriction access.

Recommendation
Contact your builder.

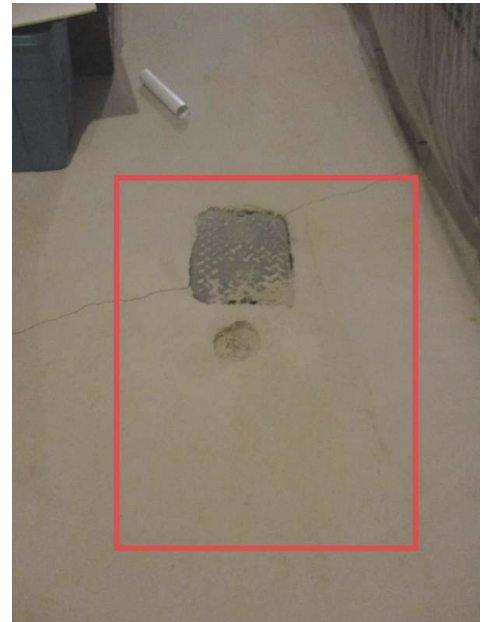
4.2.2 Floor Structure

EVIDENCE OF WATER INTRUSION

There were signs of water intrusion in the underlying floor structure. Recommend identifying source of moisture and repairing.

Contact your builder.

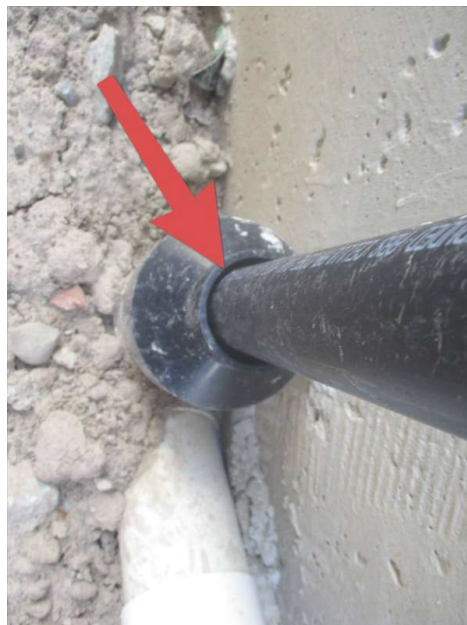
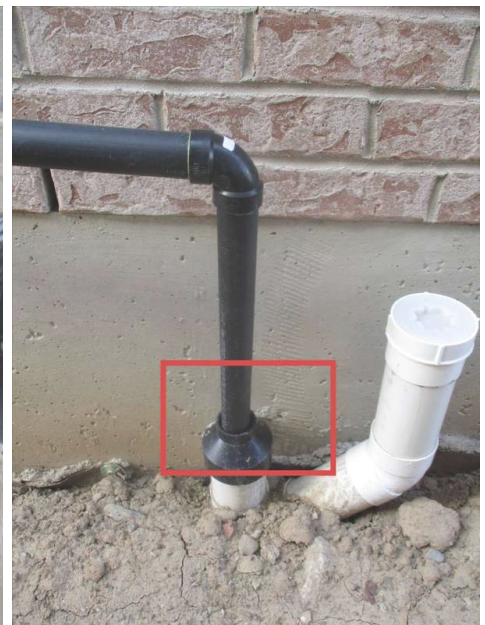
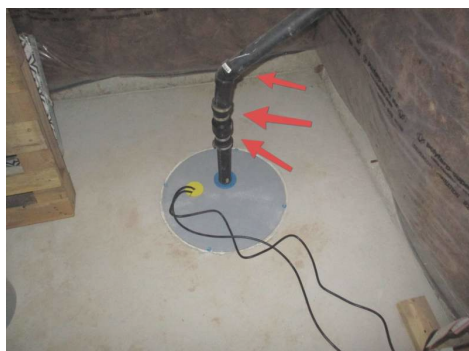
4.3.1 Sump Pump

IMPROPER INSTALLATION

Sump pump had sub-standard installation. Recommend a qualified plumber evaluate and properly install.

Loose

Contact your builder.

Seal joints to prevent piping failure.

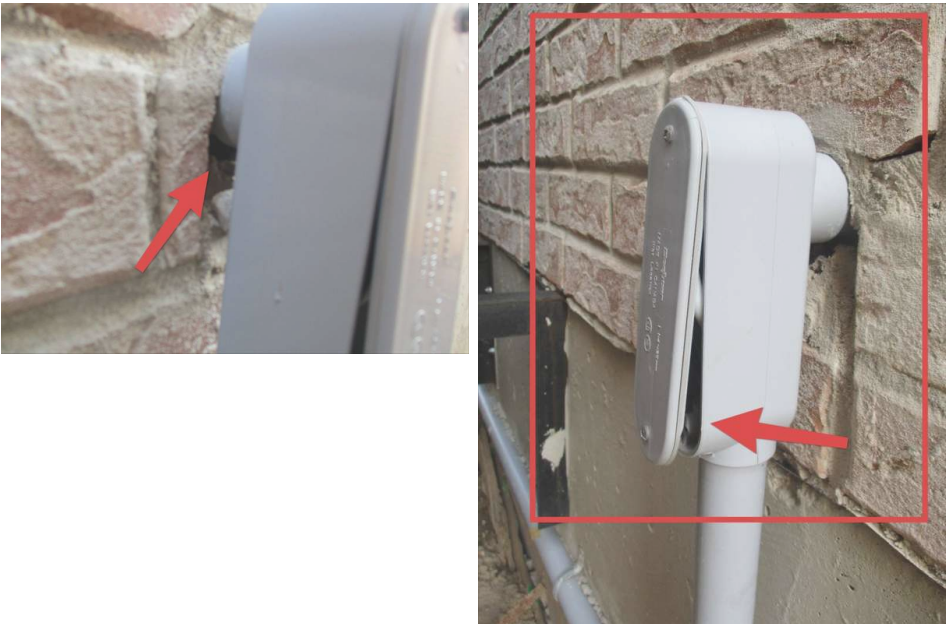
5.1.1 Service Entrance Conductors

WATER INTRUSION

There is possible water intrusion and the meter / service entrance. Moisture can deteriorate the electrical equipment. Recommend that a licensed electrician repair / replace as needed.

Recommendation
Contact your builder.

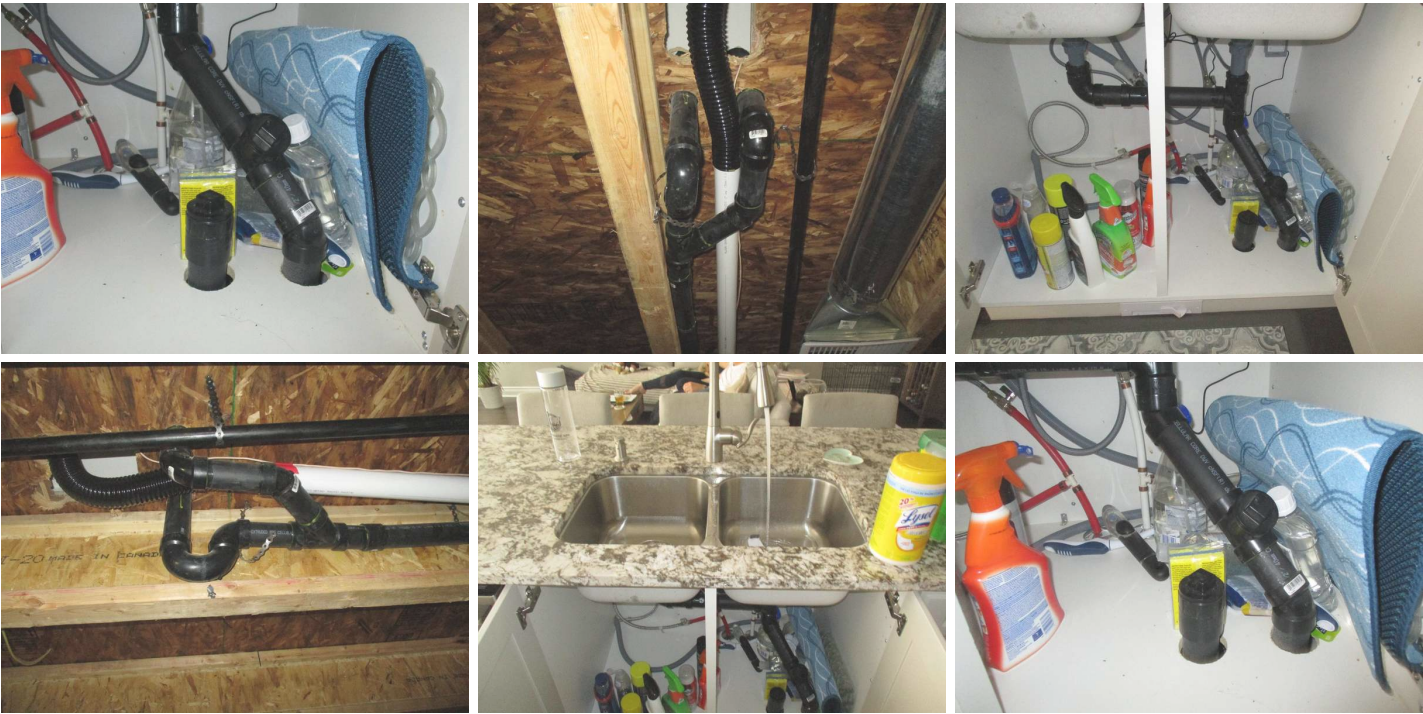
6.1.1 Kitchen Sink

IMPROPER INSTALLATION

Improper installation of the drian and waste systems for kitchen sink. Poor construction practices, missing venting at island sink, Improper trap configurantion as well.

Plumbing **trap** is a device which has a shape that uses a bending path to capture water to prevent sewer gases from entering buildings, while allowing waste to pass through also needs to have a proper clean-out installed. Recommend professional licence plumber to repair or replace and bring up to proper standards.

Recommendation
Contact your builder.

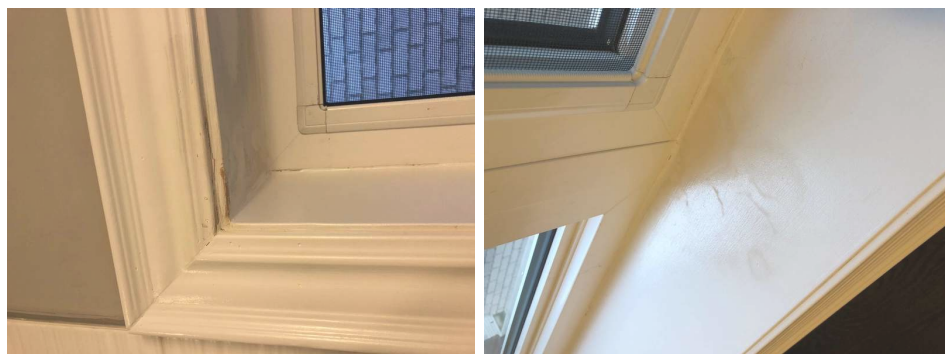
7.2.1 Windows

IMPROPER INSTALLATION

Windows appear to not be operating properly due to substandard installation. Signs of water and moisture penetrations and also losing energy (poor caulking methods) Recommend window specialist evaluate.

Contact your builder.

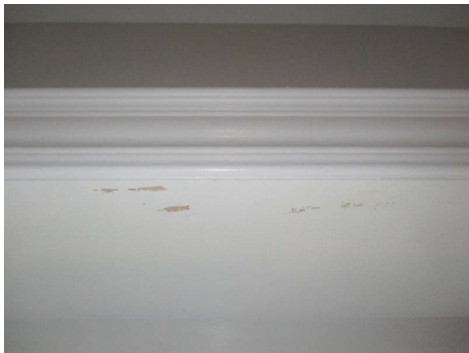
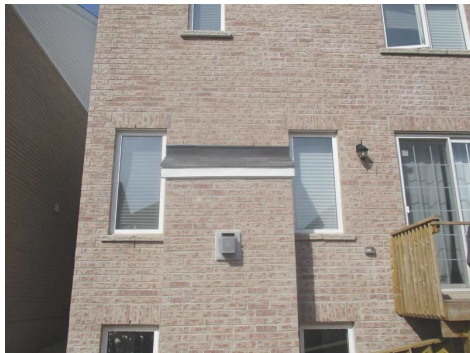
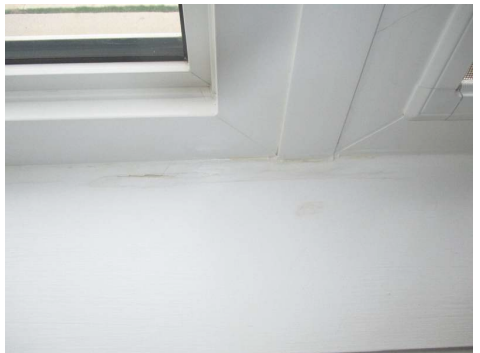
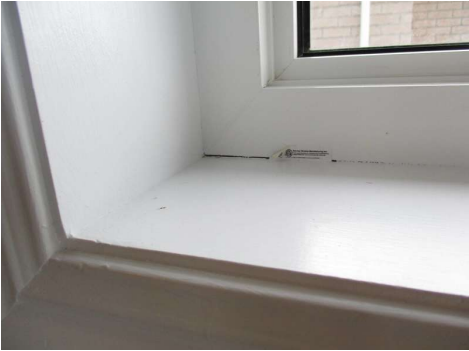
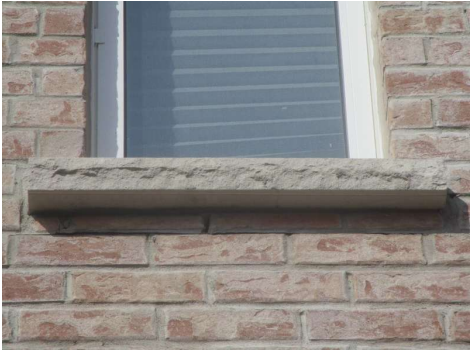
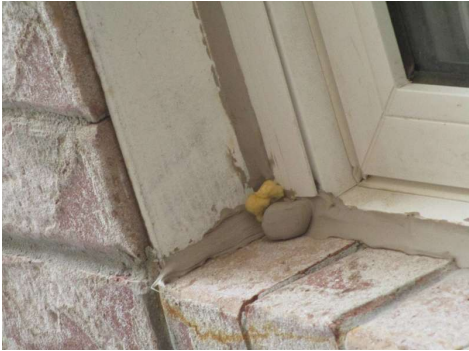
8.2.1 Windows

IMPROPER INSTALLATION

Windows appear to not be operating properly due to substandard installation. Signs of water and moisture penetrations and also losing energy (poor caulking methods) Recommend window specialist evaluate.

Contact a qualified window repair/installation contractor.

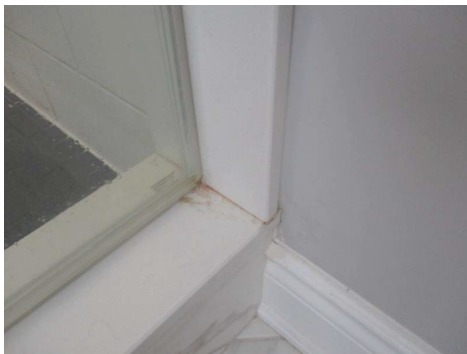
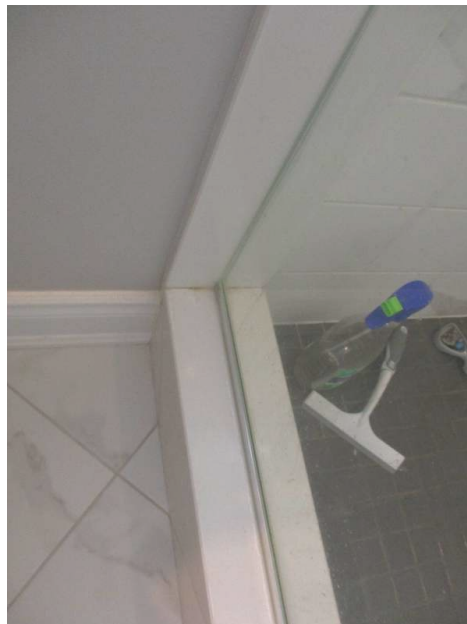
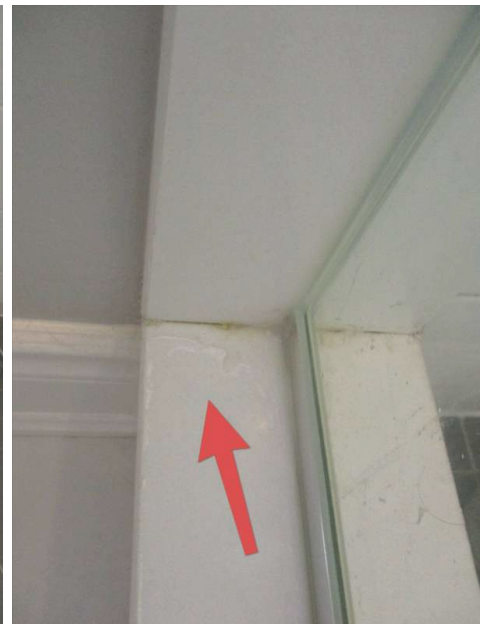
SHOWER GLASS & DOOR

Master shower showing signs of water and moisture near the glass and door. Sealing method appears to have been installed substandard.

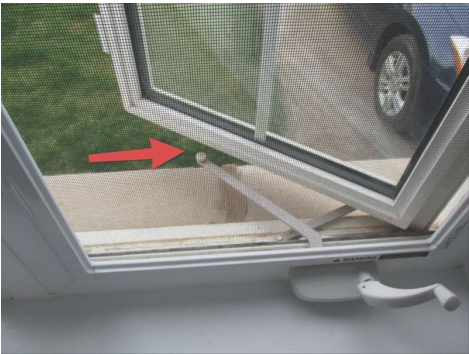
DAMAGED

One or more windows appears to have general damage, but are operational. Recommend a window professional clean, lubricate & adjust as necessary.

Contact your builder.

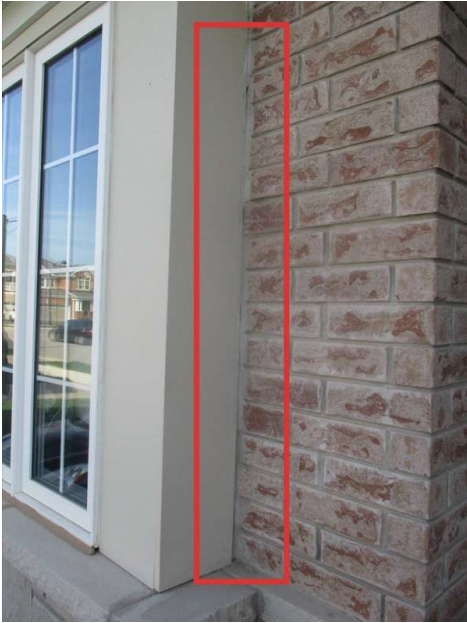
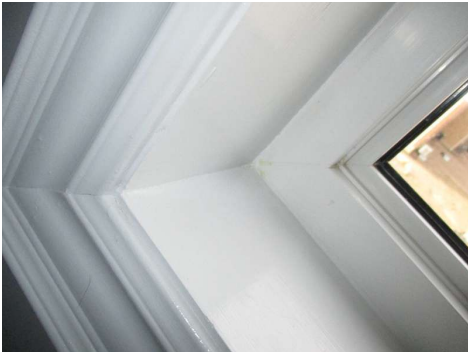
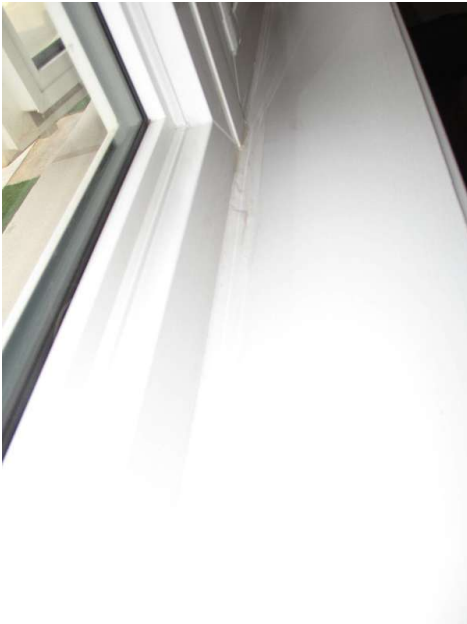
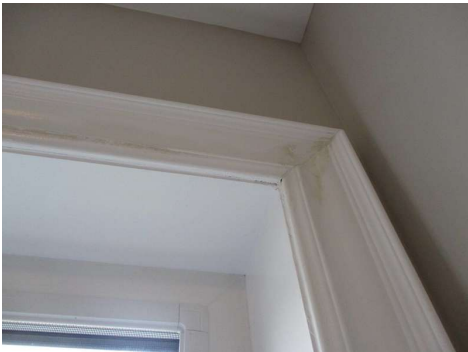
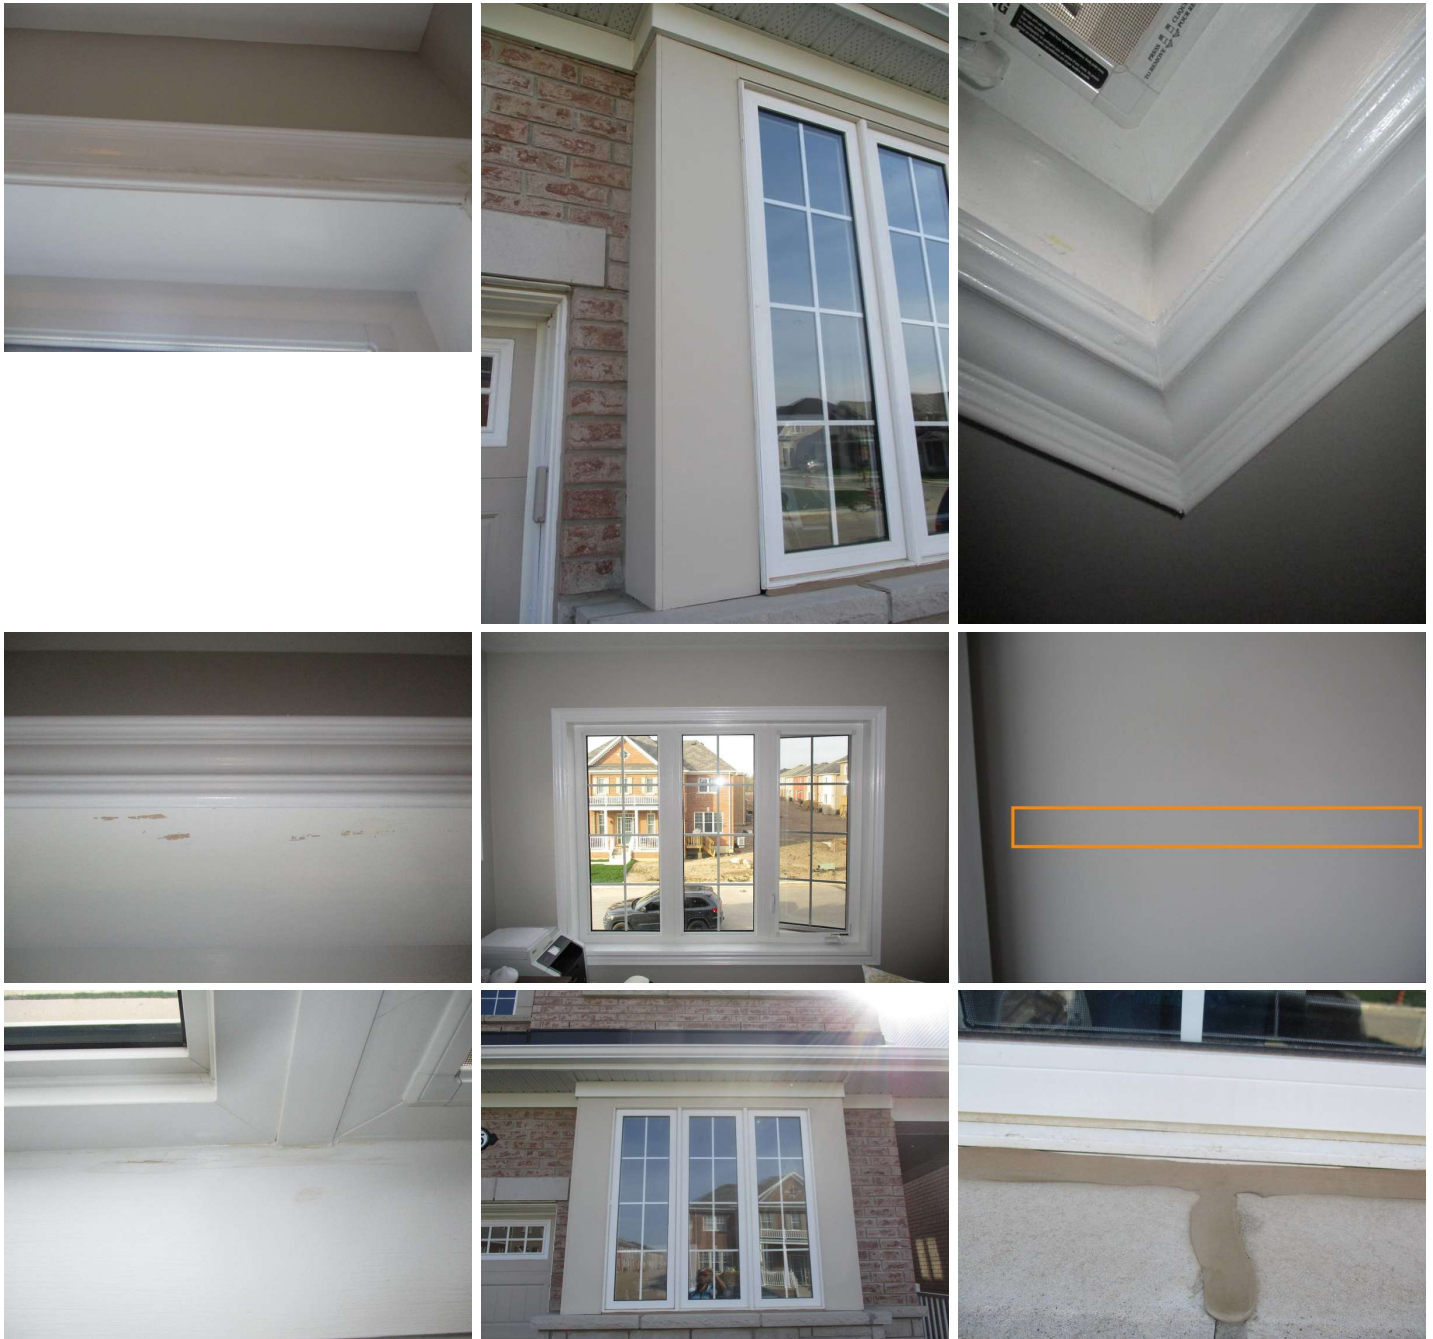
13.1.2 Windows

IMPROPER INSTALLATION

Windows appear to not be operating properly due to substandard installation. Recommend window specialist evaluate. Showing signs of moisture and water damage at sills interior an exterior.

Contact a qualified window repair/installation contractor.

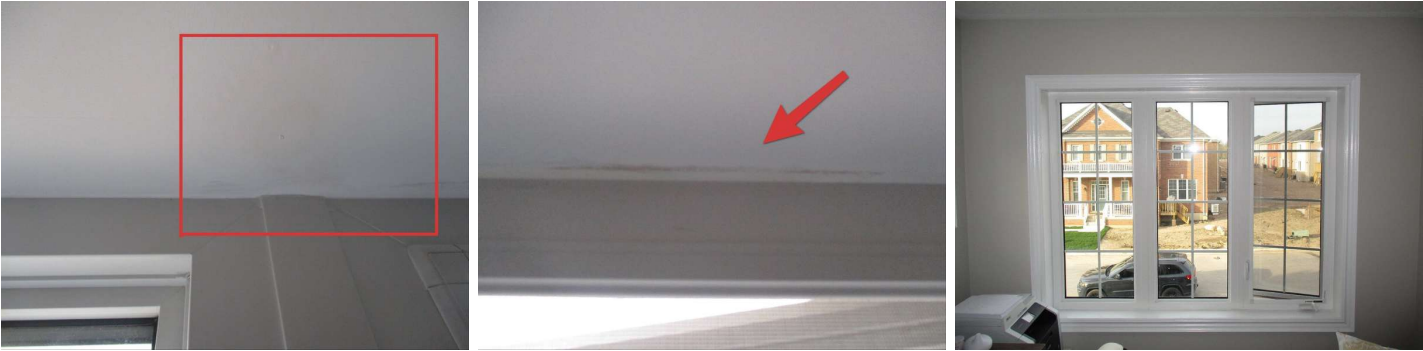
STAIN(S) ON CEILING

There is a stain on ceiling/wall that requires repair and paint. Source of staining should be determined.

Contact your builder.

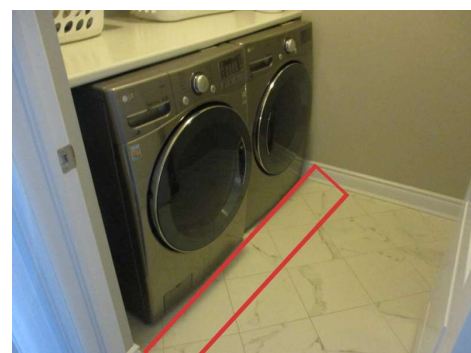
14.2.1 Drain, Waste, & Vent Systems

EMERGENCY DRAIN/CURB MEMBRANE

If the washing machine or its hoses leak onto the floor, the leak can spread onto the hardwood in nearby rooms on the same level or drip down onto the basement. Leaks in your laundry room can lead to major repairs in other areas of your home. You can waterproof your laundry room floor to prevent problems in this area.

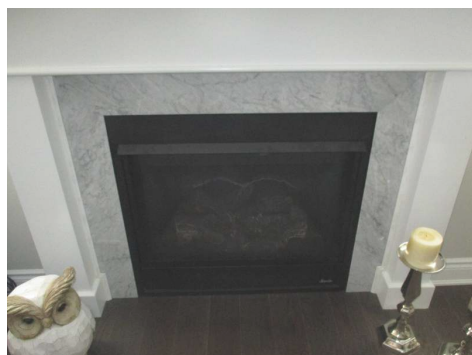
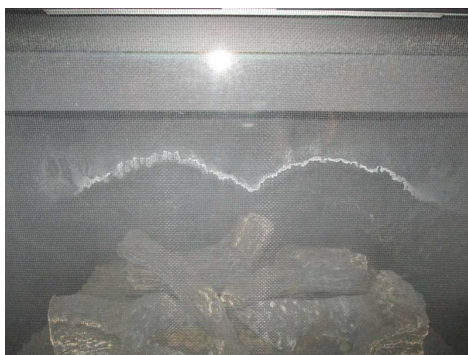
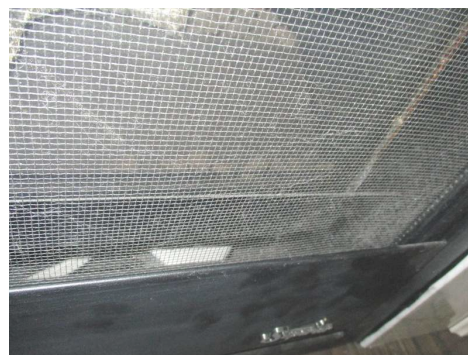
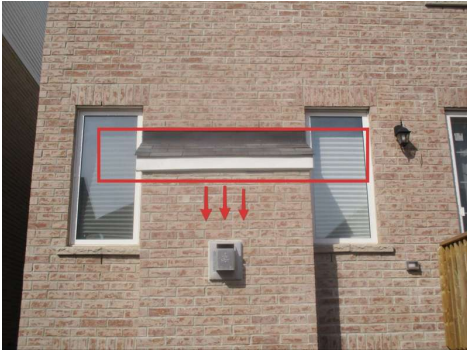
VENT IMPROPERLY INSTALLED

Gas fire place exhaust vent was improperly installed. Showing signs of water penetration and moisture. Recommend a qualified HVAC contractor evaluate and repair.

Living room gas fireplace showing signs of water penetration entering at the exterior vent. Recommend contracting a qualified contractor to prevent further damage to the home.

Missing gutters or missing rain cover.

Contact your builder.

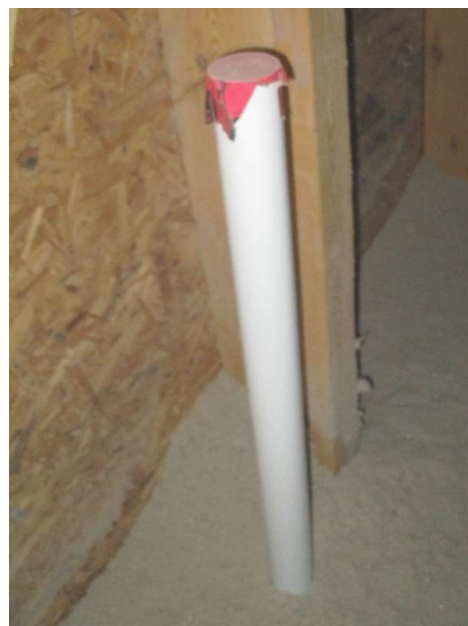
IMPROPER INSTALLATION

An unknown white pvc pipe venting into the attic was installed. Recommend a qualified contractor evaluate and correct.

Unknown white PVC piping located venting into the attic areas. Recommend qualified professional to further investigate the situation.

Contact your builder.

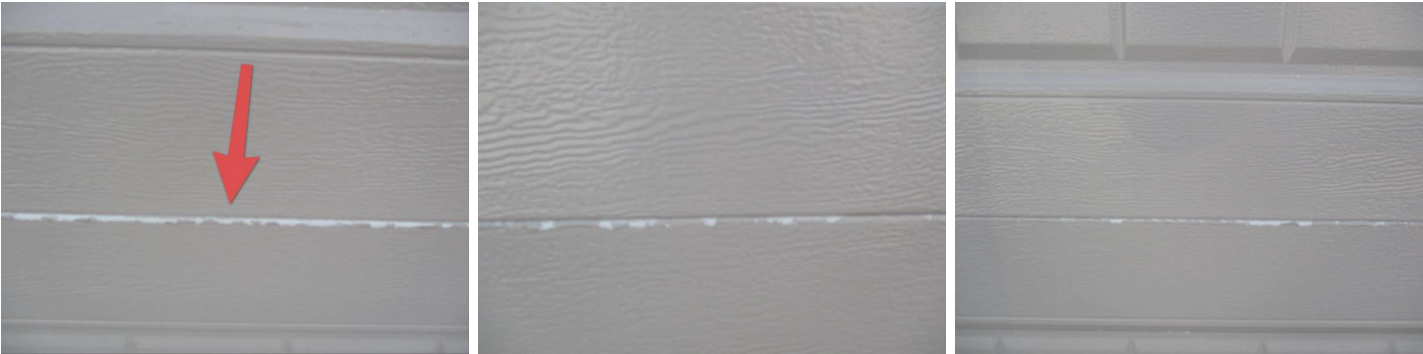
PANEL DAMAGE

Garage door panel is damaged and may need repair/replacement. Recommend a qualified garage door contractor evaluate.

Contact your builder.
