HOME INSPECTION REPORT

518 Meadowwood Dr SW
Olympia WA 98502

MARCH 22, 2021

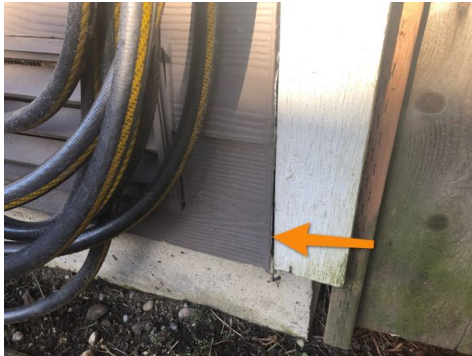
3.5.2 Exterior Siding Notes

TOUCH-UP PAINT/CAULK

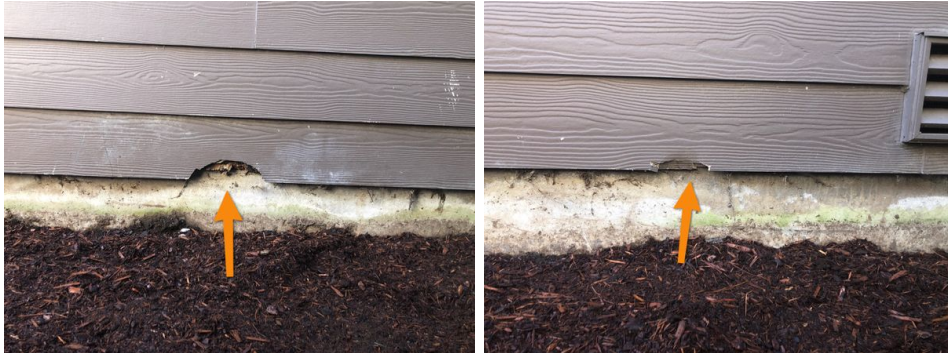
3.5.4 Exterior Siding Notes

DAMAGED SIDING

Observed areas of damaged siding around the residence that should be repaired to help prevent moisture intrusion issues. These damaged areas can allow moisture to penetrate the walls if not properly repaired.

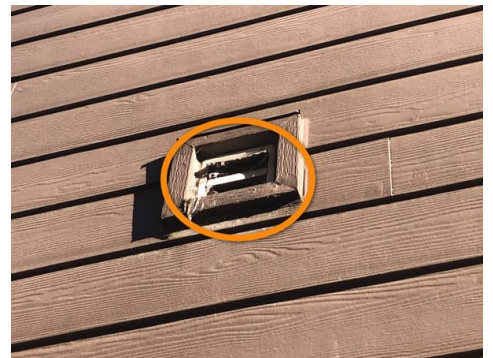
3.5.5 Exterior Siding Notes

DRYER VENT DEBRIS

The dryer vent is full of debris. We recommend cleaning to allow for proper venting of the dryer.

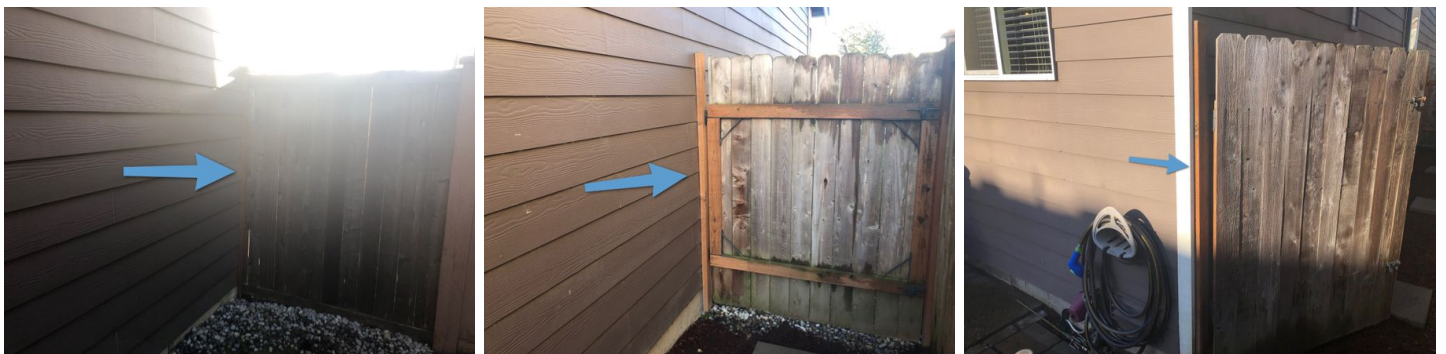
3.5.6 Exterior Siding Notes

FENCE ATTACHED TO HOUSE

Fence(s) were attached to or in contact with the building exterior. Such attachments can serve as a pathway for wood-destroying insects and can retain moisture against the exterior after it rains. We recommend repairs as necessary so there is at least a 2-inch gap between rails and building exteriors.

Contact a qualified professional.

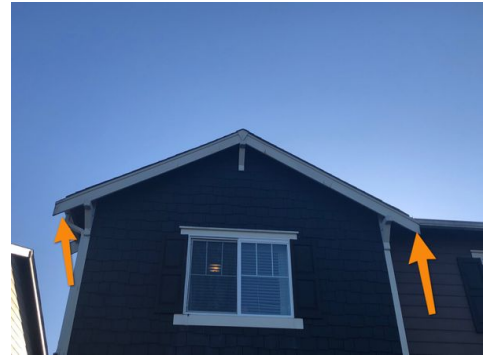
3.7.1 Fascia, Trim & Eaves

Sections of the fascia board or wood trim around the residence are slightly weathered, and should be serviced as necessary to prevent further deterioration. Service such as scraping, repainting and sealing.

Contact a qualified handyman.

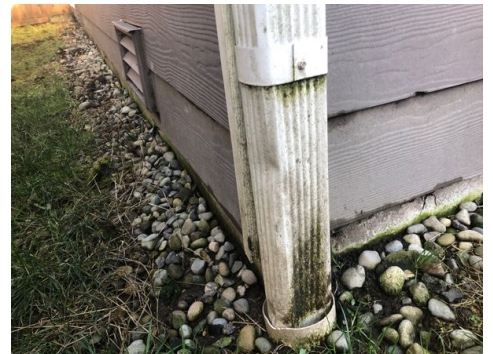
3.9.1 Downspouts

DAMAGED/DENTED DOWNSPOUT

There is a downspout that is dented/damaged. Recommend repairs or replacement.

Contact a qualified professional.

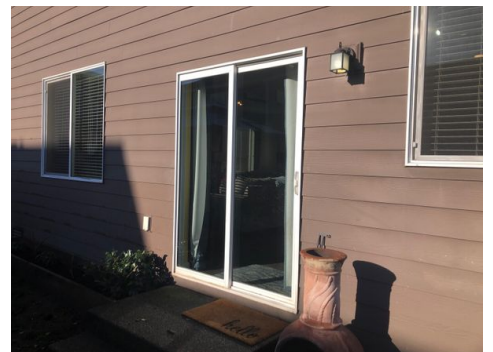
3.10.1 Exterior Doors

SLIDING DOOR SCREEN MISSING/DAMAGED

The rear sliding screen is missing or needs work. Have it repaired by a qualified contractor.

Contact a qualified handyman.

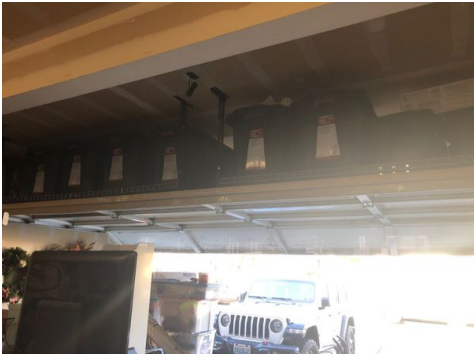
There was not a garage door opener present during the inspection. Recommend installing as desired.

Contact a qualified garage door contractor.

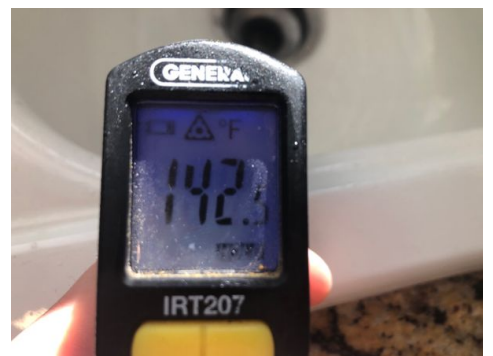
The water temperature is too high and is a potential hazard. Recommend water temperature be lowed not to exceed 120 degrees.

Recommended DIY Project

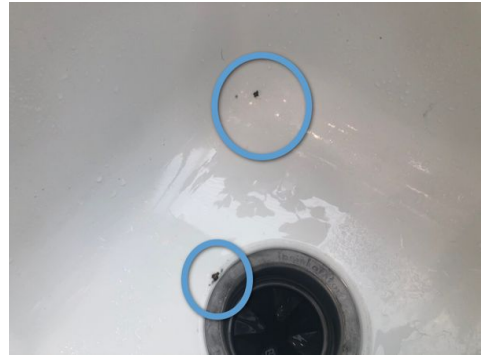
SINK CHIPPED/DAMAGED

The kitchen sink has chips/damage. Recommend monitoring and repairing as needed.

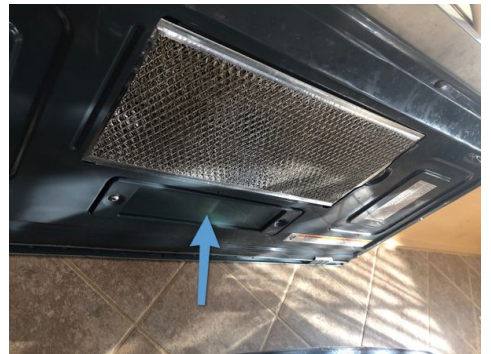
9.5.1 Exhaust Fan Notes

HOOD BULB MISSING/BURNED OUT

The headlight bulb is missing or burnt out. Recommend installing me testing.

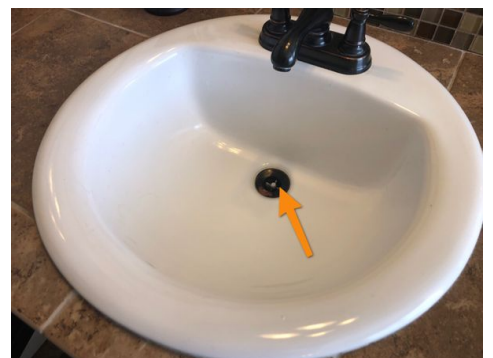
SINK STOPPER(S) MISSING

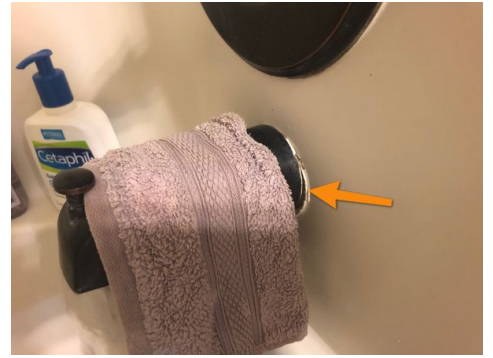
11.4.1 Tub-Shower

CAULKING OR SEALING

I recommend caulking or sealing around shower valves and faucets etc to help prevent moisture intrusion behind or into the walls. Monitoring these areas is also recommended to help ensure an adequate seal is in place.

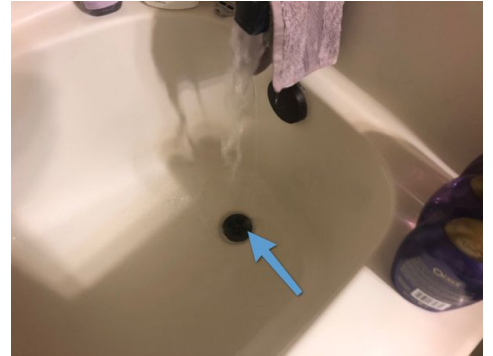
11.4.2 Tub-Shower

TUB STOPPER IS MISSING

The mechanical tub stopper is missing or incomplete and should be repaired or replaced.

Recommended DIY Project

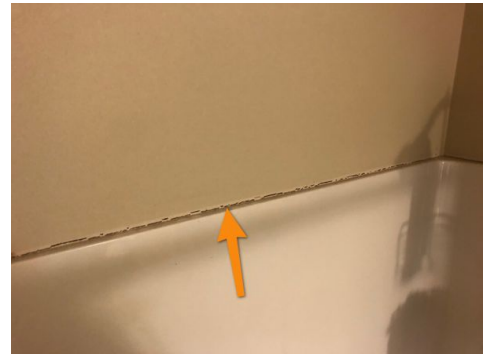
11.4.3 Tub-Shower

MISSING OR DETERIORATED CAULK/GROUT

The tub surround is has missing or deteriorated caulk/grout. Recommend caulking or sealing to prevent moisture intrusion.

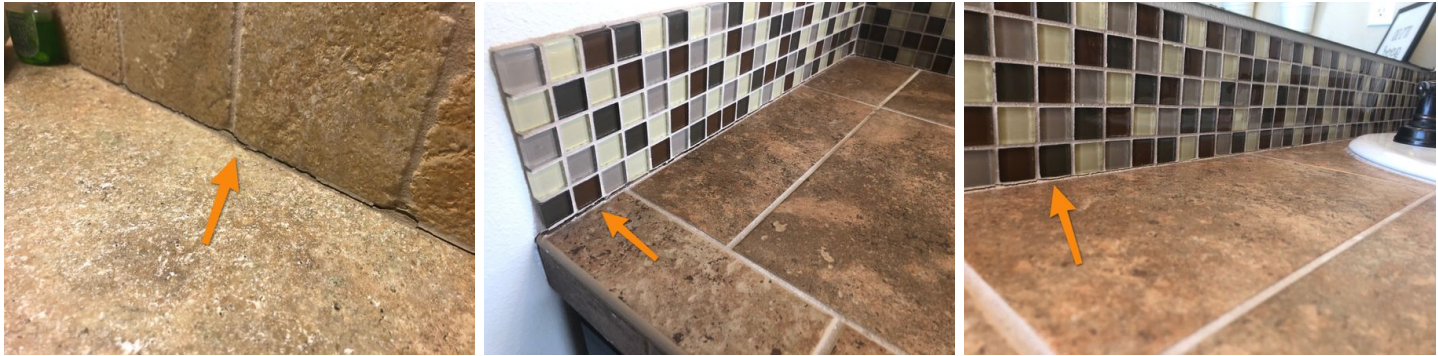
11.6.1 Countertop

MISSING OR DETERIORATED CAULK/GROUT

The caulking or grout for the backsplash is missing, has gaps and/or not installed properly. We advise caulking/grout be installed and/or gaps filled to prevent possible water intrusion.

Recommended DIY Project

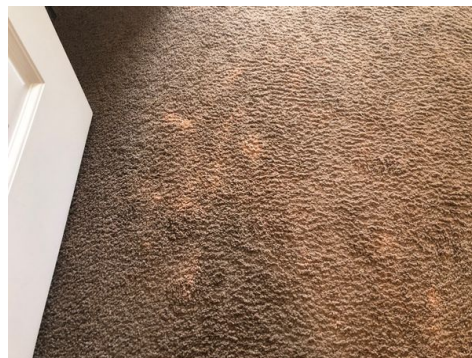
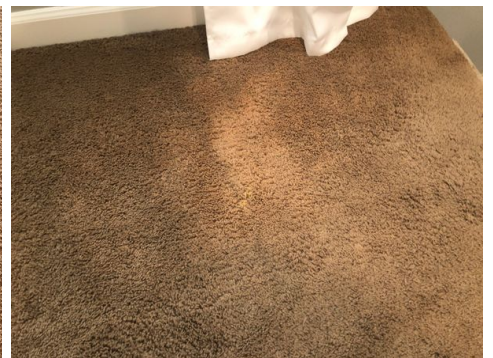
13.3.1 Flooring

CARPET IS STAINED

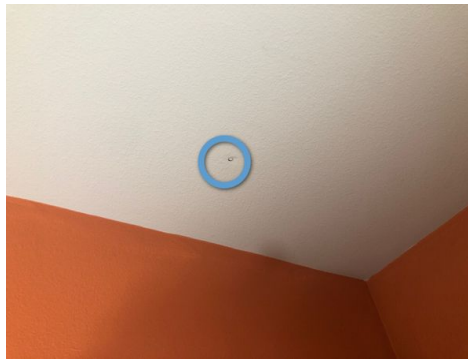
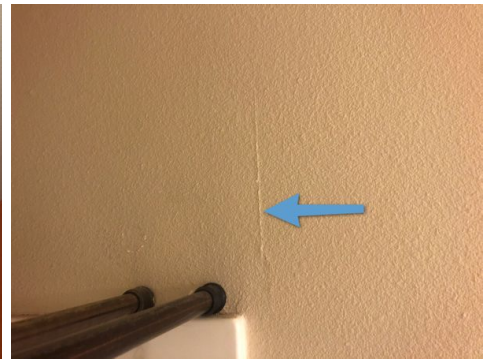
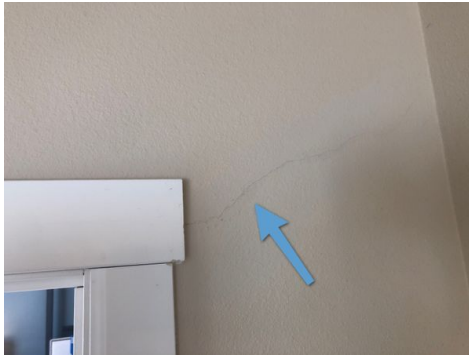
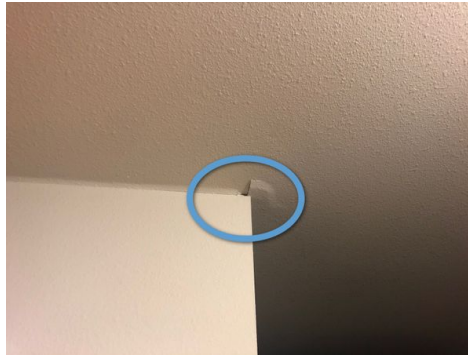
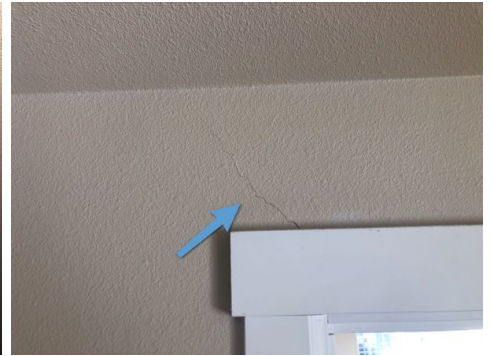
13.4.1 Walls and Ceiling

TYPICAL SETTLEMENT CRACKING/NAIL POPS

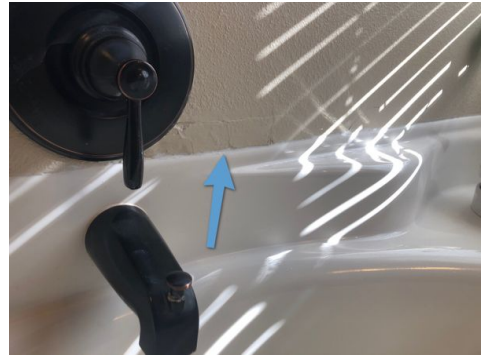
13.4.2 Walls and Ceiling

PATCH/PAST REPAIR

Contact a qualified professional.

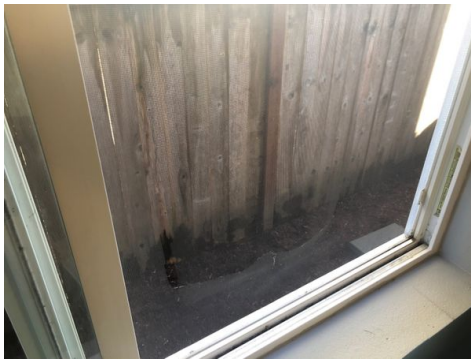
13.5.1 Windows

SCREENS DAMAGED/MISSING

Contact a qualified professional.
