## RENTAL PROPERTY CONDITION REPORT

1234 Rental St  
Aurora, CO 80010

Mike Barnhill  
APRIL 28, 2019

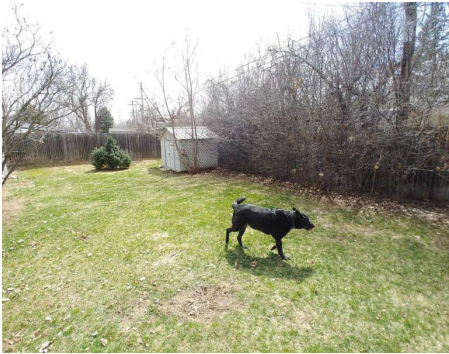
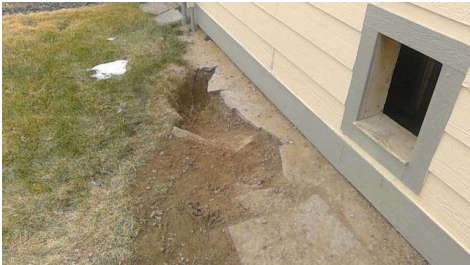
### Comments: Yard

There is pet damage in the back yard.

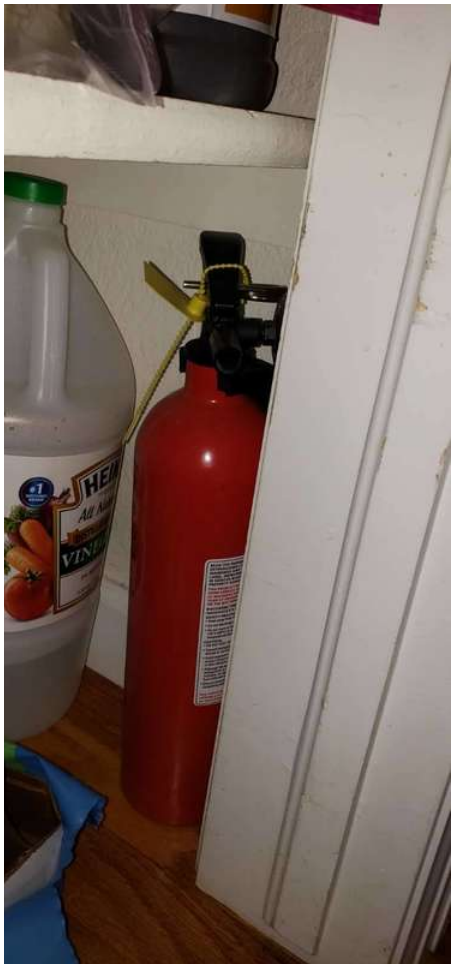
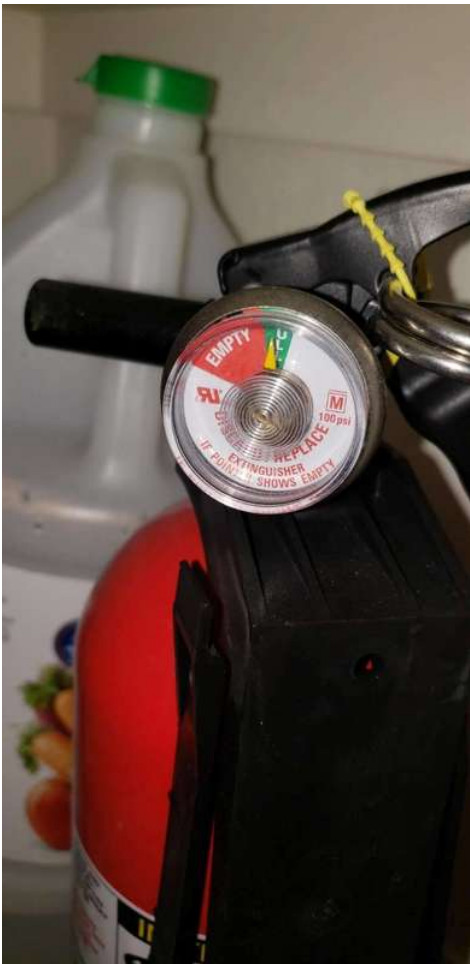
**Fire Extinguisher: Fire Extinguisher**

Present, Beneath Kitchen Sink

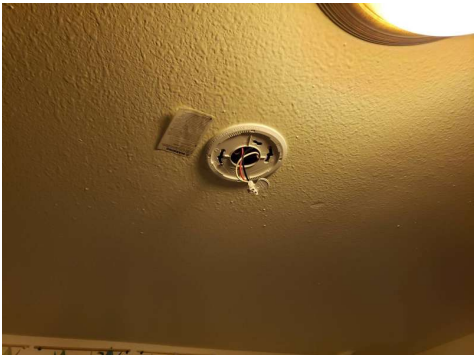
3.1.1 Smoke and Carbon Monoxide Detectors

**CARBON MONOXIDE DETECTOR NOT PRESENT/WORKING**

Safety Hazard

A Carbon Monoxide detector was not present near the bedrooms. The combo unit had been removed

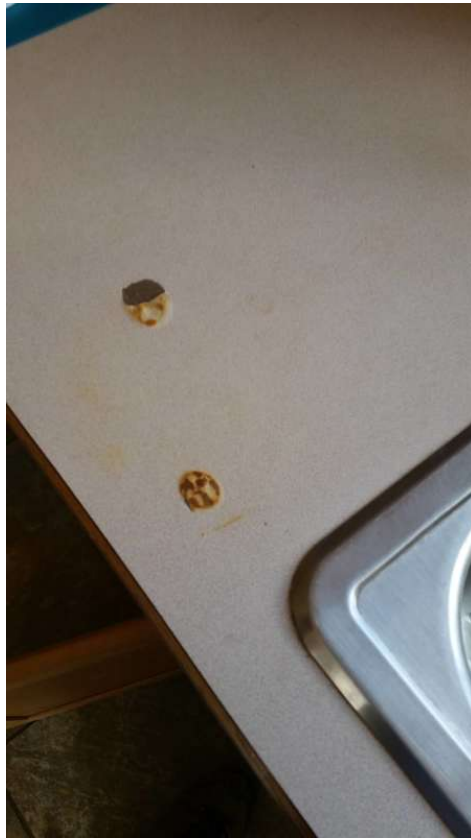
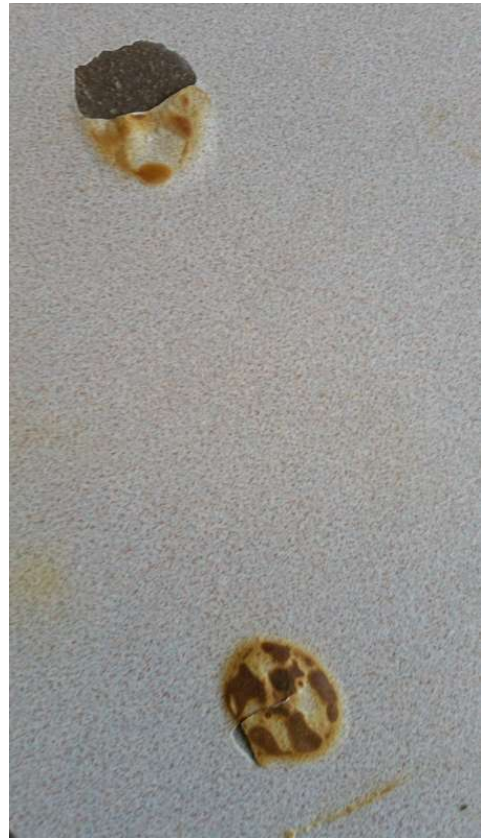
## 3.4.1 Kitchen/Appliances

**COUNTER TOP DAMAGE**

There are burn or scorch damage to the counter top by the sink.

Maintenance/Repair

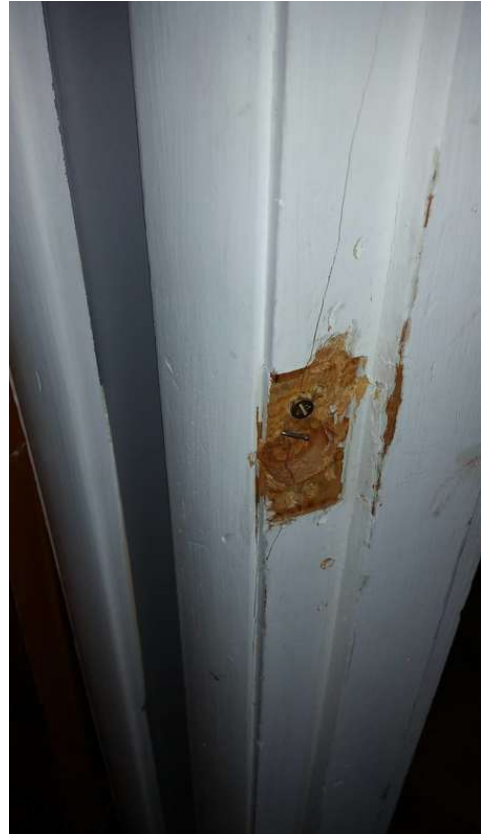
## 3.7.1 Interior doors, walls, stairs and general condition

**DOOR DAMAGE**

There is damage to the door frame in the north west bedroom.
