RESIDENTIAL INSPECTION

1300 34th Ave SW
Minot ND 58701

Cory Gibbons & Heather Schoenborn

AUGUST 17, 2018

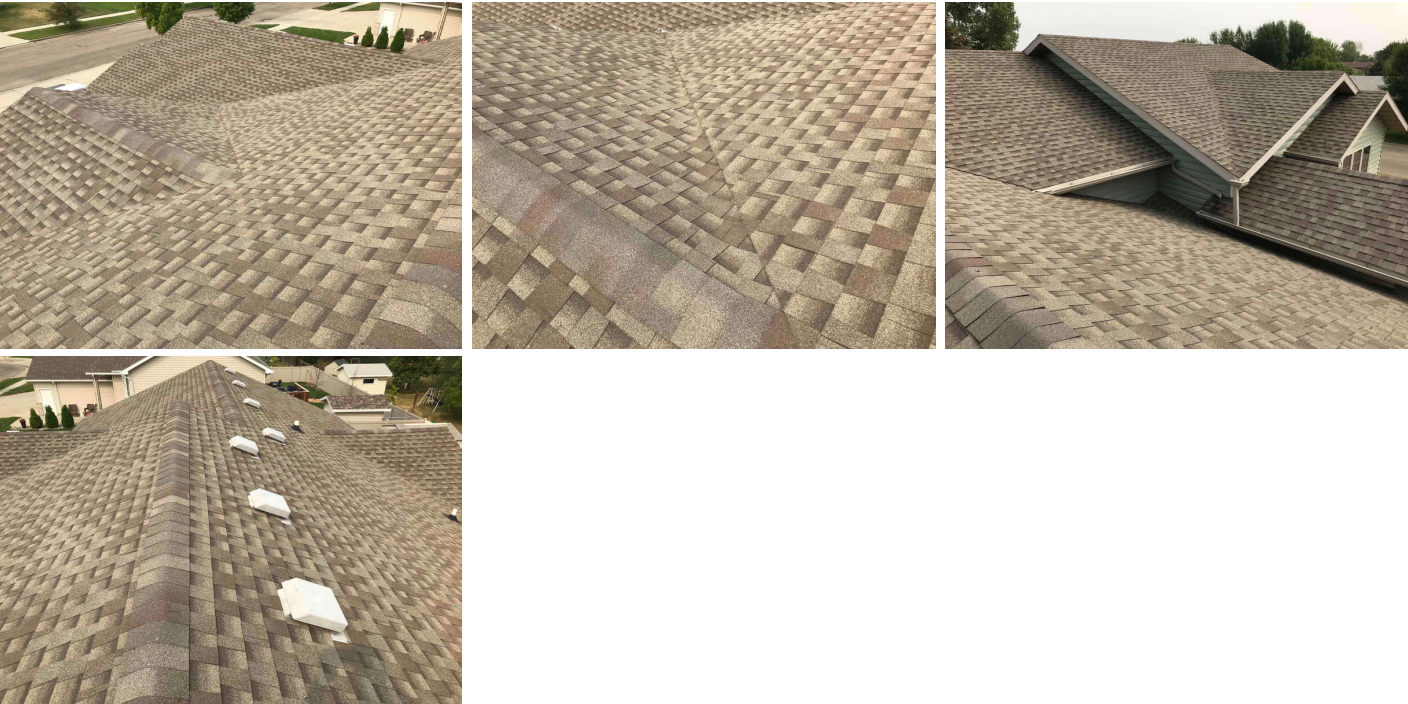
Roof View

The shingles were inspected at visible portions for excessive granule loss, signs of curling or delamination, loss of adhesion between the shingles, and any other signs of damage or excessive age. The shingles appeared to be in satisfactory condition, allowing for normal wear and tear, at the time of inspection. No deficiencies were observed unless otherwise noted in this report.

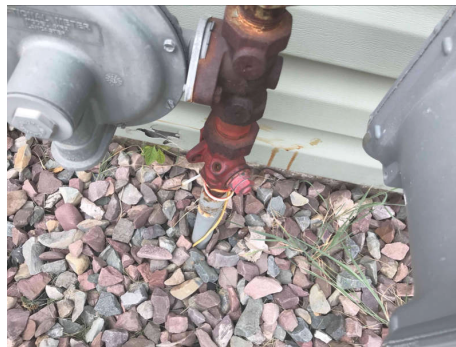
Main Gas Shut-off: Main Fuel Shut-Off (Location)

At Meter

Satisfactory

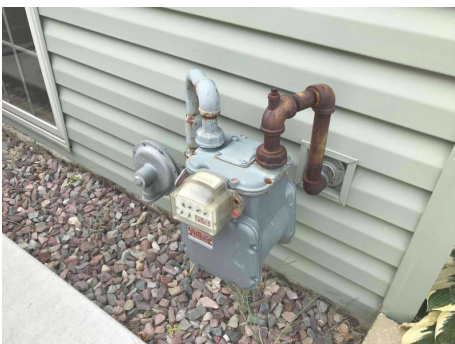
Gas Supply Lines: Fuel Distribution Material

Black Steel

At the time of the inspection, the Inspector observed no deficiencies in the condition of the gas supply pipes. Most pipes were not visible due to interior wall coverings.

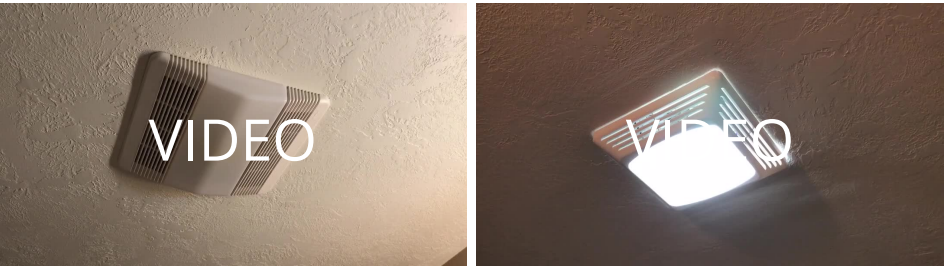
The exhaust fan was excessively noisy at the time of the inspection and may need to be replaced soon. This is for your information.

Recommendation
Contact a qualified professional.

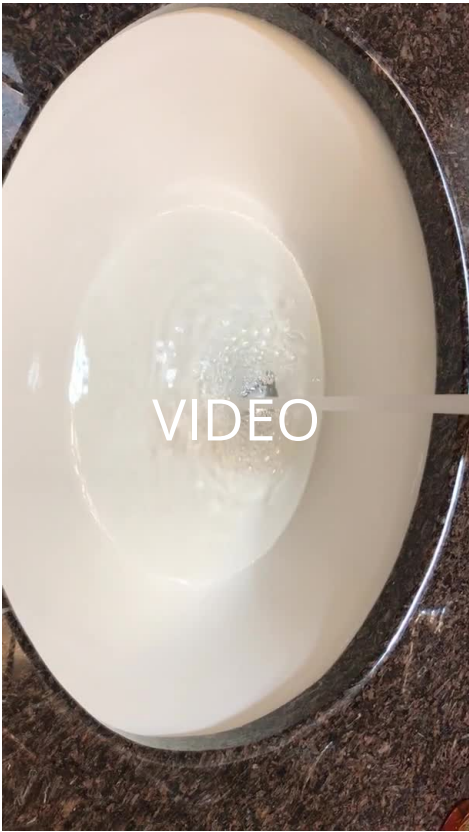
9.3.2 Bathrooms

SINK (SLOW TO DRAIN)

This bathroom sink was slow to drain. The blockage should be located and cleared by a qualified plumbing contractor.

Recommendation
Contact a handyman or DIY project

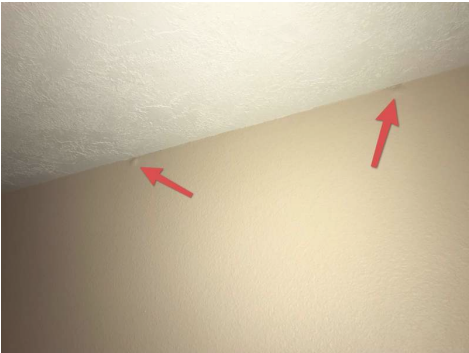
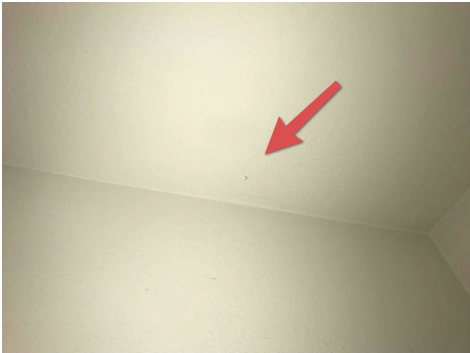
1st Floor North Bedroom Closet

9.4.1 Bedrooms

Protruding nail heads visible in ceilings in this bedroom appeared to be the result of framing members shrinking after original construction was complete. Framing lumber is often installed with a relatively high moisture content and typically shrinks as it dries. Once framing has reached moisture equilibrium with the homesite environment, framing will become stable and nail pops can be repaired without concern that they will reappear. The time required to reach stability depends on the moisture content of framing materials at the time of original construction and humidity levels at the homesite. The time frame may vary between one and two years in many environments. The Inspector recommends repair by a qualified drywall or painting contractor once the condition appears stable.

Recommendation
Contact a handyman or DIY project

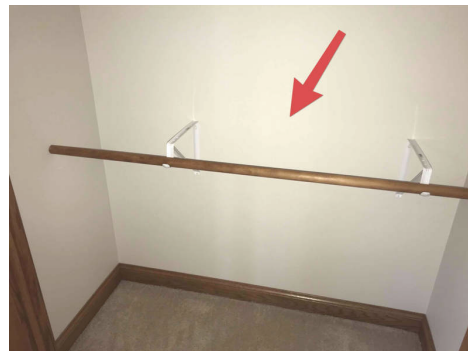
1st Floor Northwest Bedroom Closet

9.4.2 Bedrooms

Recommendation

Contact a handyman or DIY project

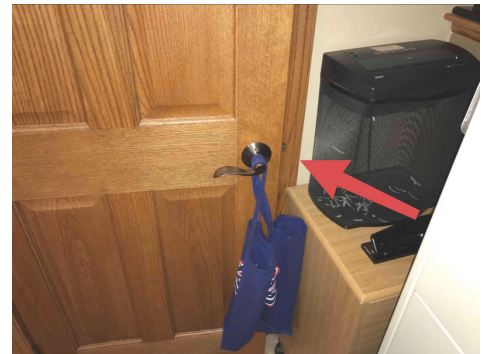
Southwest Basement Bedroom Closet

9.9.1 Doors

Recommendation

Contact a handyman or DIY project

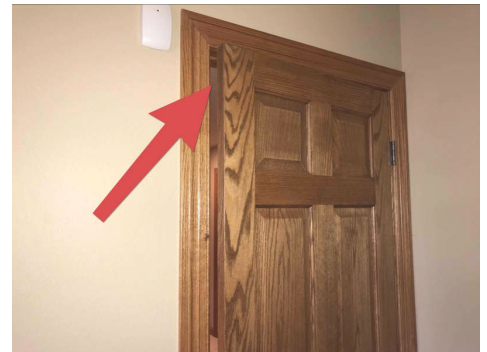
Northwest Basement Bedroom

9.9.2 Doors

Recommendation

Contact a handyman or DIY project

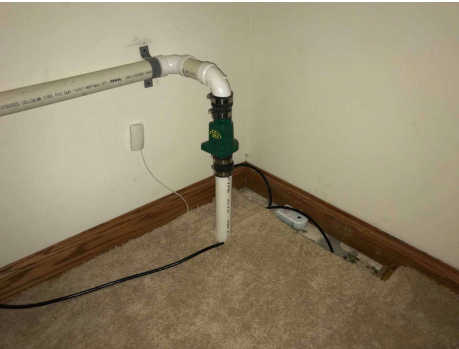
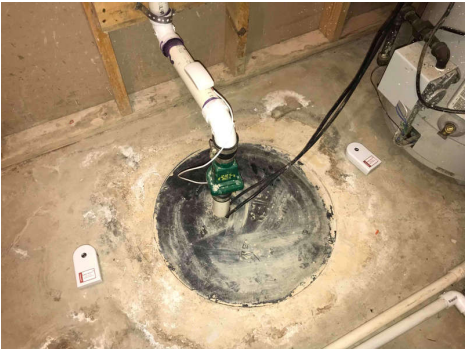
Sump Pumps / Sewage Ejectors: Sump Pump (Installed)

The home had a sump pump installed in a pit in the basement floor. Sump pumps are designed to pump rising groundwater to the home exterior before it reaches and floods the finished floor. They require regular testing and service if they are to be relied upon when they are needed. The Inspector recommends regular service by a qualified contractor to ensure that the pump will work when needed. You should have this sump pump serviced upon or before purchase of this home.

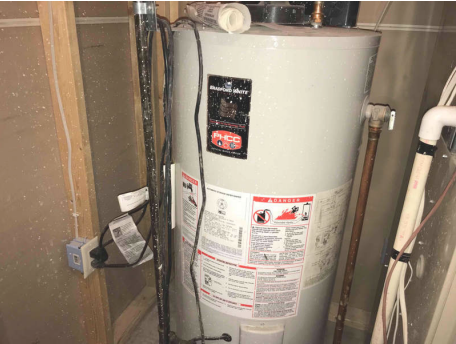
Water Heater: Location
Basement, Mechanical Room

Water Heater: Capacity
40 Gallons

Water Heater: Model Number
MITW40L6BN12

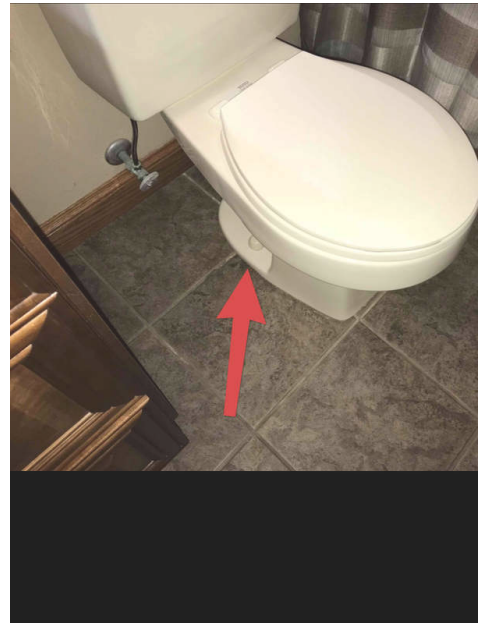
1st Floor Hall Bathroom

11.5.2 Fixtures / Faucets

Recommendation

Contact a handyman or DIY project

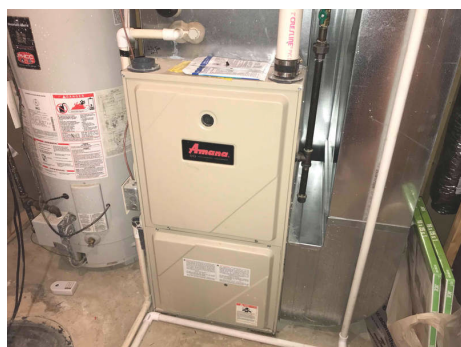
Heating Equipment: Type

Gas-Fired (High Efficiency)

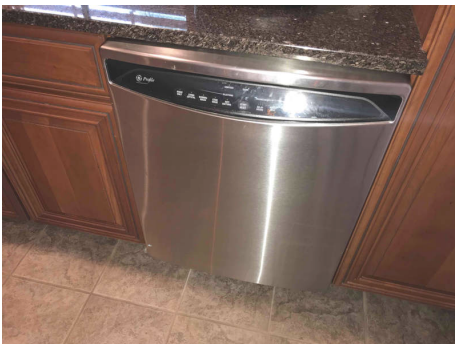
Dishwasher: Dishwasher (OK)

At the time of the inspection, the Inspector observed no deficiencies in the condition and operation of the dishwasher. It was operated through a cycle.

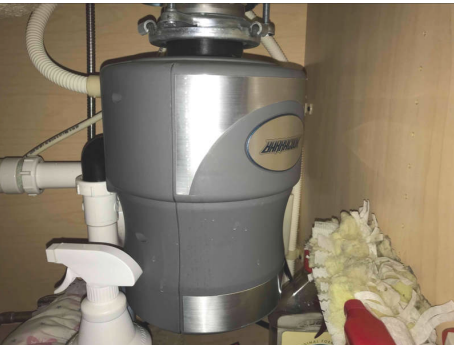
Garbage Disposal: Disposal (OK)

At the time of the inspection, the Inspector observed no deficiencies in the condition and operation of the garbage disposal.

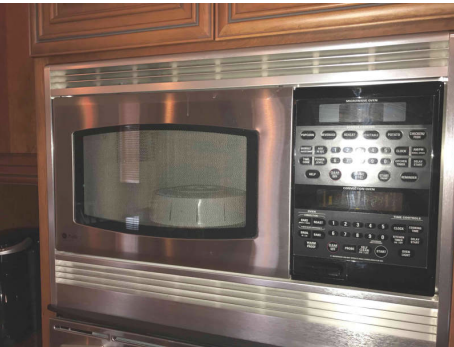
Microwave Ovens: Microwave (OK)

At the time of the inspection, the Inspector observed no deficiencies in the condition and operation of the built-in microwave oven. Built-in microwave ovens are tested using normal operating controls. Unit was tested and appeared to be serviceable at time of inspection. Leak and/or efficiency testing is beyond the scope of this inspection. If concerned, you should seek further evaluation by qualified technician prior to closing.

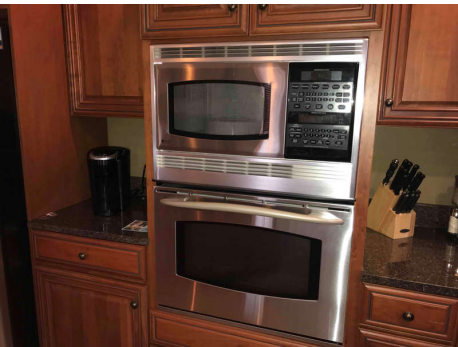
Range/Oven/Cooktop:
Range/Oven Type
Built-In Oven

Range/Oven/Cooktop: Range/Oven Condition
Satisfactory

The oven was operated by placing into "Bake" mode, and heat was produced from the element(s). Temperature calibration, "clean" options, and other functions are not tested for. You are recommended to seek further evaluation of additional functions if desired/needed. No indications of deficiencies were observed at the time of inspection, unless otherwise noted in this report.

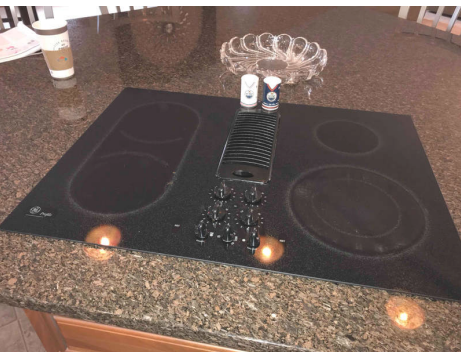
Range/Oven/Cooktop: Electric Built-In Oven (OK)

At the time of the inspection, the Inspector observed no deficiencies in the condition and operation of the electric built-in oven.

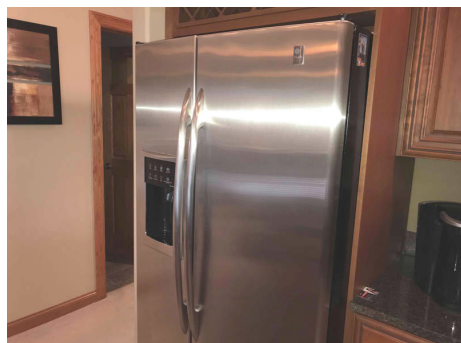
Refrigerator: Type

Side-By-Side

Satisfactory
