HOME INSPECTION REPORT

20905 83rd St Ct E
Bonney Lake WA 98391

Hal Marshall
NOVEMBER 23, 2019

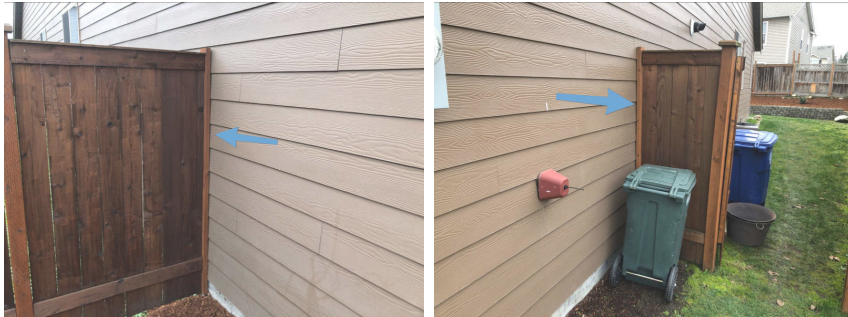
Fence(s) were attached to or in contact with the building exterior. Such attachments can serve as a pathway for wood-destroying insects and can retain moisture against the exterior after it rains. We recommend repairs as necessary so there is at least a 2-inch gap between rails and building exteriors.

Recommendation

Contact a qualified professional.

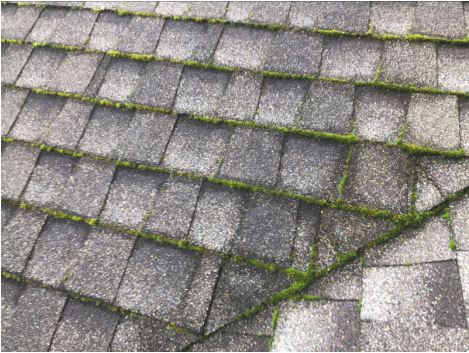
Parts of the roof need to be cleaned of moss and/or debris. This can restrict drainage and lead to moisture intrusion and moisture damage if not corrected.

Recommendation

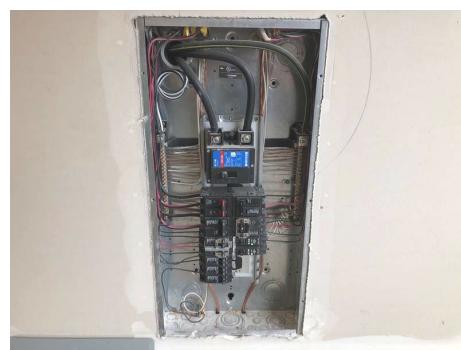
Panel Size, Location & Photo:**Panel Amps, Location and Picture**

Garage, 200 AMP

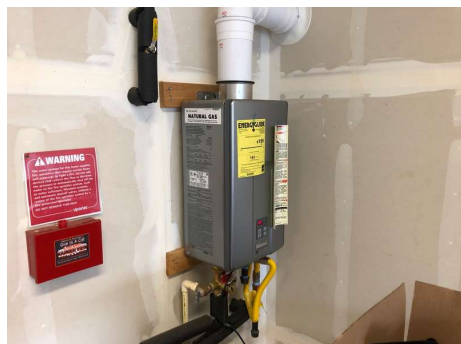
Garage

Hot water is provided by a tankless, water heater that is wall-mounted.

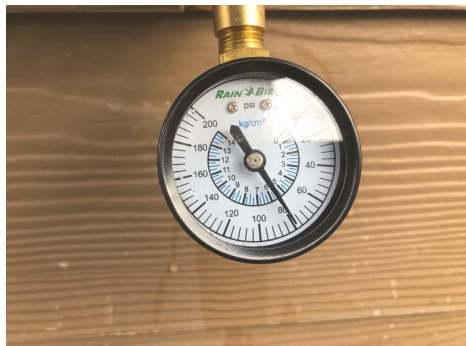
Main Water Shut-Off, Distribution & Supply: House Pressure PICTURE-Acceptable

The pressure at the street was within industry standards, between 40 and 80 and a regulator is not required on the plumbing system.

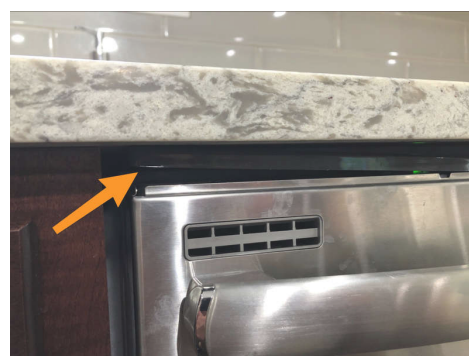
DISHWASHER TRIM DAMAGE

The trim around the buttons on the dishwasher is functional but damaged and you may want to have it repaired.

Recommendation

Contact a qualified appliance repair professional.

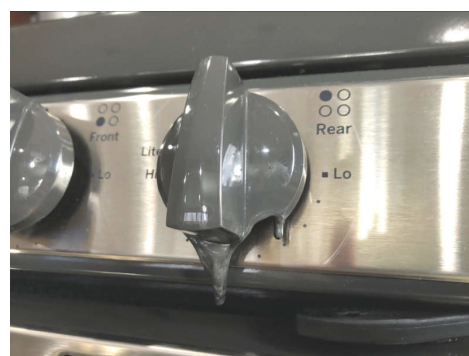
10.3.1 Range

STOVE TOP KNOB DAMAGED

A control knob on the range is damaged, recommend it be repaired or replaced.

Recommendation

Recommended DIY Project

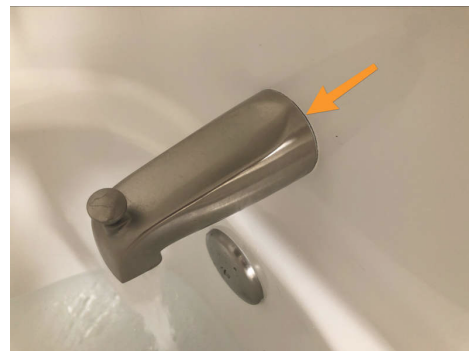
I recommend caulking or sealing around shower valves and faucets etc to help prevent moisture intrusion behind or into the walls.

Monitoring these areas is also recommended to help ensure an adequate seal is in place.

Recommendation

Contact a qualified handyman.

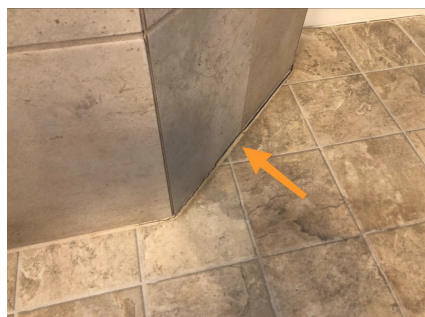
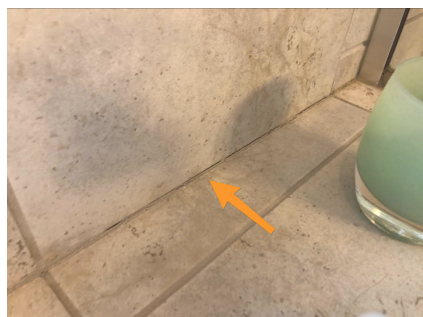
11.4.2 Tub-Shower

MISSING OR DETERIORATED CAULK/GROUT

The tub surround is has missing or deteriorated caulk/grout. Recommend caulking or sealing to prevent moisture intrusion.

Recommendation

Contact a qualified professional.
