# MOUNTAINS TO SOUND HOME INSPECTION LLC

## HOME INSPECTION REPORT

27109 109th Ct SE  
Kent WA 98030

Araceli Manjarrez  
MARCH 19, 2020

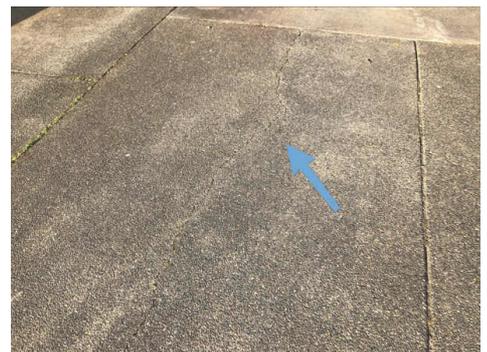
**MODERATE CRACKS IN DRIVEWAY**

There are a few cracks in the driveway which is mostly cosmetic but you may want to view for yourself and repair as necessary.

Recommend monitoring.

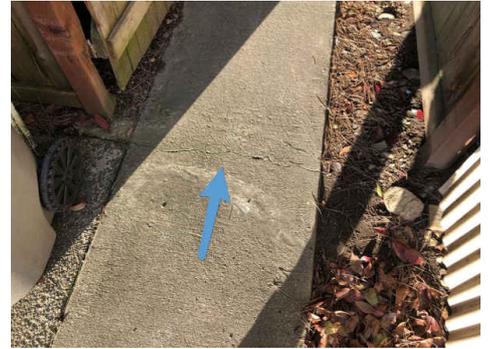
3.2.2 Driveway, Walkways & Patio

**CRACKS IN WALKWAYS**

There are a few cracks in the walkways around the residence that are mostly cosmetic. We suggest you view these yourself and repair as necessary.

Contact a qualified professional.

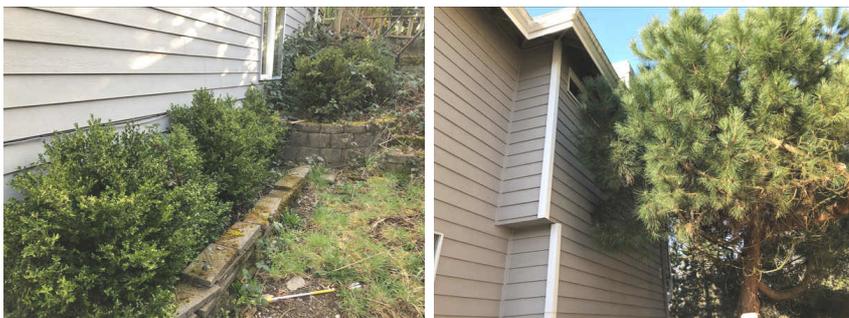
3.5.1 Exterior Siding Notes

**VEGETATION IS ENCROACHING**

Vegetation is encroaching on the structure, and should be kept a minimum of twelve inches away for the general welfare of the walls and foundation.

Contact a qualified landscaping contractor

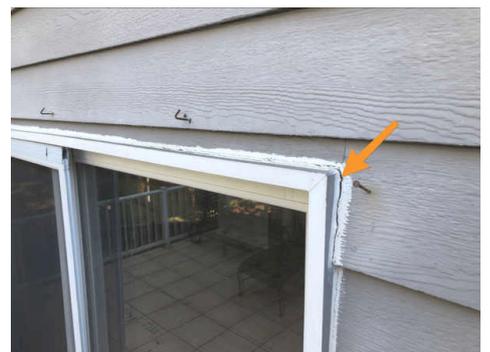
3.5.3 Exterior Siding Notes

**DAMAGED SIDING**

Recommendation  
Contact a qualified handyman.

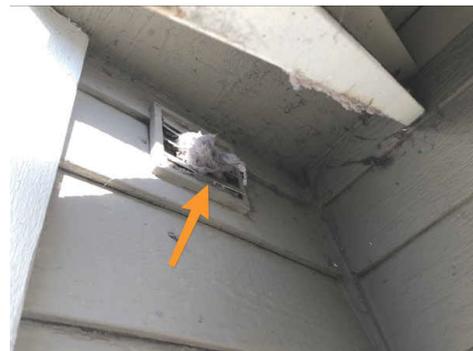
The dryer vent is full of debris. We recommend cleaning to allow for proper venting of the dryer.

Recommendation  
Contact a qualified professional.

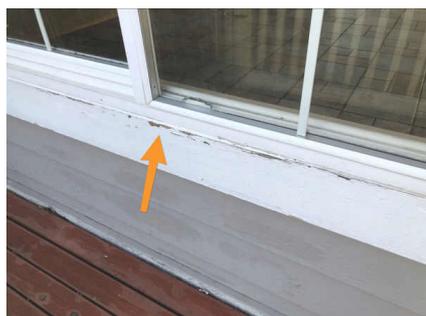
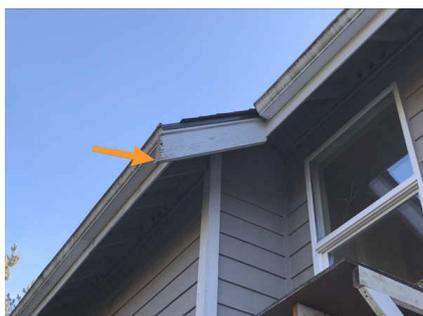
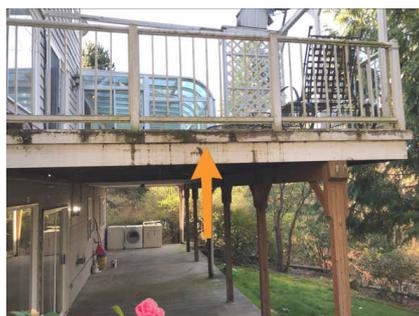
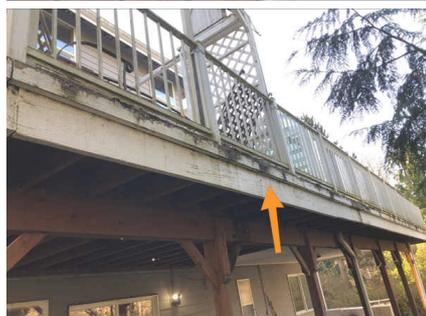
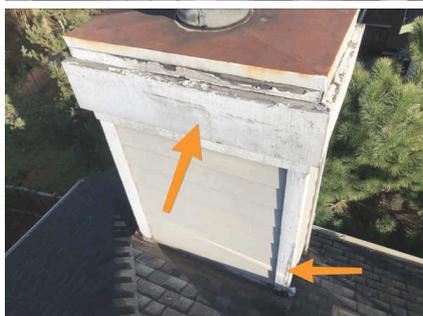
3.7.2 Fascia, Trim & Eaves

**TRIM MISSING/DAMAGED**

Contact a qualified handyman.

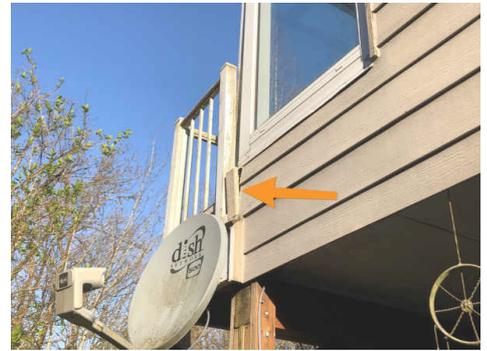
A piece of trim is damaged or missing. Recommend repairs.

Contact a qualified professional.

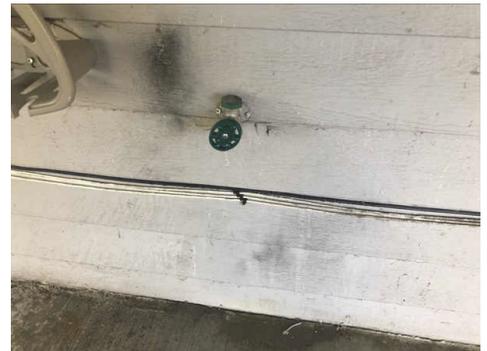
3.8.2 Exterior Plumbing

**NOT SECURED TO WALL**

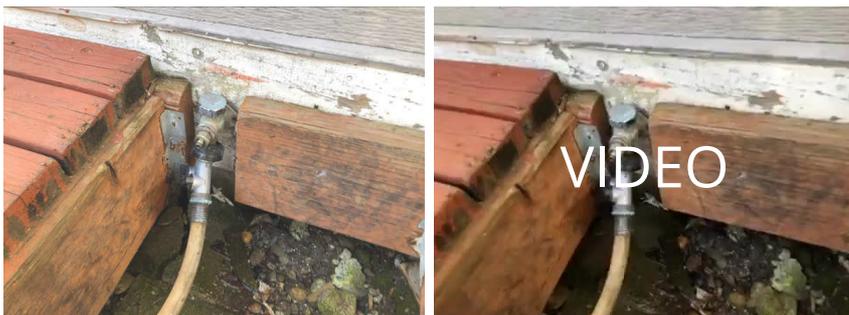
The hose bib is not secured to the wall. This could potentially damage the Plumbing. Recommend securing.

Contact a qualified professional.

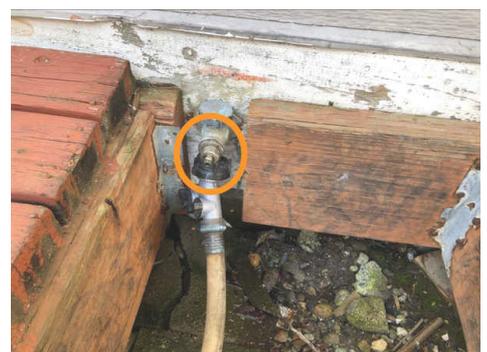
3.8.3 Exterior Plumbing

**HOSE BIB MISSING HANDLE**

A hose bib is missing a handle, which should be replaced.

Contact a qualified handyman.

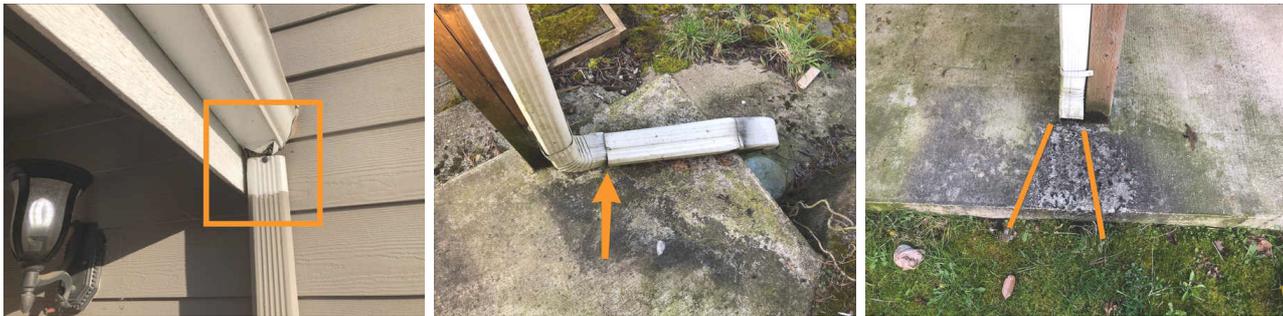
## 3.9.1 Downspouts

**SOME DOWNSPOUTS ARE MISSING OR NEED TO BE RECONNECTED OR SERVICED**

Some downspouts are missing parts or need to be reconnected or serviced.

Contact a qualified roofing professional.

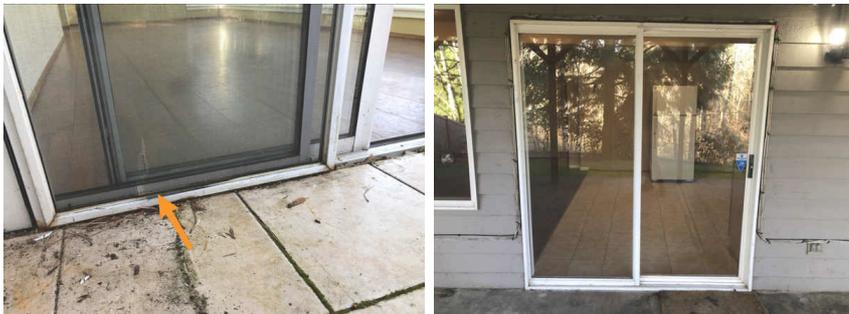
## 3.10.1 Exterior Doors

**SLIDING DOOR SCREEN MISSING/DAMAGED**

The rear sliding screen is missing or needs work. Have it repaired by a qualified contractor.

Contact a qualified handyman.

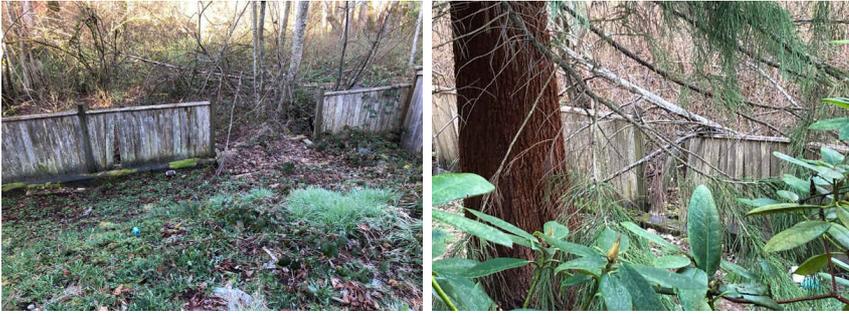
## 3.12.1 Fences &amp; Gates

**DAMAGED FENCING**

Observed some damaged fencing on the property that will need to either be repaired or replaced.

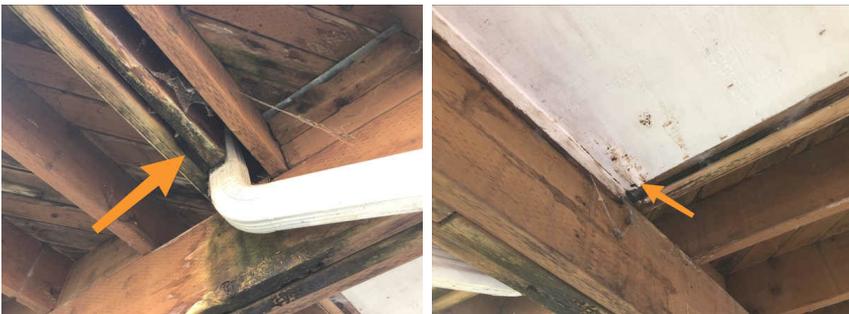
## 3.15.2 Deck

**DECK IS DETERIORATED**

One or more sections of the deck are damaged or deteriorated. Further evaluation and repair is recommended

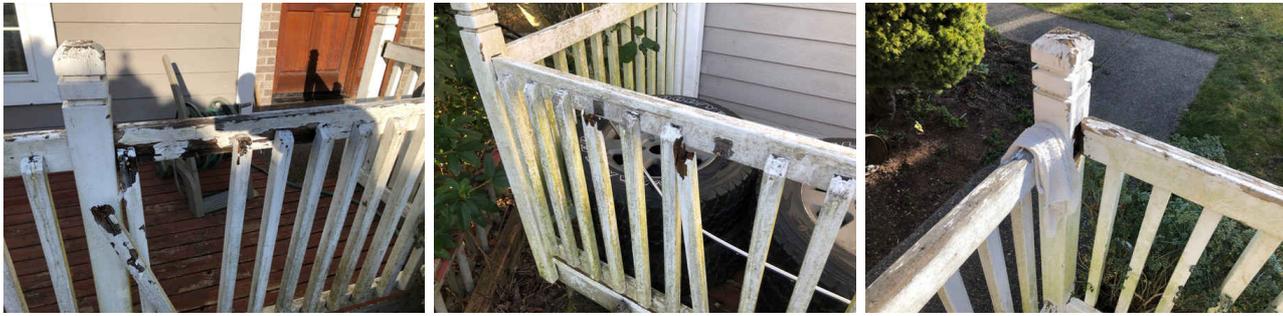
3.15.4 Deck

**WEATHERED**

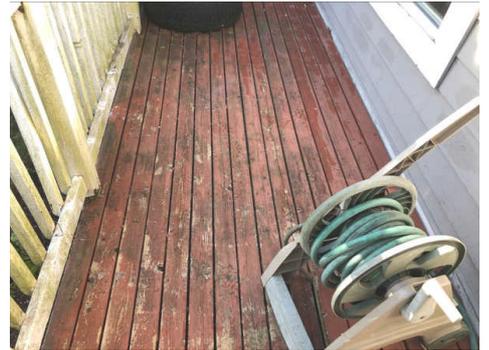
Portions of the deck we're weathered and in need of minor repairs and maintenance.

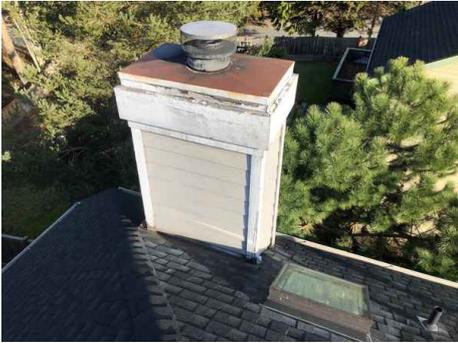
**Chimney On Roof & Photo:**  
**Chimney Photo**

The chimney has a functional weather cap/spark arrestor.

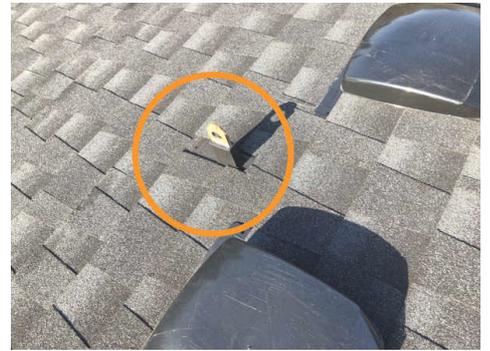
**ROOF SAFETY BRACKET COVER MISSING**

The roof super anchor safety bracket cover is missing and/or not installed, it's plastic protective cover and leakage is possible. We recommend that the safety anchor bracket cover be installed and secured in accordance with industry standards.

Contact a qualified professional.

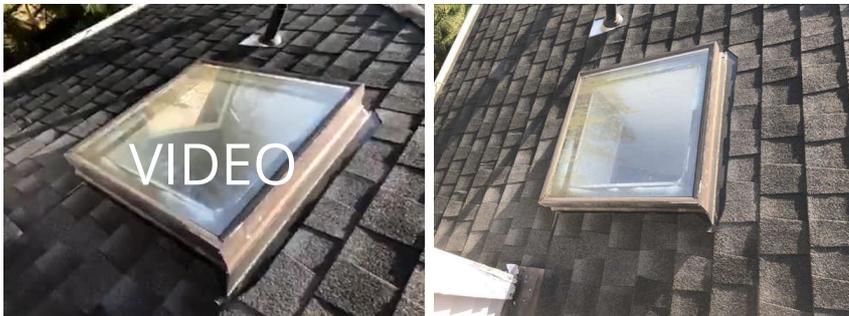
4.6.1 Skylights

**LOOSE SKYLIGHT**

The skylight is loose. We recommend securing.

Contact a qualified professional.

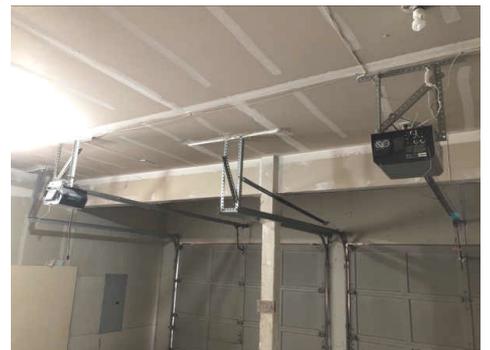
The garage door will not close on demand when the wall button is pressed. Further evaluation and service as necessary from a qualified garage door technician is recommended.

Contact a qualified garage door contractor.

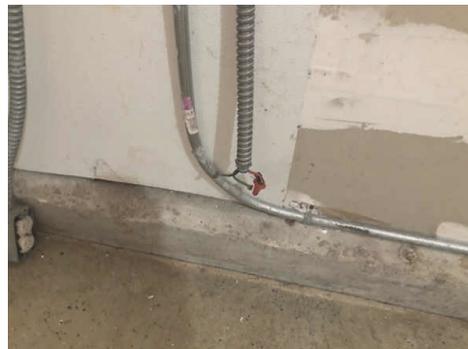
5.11.2 Outlets, Electrical Observations

### **COVERPLATE MISSING/UNSECURED OUTLET**

Recommendation

Contact a qualified handyman.

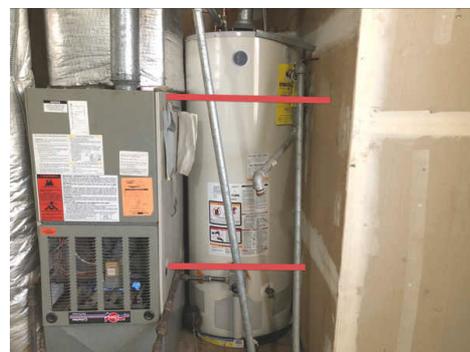
## 8.1.2 Water Heating System

**WATER TEMP TOO HIGH**

Recommendation  
Recommended DIY Project

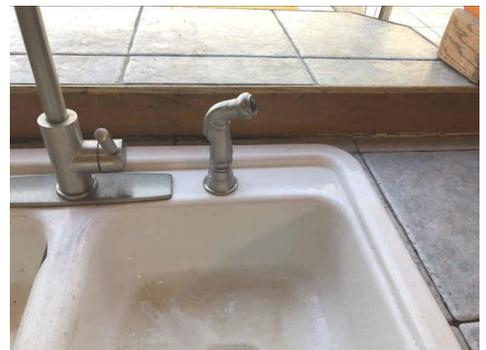
## 9.2.1 Trap and Drain

**LEAK AT DRAIN LINE BELOW THE SINK**

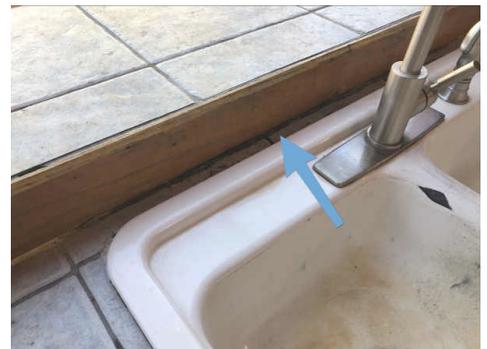
## 9.4.2 Countertop

**MISSING OR DETERIORATED CAULK/GROUT**

The caulking or grout for the backsplash is missing, has gaps and/or not installed properly. We advise caulking/grout be installed and/or gaps filled to prevent possible water intrusion.

Recommended DIY Project

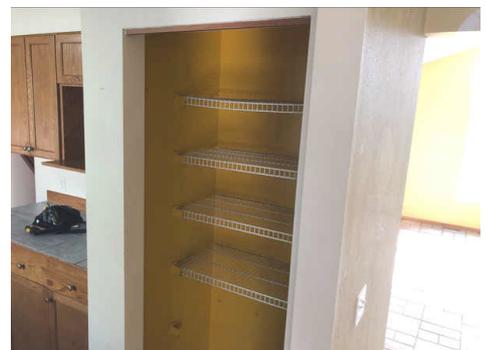
## 9.7.1 Doors

**DOOR MISSING**

The pantry door is missing. Recommend installing one.

Contact a qualified professional.

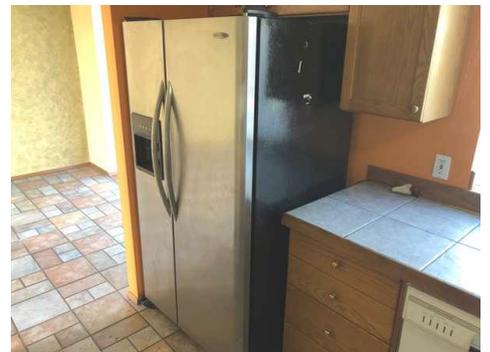
### UNPLUGGED

The refrigerator was not inspected for function due to it being unplugged.

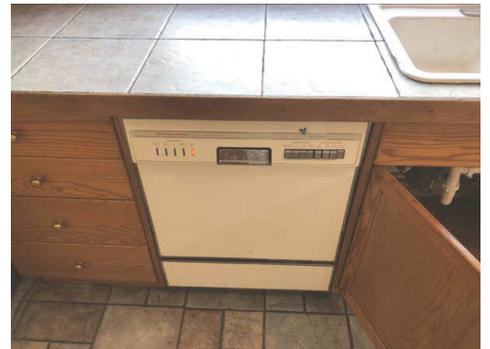
10.2.1 Dishwasher

Dishwasher was inoperable using standard controls. Recommend a qualified plumber or contractor evaluate.

Contact a qualified professional.

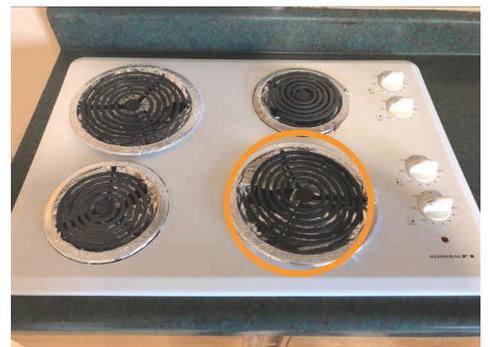
10.4.1 Range

### ELEMENT NOT WORKING

One of the elements on the electric range does not respond, and should be replaced.

Contact a qualified appliance repair professional.

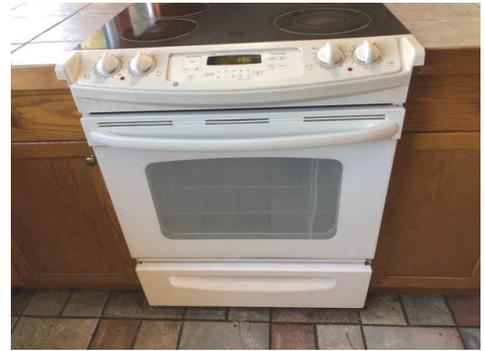
10.4.2 Range

**OVEN DID NOT WORK ON DEMAND**

The kitchen oven did not work on demand. Recommend repairs or replacement.

Contact a qualified professional.

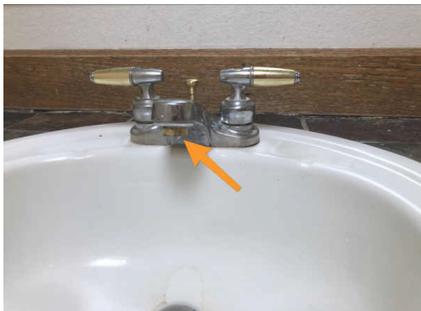
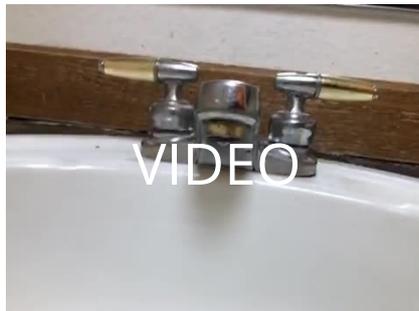
The faucet drips or runs continuously and should be repaired or replaced as necessary.

Contact a qualified handyman.

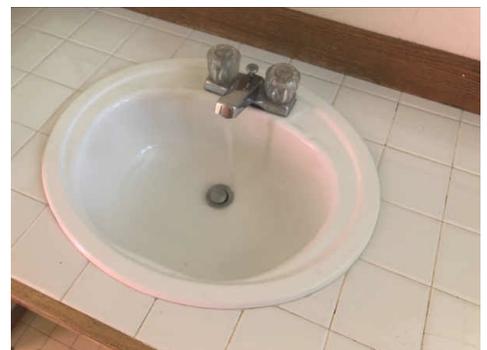
### 11.1.2 Sink and Faucet

The sinkstopper does not work properly and repair is recommended.

Contact a qualified handyman.

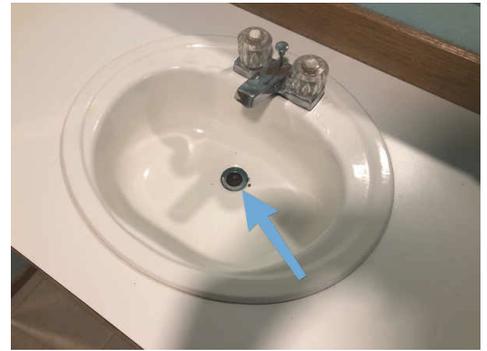
### 11.1.3 Sink and Faucet

#### SINK STOPPER(S) MISSING

Contact a qualified handyman.

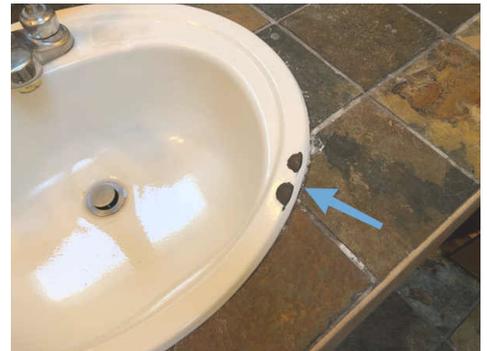
11.1.4 Sink and Faucet

**SINK DAMAGE**

The sink has some cosmetic damage. Recommend repairs/replacement if desired.

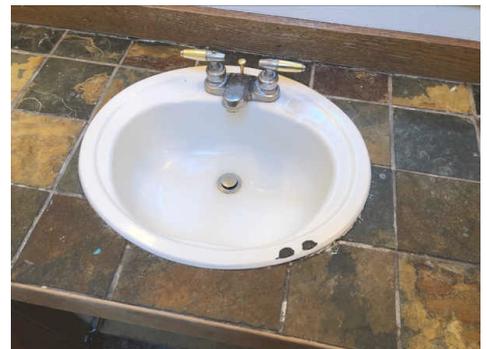
11.2.1 Trap and Drain

**SLOW DRAIN**

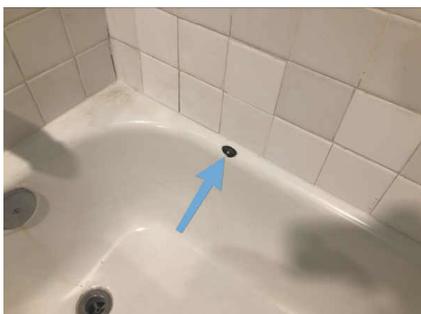
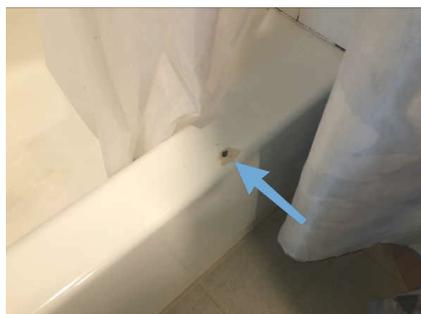
11.4.1 Tub-Shower

**TUB AREA COSMETIC DAMAGE**

The tub area has some cosmetic damage that you should view for yourself and repair as necessary.

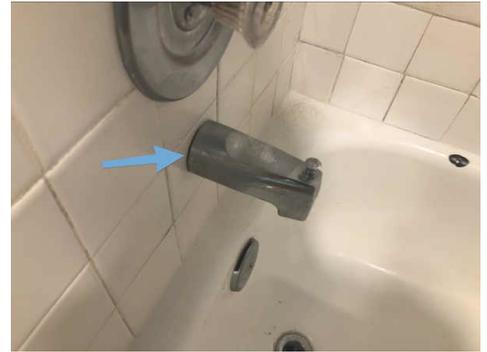
## 11.4.2 Tub-Shower

I recommend caulking or sealing around shower valves and faucets etc to help prevent moisture intrusion behind or into the walls.

Monitoring these areas is also recommended to help ensure an adequate seal is in place.

Contact a qualified handyman.

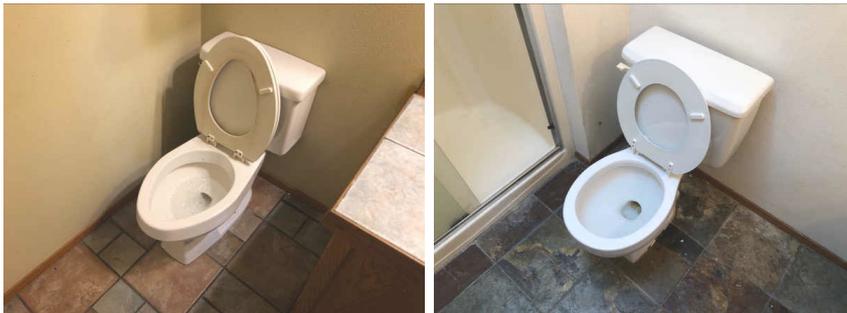
## 11.5.1 Toilet

Medium Priority
**FUNCTIONAL BUT LOOSE**

The toilet is functional, but loose on the floor and should be secured by a qualified technician, for safety reasons and to prevent possible damage or leaking from around the toilet.

Contact a qualified plumbing contractor.

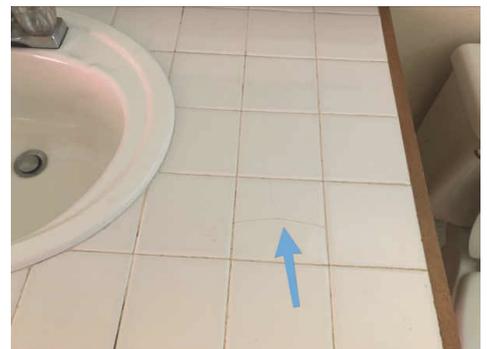
## 11.6.1 Countertop

Low Priority
**COUNTERTOP DAMAGE**

The countertop has some damage on it and you may want to have it repaired or replaced.

Contact a qualified general contractor.

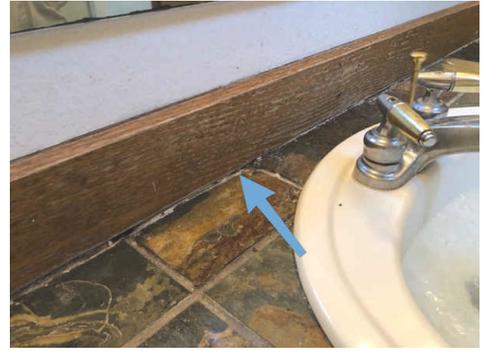
## 11.6.2 Countertop

Low Priority
**MISSING OR DETERIORATED CAULK/GROUT**

The caulking or grout for the backsplash is missing, has gaps and/or not installed properly. We advise caulking/grout be installed and/or gaps filled to prevent possible water intrusion.

Recommended DIY Project

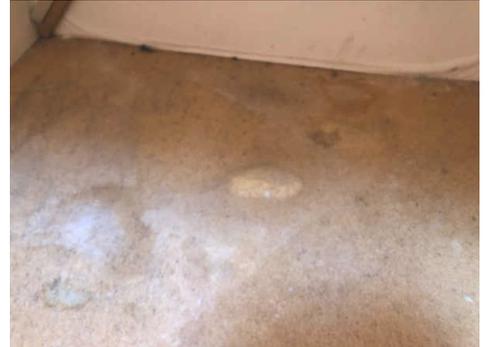
#### 11.7.1 Cabinets

### **SINK CABINET MOISTURE DAMAGED-LIGHTLY**

The floor of the sink cabinet is functional but slightly moisture stained. I recommend you should view this and correct as desired.

Recommend monitoring.

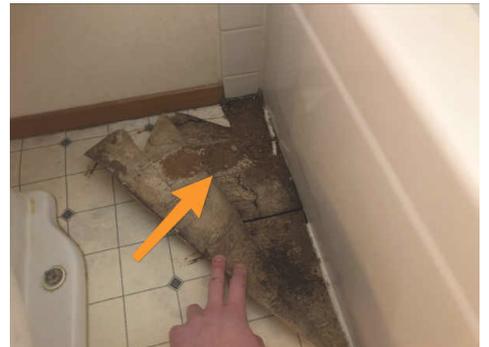
#### 11.10.1 Flooring

### **MOISTURE HAS PENETRATED SLAB BENEATH FINISHED FLOOR**

Moisture has penetrated beneath the finished floor and onto the subfloor. We can elaborate on this condition, but it should be evaluated by a specialist and repaired.

Contact a qualified professional.

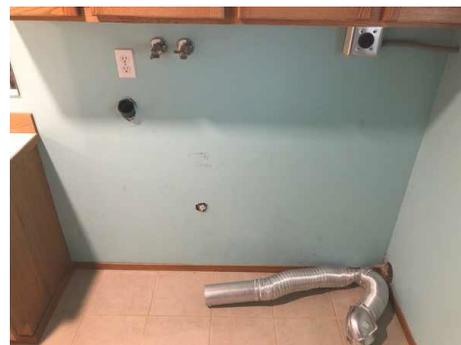
There was not a washer or dryer at the time of the inspection

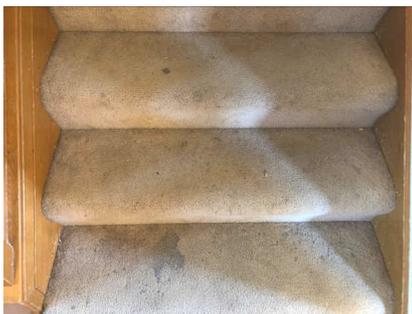
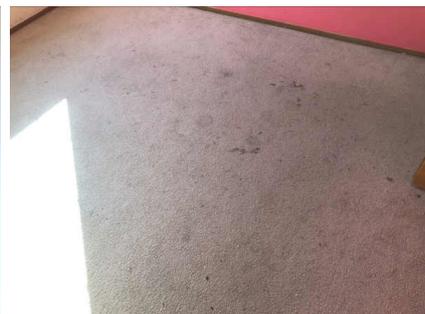
13.3.1 Flooring

**CARPET IS STAINED.**

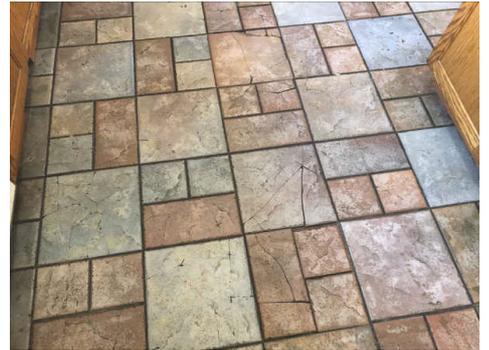
## 13.3.3 Flooring

**TRANSITION STRIPS MISSING**

Transition strips were missing or damaged between one surface to another. Recommend installing as needed.

Recommendation

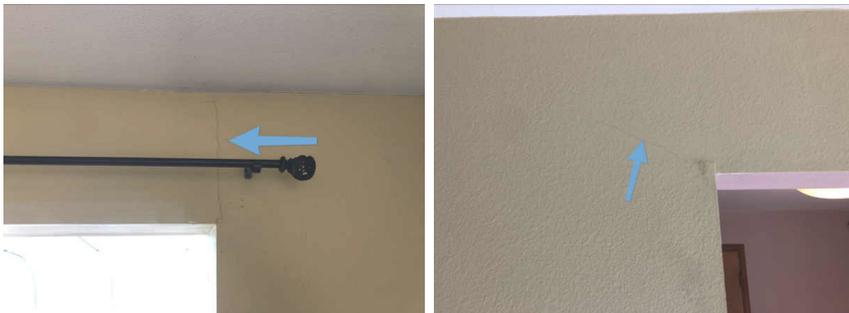
13.4.3 Walls and Ceiling

**EVIDENCE OF MOISTURE INTRUSION**

There is evidence of moisture intrusion on the on the wall/ceiling. Recommend having the condition further evaluated and repaired by a licensed contractor.

Recommendation

Contact a qualified general contractor.

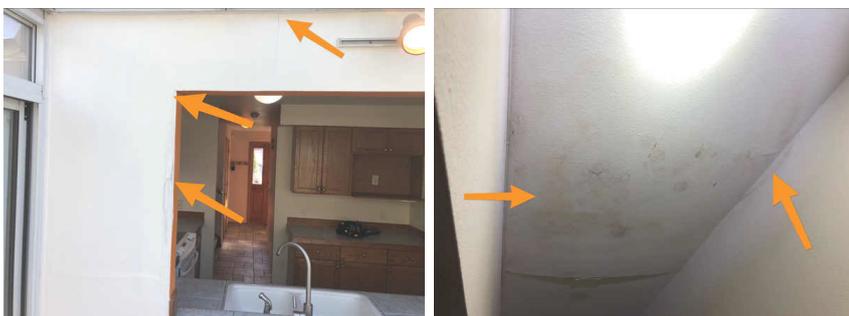
13.4.4 Walls and Ceiling

**WALL/CEILING DAMAGED**

The wall/ceiling has some damage and repair is recommended.

Recommendation

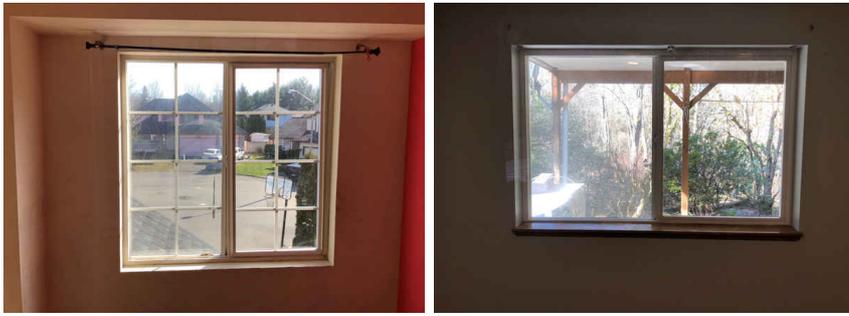
13.5.2 Windows

**A WINDOW LOCK IS MISSING OR DOES NOT ENGAGE**

A window lock is missing or does not engage, and should be serviced.

Recommendation

Contact a qualified window repair/installation contractor.

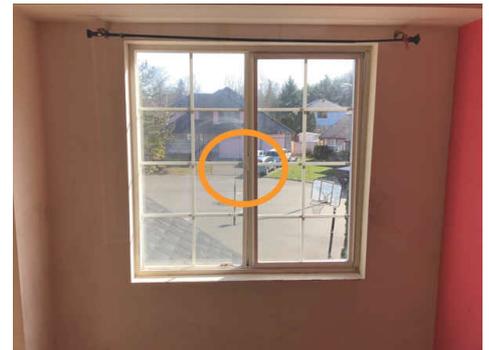
13.5.3 Windows

**SCREENS DAMAGED/MISSING**

Window screens were missing or damaged in one or more areas. We recommend repair or replacement as needed.

Recommendation

Contact a qualified professional.

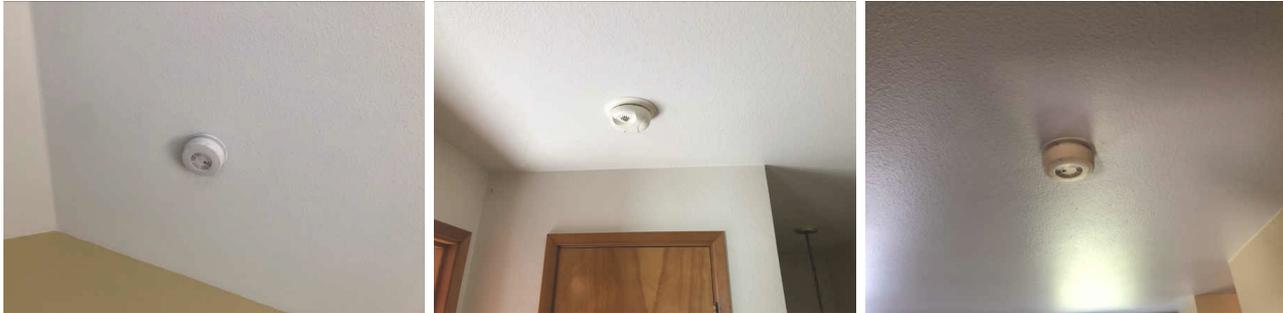
## 13.7.3 Smoke &amp; CO Detectors Notes

**THE SMOKE DETECTORS MISSING**

The smoke detector is missing and should be installed as a fire safety feature.

Recommendation

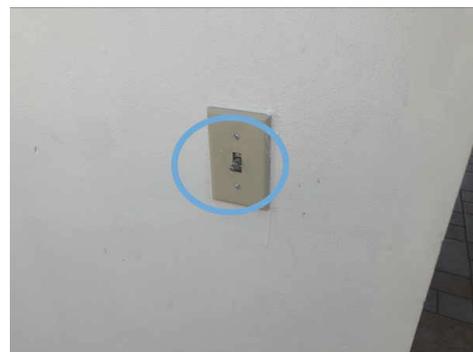
13.12.1 Outlets, Electrical

**MISSING COVERS**

There were missing covers that should be installed

Recommendation

Contact a qualified handyman.

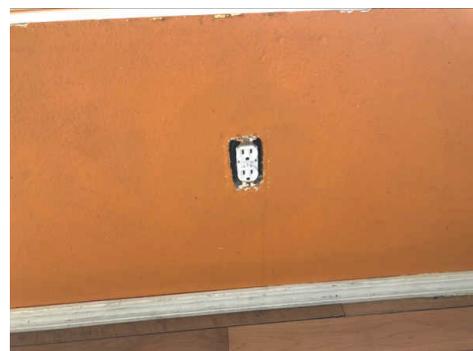
13.12.2 Outlets, Electrical

**DAMAGED OUTLET**

A damaged Outlet was observed. Recommend replacement.

Recommendation

Contact a qualified professional.

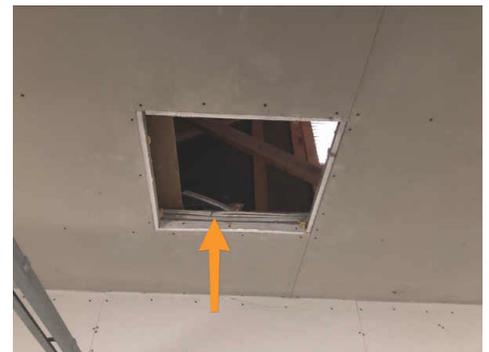
14.5.1 Insulation Notes

**DISPLACED OR REMOVED INSULATION**

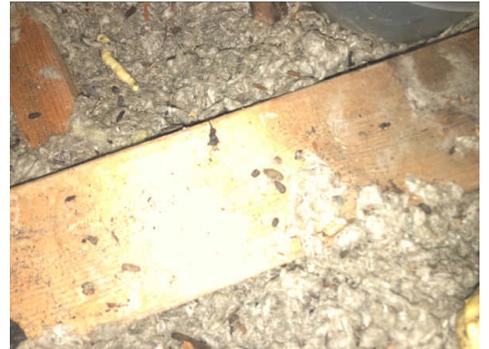
The attic has evidence of rodent activity. We recommend ceiling access points in eliminating any active rodent activity
