HOME INSPECTION REPORT

1203 Sigafos Ave NW
Orting WA 98360

Jerry Velasquez
OCTOBER 16, 2019

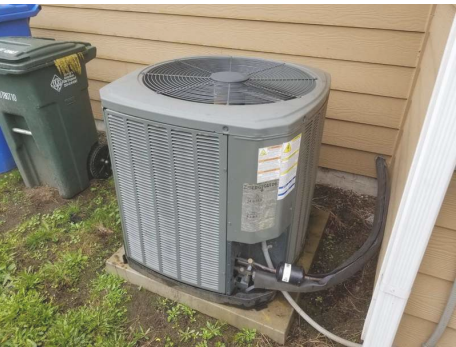
Air Conditioning/Heat Pump:
Equipment Photo

Air Conditioning/Heat Pump:
Condensing Coils Acceptable

The condensing coil(s) respond to the thermostat and are functional.

Air Conditioning/Heat Pump:
Refrigerant Lines Acceptable

The refrigerant lines are in acceptable condition where viewed.

Because outside temperature was below 60 degrees, we are unable to test the unit. Most manufacturers recommended temperatures be at 60 degrees or above for 48 hours prior to running air conditioners. I recommend servicing.

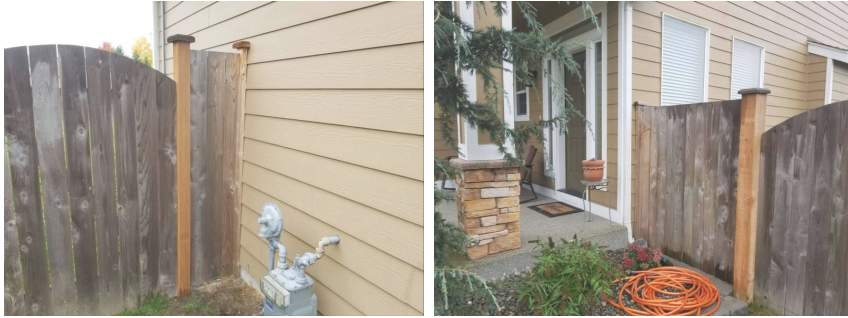
Fence(s) were attached to or in contact with the building exterior. Such attachments can serve as a pathway for wood-destroying insects and can retain moisture against the exterior after it rains. We recommend repairs as necessary so there is at least a 2-inch gap between rails and building exteriors.

Contact a qualified professional.

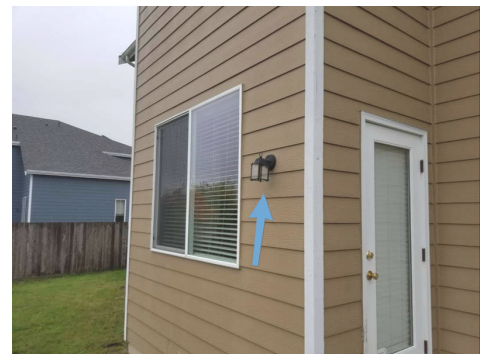
3.15.1 Lights

LIGHT BULBS MISSING OR BURNT OUT

Some lights around the residence did not have light bulbs or the bulbs were burnt out. Recommend replacing bulbs and testing.

Contact a qualified professional.

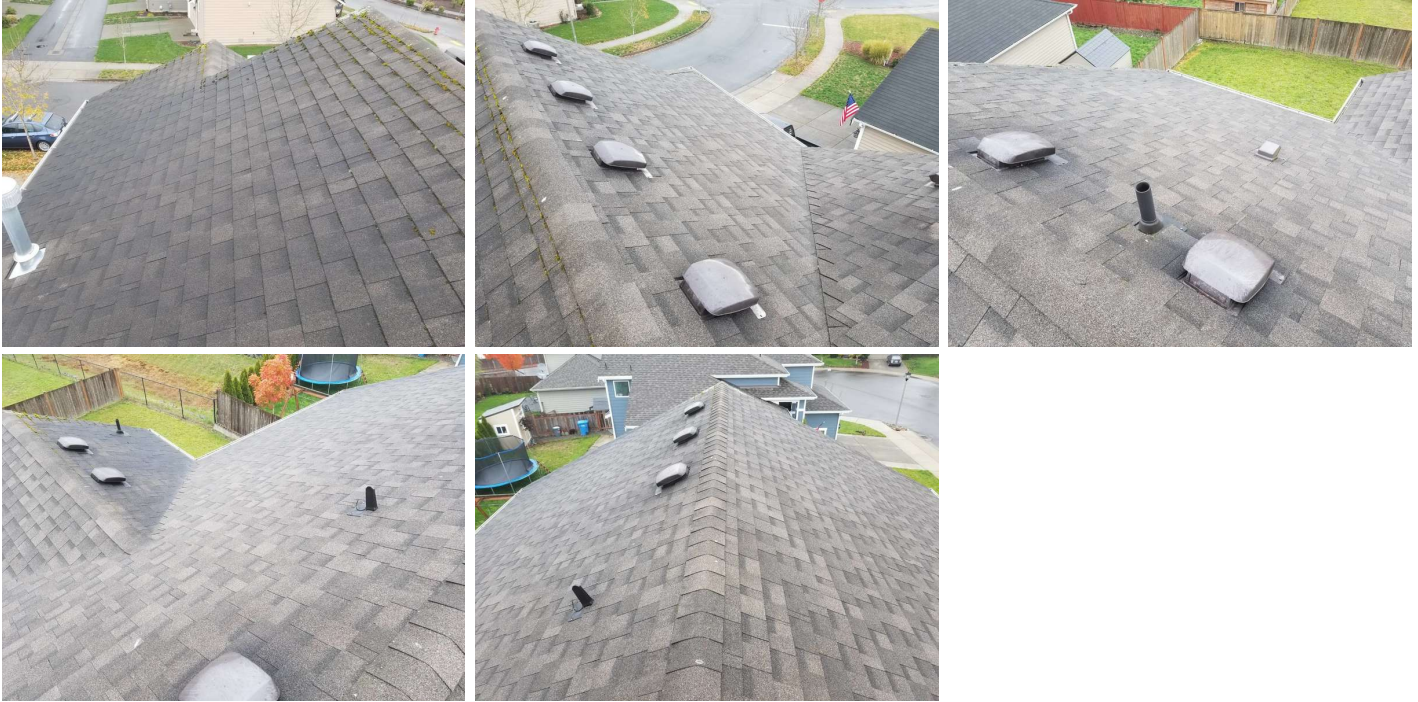
Method of Evaluation & Photos: Method of Evaluation & Photos

Walking on its surface

Composition Shingle Roof Notes: Acceptable

The roof is in generally acceptable condition. Any exceptions will be noted below. NOTE: This is not guarantee against leaks.

Parts of the roof need to be cleaned of moss and/or debris. This can restrict drainage and lead to moisture intrusion and moisture damage if not corrected.

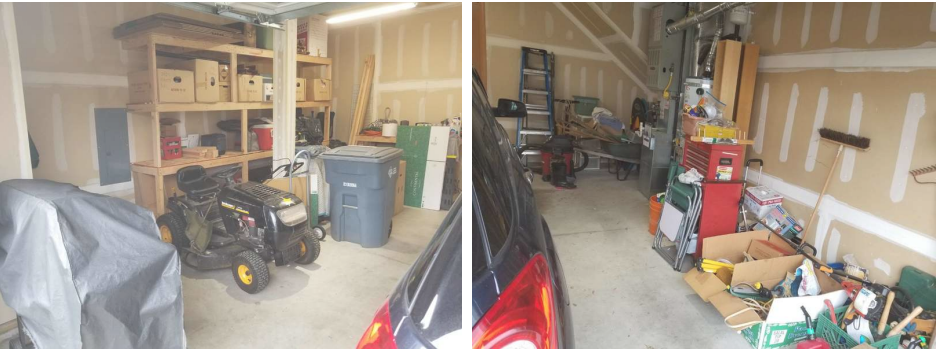
Picture and size of garage: Picture and size of garage

Double Car Garage
The garage and its components were evaluated

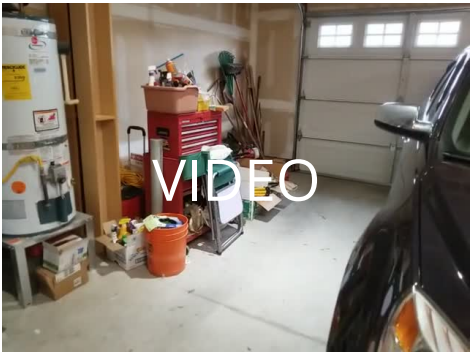
The garage is too full of storage to permit a clear view of the entire slab. I recommend evaluating the floor yourself once the storage is removed.

Recommendation
Recommended DIY Project

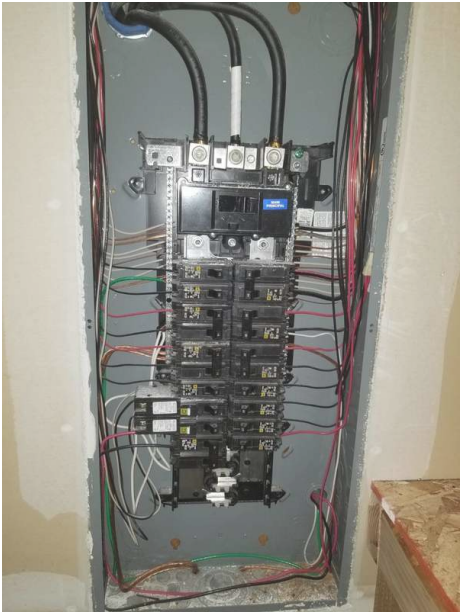
Service Entrance: Main Lines Underground	Service Entrance: Main Lines Acceptable The electrical service entrances are acceptable	Panel Size, Location & Photo: Panel Amps, Location and Picture Garage, 200 AMP

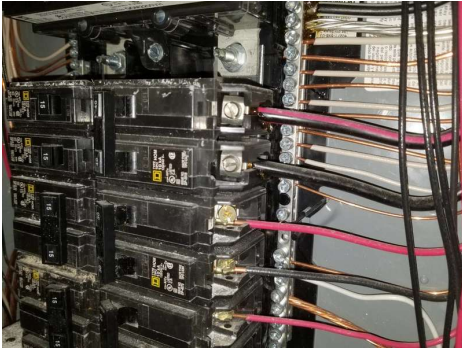
Wiring Notes: Aluminum but only on the larger circuits

There is modern aluminum wiring in the panel but only on the larger circuits such as: the range and a/c unit.

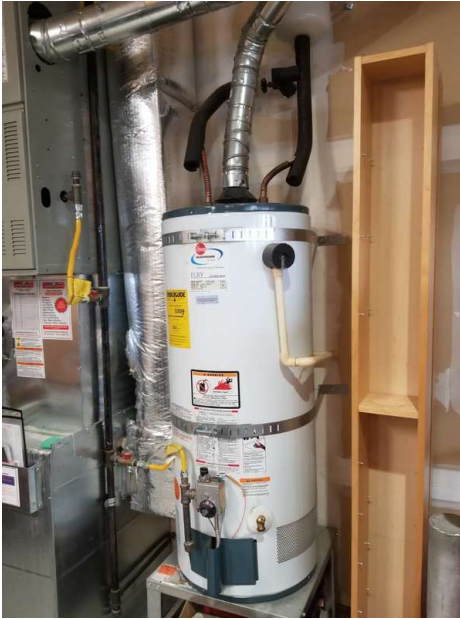
Water Heating System: Water Shut-Off Valve & Connectors

The shut-off valve and water connectors appear functional, but was not tested.

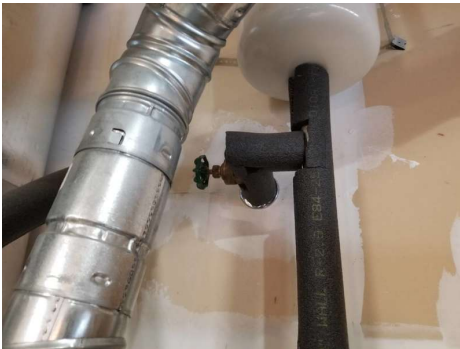
Water Heating System: Relief Valve & Discharge Pipe-Acceptable

The water heater is equipped with a mandated pressure-temperature relief valve and pipe.

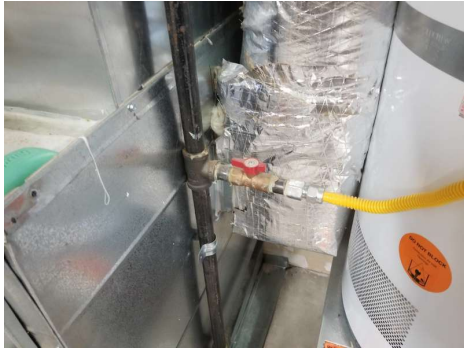
**Water Heating System: Vent Flue-Acceptable**

The vent/flue was in good repair and was mechanically fastened and met proper clearances at the time of the inspection.

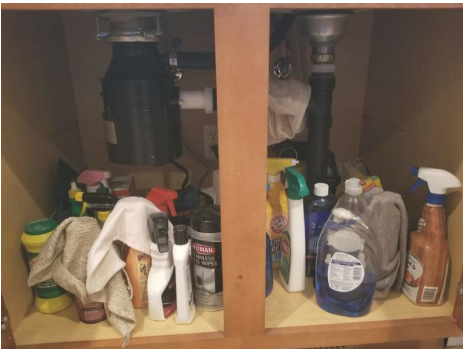
Under Sink Photos

The presence of seller's items limited our view of the cabinet and plumbing below the sink.

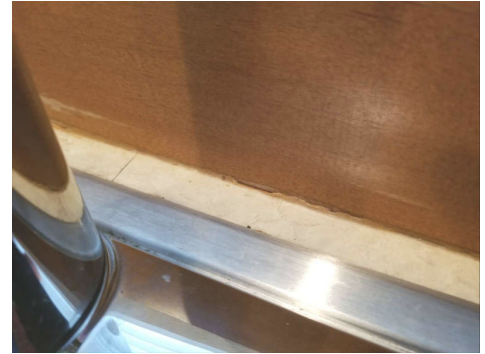
MISSING OR DETERIORATED CAULK/GROUT

The caulking or grout for the backsplash is missing, has gaps and/or not installed properly. We advise caulking/grout be installed and/or gaps filled to prevent possible water intrusion.

Recommended DIY Project

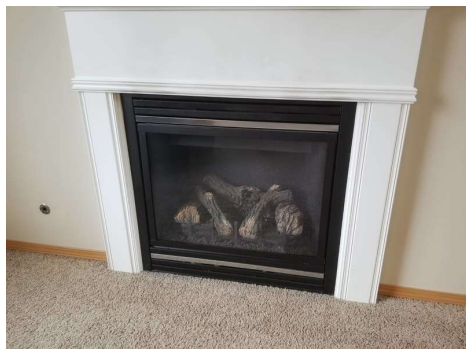
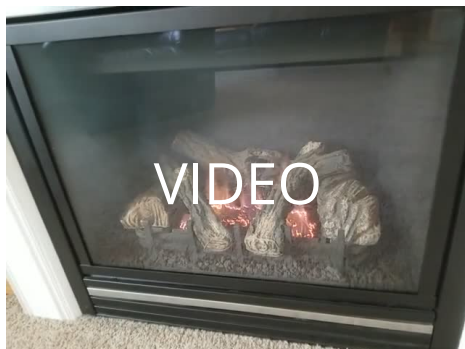
Fireplace Notes: Type of fireplace & Photo

Natural Gas

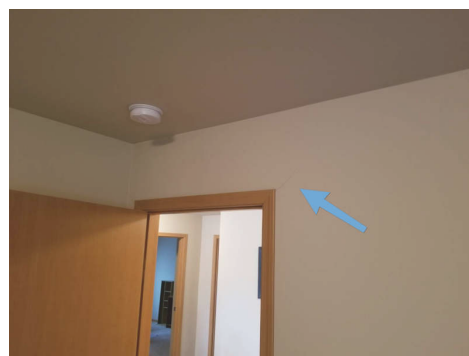
TYPICAL SETTLEMENT CRACKING/NAIL POPS

Observed typical settlement type cracking and nail pops on walls and ceilings. Recommend repairs as needed. Home owner to identify all areas for repair.

Recommend monitoring.

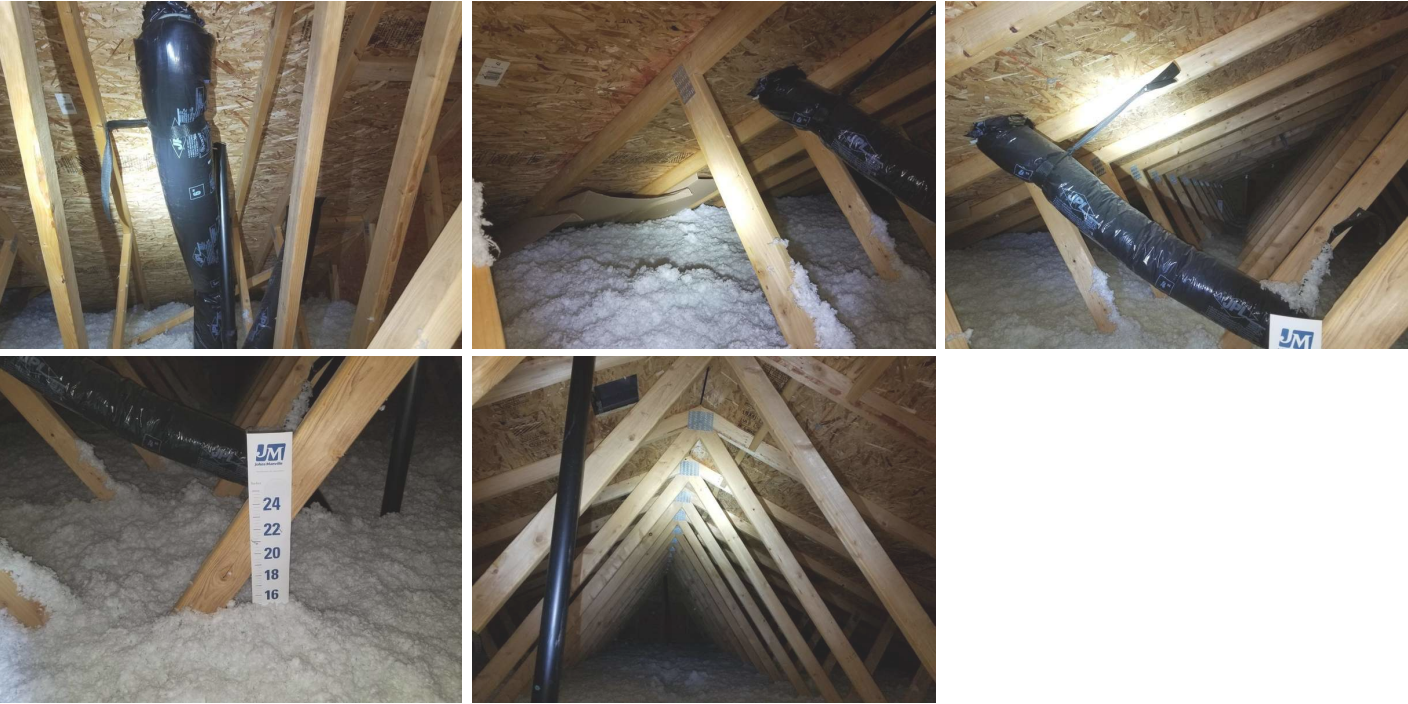
Attic Photos

Attic Access Location Master Bedroom closet	Insulation Notes: Acceptable Insulation is acceptable	Insulation Notes: Insulation Type Blown, Fiberglass
Exhaust Ducts: Acceptable The visible portions of the exhaust ducts appear to be functional.	Plumbing Vents: Acceptable The accessible plumbing vents were in acceptable condition.

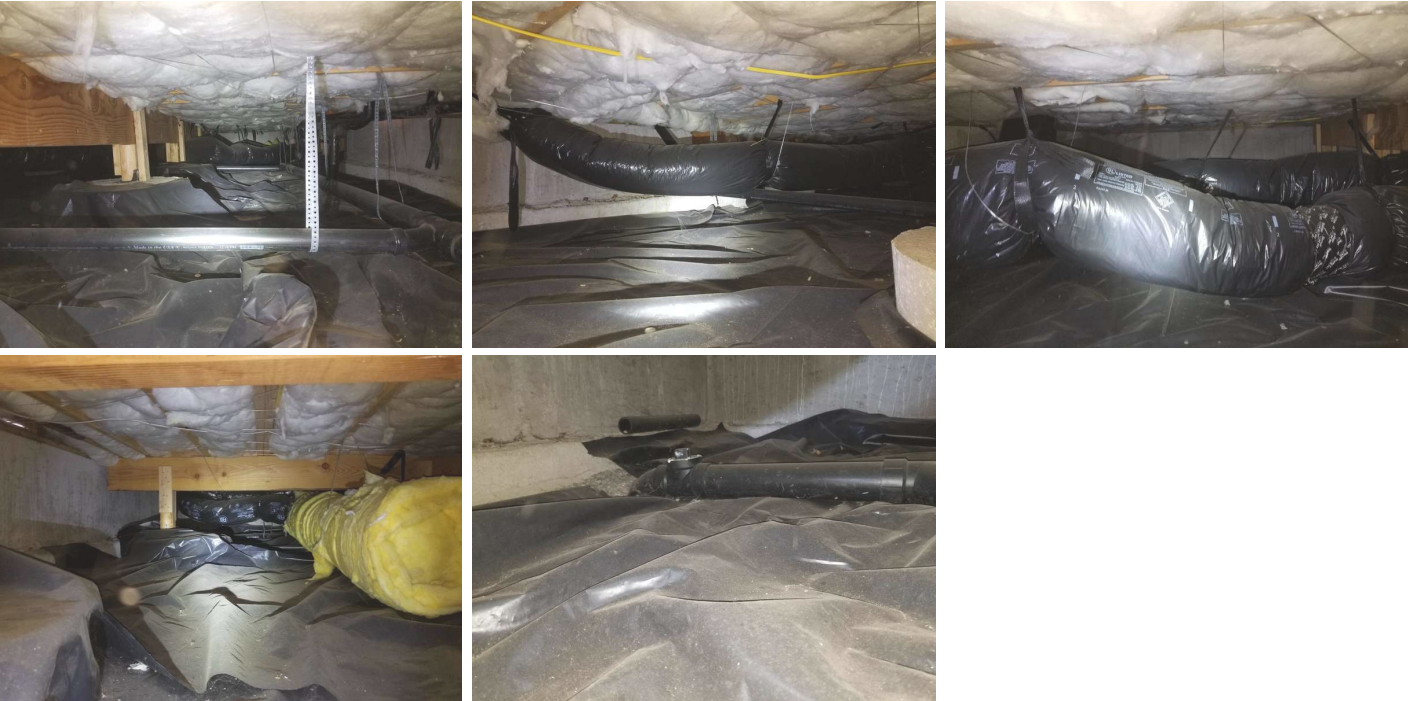
Crawlspace Notes: Crawlspace Photos

Crawlspace Entered

Crawlspace Traversed
