# MOUNTAINS TO SOUND HOME INSPECTION LLC

## HOME INSPECTION REPORT

2505 SW Cloverdale St  
Seattle WA 98106

James & Stacey Morrison  
JULY 3, 2018

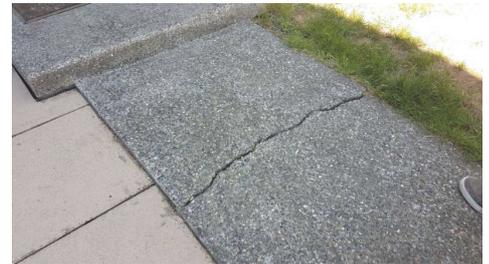
**CRACKS IN WALKWAYS**

There are a few cracks in the walkways around the residence that are mostly cosmetic. We suggest you view these yourself and repair as necessary.

Recommendation

Contact a qualified professional.

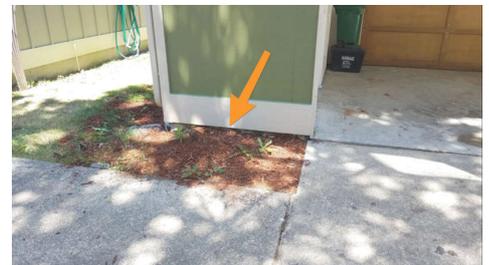
3.5.1 Exterior Siding Notes

**EARTH TO WOOD CONTACT**

The siding was in contact with or nearly contacting soil or mulch or concrete. This is a condition conducive to deterioration and wood destroying organism infestation. We recommend removing soil a six-inch space between any siding material and soil where possible and repairs to any damaged or deteriorated siding.

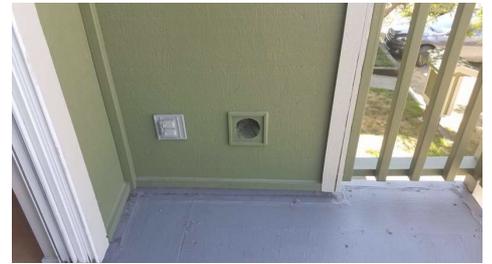
3.5.2 Exterior Siding Notes

**EXTERIOR VENTS NEED REPAIR**

The vent is missing or damaged and is in need of replacement.

Recommendation

Contact a qualified professional.

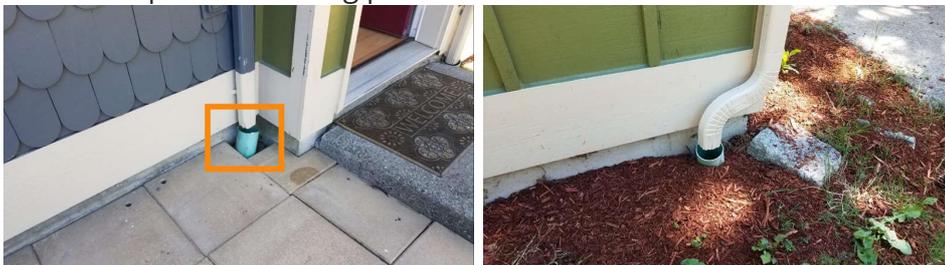
3.9.1 Downspouts

**SOME DOWNSPOUTS ARE MISSING OR NEED TO BE RECONNECTED OR SERVICED**

Some downspouts are missing parts or need to be reconnected or serviced.

Recommendation

Contact a qualified roofing professional.

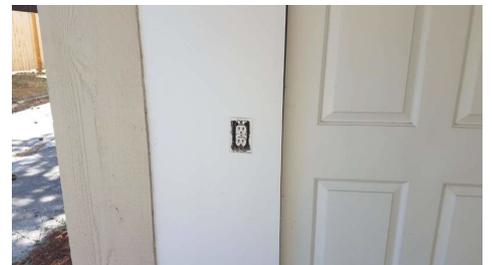
3.14.1 Outlets, Electrical Observations

**MISSING WEATHER SEALS**

There is at least one exterior outlets that are missing weather seals or covers which are recommended for safety and to keep moisture from damaging the outlet.

Recommendation

Contact a qualified handyman.

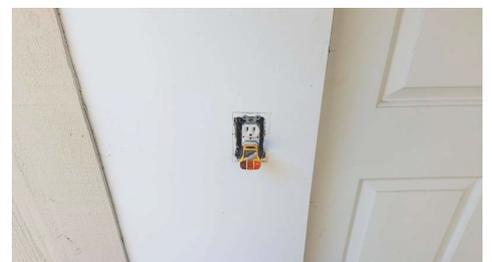
3.14.2 Outlets, Electrical Observations

**OPEN NEUTRAL OUTLET**

Recommendation

Contact a qualified electrical contractor.

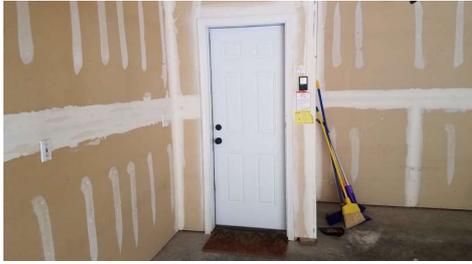
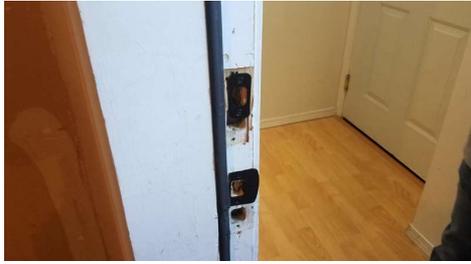
The house garage entry door is functional but does not self-close. It also rubs on the frame and has some minor frame damage. This may not have been required when the house was built and you may elect to have self-closing hinges installed for modern fire safety.

Recommendation

Contact a qualified handyman.

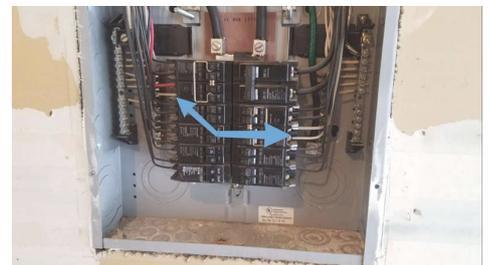
Neutral wires (white) which are being used as hot power, were not taped to show use as HOT. Recommend that black electrical tape be installed on these white wires.

Recommendation

Contact a qualified professional.

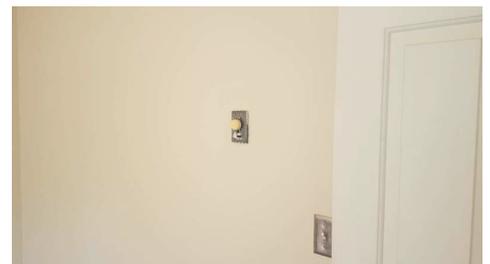
#### **HEATER COVER MISSING**

One or more of the heater covers were missing. Recommend replacing as needed.

Recommendation

Contact a qualified professional.

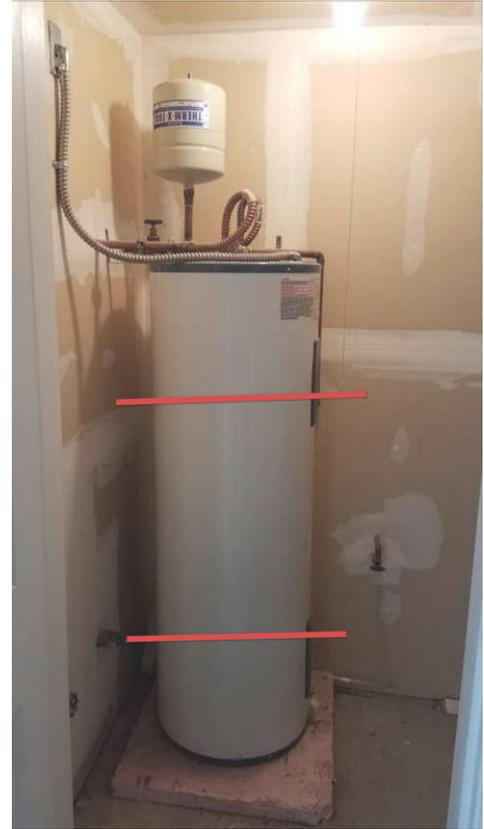
#### SEISMIC STRAPS - MISSING/INSUFFICIENT

The hot water heater was missing seismic straps or was insufficiently anchored. Recommend two straps to properly secure water heater in the case of an earthquake.

Recommendation

Contact a qualified professional.

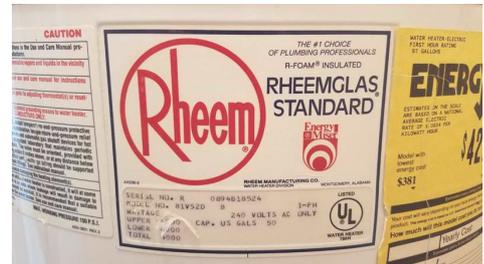
### 8.1.2 Water Heating System

The water heater is beyond its expected life. The need for replacement can be expected in the near future.

Recommendation

Contact a qualified professional.

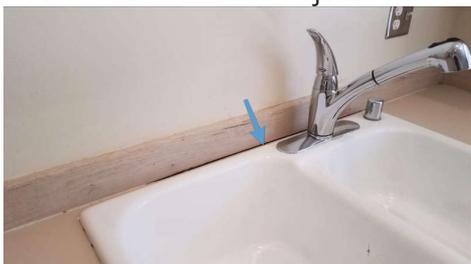
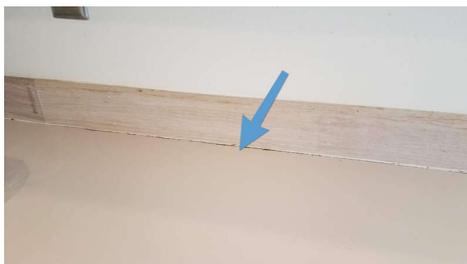
### MISSING OR DETERIORATED CAULK/GROUT

The caulking or grout for the backsplash is missing, has gaps and/or not installed properly. We advise caulking/grout be installed and/or gaps filled to prevent possible water intrusion.

#### Recommendation

#### Recommended DIY Project

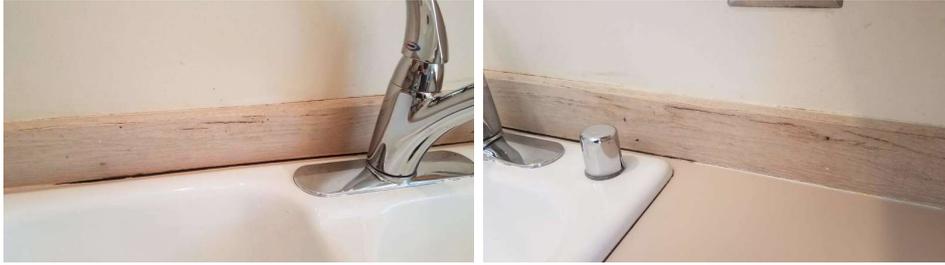
## 9.4.2 Countertop

**BACKSPLASH MINOR DAMAGED**

The backsplash is missing. Recommend repair.

Recommendation

Contact a qualified professional.

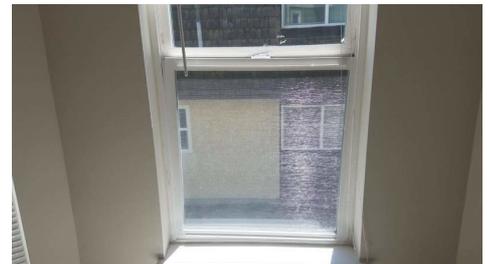
**MISSING OR DAMAGED HARDWARE**

The window is missing or has damaged hardware and is in need of service to be functional.

Recommendation

Contact a qualified professional.

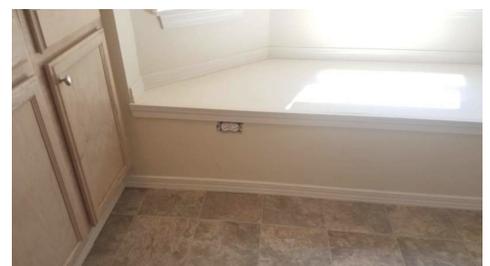
9.10.1 Outlets, Electrical  
Observations

**MISSING COVERPLATE**

There was missing covers that should be installed.

Recommendation

Contact a qualified professional.

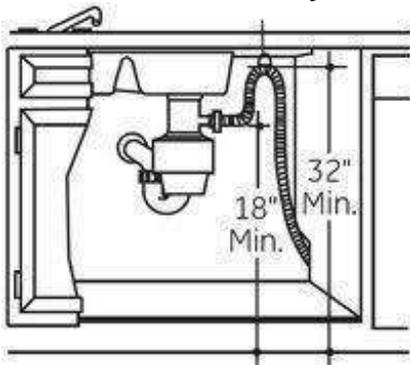
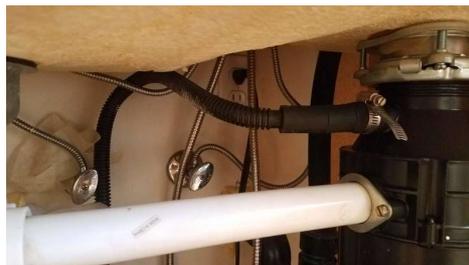
Dishwasher drain pipe was installed without an air gap/high loop to prevent cross contamination. Recommend a qualified licensed professional evaluate and or repair.

Recommendation

Recommended DIY Project

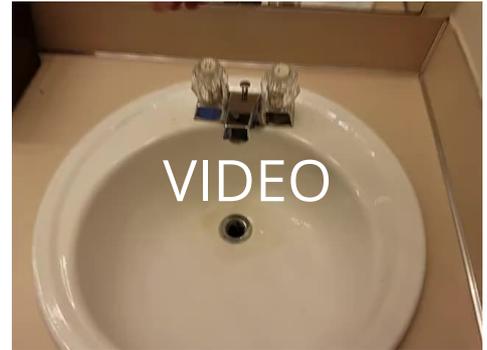
11.1.2 Sink and Faucet

The water pressure was low. Recommend further evaluation to determine the cause and repair as needed.

Recommendation

Contact a qualified professional.

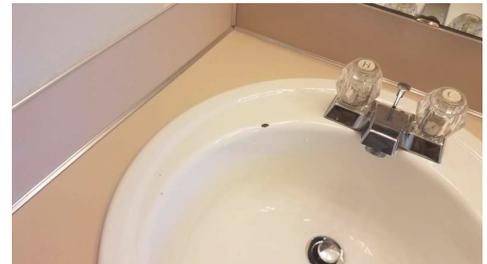
11.1.3 Sink and Faucet

The sink has scratches or chips which should be monitored or repaired.

Recommendation

Contact a qualified countertop contractor.

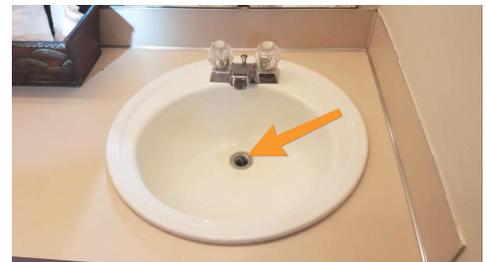
11.1.4 Sink and Faucet

**SINK STOPPER(S) MISSING**

Recommendation

Contact a qualified handyman.

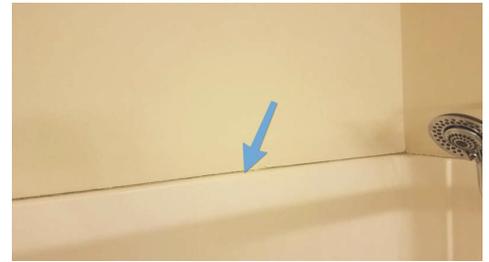
11.4.1 Tub-Shower

**MISSING OR DETERIORATED CAULK/GROUT**

The tub surround is has missing or deteriorated caulk/grout. Recommend caulking or sealing to prevent moisture intrusion.

Recommendation

Contact a qualified professional.

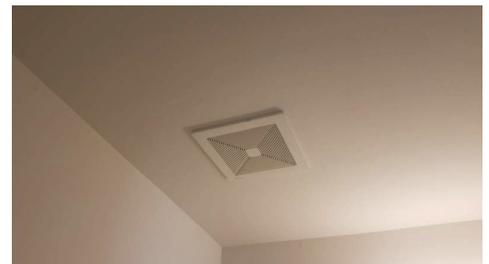
11.8.1 Exhaust Fan

### EXHAUST FAN DID NOT WORK ON DEMAND

Recommendation

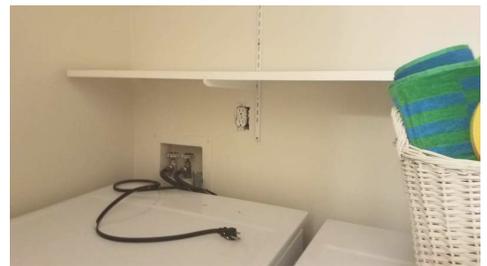
### 12.12.1 Outlets, Electrical Observations

#### **MISSING COVERPLATE**

A switch or outlet is missing a cover and one should be installed

Recommendation

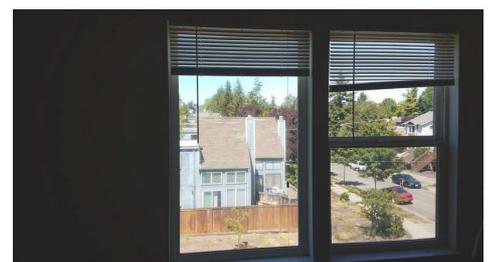
##### MASTER BEDROOM

#### **BROKEN SEALS**

A window(s) has broken hermetic seals, and should be replaced. This is evident from fogging, or condensation forming between the panes of glass, that confirm that the seal has failed. If you are concerned we recommend that you have a professional check out all the windows within the residence.

Recommendation

Contact a qualified window repair/installation contractor.

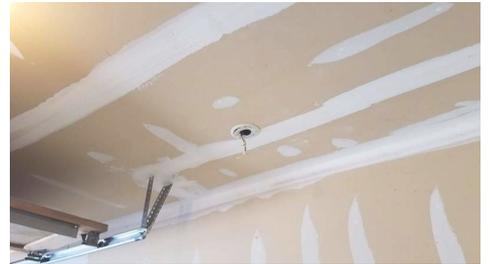
GARAGE

**THE SMOKE DETECTORS MISSING**

The smoke detector is missing and should be installed as a fire safety feature.

Recommendation

Contact a qualified handyman.

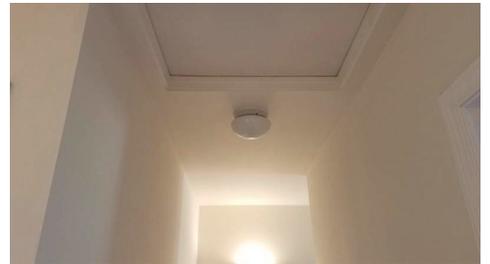
3RD FLOOR HALLWAY

A light fixture did not have light bulbs or the bulbs were burnt out. Recommend replacing bulbs and testing.

Recommendation

Contact a qualified handyman.

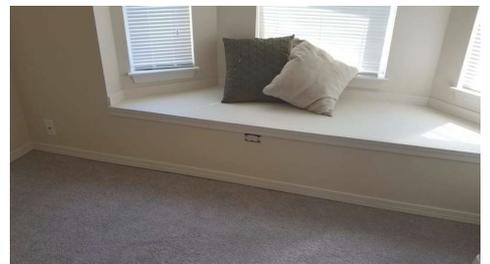
3RD FLOOR LEFT REAR BEDROOM

**MISSING COVERS**

There were missing covers that should be installed

Recommendation

Contact a qualified handyman.

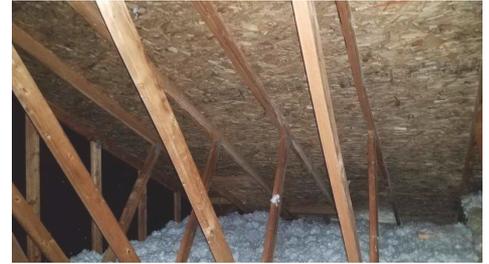
#### DECK STAINING

Discoloration and dark staining was observed on the roof sheathing. This is often caused by poor ventilation and is commonly considered a microbial growth. Recommend improving ventilation and cleaning.

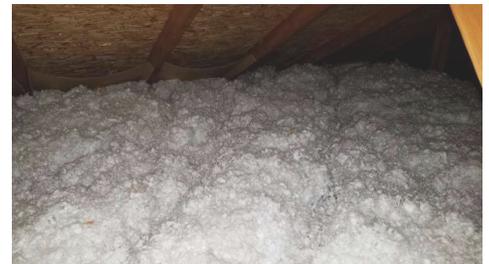
#### RODENT ACTIVITY

The attic has evidence of rodent activity. We recommend ceiling access points in eliminating any active rodent activity

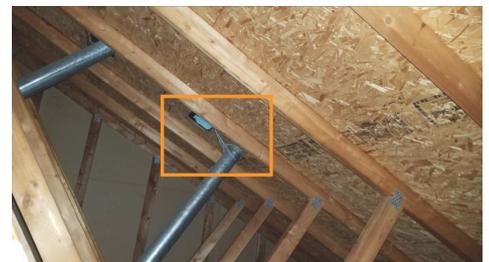
### 14.7.1 Exhaust Ducts

#### BATHROOM EXHAUST SEPARATED NEEDS REPAIR

The bathroom exhaust duct is separated, and should be repaired.
