## HOME INSPECTION REPORT

4814 97th Ave W Unit A  
Tacoma WA 98467

APRIL 16, 2020

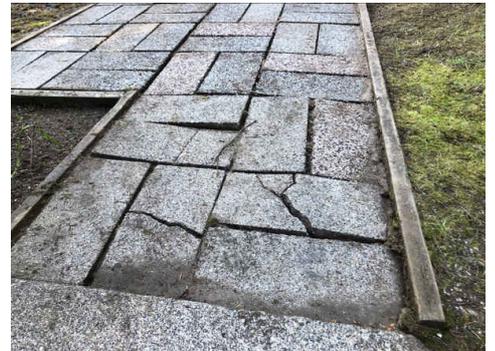
The brick or paver walkways are uneven most likely from being poorly laid and you may want to have it repaired.

Contact a qualified professional.

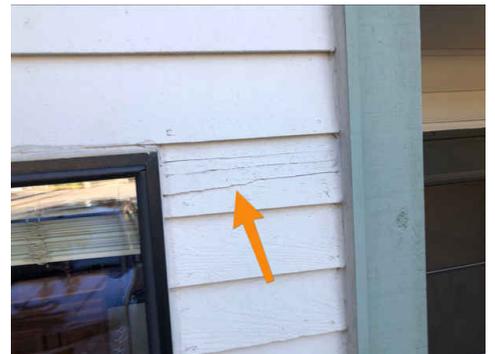
**DAMAGED SIDING**

Observed areas of damaged siding around the residence that should be repaired to help prevent moisture intrusion issues. These damaged areas can allow moisture to penetrate the walls if not properly repaired.

Contact a qualified handyman.

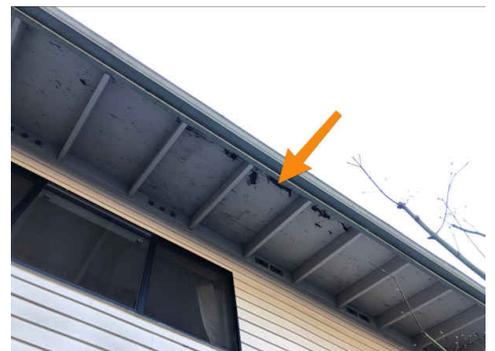
**SECTIONS OF FASCIA OR WOOD TRIM ARE WEATHERED**

Sections of the fascia board or wood trim around the residence are slightly weathered, and should be serviced as necessary to prevent further deterioration. Service such as scraping, repainting and sealing.

Contact a qualified handyman.

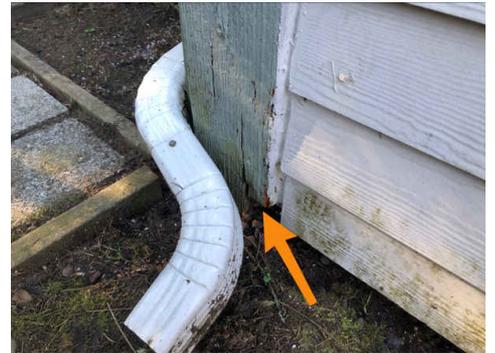
### SECTIONS OF FASCIA & TRIM MOISTURE DAMAGED

Sections of the fascia board or wood trim are weathered, moisture damaged and should be serviced or replaced as necessary by a qualified professional contractor to help prevent further wear or deterioration.

Contact a qualified handyman.

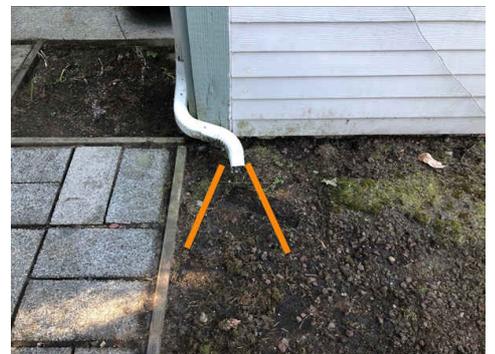
### DOWNSPOUTS MISSING COMPONENTS

The downspouts are missing parts. Recommend repairs to allow for proper drainage away from the structure.

Contact a qualified professional.

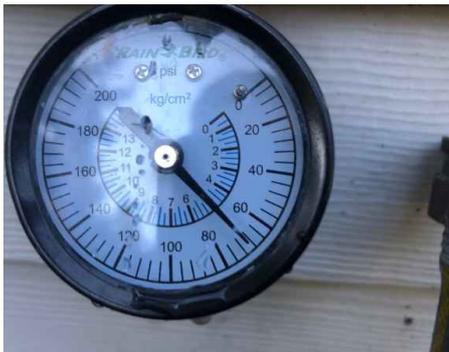
### Main Water Shut-Off, Distribution & Supply: House Pressure PICTURE-Acceptable

The pressure at the street was within industry standards, between 40 and 80 and a regulator is not required on the plumbing system.

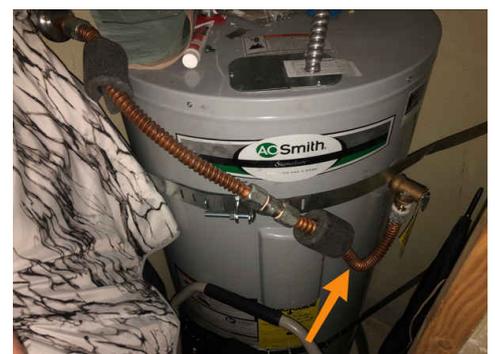
The discharge pipe from the relief valve includes a flexible line and should be replaced with a solid copper discharge pipe. This is because flexible lines can become kinked and possibly prevent the relief valve from working properly in the event it needs to release temperature or pressure and may cause a dangerous situation.

Contact a qualified plumbing contractor.

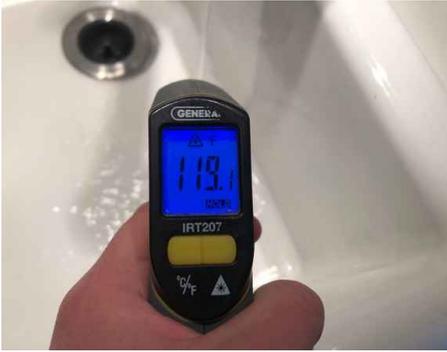
**Sink and Faucet: Water temp**

The Water temp at the Kitchen Faucet is Currently noted in the photo below. The U.S. Consumer Product Safety Commission (CPSC) urges all users to keep their water heater temps at 120 degrees Fahrenheit to prevent scalding and bacteria prevention reasons.

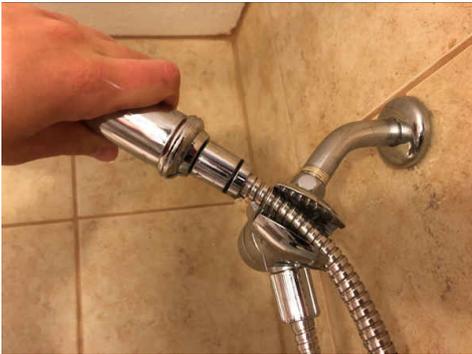
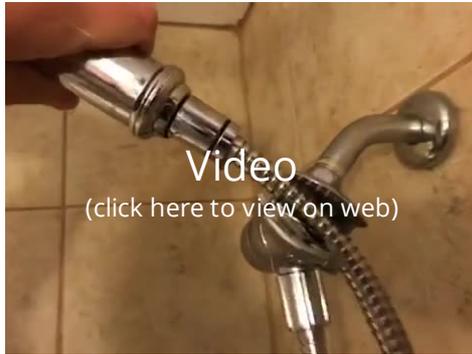
### SHOWER HEAD LEAK

The shower head leaked at the base of the head or hose. The joint should be tightened or sealed to prevent leakage.

Contact a qualified professional.

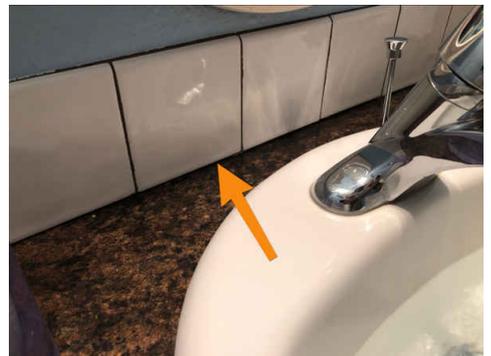
### MISSING OR DETERIORATED CAULK/GROUT

The caulking or grout for the backsplash is missing, has gaps and/or not installed properly. We advise caulking/grout be installed and/or gaps filled to prevent possible water intrusion.

Recommended DIY Project
