HONEST HOME INSPECTION, LLC

## RESIDENTIAL REPORT

11383 Entrevaux Dr  
Eden Prairie, MN 55347

MARCH 10, 2020

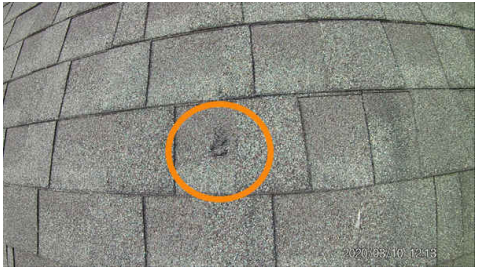
2.1.2 Coverings

VULNERABLE AREAS

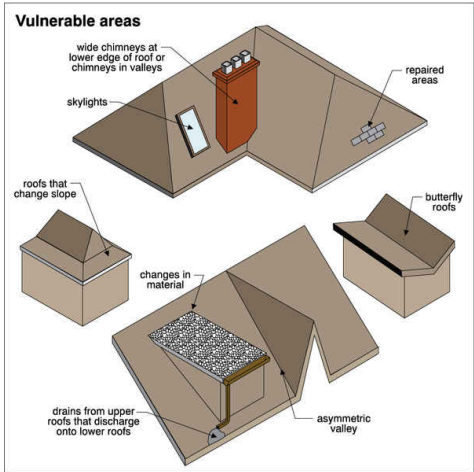
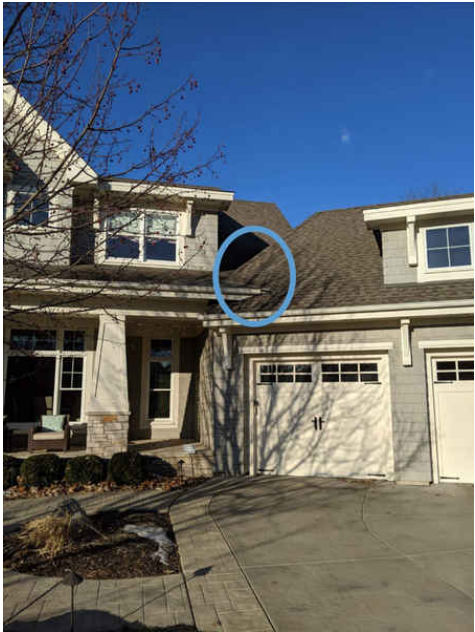
Vulnerable areas are architectural elements that capture snow, ice and water flow on the roof. Pay attention to vulnerable areas for degradation of roofing sealant, flashings, and siding materials, as these can lead to water penetration and rot issues. Facilitate repair as soon as any deterioration might be detected to preserve longevity of materials and help prevent water penetration. Contact a licensed roofing contractor for repairs as needed.

Recommend monitoring.

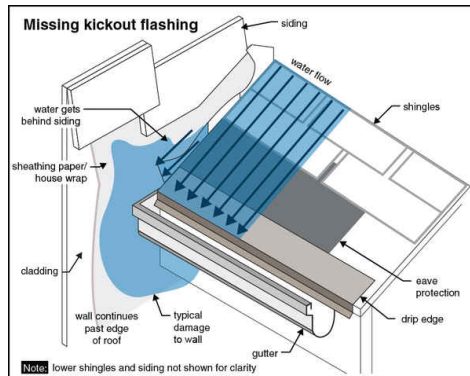
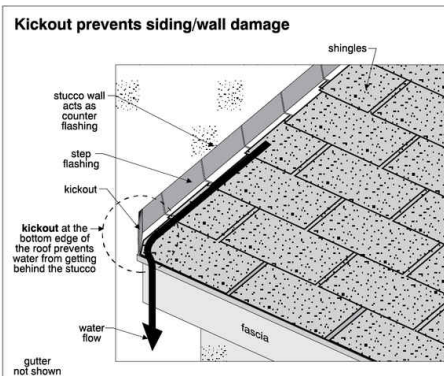
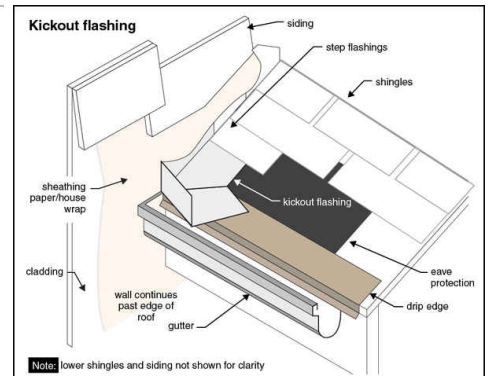
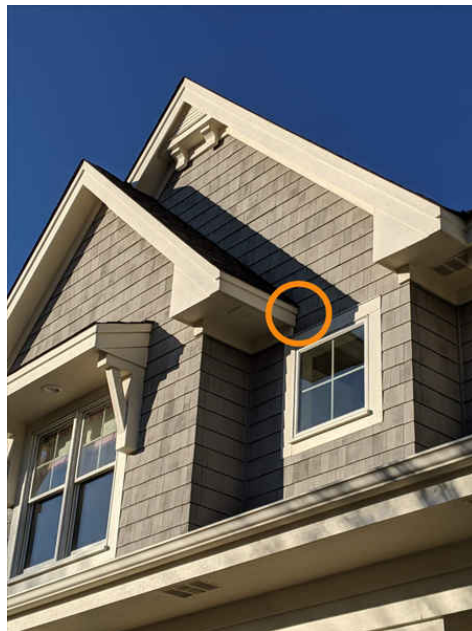
## 2.2.1 Flashings

**MISSING KICKOUT FLASHING(S)**

No kick out flashing present where lower roof meets upper sidewall, (possible several locations). Potential for interior water penetration and rot issues, recommend further evaluation and repair by a licensed roofing contractor.

Kick out flashing undersized

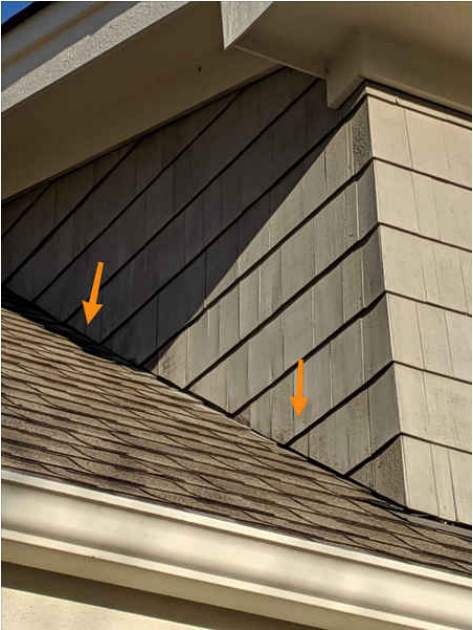
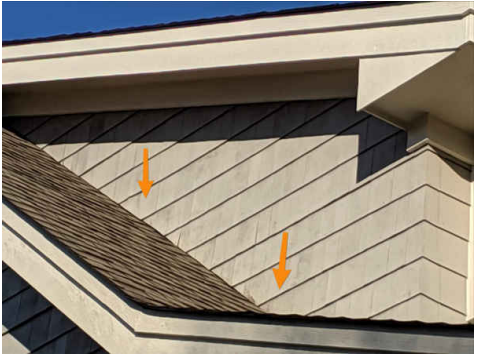
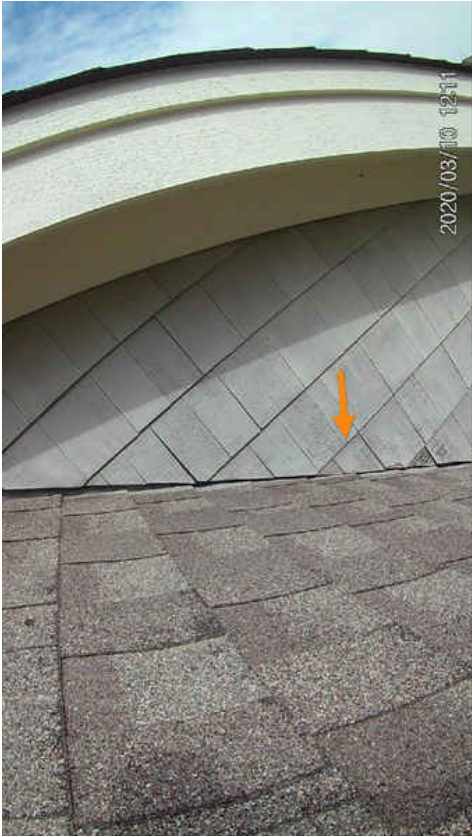
Siding should be cut back a minimum of 2 inches where it meets the roof, step flashings should be visible. Siding material at risk for deterioration where it meets the roof. Recommend further evaluation and repair by a licensed contractor.

Recommendation  
Contact a qualified siding specialist.

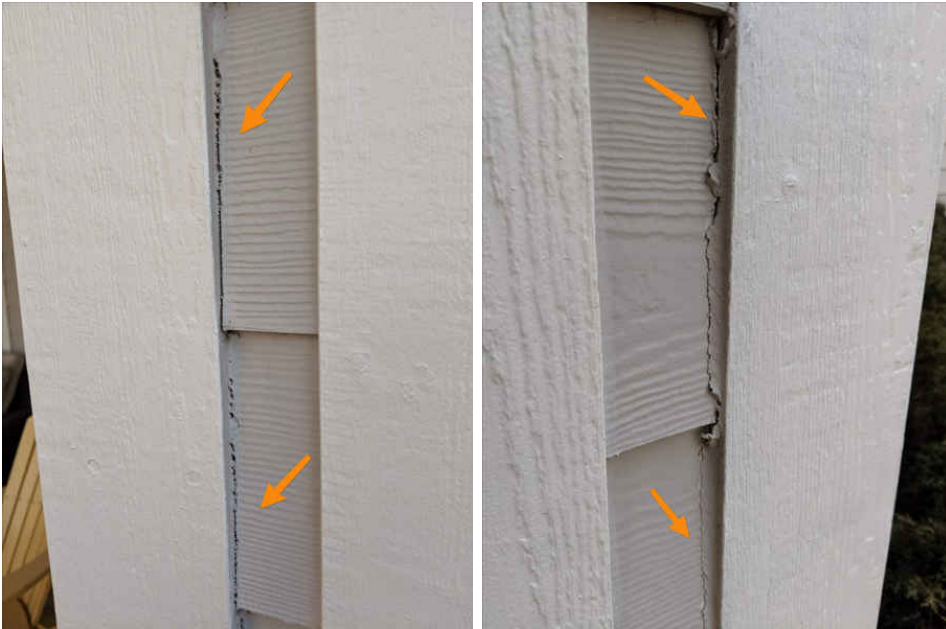
### 3.1.1 Siding, Flashing & Trim

#### **EXTERIOR TRIM - CAULK MISSING OR DETERIORATED**

Areas where exterior siding meets the exterior trim should be sealed with a urethane sealant such as Vulkem. Areas are exposed to potential water penetration and deterioration. Recommend the resealing of joints between exterior siding and trim by a qualified siding professional.

Contact a qualified siding specialist.

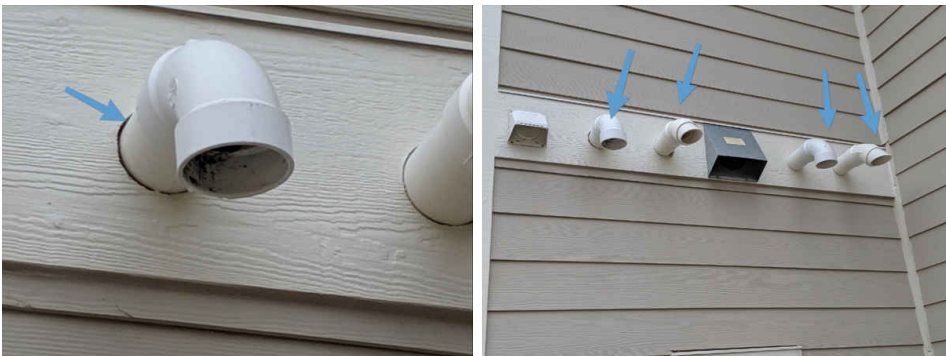
### 3.1.2 Siding, Flashing & Trim

#### **SEALANT MISSING - WALL PENETRATIONS**

Gaps and holes around wall penetrations can allow moisture and pest intrusion. Recommend apply sealant or appropriate trims around wall penetrations.

Contact a qualified siding specialist.

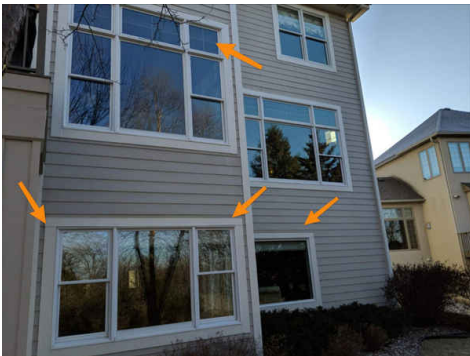
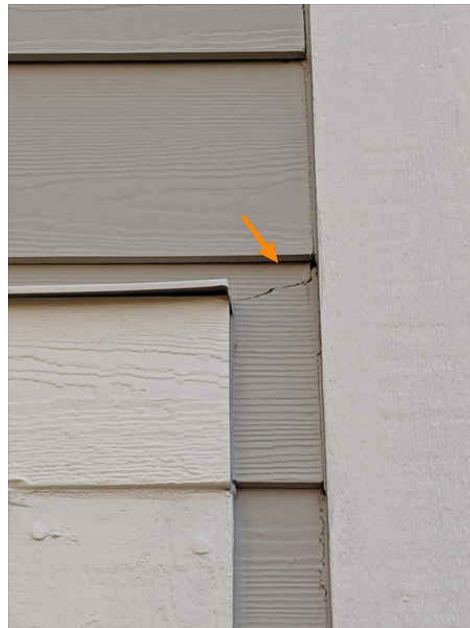
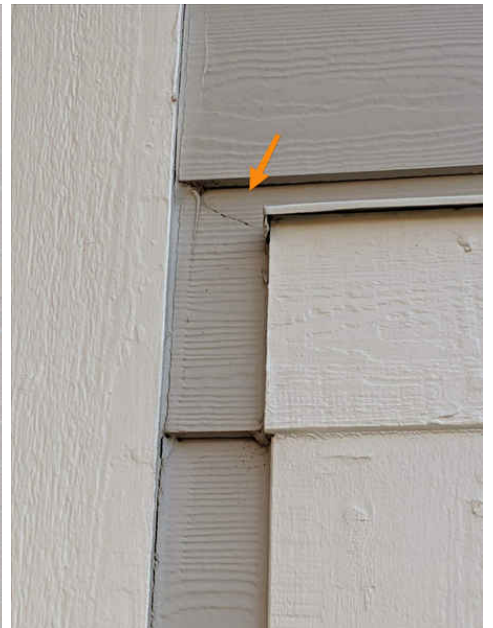
### 3.1.4 Siding, Flashing & Trim

#### **SIDING - CRACKED**

Fiber cement siding cracked around the corners of exterior windows, potential for interior water penetration and deterioration of surrounding materials. Recommend further evaluation and repair by a qualified siding contractor.

Contact a qualified siding specialist.

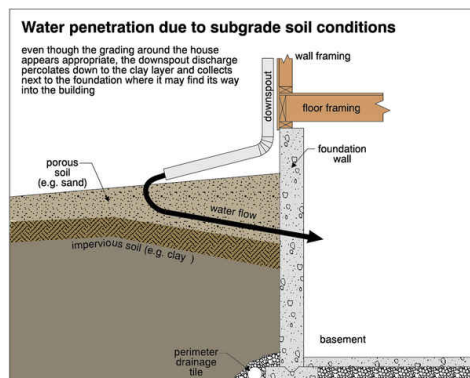
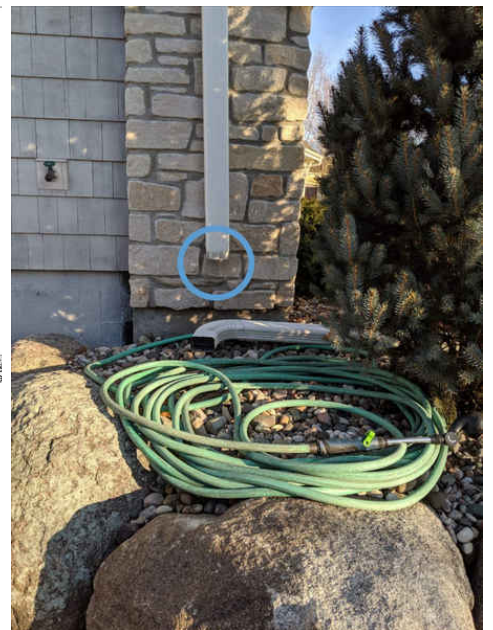
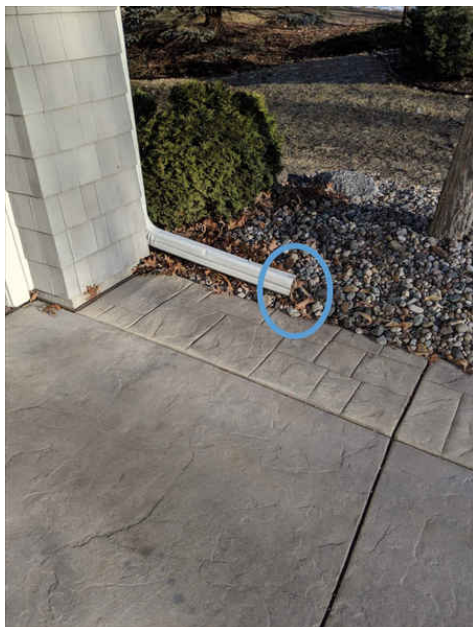
### 3.3.1 Gutter Systems

One or more downspouts drain too close to the homes foundation. This can result in excessive moisture in the soil at the foundation, potentially leading to structural movement and interior water penetration. Recommend install downspout extensions to drain a minimum of 6 feet from the foundation.

Discharge onto driveway will cause excess ice buildup

Contact a handyman or DIY project

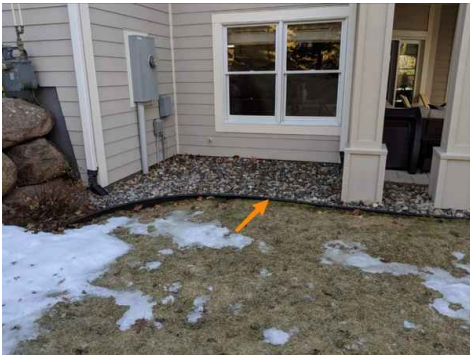
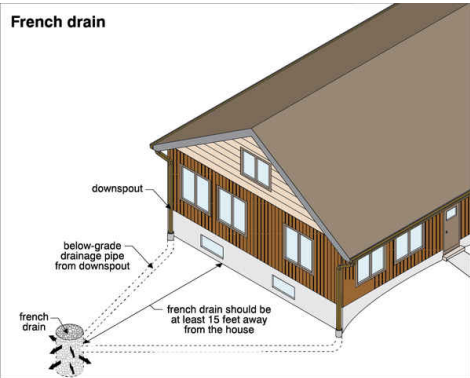
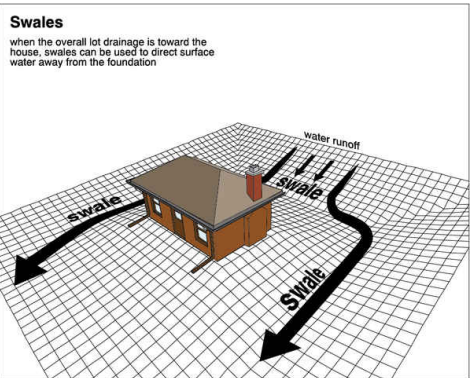
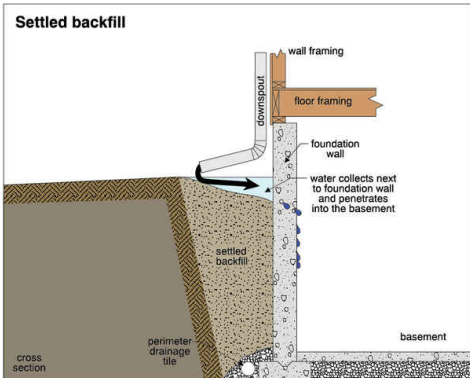
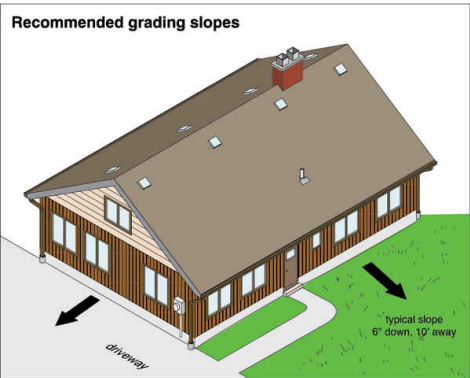
3.6.1 Vegetation, Grading, Drainage & Retaining Walls

Several low areas and improper grade around the property, could possibly lead to an interior water penetration issue. Recommend improve exterior grade to slope away from the home and implement proper drainage in confined areas to carry roof water discharge away from the foundation.

Contact a qualified landscaping contractor

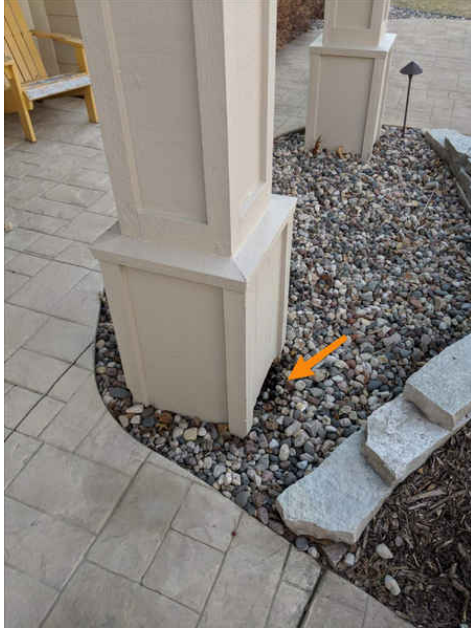
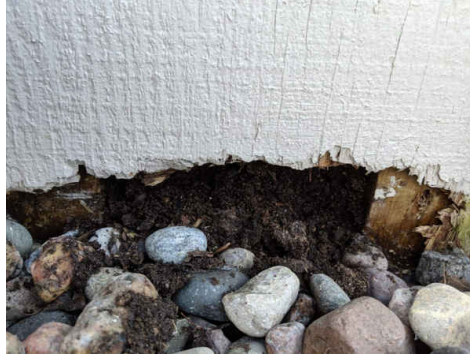
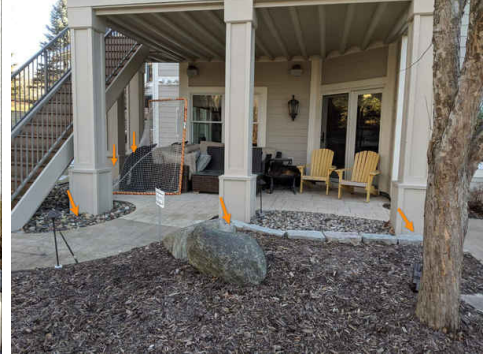
## 3.7.1 Decks

**DECORATIVE COLUMN WRAP - DETERIORATED**

Wood materials of decorative column wrap at base of deck are deteriorated due to soil contact. Potential for further deterioration and rot issues, recommend further evaluation and repair by a licensed contractor. \*Consider use of water resistive materials.

Soil buildup inside wood enclosure

Base of columns at risk for deterioration

Contact a qualified carpenter.

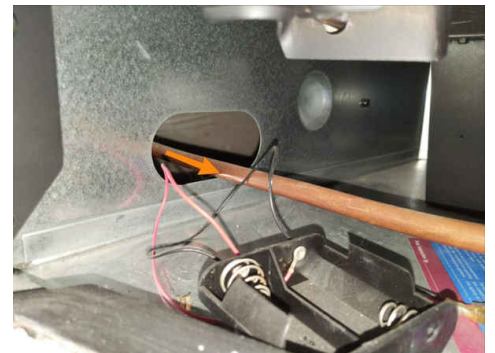
Gas fireplace, copper gas supply line is touching the metal enclosure, possible for vibrations from fan operation to cause damage to gas line. Recommend adjustment of gas line by qualified plumber or fireplace technician.

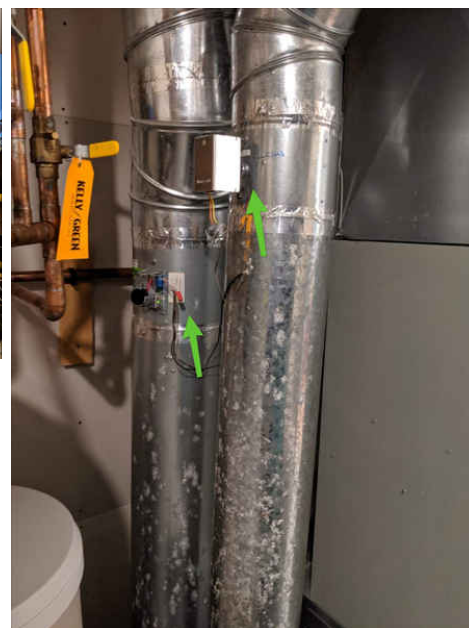
Zone dampers

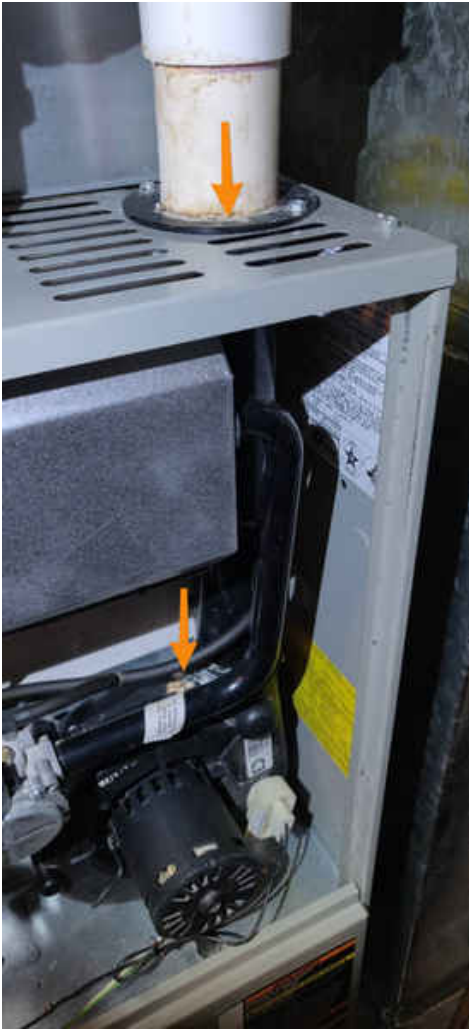
Visible staining and mineral buildup from exhaust condensate running back into the furnace from the flue vent. Indications of possible venting issues and damage to surrounding equipment. Recommend further evaluation by a licensed HVAC contractor.

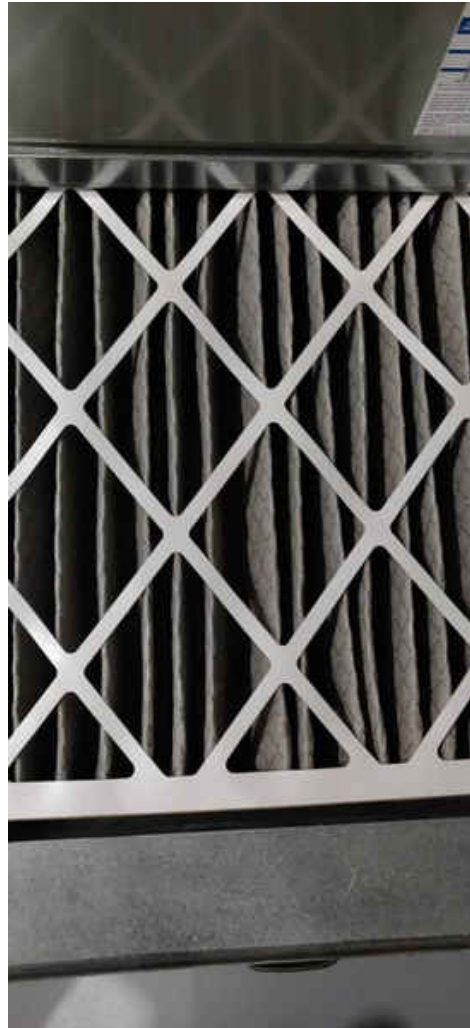
### 6.1.2 Equipment

#### **FILTER - DIRTY**

Mechanical air filter dirty, a clogged air filter can greatly affect appliance performance. Air filters should be checked and changed at least every three months, more often if a higher quality filter is used. Recommend replace air filter and consider duct cleaning to remove dust and dander from the system.

Recommended DIY Project

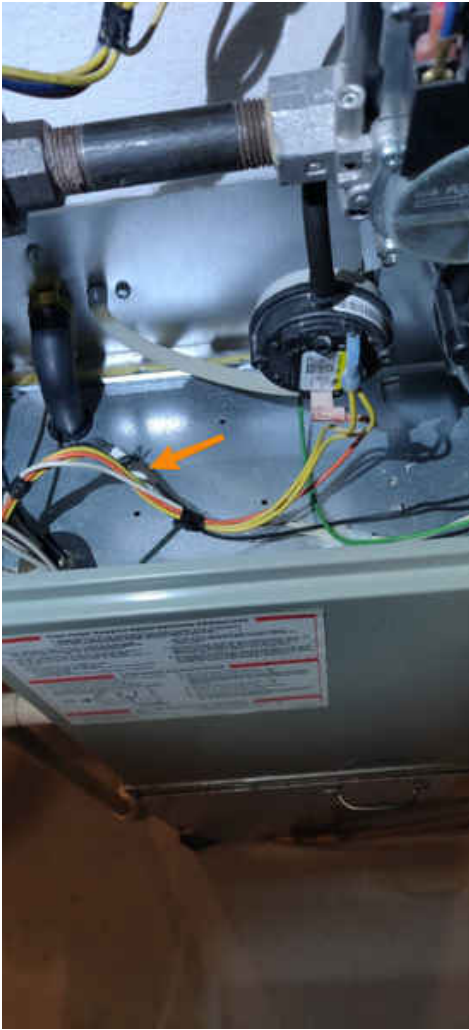
Part left in cabinet

Contact a qualified HVAC professional.

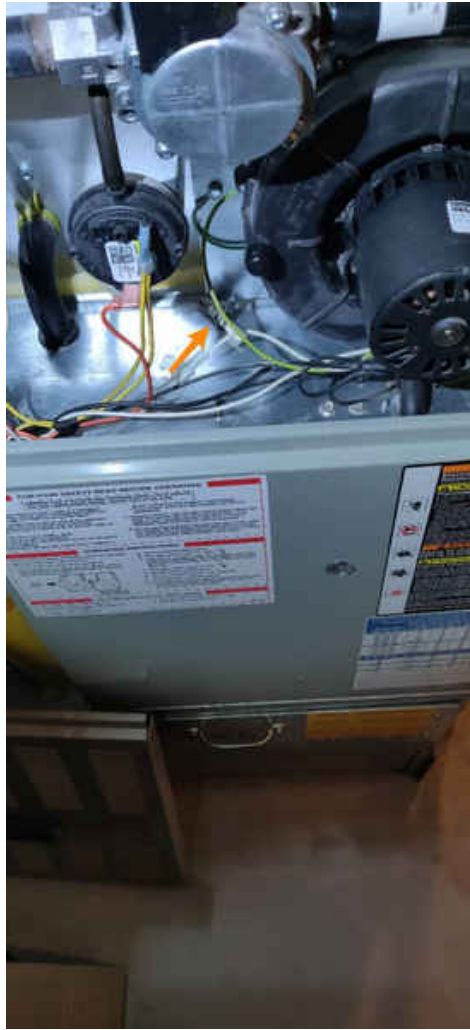
Part left in cabinet

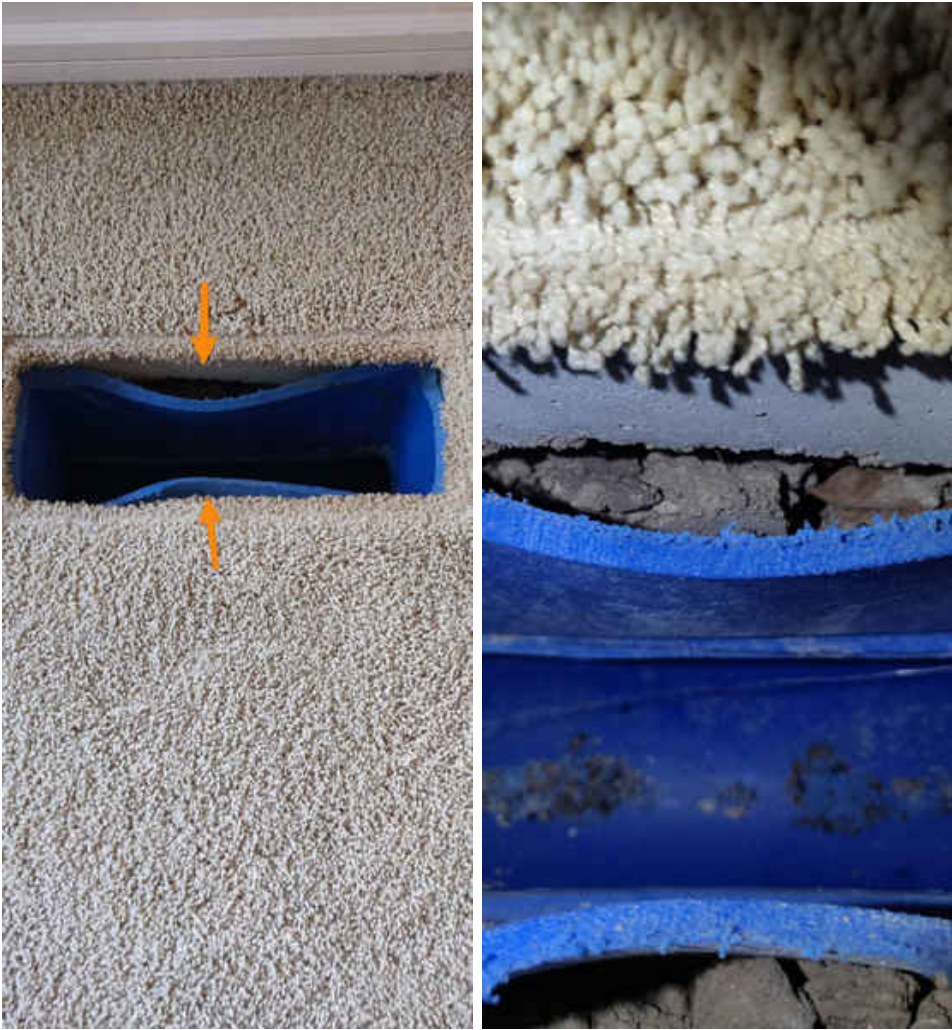
Gaskets between registers and below grade ducts are warped. Visible soil present around gaskets allows for possible moisture and radon penetration, and reduces radon reduction system effectiveness. Recommend further evaluation and repair by licensed HVAC contractor.

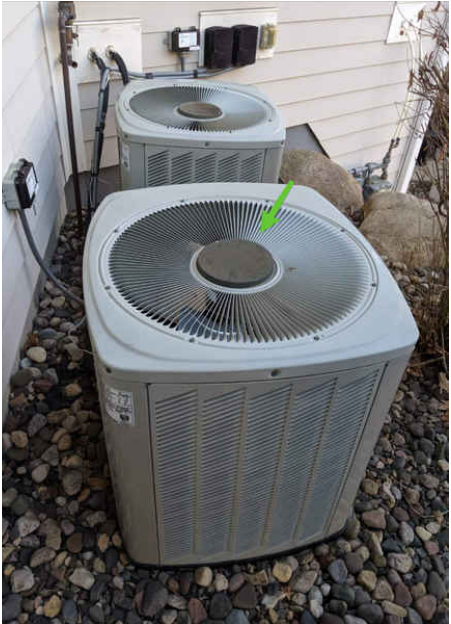
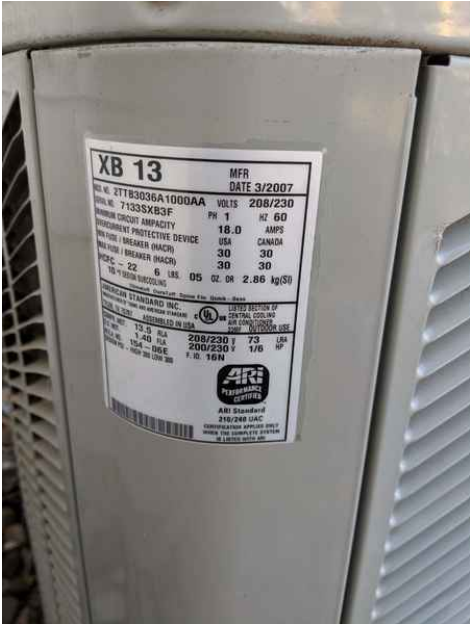
<b>Air Conditioning Cooling Type</b> Air Cooled	<b>Energy Source/Type</b> Central Air Conditioner, Electric	<b>Location</b> Exterior West
<b>Cooling Equipment: Approximate Age</b> West Exterior 13 Years Year of manufacturer 2007	<b>Cooling Equipment: Approximate Age</b> 14 Years Year of manufacture 2006	<b>Cooling Equipment: Failure Probablility</b> High
<b>Cooling Equipment: Refrigerant Type</b> R-22	<b>Cooling Equipment: Typical Life Expectancy</b> 12 to 15 Years	<b>Normal Operating Controls:</b> Thermostat Digital, Programmable
<b>Distribution System: Configuration</b> Central	<b>Presence of Installed Cooling Source in Each Room: Rooms With Available Cooling</b> Central Air	
<b>Cooling Equipment: Brand</b> Trane Model# 2TTB3036A1000AA Serial# 7133SXB3F

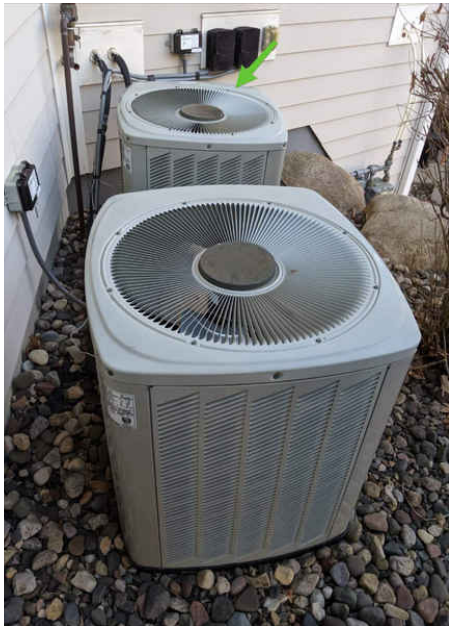
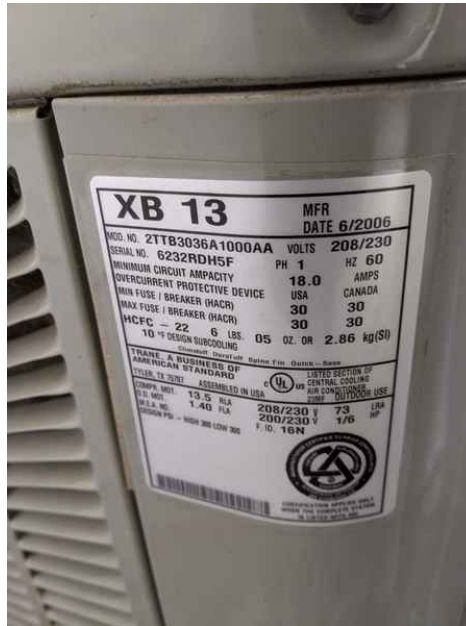
**Cooling Equipment: Brand**

Trane

Model# 2TTB3036A1000AA

Serial# 6232RDH5F

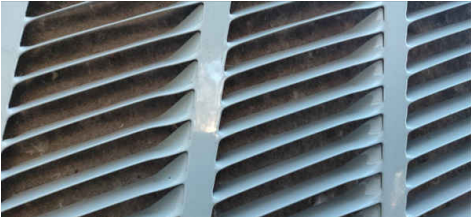
7.1.3 Cooling Equipment

RECOMMEND YEARLY SERVICE

Recommend yearly service, cleaning and maintenance of cooling equipment by a qualified HVAC contractor. \*Consider a home maintenance service such as those offered by your local utility.

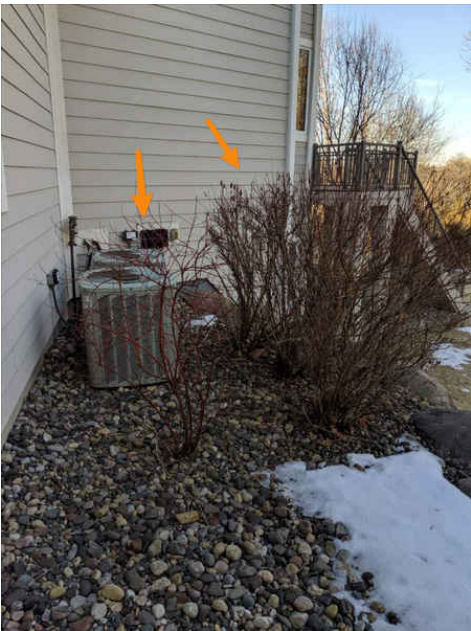
Vegetation was too close to the compressor, which can limit heat dissipation and limit effectiveness. Recommend cutting back vegetation to avoid overheating compressor.

Contact a qualified landscaping contractor

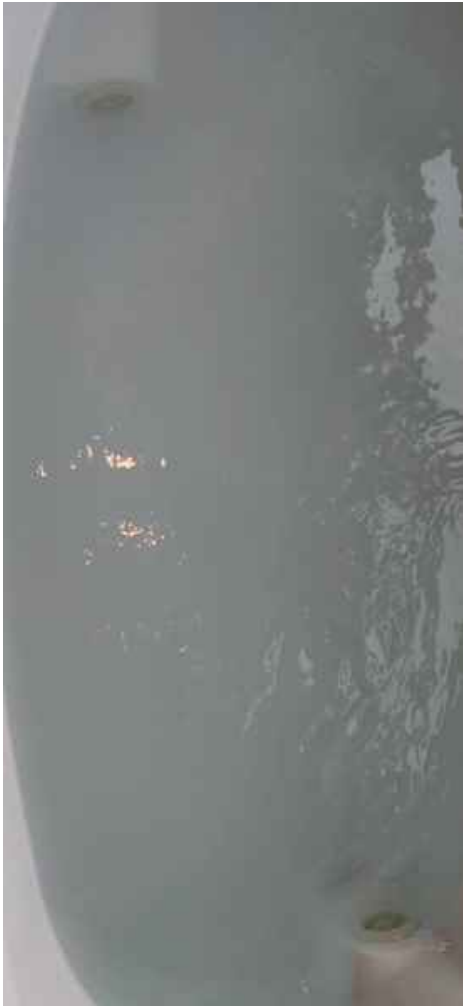
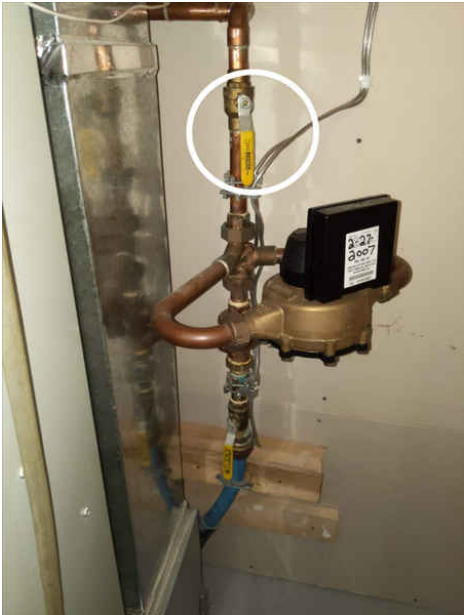
<b>Water Source</b> Public	<b>Fixtures: Types of Fixtures Present</b> Bath Tub(s)	<b>Main Water Shut-off Device: Location</b> Basement, Utility Room

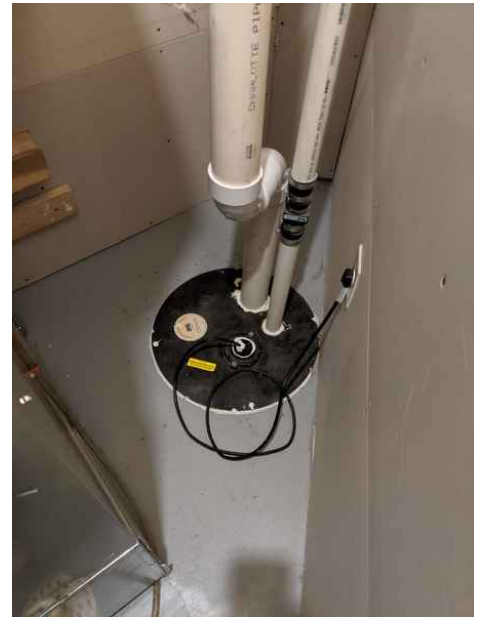
**Sump Pump: Location**

Basement, Utility Room

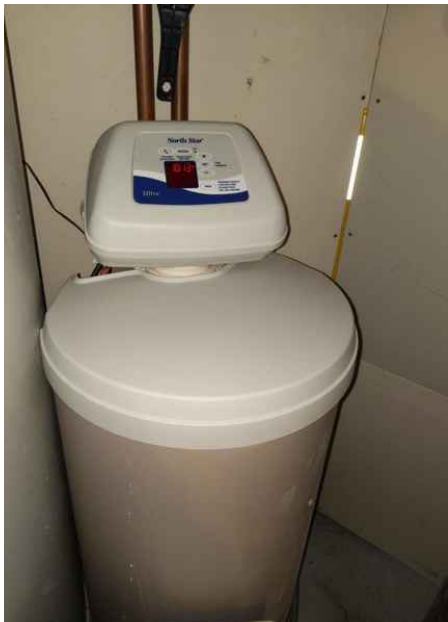
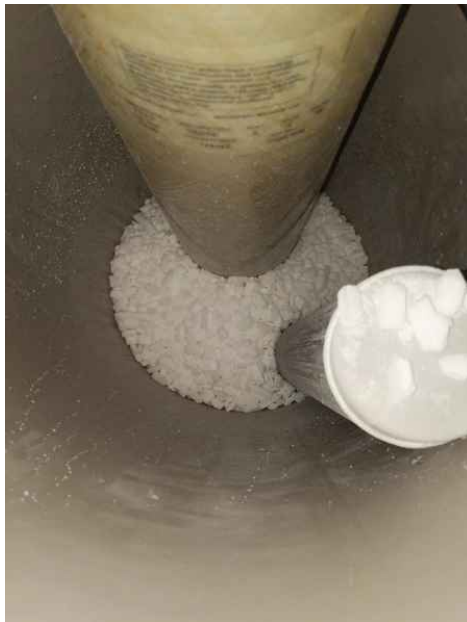
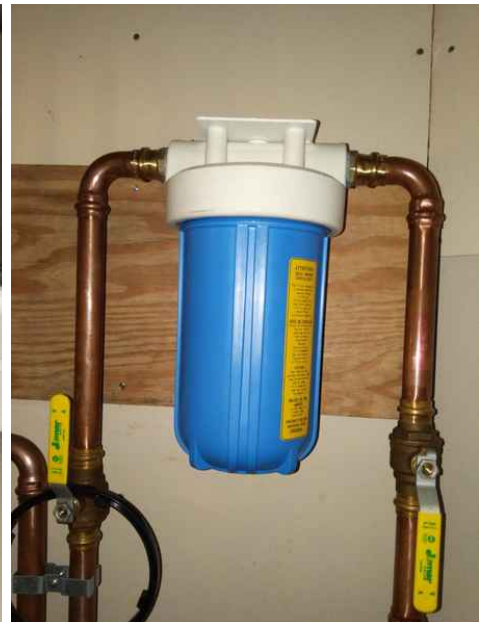
**Water Treatment Systems**

Water Softener, Sediment Filter

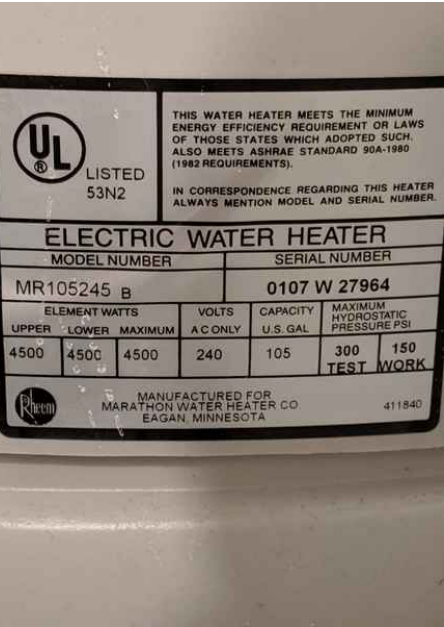
Hot Water Systems, Controls, Flues & Vents: Manufacturer

Marathon  
Rheem  
Model# MR105245 B  
Serial# 0107W27964

I recommend flushing & servicing your water heater tank annually for optimal performance. Water temperature should be set to at least 120 degrees F to kill microbes and no higher than 130 degrees F to prevent scalding.  
[Here is a nice maintenance guide from Lowe's to help.](#)

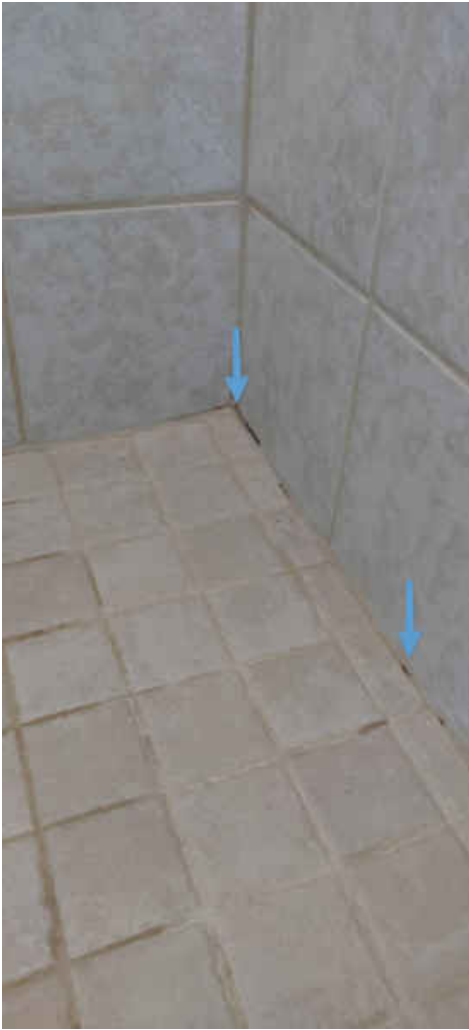
**CAULK DETERIORATED/MISSING -  
SHOWER SURROUND**

Caulk around base of tiled tub surround is deteriorated or missing, potential for moisture penetration through grout and loose tile. Recommend remove failed caulk and replace with an anti-microbial, tub and shower caulk.

Recommendation  
Contact a handyman or DIY project

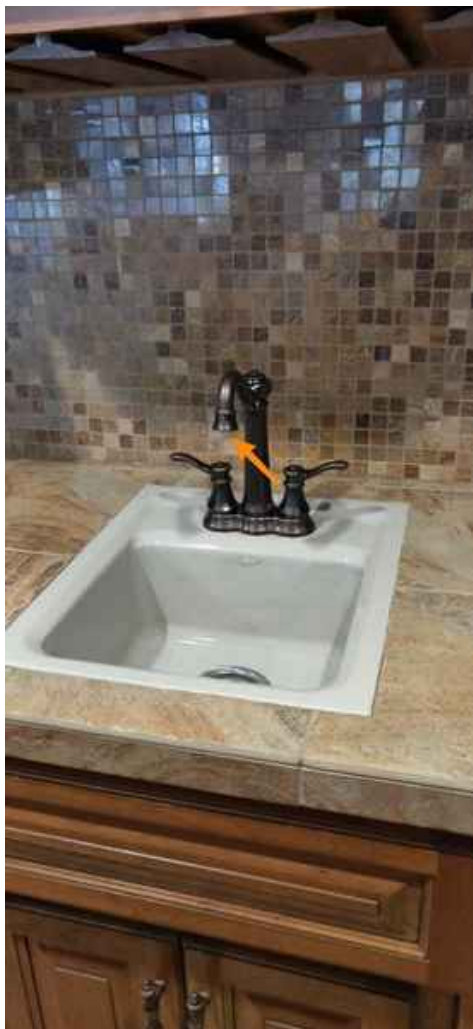
### 8.1.2 Fixtures

## **FAUCET - DRIPPING**

Faucet drips at basement bar sink, potential for excess water waste. Recommend repair or replacement by a licensed plumbing contractor.

Contact a qualified plumbing contractor.

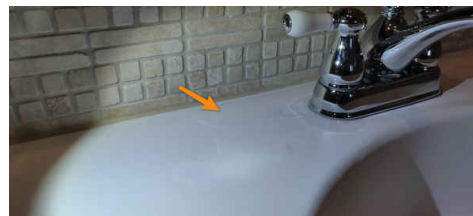
Faucet leaking from base, potential for water damage to surrounding materials and finishes. Recommend repair or replacement by a licensed plumbing contractor.

Faucet leaking right sink and Jack and Jill bathroom

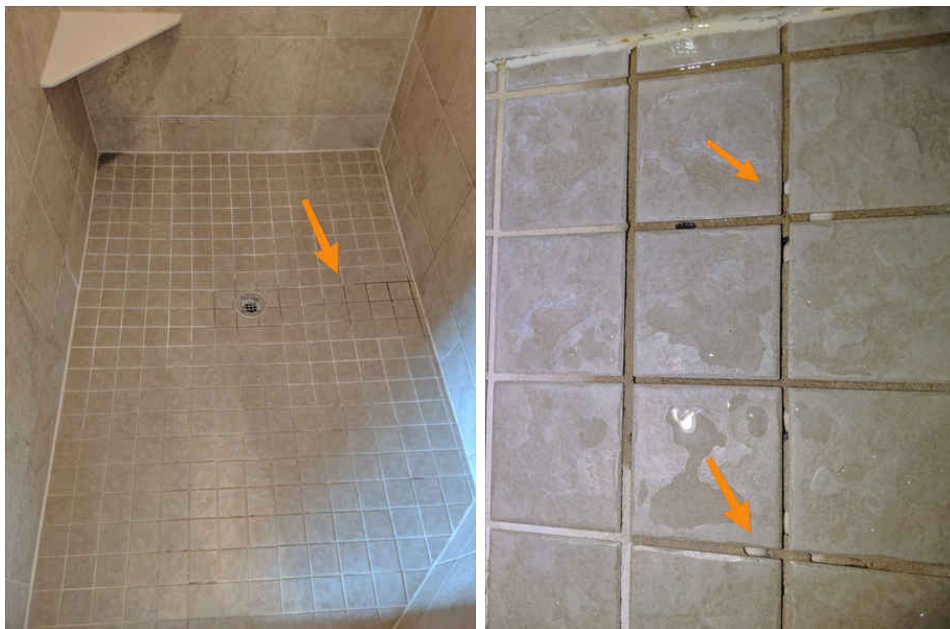
**GROUT MISSING FROM TILE SURROUND**

Grout missing from between tiles in shower floor, potential for water penetration issues and tiles coming loose. Recommend further evaluation and repair of grout by a qualified tile contractor.

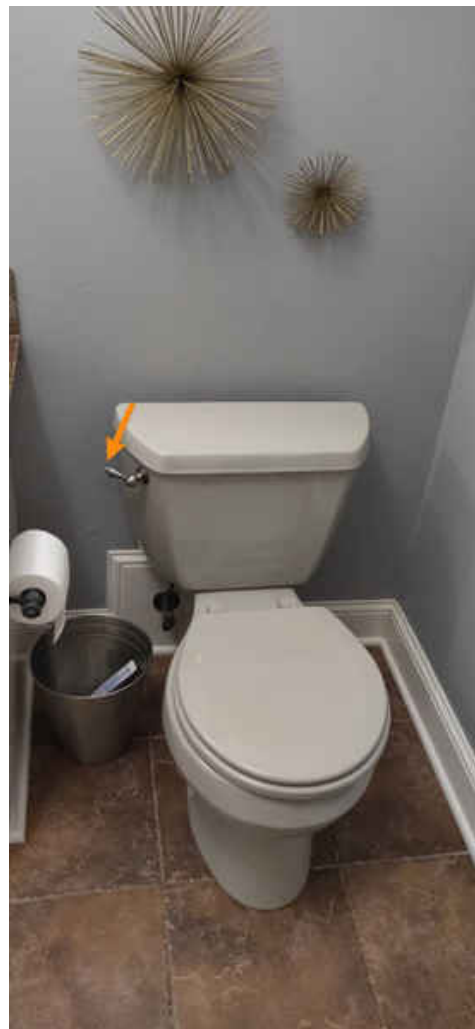
## 8.1.6 Fixtures

**TOILET - WEAK FLUSH**

Flush handle requires holding longer than normal operating time. Poses potential for incomplete flush cycle. Recommend repair by a licensed plumbing contractor.

Contact a qualified plumbing contractor.

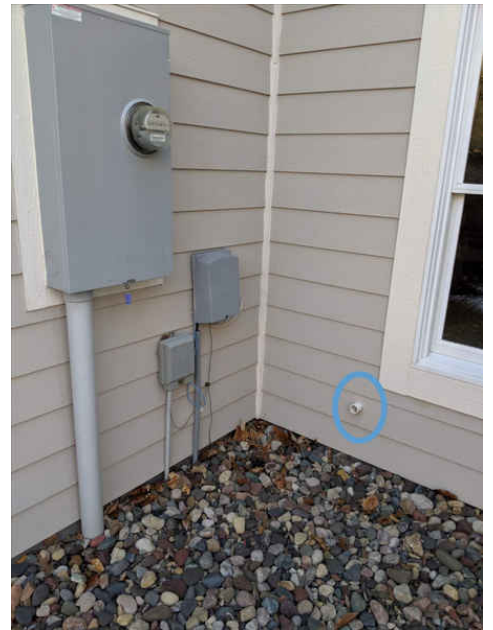
**SUMP PUMP - DISCHARGE TOO CLOSE TO FOUNDATION**

Sump pump discharges too close to foundation. Recommend add discharge hose for better drainage, and to move water away from the foundation. \*Consider below grade drainage options.

Contact a handyman or DIY project

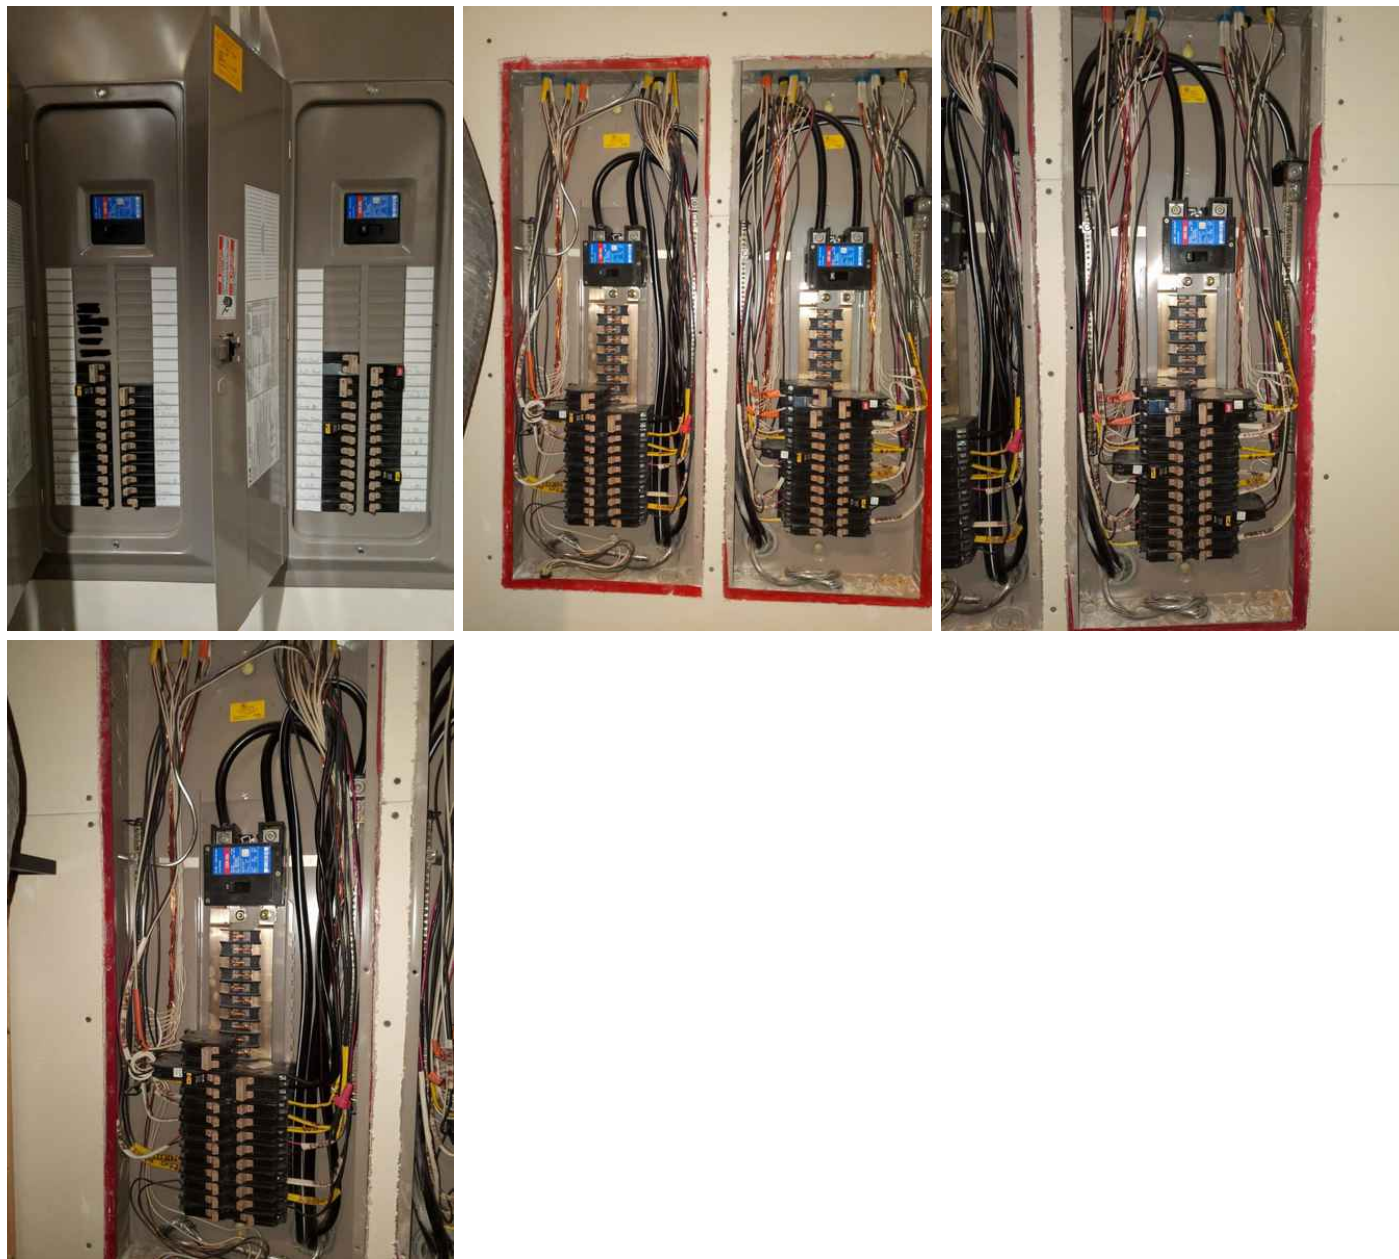
## Main Service & Grounding, Main Overcurrent Device: Panel Manufacturer

Eaton

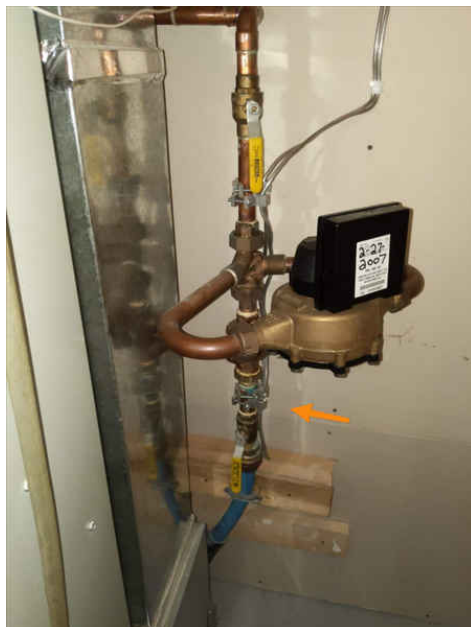
Supplied ground with main panel feeder wires are not connected

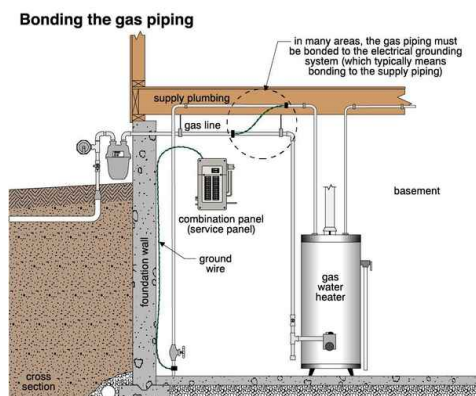
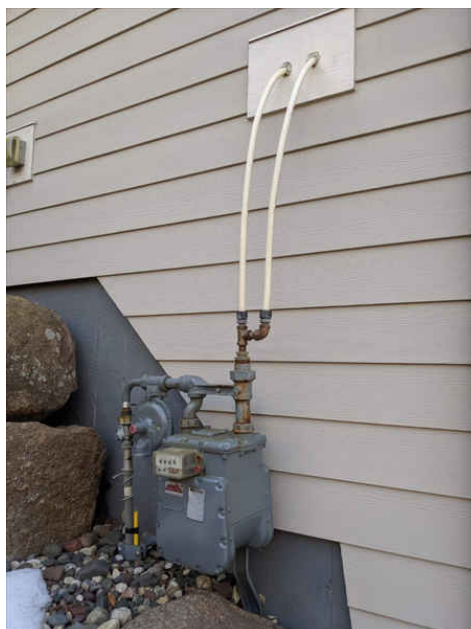
### 9.2.2 Main Service & Grounding, Main Overcurrent Device

## INADEQUATE BONDING FOR GAS AND WATER LINES

CSST at risk for lightning strike without bond

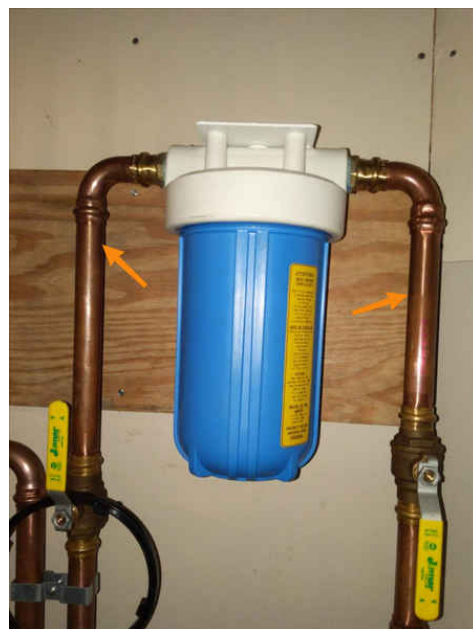
Missing bonding jumper

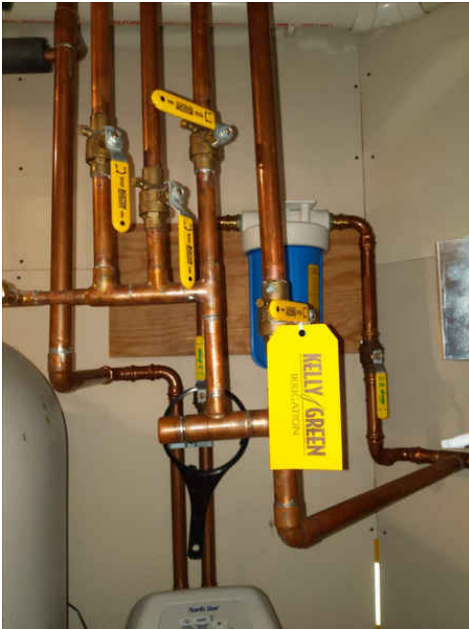
No bond wire s visible at plumbing

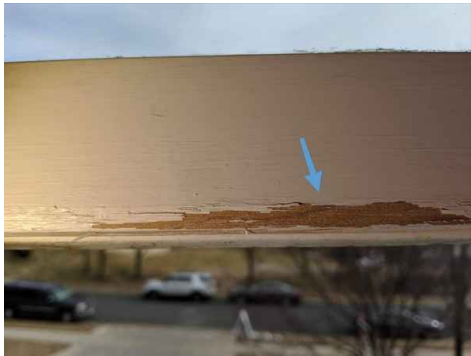
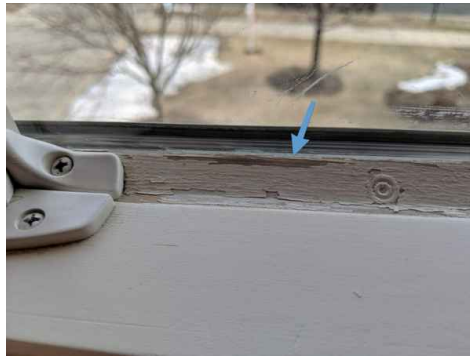
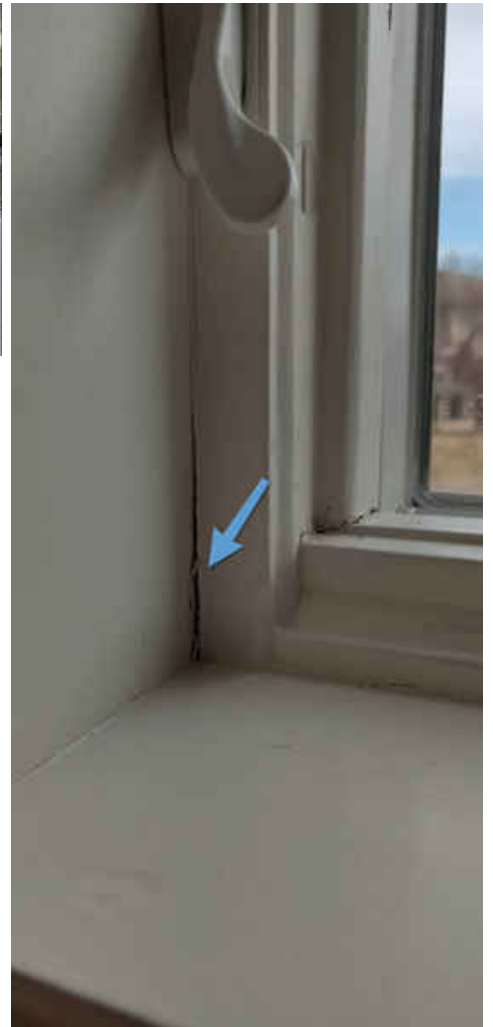
Caulking failed

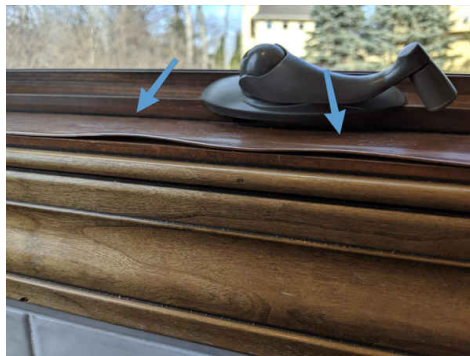
11.5.1 Countertops & Cabinets

### **POOR/MISSING CAULK**
