HONEST HOME INSPECTION, LLC

## RESIDENTIAL REPORT

11383 Entrevaux Dr  
Eden Prairie, MN 55347

MARCH 10, 2020

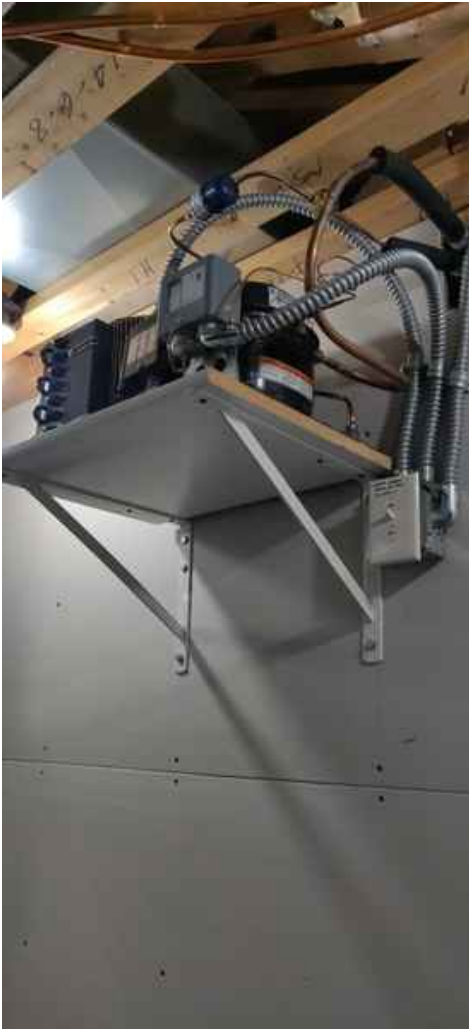
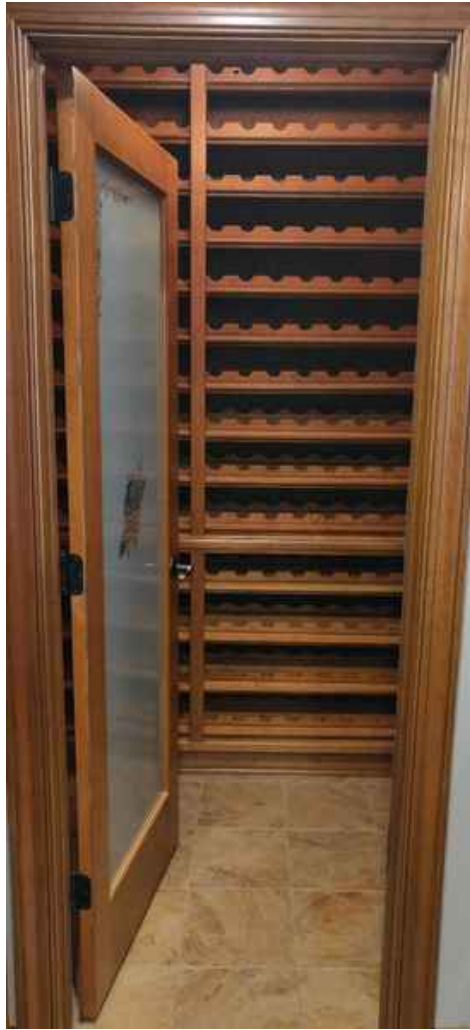
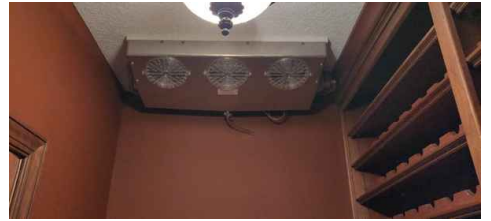
## WINE UNIT NOT TESTED

Wine Room was powered off and therefore not tested.

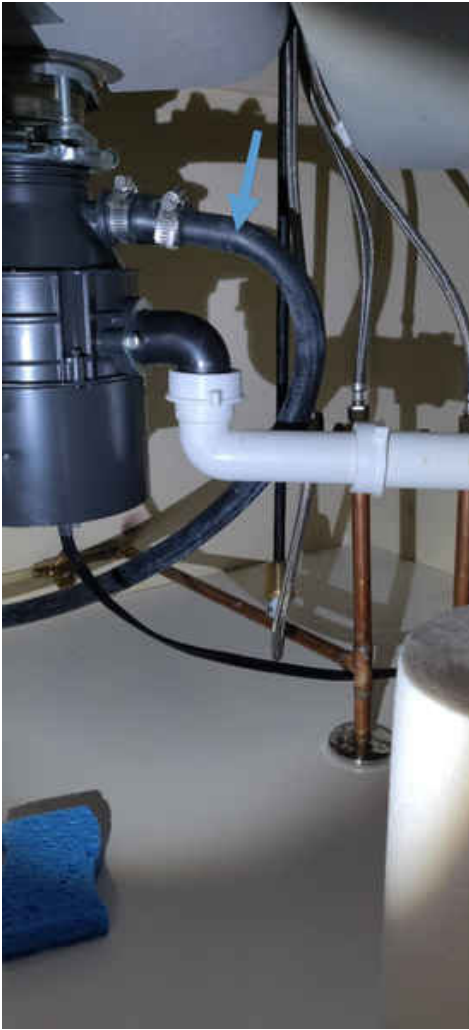
### 12.4.1 Dishwasher

#### **BACK FLOW PREVENTION MISSING**

A high loop or back flow prevention air gap are missing from the dishwasher drain line, these prevent the flow of water back into the dishwasher after it drains. Recommend installation of a high loop in the dishwasher drain line.

##### Recommendation

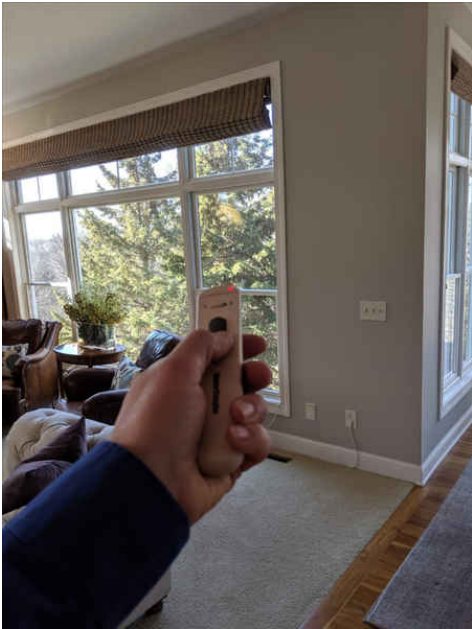
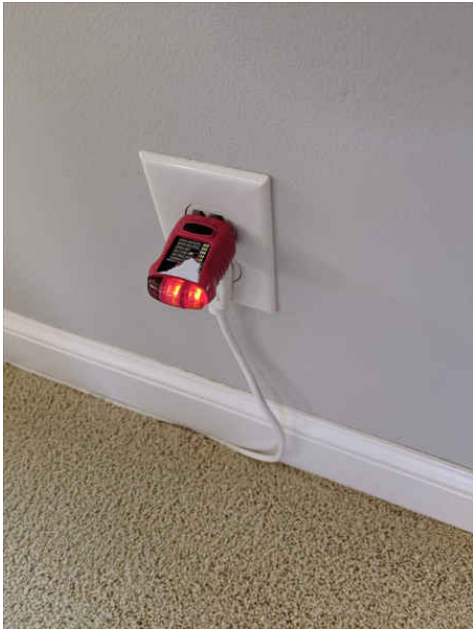
#### 12.8.1 Powered Blinds

### **POWERED BLINDS - INOPERATIVE**

Powered blinds were inoperative at time of inspection, recommend contact a electric blind installer for repairs or replacement.

#### Recommendation

Contact a qualified professional.

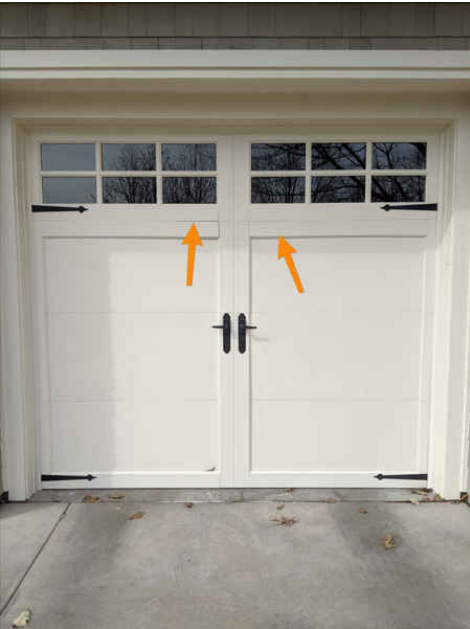
#### GARAGE DOOR - FAUX EXTERIOR LOOSE

Faux trim on garage door exterior is loose, potential for failure and further damage. Recommend repair or replacement by qualified garage door contractor.

Recommendation

Contact a qualified garage door contractor.

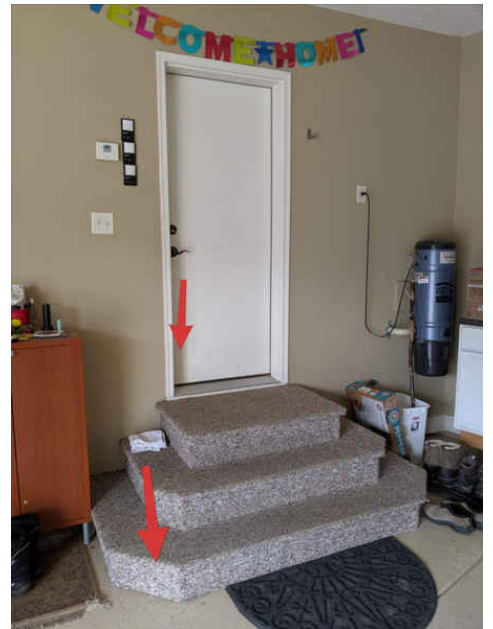
### 13.9.1 Garage Steps

#### GARAGE STEPS - MISSING HANDRAIL

Contact a qualified professional.
