HOME INSPECTION REPORT

9601 48th Dr NE
Marysville WA 98270

Marty Delaine
JUNE 11, 2020

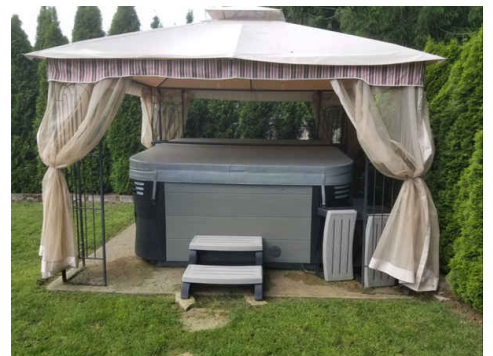
Limitations**Site & Other Observations****HOT TUB NOT INSPECTED**

Evaluation of the hot tub is beyond the scope of Home Inspection. We did not inspect the hot tub. Recommend it be evaluated by a Pool & Spa Service Company.

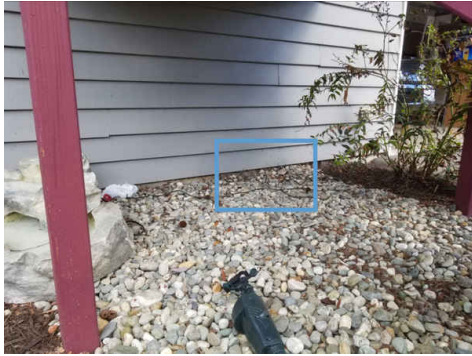
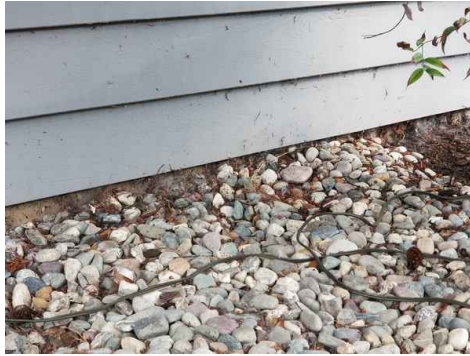
3.5.1 Exterior Siding Notes

The siding was in contact with or nearly contacting soil or mulch or concrete. This is a condition conducive to deterioration and wood destroying organism infestation. We recommend removing soil a six-inch space between any siding material and soil where possible and repairs to any damaged or deteriorated siding.

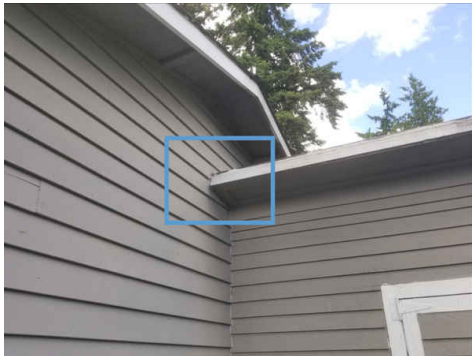
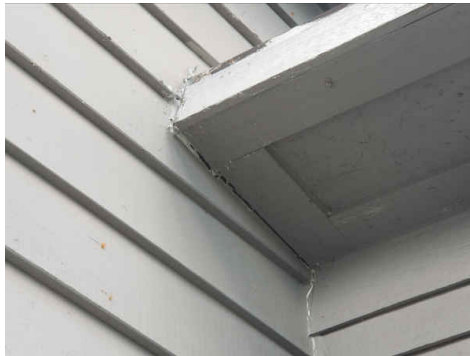
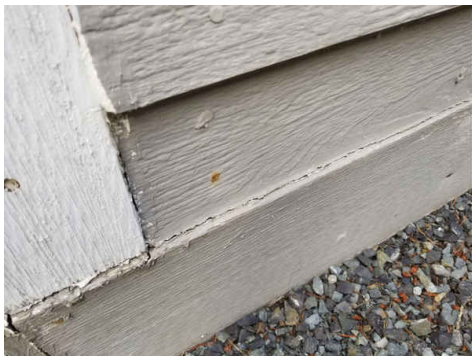
3.5.2 Exterior Siding Notes

TOUCH-UP PAINT/CAULK

Contact a qualified handyman.

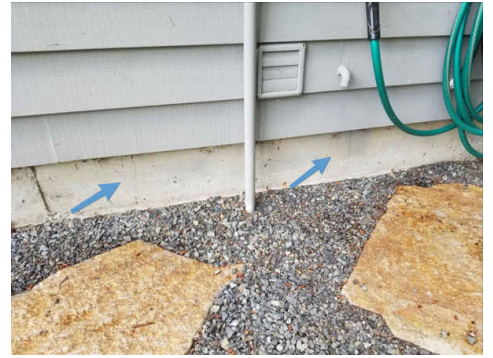
3.6.1 Foundation as Viewed from the Exterior

SMALL CRACKS

Hairline and/or small cracks, within normal tolerances were visible. This type of cracking is often a result of shrinkage of materials and/or minor settlement and usually does not affect the performance of the foundation.

Recommend monitoring.

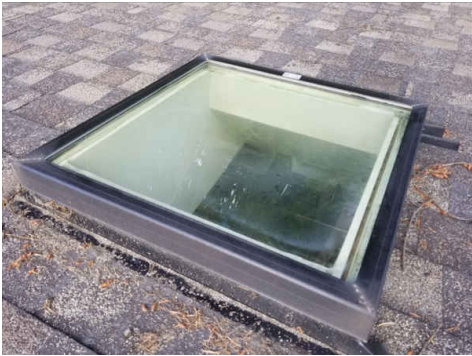
4.6.1 Skylights

SKYLIGHT SEAL

The skylight has a broken seal between the two panes of glass. This allows staining and moisture to develop inside the two panes. This is considered a cosmetic defect and repair or replacement as needed is recommended.

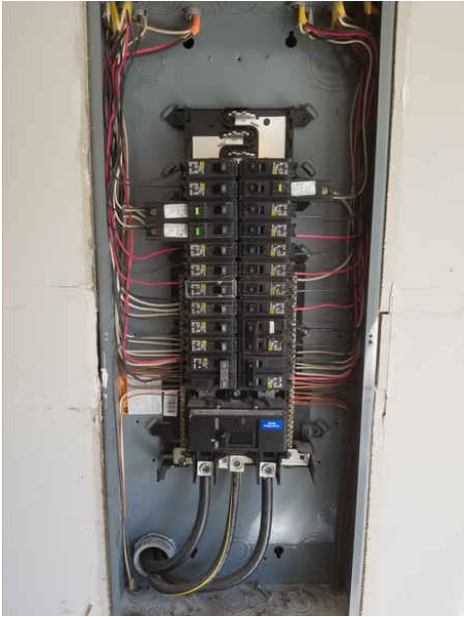
| Service Entrance: Main Lines Underground | Service Entrance: Main Lines Acceptable The electrical service entrances are acceptable. | Panel Size, Location & Photo: Panel Amps, Location and Picture Garage, 200 AMP |

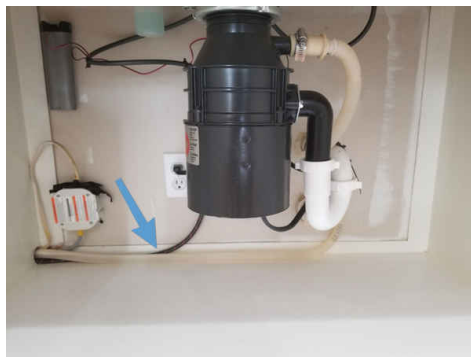
Dishwasher drain pipe was installed without an air gap/high loop to prevent cross contamination. Recommend a qualified licensed professional evaluate and or repair.

Recommended DIY Project

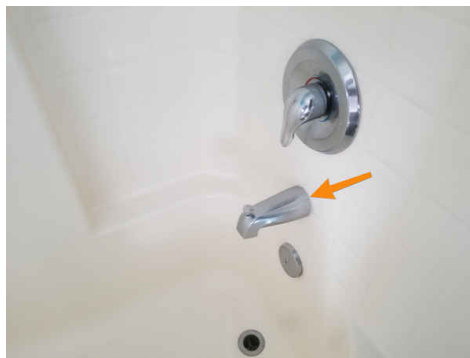
I recommend caulking or sealing around shower valves and faucets etc to help prevent moisture intrusion behind or into the walls. Monitoring these areas is also recommended to help ensure an adequate seal is in place.

Contact a qualified handyman.

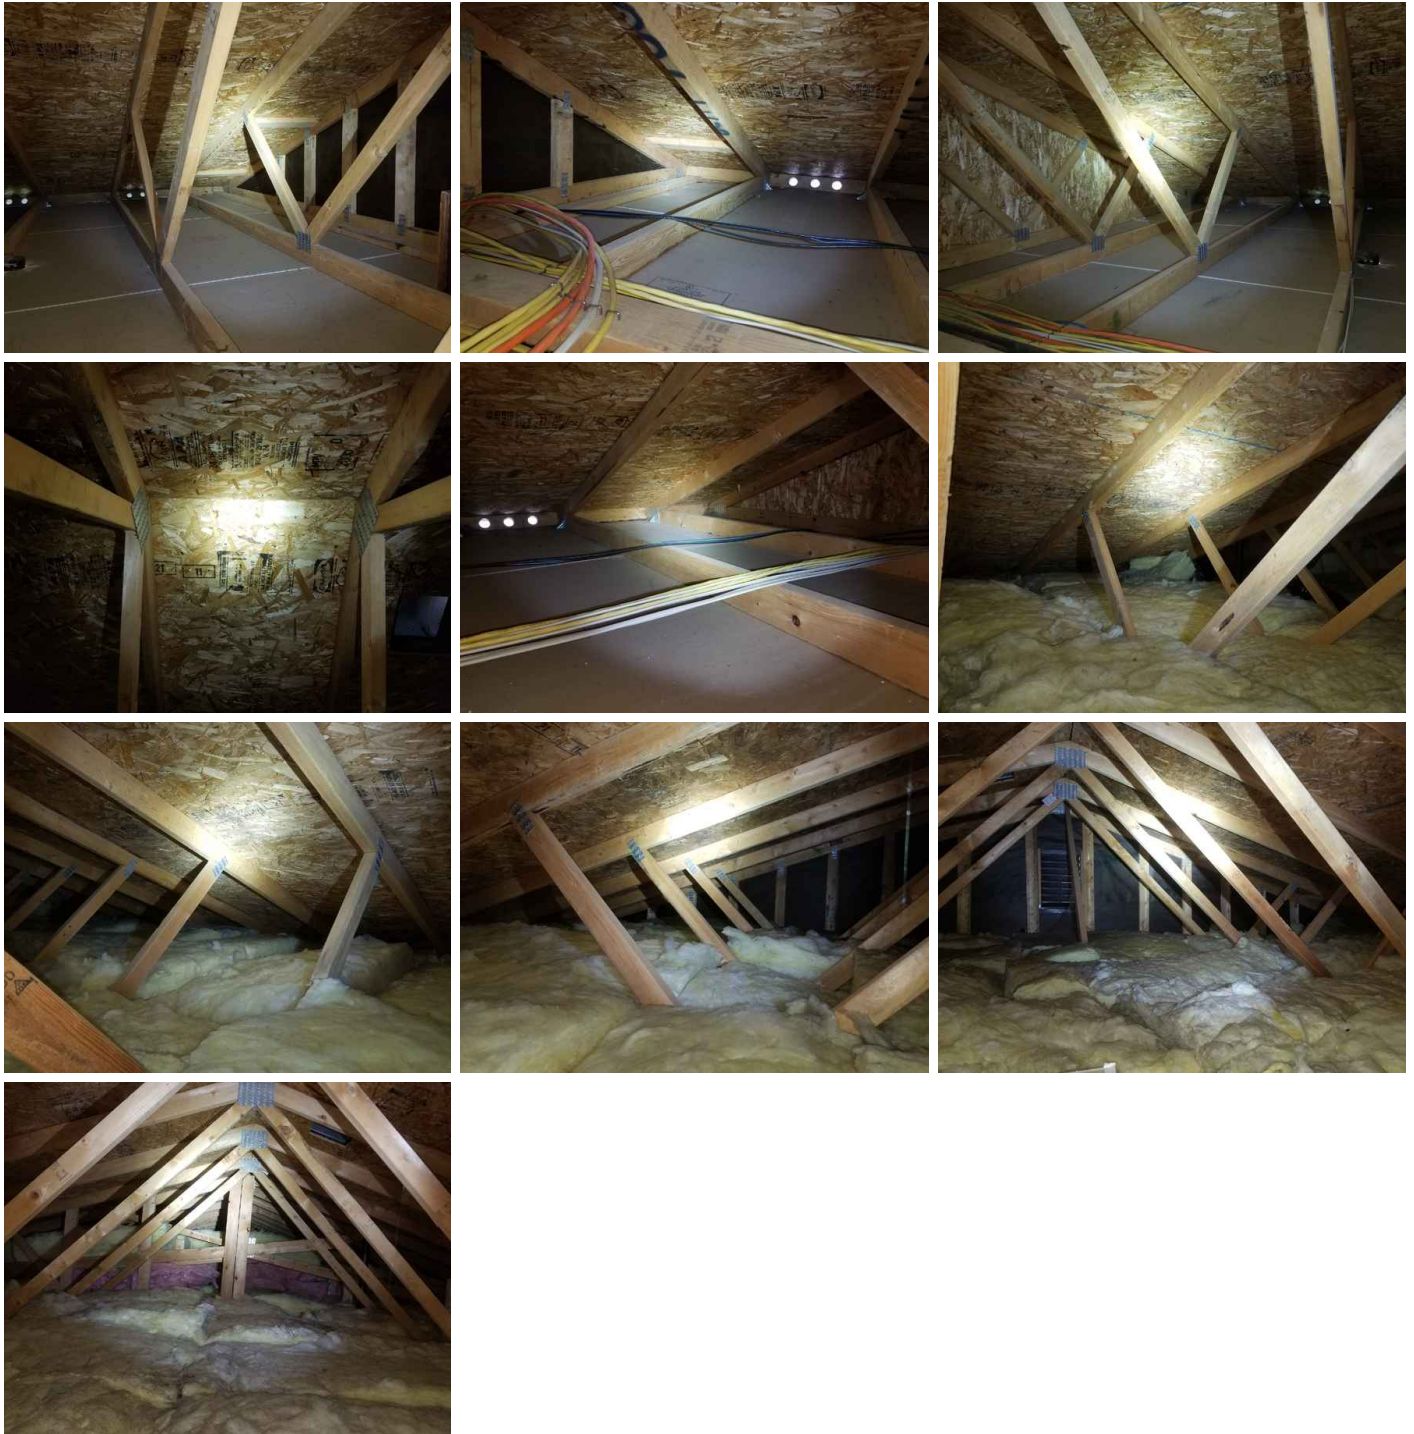
Attic Photos

Framing Notes: Factory-built truss system - Acceptable

The roof framing is in satisfactory condition. The roof framing consists of a factory-built wood truss system, comprised of components called chords, webs, and struts that are connected by metal gussets nailed in place. Each component of the truss is designed for a specific purpose, and cannot be removed or modified without compromising the integrity of the entire truss. The lowest component, which is called the chord and to which the ceiling is attached, can move by thermal expansion and contraction and cause creaking sounds, which are more pronounced in the mornings and evenings along with temperature changes. Such movement has no structural significance, but can result in small cracks or divots in the drywall or plaster.

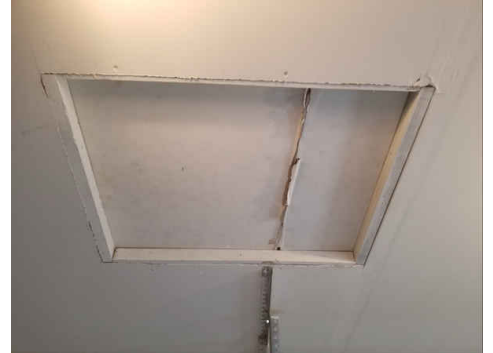
COVER MISSING OR DAMAGED

The attic cover is missing or damaged. Recommend repair.
