MOUNTAINS TO SOUND HOME INSPECTION LLC

HOME INSPECTION REPORT

10650 NE 9th Pl #1123
Bellevue WA 98004

MAY 14, 2020

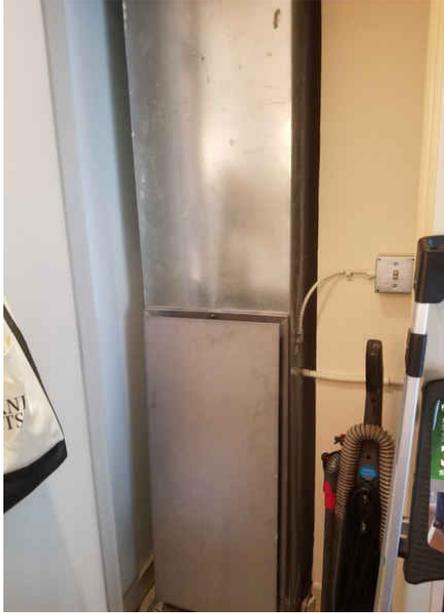
Electric Heating Notes: Equipment Photo

Electric Heating Notes: Electric Furnace Acceptable

The furnace was functional and responds when prompted at its thermostat. I recommend further review from a qualified HVAC technician for more information or a detailed evaluation, at least before the close of escrow, or as you feel necessary.

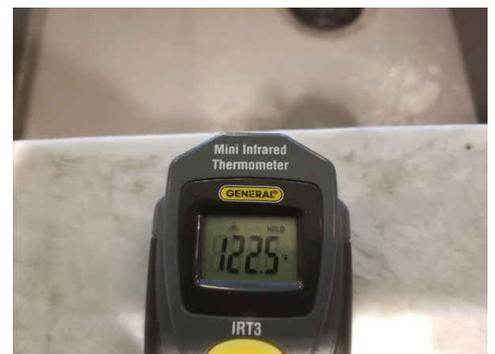
5.1.1 Sink and Faucet

WATER TEMP TOO HIGH

The Water temp at the Kitchen Faucet is over 120 Degrees. The U.S. Consumer Product Safety Commission (CPSC) urges all users to lower their water heater temps to 120 degrees Fahrenheit.

Recommended DIY Project

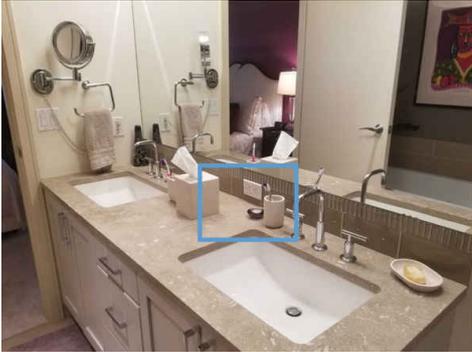
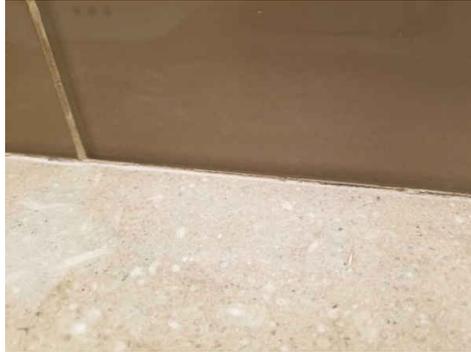
7.6.1 Countertop

MISSING OR DETERIORATED CAULK/GROUT

The caulking or grout for the backsplash is missing, has gaps and/or not installed properly. We advise caulking/grout be installed and/or gaps filled to prevent possible water intrusion.

Recommended DIY Project

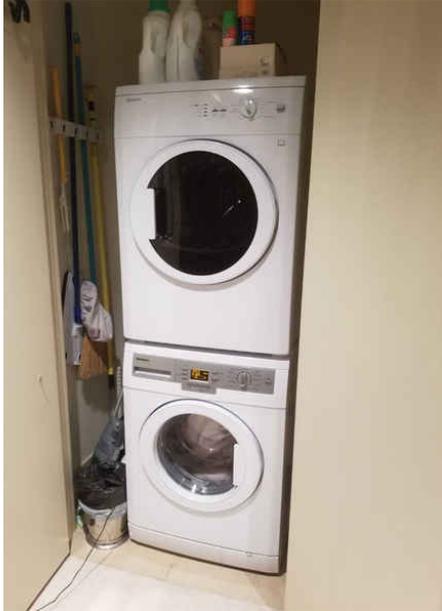
Washer & Dryer: Equipment photos

Washer & Dryer: Dryer power source

220 Electric

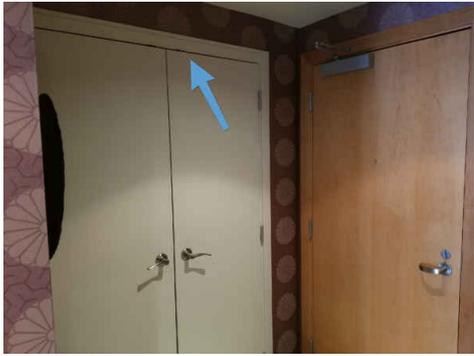
9.6.1 Closet

DOOR NEEDS TYPICAL HARDWARE, SERVICE

RIGHT DOOR OF FRONT CLOSET

The closet door needs typical hardware, service to work, slide, open, or latch smoothly.

Contact a qualified handyman.
