HOME INSPECTION REPORT

2331 W Crockett St Unit B
Seattle WA 98199

Bryce Salter
JUNE 5, 2020

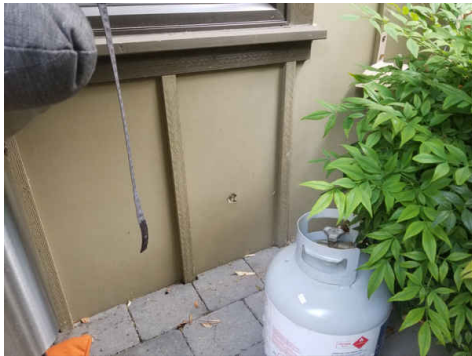
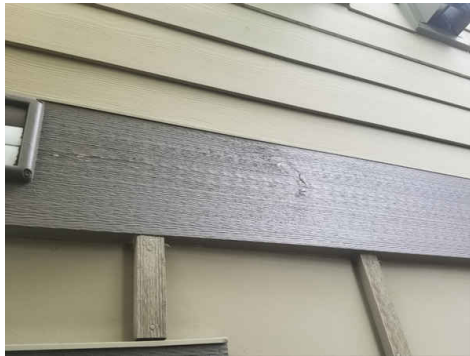
MINOR DAMAGE

Recommendation

Contact a qualified professional.

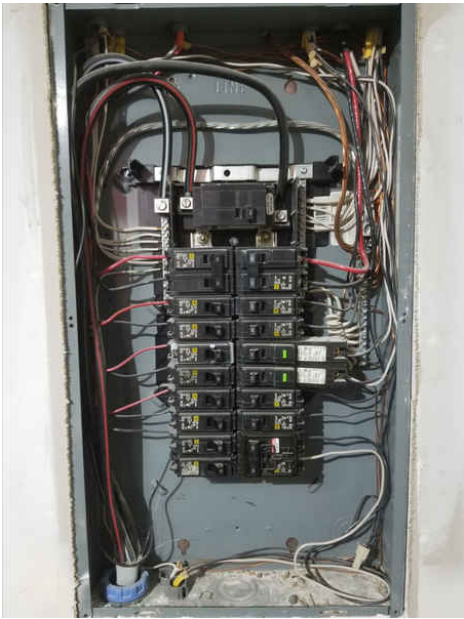
Panel Size, Location & Photo:
Panel Amps, Location and Picture
Garage, 100 Amp

Wiring Notes: Electrical Service Conductors
Aluminum, 120/240 volt

Wiring Notes: Acceptable
The visible portions of the wiring have no deficiencies.

Circuit Breakers: Acceptable
There are no visible deficiencies with the circuit breakers.

Panel Size, Location & Photo: Earth Ground
The panel is grounded at the main water shutoff
The main panel grounding was observed and found to be in good repair and of adequate function at the time of the inspection.

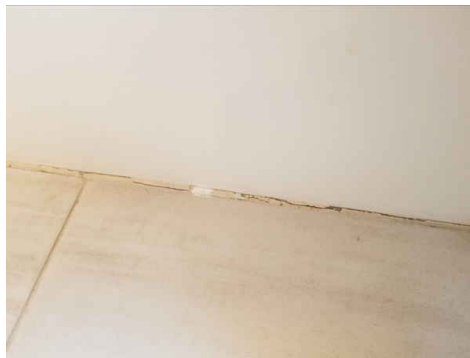
10.4.1 Tub-Shower

MISSING OR DETERIORATED CAULK/GROUT

The tub surround is has missing or deteriorated caulk/grout. Recommend caulking or sealing to prevent moisture intrusion.

Recommendation

Contact a qualified professional.

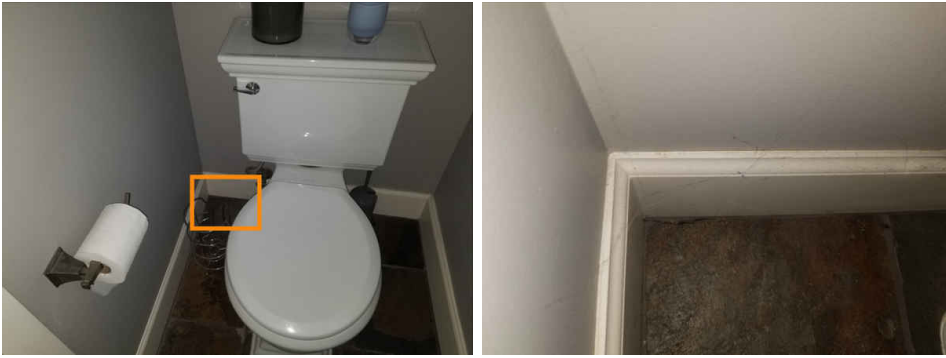
10.10.1 Flooring

MINOR CRACKS IN FLOOR TILES OR GROUT LINES

There are minor and typical cracks in the floor tiles or grout lines, which you should view for yourself. They are likely to have been caused by normal settlement, but you may wish to seek the opinion of a specialist; especially if you are concerned or desire more information.

Recommendation

Contact a qualified flooring contractor

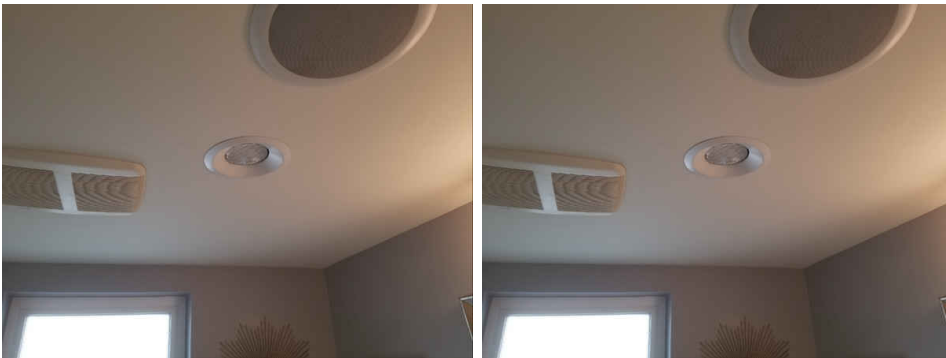
10.13.1 Lights, Wall Switches

CEILING LIGHT NOT WORKING

A light fixture did not have light bulbs or the bulbs were burnt out. Recommend replacing bulbs and testing.

Recommendation

Contact a qualified electrical contractor.

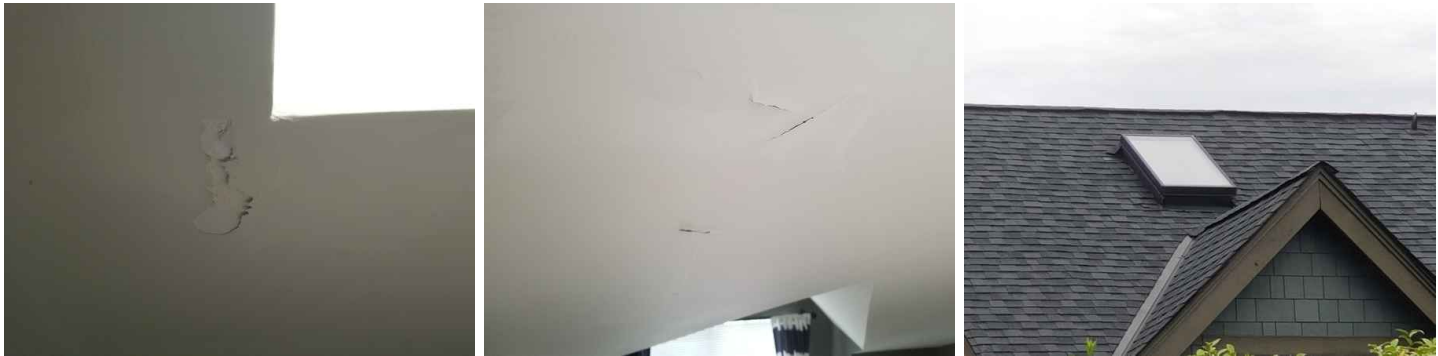
12.4.2 Walls and Ceiling

SPALLING DRYWALL COMPOUND

The drywall covering near the skylight protrusion was noted to be spalling or beginning to crack or chip. Our limited view of the skylight in question did not uncover any adverse effects at the time of inspection. A further evaluation by a licensed roofing professional would be appropriate.

Recommendation

Contact a qualified professional.
