## HOME INSPECTION REPORT

9335 NE 142nd St  
Kirkland WA 98034

Cyndi Higgins  
MARCH 28, 2019

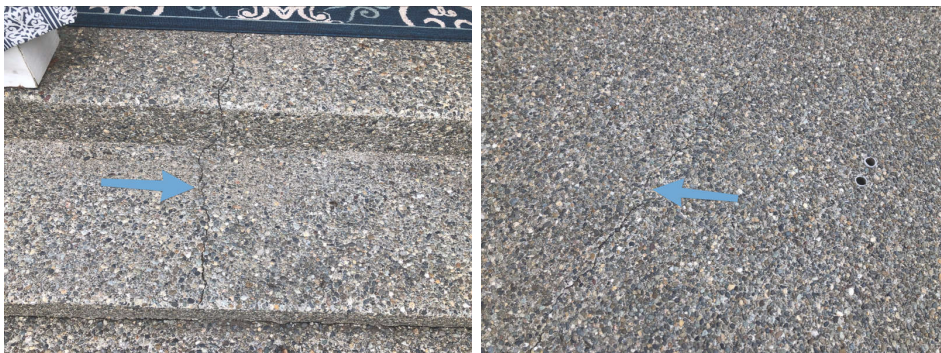
### PATIO FLOOR CRACKS

There are cracks in the rear patio floor that you should view for yourself and correct as desired.

Contact a qualified concrete contractor.

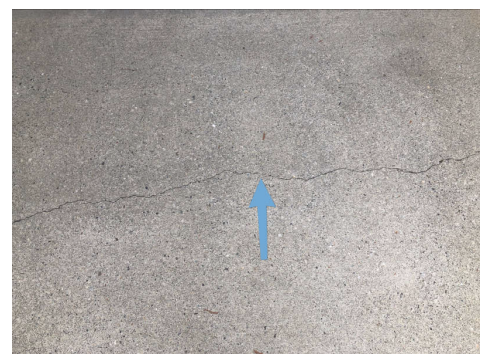
3.2.2 Driveway, Walkways & Patio

### SMALL CRACKS IN DRIVEWAY

There are common cracks in the driveway that would not necessarily need to be serviced.

Recommend monitoring.

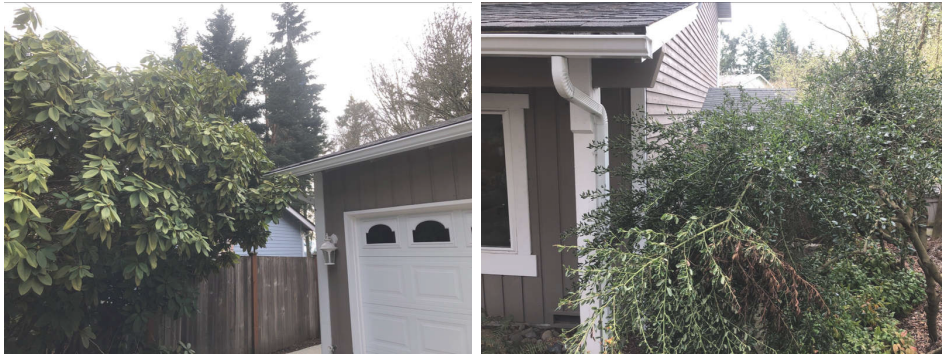
3.5.1 Exterior Siding Notes

Vegetation is encroaching on the structure, and should be kept a minimum of twelve inches away for the general welfare of the walls and foundation.

Contact a qualified landscaping contractor

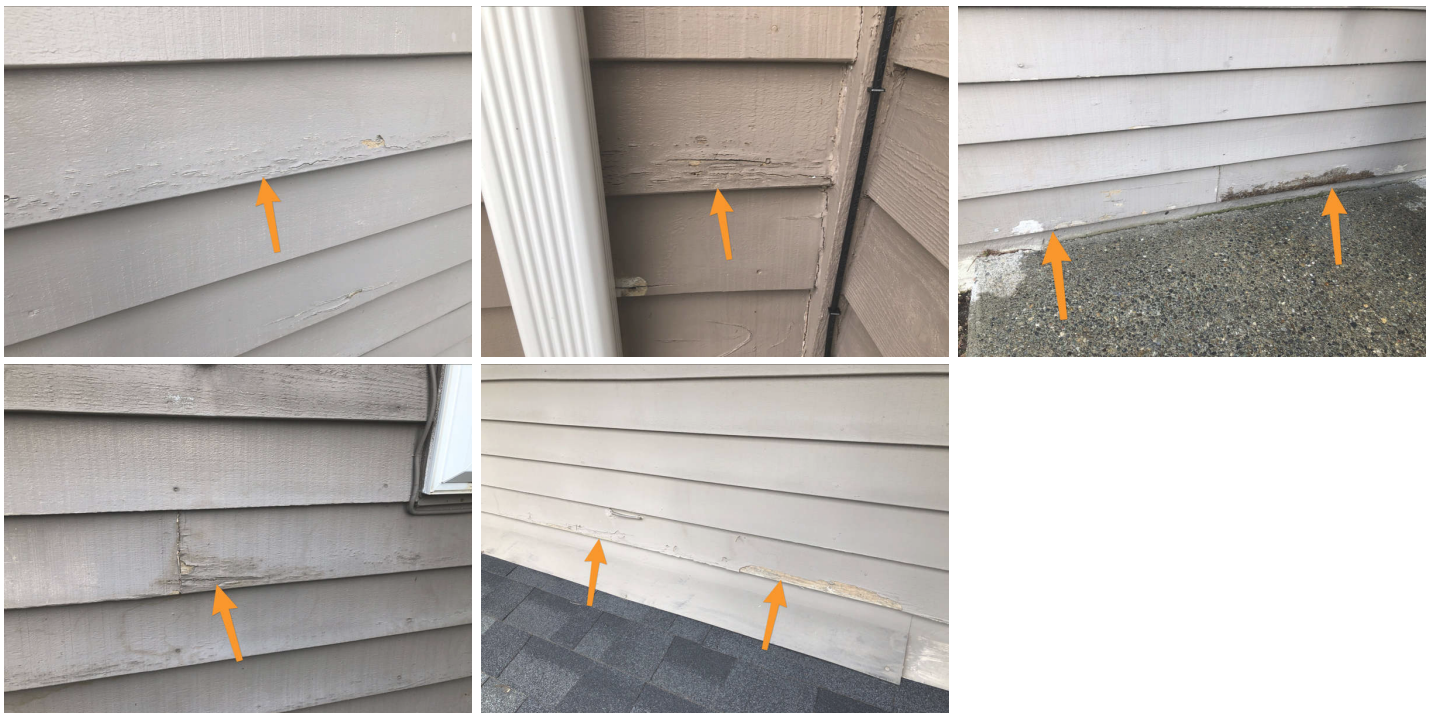
3.5.2 Exterior Siding Notes

**WEATHERED SIDING**

The exterior siding is weathered. Maintenance and minor repairs are recommended.

Contact a qualified professional.

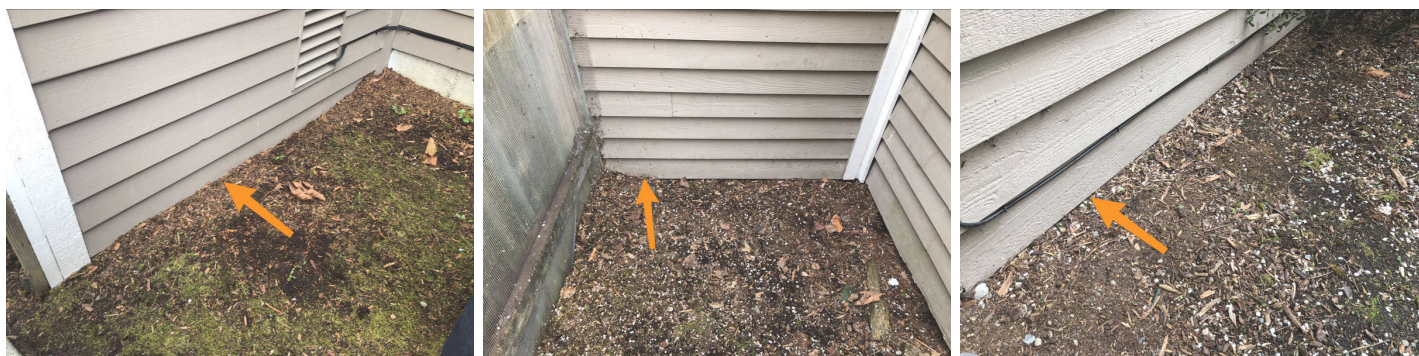
3.5.3 Exterior Siding Notes

**EARTH TO WOOD CONTACT**

The siding was in contact with or nearly contacting soil or mulch or concrete. This is a condition conducive to deterioration and wood destroying organism infestation. We recommend removing soil a six-inch space between any siding material and soil where possible and repairs to any damaged or deteriorated siding.

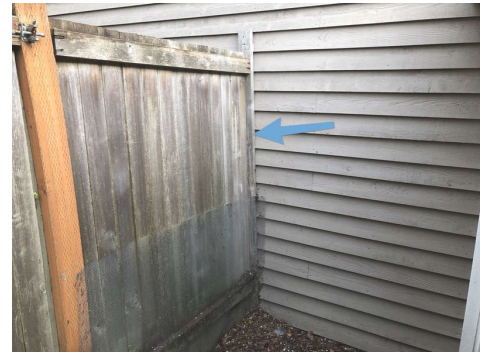
Fence(s) were attached to or in contact with the building exterior. Such attachments can serve as a pathway for wood-destroying insects and can retain moisture against the exterior after it rains. We recommend repairs as necessary so there is at least a 2-inch gap between rails and building exteriors.

Contact a qualified professional.

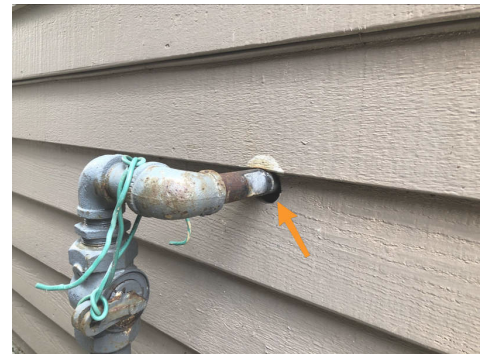
#### SEAL PENETRATIONS/GAPS

Gaps and/or holes were observed on one or more sides in the siding around plumbing, gas, cable, wiring and/or other penetrations. We advise that all the holes and the gaps be caulked and/or sealed to prevent moisture and/or pest intrusion.

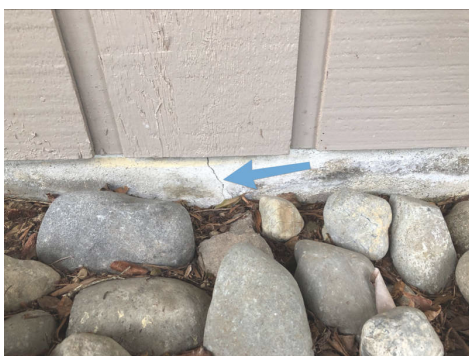
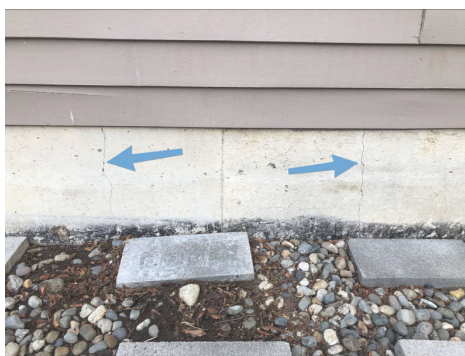
#### SMALL CRACKS

Hairline and/or small cracks, within normal tolerances were visible. This type of cracking is often a result of shrinkage of materials and/or minor settlement and usually does not affect the performance of the foundation.

Recommend monitoring.

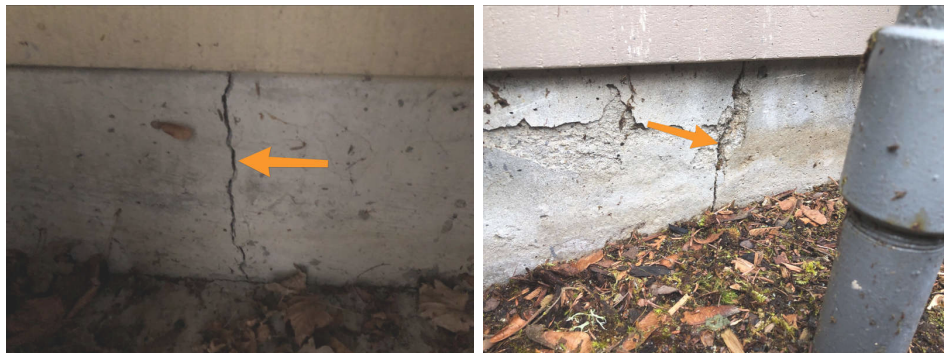
#### CRACKS MODERATE

Moderate sized cracks were observed on the Exterior foundation. This suggests unstable or settling soils. Recommend a soil or structural engineer should be consulted for corrective repairs. This may include sealing the pieces back together with a concrete or similar patch. Sealing is to deny possible moisture entry. a structural engineer evaluate and provide a report on course of action and remedy.

Contact a qualified professional.

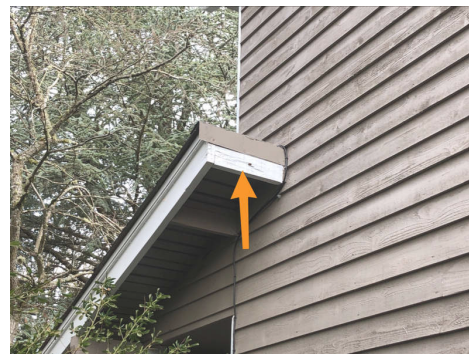
##### **SECTIONS OF FASCIA OR WOOD TRIM ARE WEATHERED**

Sections of the fascia board or wood trim around the residence are slightly weathered, and should be serviced as necessary to prevent further deterioration. Service such as scraping, repainting and sealing.

Contact a qualified handyman.

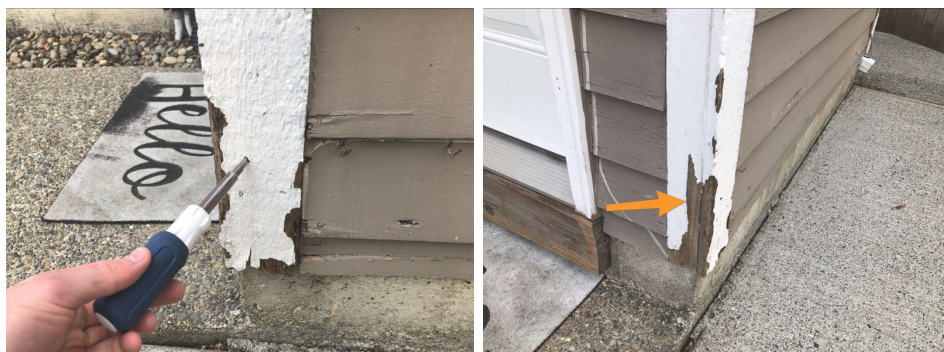
##### **SECTIONS OF FASCIA & TRIM MOISTURE DAMAGED**

Sections of the fascia board or wood trim are weathered, moisture damaged and should be serviced or replaced as necessary by a qualified professional contractor to help prevent further wear or deterioration.

Contact a qualified handyman.

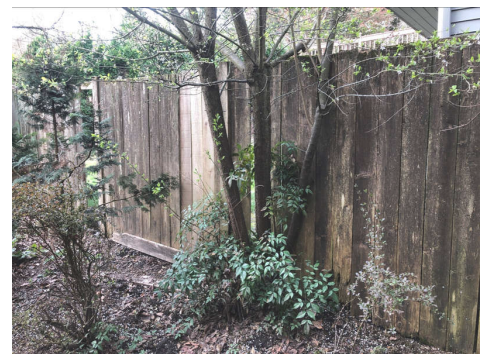
The fences are weathered. Recommend maintenance and repairs.

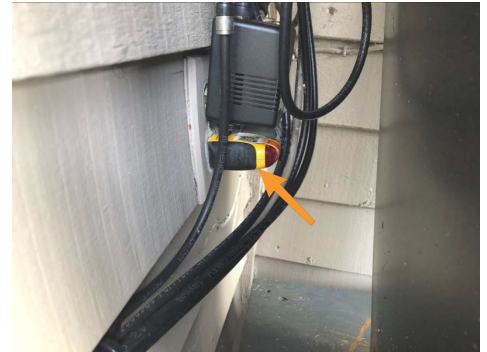
A outlet does not have power and should be demonstrated or repaired.

Contact a qualified electrical contractor.

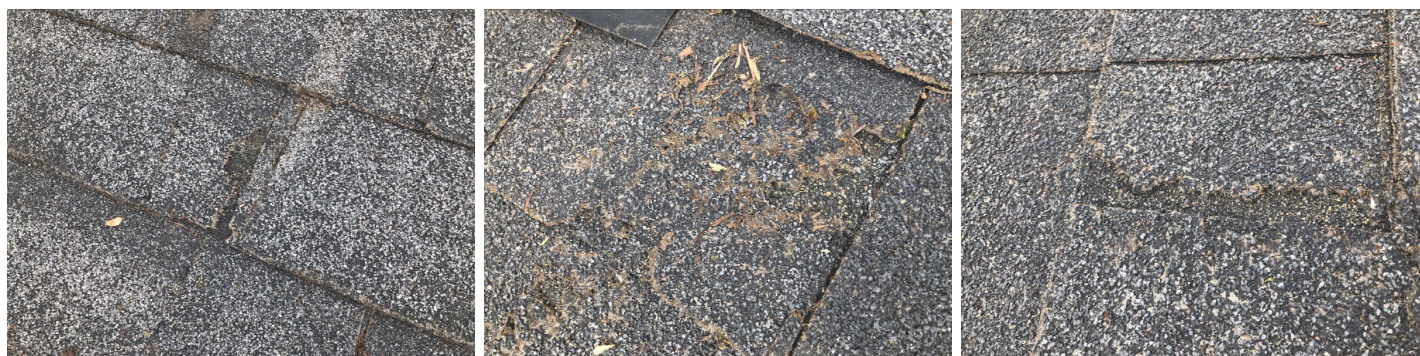
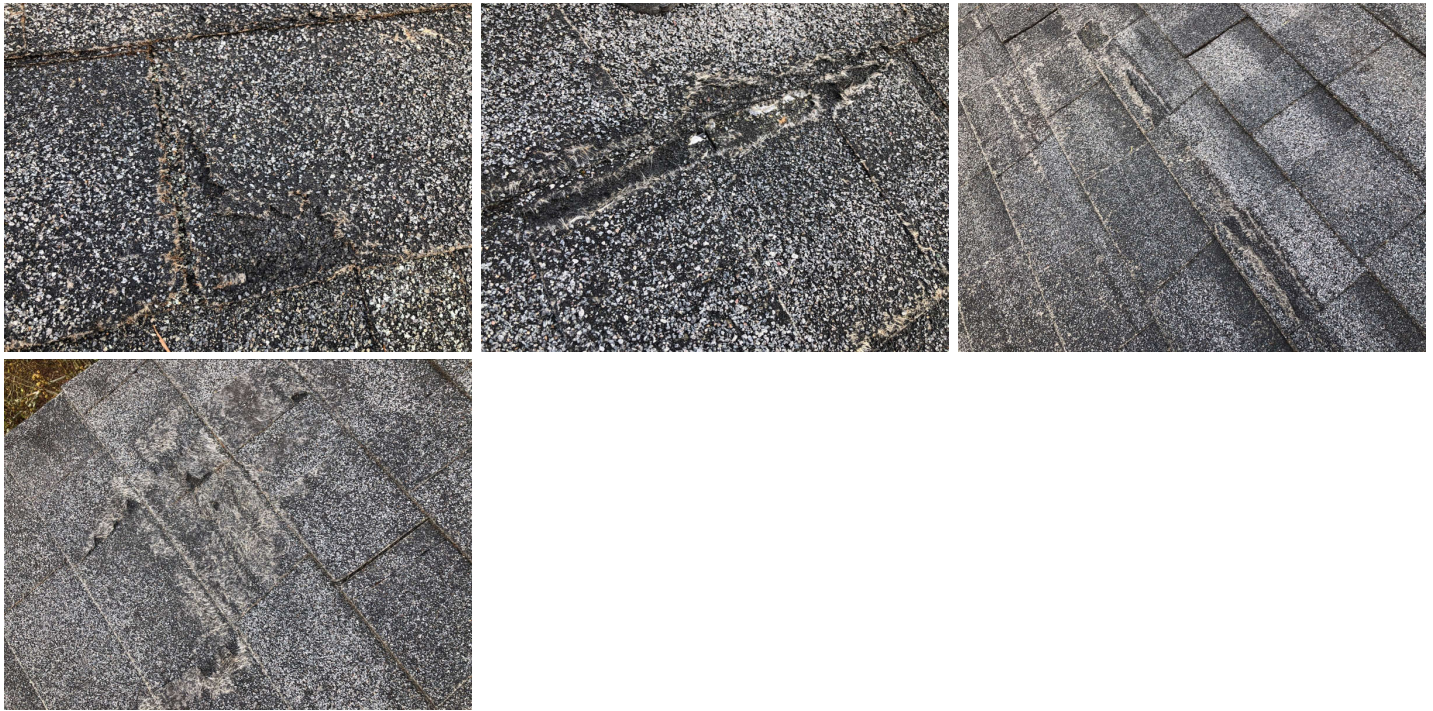
**PRIMARY STAGES OF DECOMPOSITION**

Some of the roof is in the primary stages of decomposition, which means that portions of the roof are in decline and can be susceptible to leaks. It will need to be maintained and closely monitored, because it is reaching the end of its serviceable life, we recommend to have a second opinion and unseen issues from a qualified roofer before the close of escrow and to see what future costs will be for replacement.

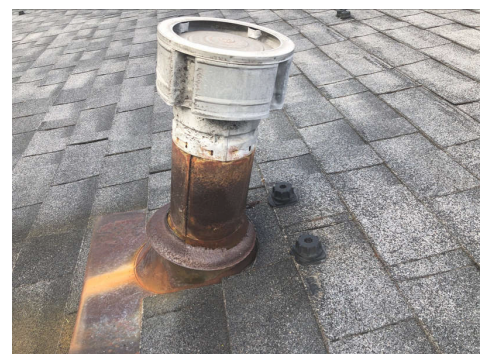
##### EXHAUST VENT DETERIORATED

The gas Appliance exhaust vent was cracked or deteriorated. We recommend repair or replacement of the vent.

Contact a qualified professional.

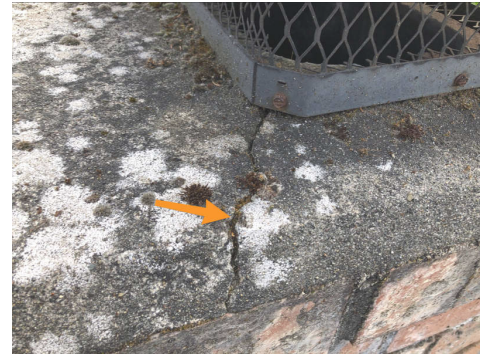
Medium Priority**THE CROWN IS CRACKED AND SHOULD BE SEALED TO HELP PREVENT FURTHER WEAR AND MOISTURE INTRUSION**

The crown, which is designed to seal the chimney wall and shed rainwater, is cracked and should be sealed to help prevent further wear and moisture intrusion.

Contact a qualified handyman.

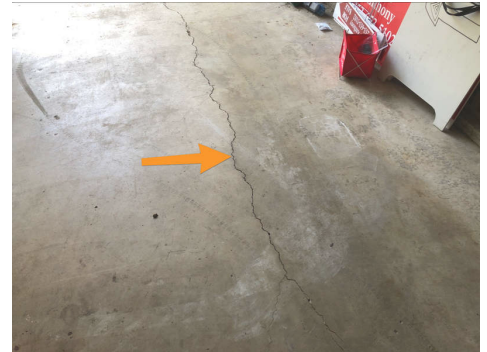
**GARAGE FLOOR CRACKED- FURTHER EVALUATION**

The garage floor is cracked and further evaluation is recommended.

Contact a qualified concrete contractor.

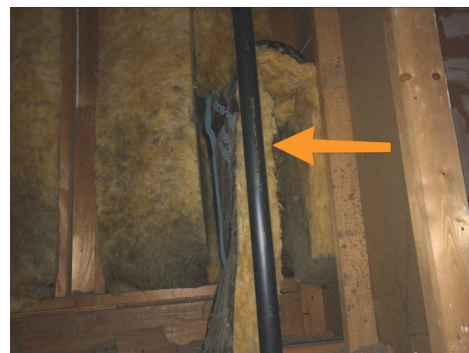
**SIDEWALL INSULATION  
FALLEN/MISSING**

The attic sidewalls are not fully insulated and should be to prevent cooling and heating loss. I recommend having a qualified contractor correct this situation.

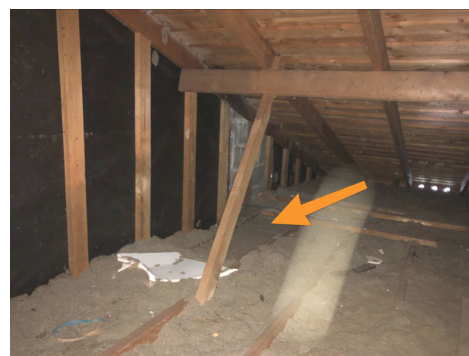
**DISPLACED OR REMOVED  
INSULATION**

There is an area of displaced or removed insulation, that should be replaced to conserve energy and prevent heating and cooling loss.
