ELEVATE HOME INSPECTION

123 Main St
Columbus OH 43221

James DeGraw
OCTOBER 20, 2021

1: INSPECTION DETAILS

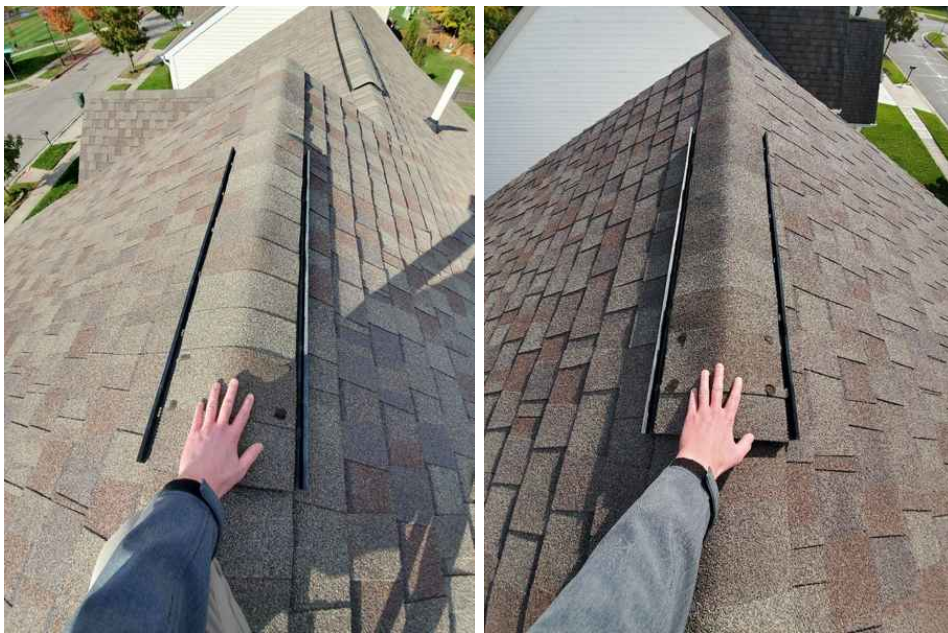
3.1.1 Roof Covering

SEALANT NEEDED

We observed exposed fasteners and/or loose seams on the roof. Fasteners & seams are common roof leak areas.

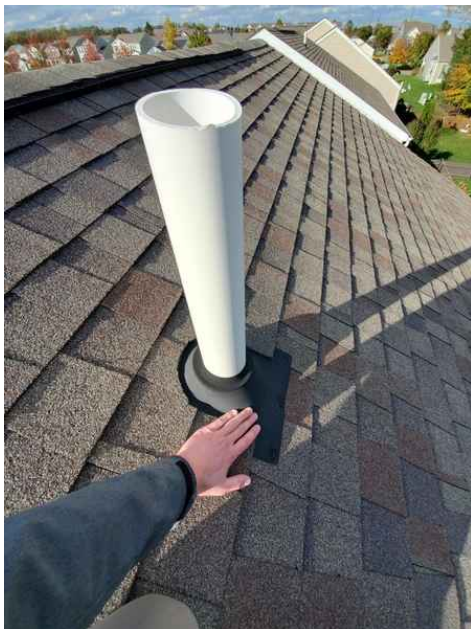
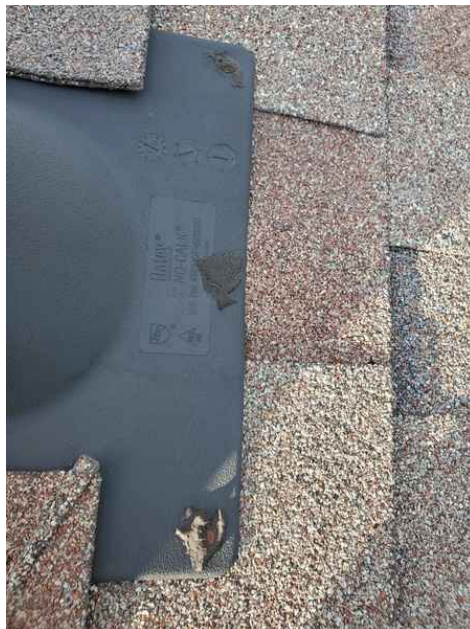
3.2.2 Flashing & Vents

SEALANT NEEDED

We observed flashing with exposed fasteners and/or gaps. These should be sealed to prevent water leaks.

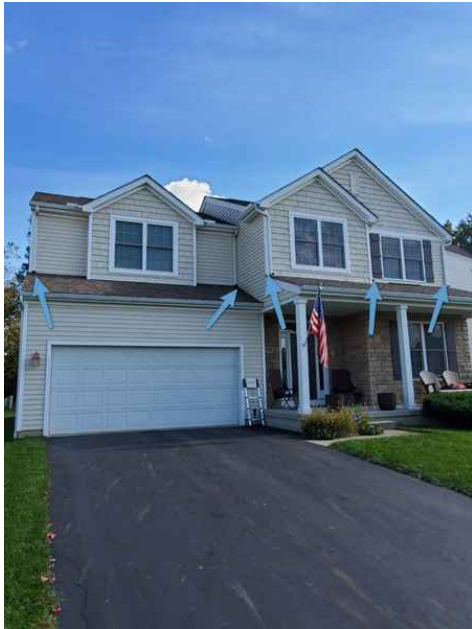
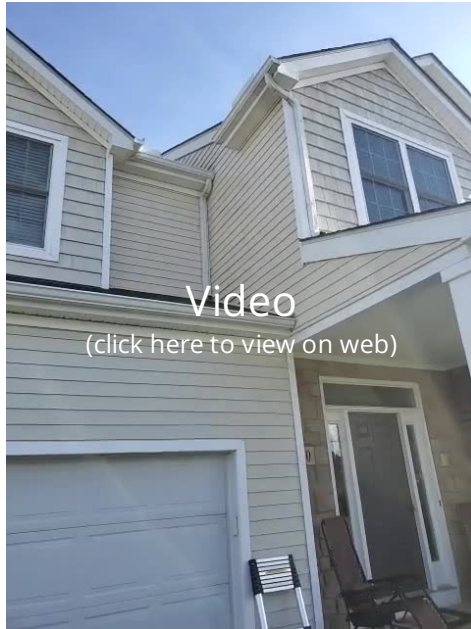
3.3.1 Gutters & Downspouts

RECOMMEND DOWNSPOUT EXTENSIONS ON ROOF

We observed a downspout that empties onto a roof. This can prematurely age the roof covering system. We recommend the downspout is extended to reach the next gutter area.

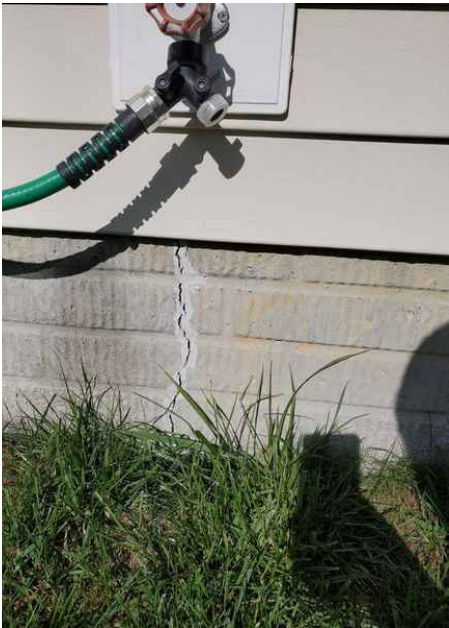
Exterior Foundation: Foundation Repairs

We observed previous foundation repairs that were likely due to minor foundation and settling issues. We recommend you monitor these areas for new cracking or movement and ask the sellers what they know about the repairs.

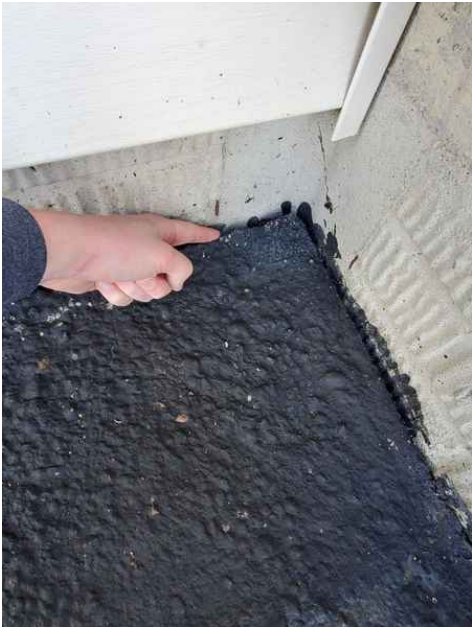
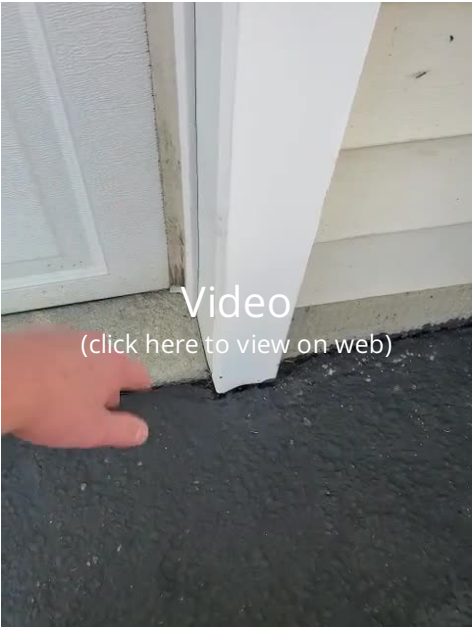
SEALANT NEEDED

We observed an area where we recommend sealant is added to keep water from entering.

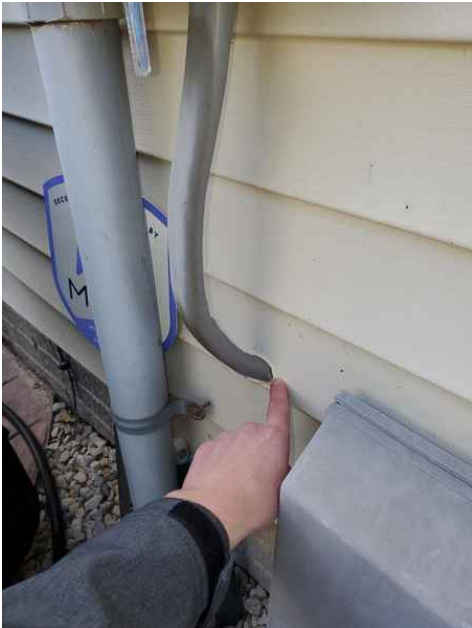
5.4.1 Wall Coverings
CAULK NEEDED

We observed degraded caulking/sealant, which could allow moisture to penetrate into the house.

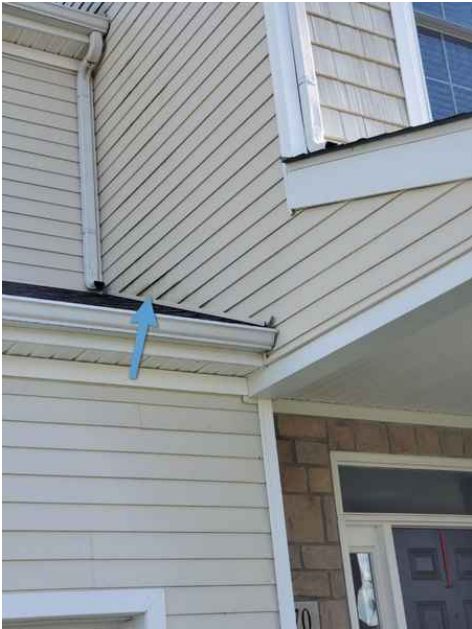
We observed signs of algae/moss/mildew on the exterior wall-covering materials. This is common on north-facing walls and shaded portions of the home. We recommend routine cleaning to remove the growth.

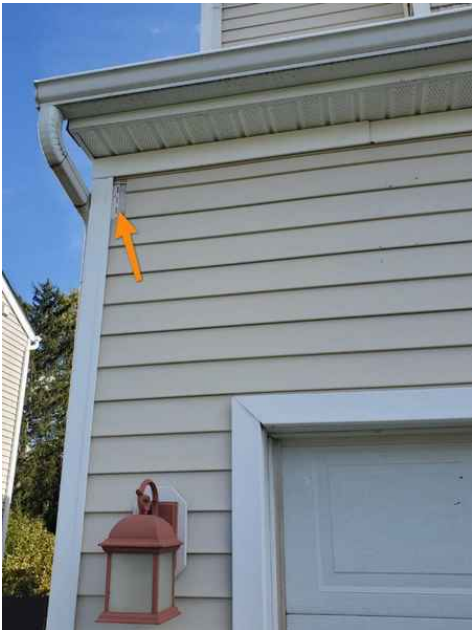
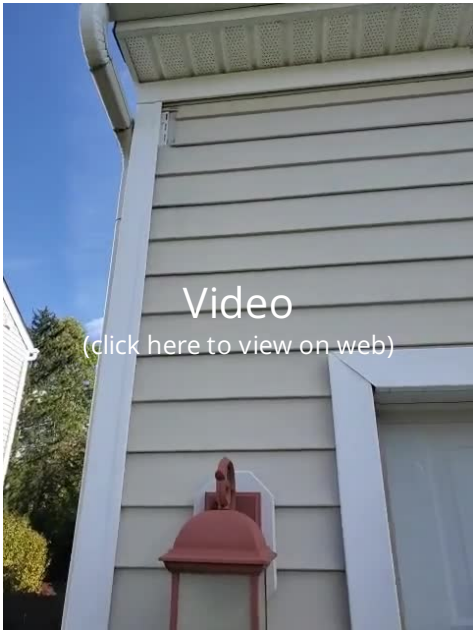
5.4.3 Wall Coverings

MISSING SIDING

We observed an area of missing wall-covering material that is likely to cause moisture damage.

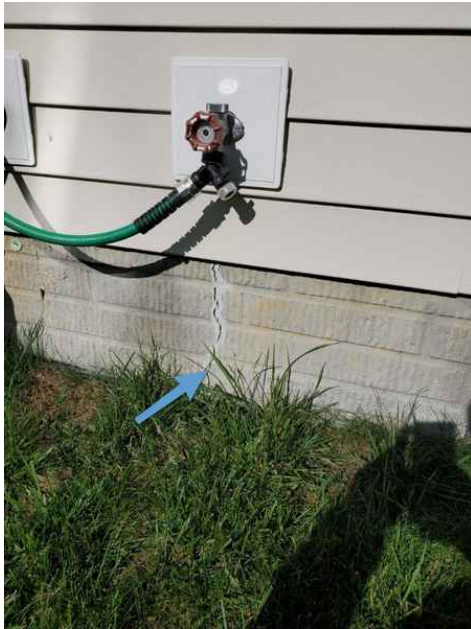
5.6.1 Exterior Foundation

MINOR CRACKING

We observed minor cracking in one or more areas of the exterior foundation. We recommend monitoring the area for additional cracking/expansion and sealing the cracks to avoid moisture entry.

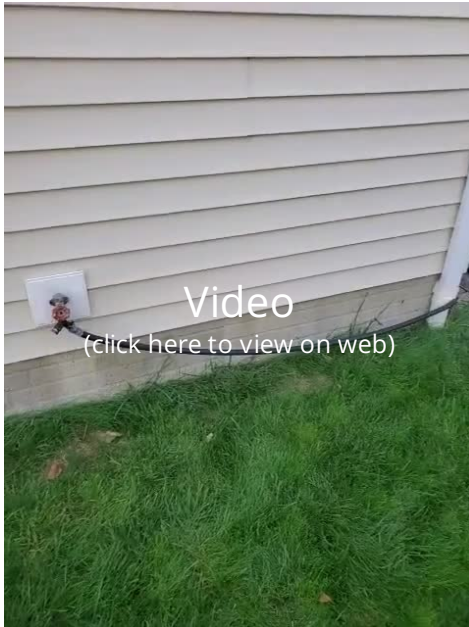
SPIGOT DAMAGED

We observed that a hose bib was damaged. Vacuum breaker was leaking. Here's a DIY repair video <https://youtu.be/59gSLqVc9A>

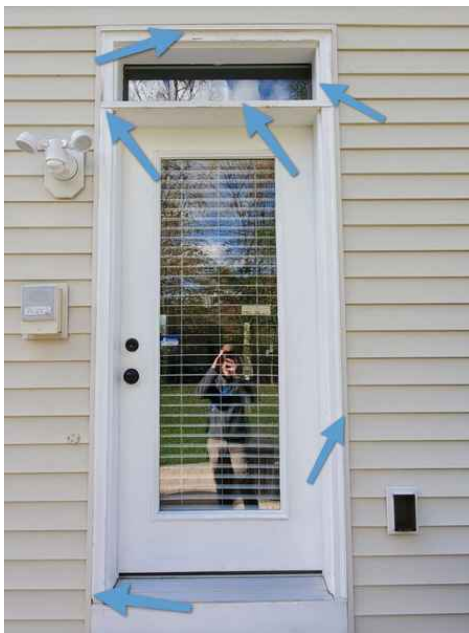
5.12.1 Exterior Doors

PAINT IN POOR CONDITION 2

We observed paint in poor condition. This should be corrected to avoid further damage.

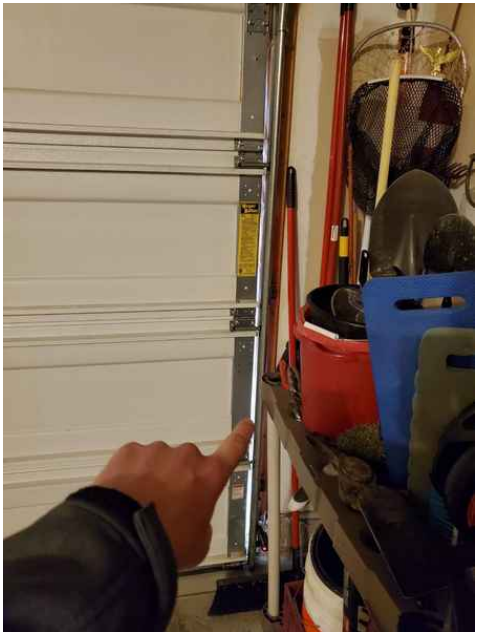
6.1.1 Vehicle Door

We observed that the weather stripping at the garage door is in poor condition. This may negatively impact any insulating, noise reduction, weather sealing, or pest control features of the garage door.

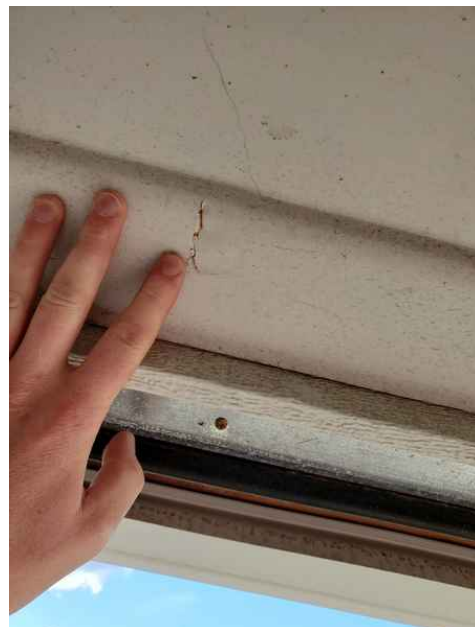
6.1.2 Vehicle Door

MINOR DAMAGE

We observed minor damage to the garage vehicle door.

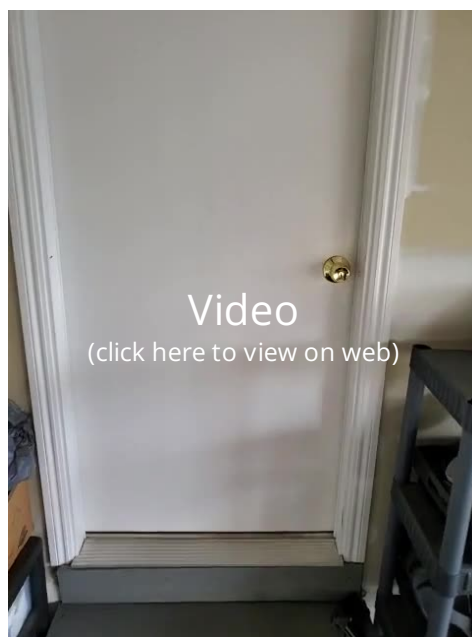
6.3.1 Garage Interior

GARAGE DOOR WASN'T SELF-CLOSING

We observed that the door between the garage and the house was not self-closing. We recommend a closer or self-closing hinges be installed to keep harmful fumes out of the home and maintain an intact fire-separation wall.

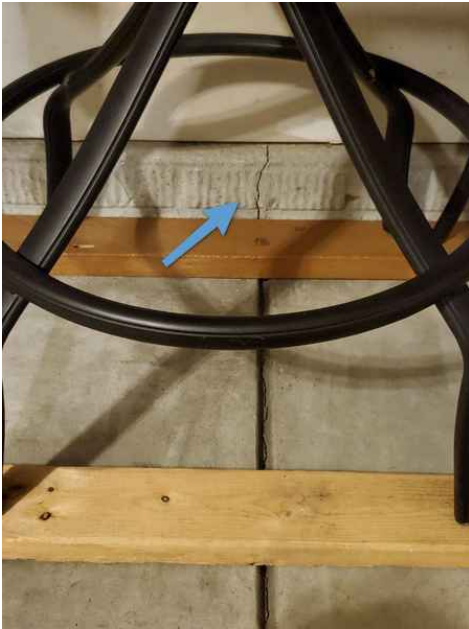
6.4.1 Garage Floor

MINOR CRACKS

We observed cracks in the garage floor. These are common and are not often structural concerns. We recommend that these cracks be sealed and monitored.

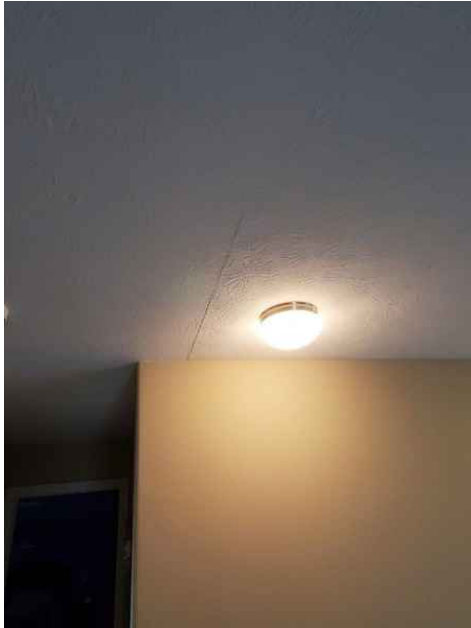
2nd Floor Ceiling

MINOR CRACKING

We observed minor cracks on interior surfaces which appeared to be the result of long-term settling. Minor settling is common. These areas should be monitored to ensure that the cracks do not grow.

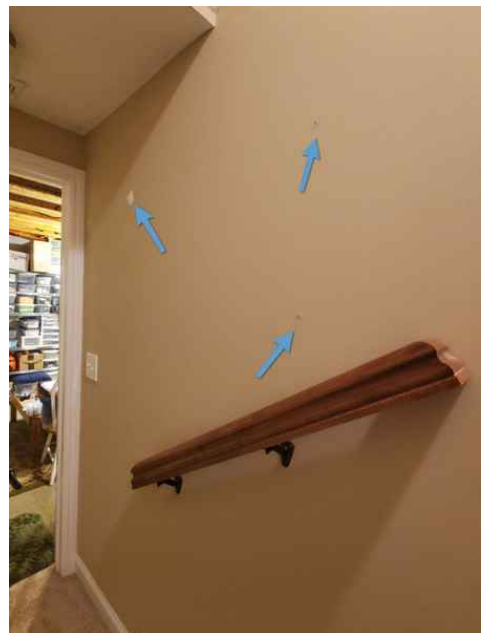
Basement Stairwell

SURFACE DAMAGE

We observed damage to a finished interior surface.

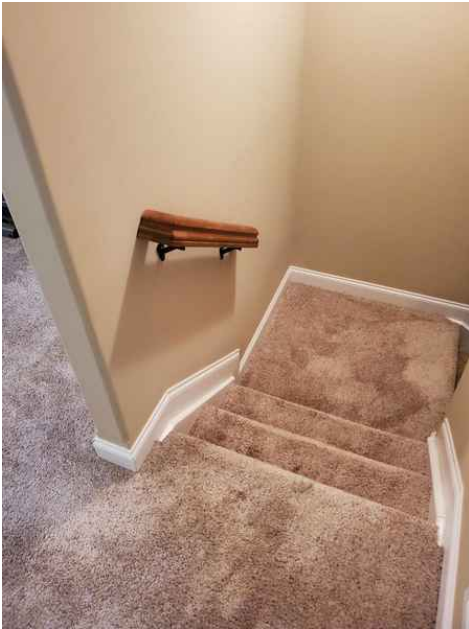
7.7.1 Stairs & Handrails

HANDRAIL LOOSE

We observed a loose handrail.

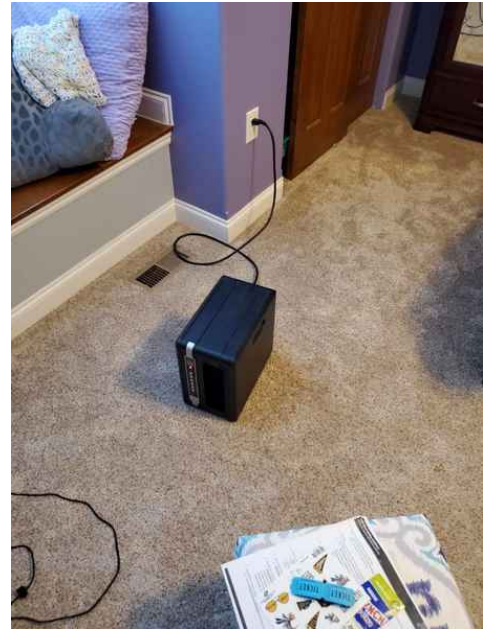
Bedroom Above Garage

SPACE HEATERS OBSERVED

We observed space heaters in the home during the inspection. This may indicate that the current occupants experience insufficient heat from the permanent heating equipment. We recommend asking the sellers about this.

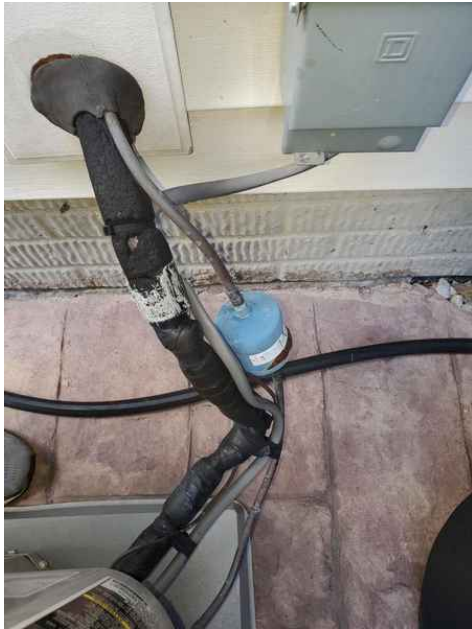
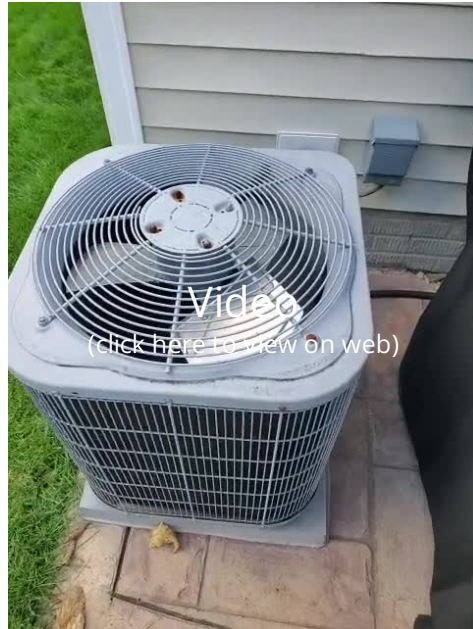
11.2.2 Cooling & Condensate

EXTERIOR ELECTRICAL UNPROTECTED

We observed exterior electrical that was not properly protected with waterproof conduit.

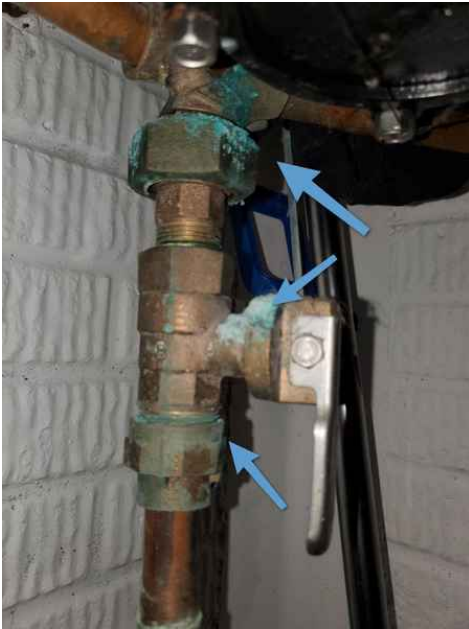
CORROSION

We observed more-than-expected corrosion at pipe fittings in one or more areas. Continued corrosion can cause leaks, but no active leaks were observed.

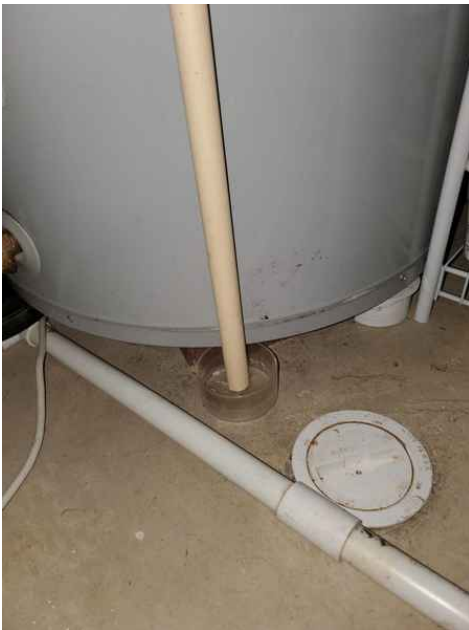
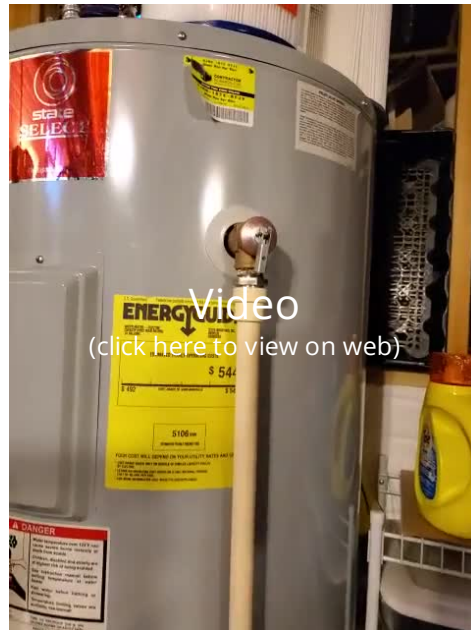
12.2.1 Water Heater

TPR VALVE EXTENSION ISSUE

We observed an issue with the TPR (temperature, pressure, and relief) valve extension.

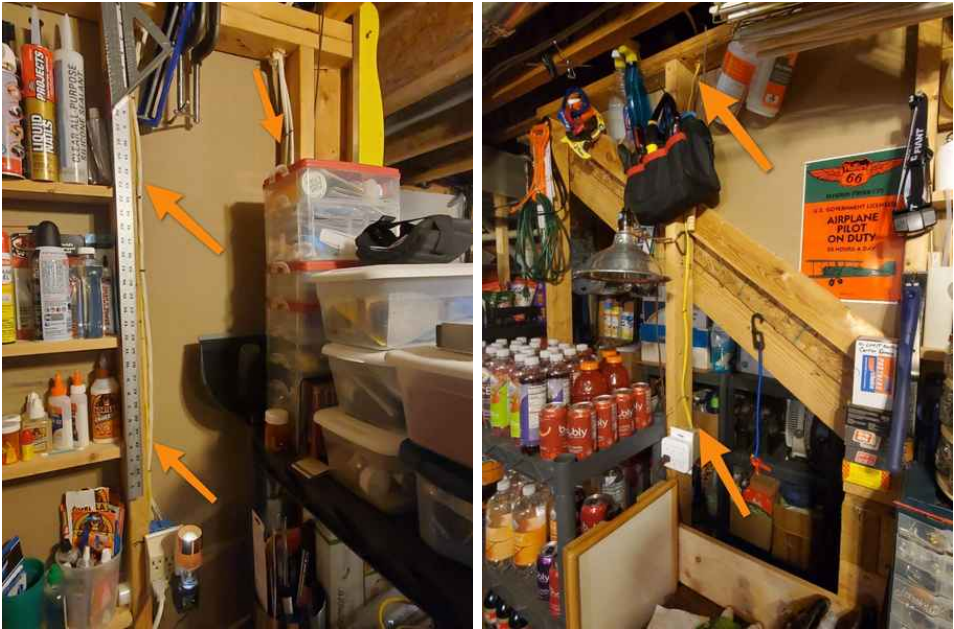
15.1.1 Basement

We observed electrical wiring that is subject to damage and should be protected inside a finished wall or a conduit.

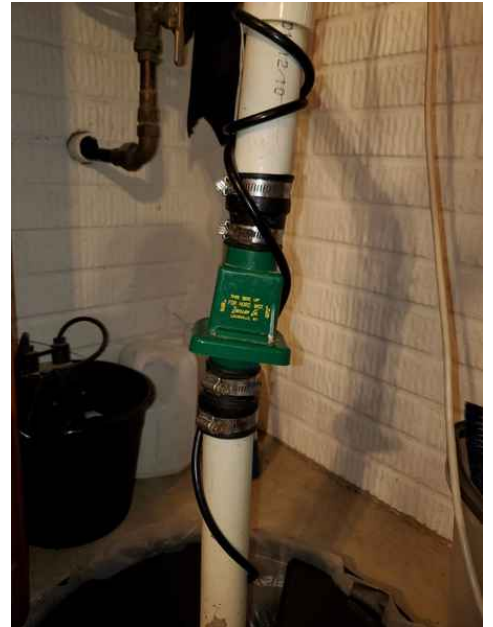
We observed a check valve that appears poorly installed. It may leak or fail to work properly over time.

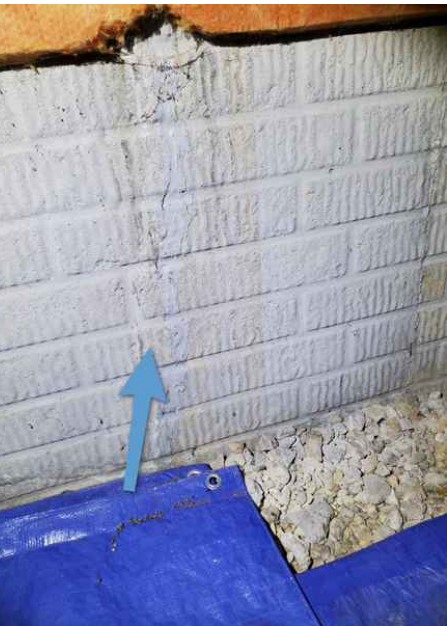
Crawlspace: Foundation Repairs

We observed in area where foundation repairs were made. We recommend you ask the seller for more information about this repair.

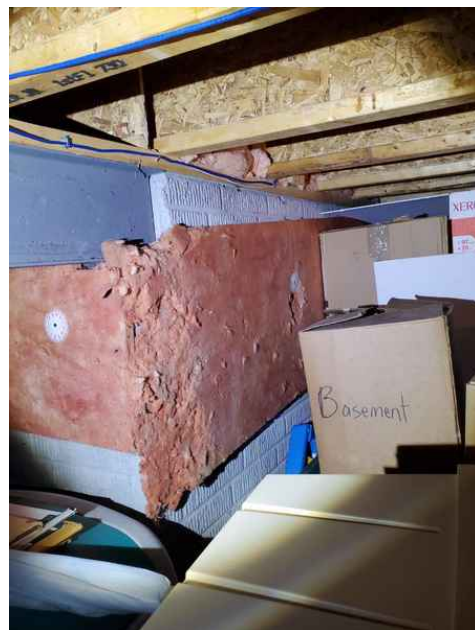
We observed insulation that was installed poorly in an area of the crawlspace.

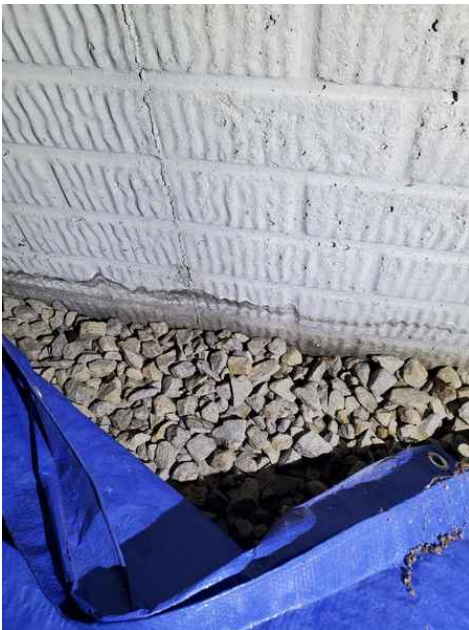
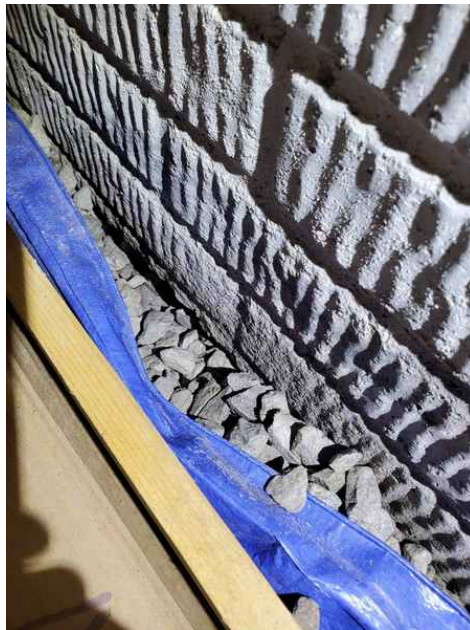
16.1.4 Crawlspace

WET AREAS

We observed wet areas and evidence of past water presence in the crawlspace.

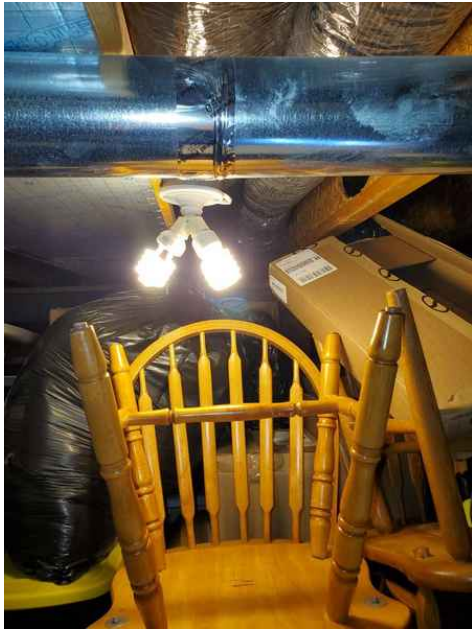
16.1.5 Crawlspace

LIGHT BULBS NEED PROTECTION

We observed light bulbs in the crawlspace that are subject to damage. We recommend a protected service-area light fixture here instead.
