# MOUNTAINS TO SOUND HOME INSPECTION LLC

## HOME INSPECTION REPORT

1507 SW 325th Pl  
Federal Way WA 98023

Vera Perez  
MARCH 5, 2020

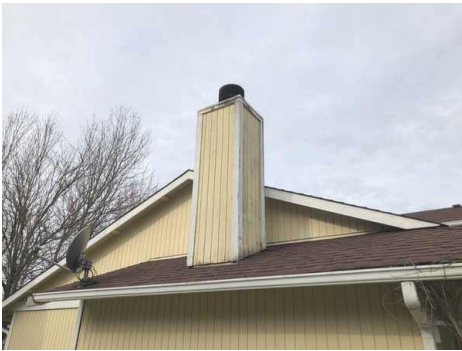
**Exterior Chimney: Serviceable Condition**

The exterior chimney was in serviceable condition. See additional notes in the roofing section of this report.

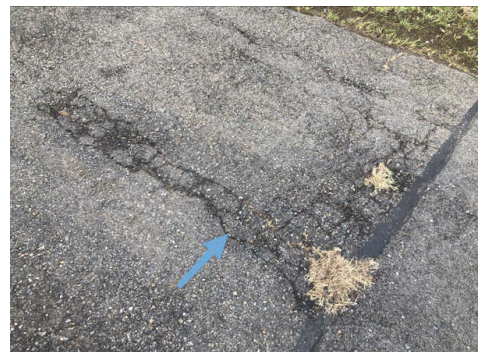
**MODERATE CRACKS IN DRIVEWAY**

There are a few cracks in the driveway which is mostly cosmetic but you may want to view for yourself and repair as necessary.

Recommend monitoring.

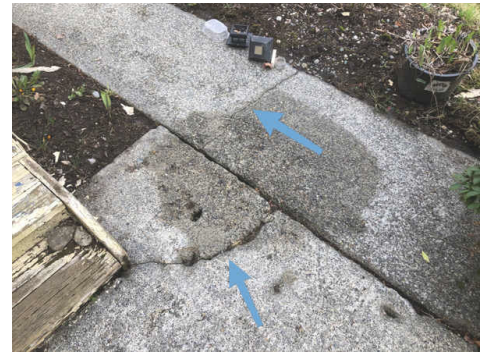
## 3.2.2 Driveway, Walkways &amp; Patio

**CRACKS IN WALKWAYS**

There are a few cracks in the walkways around the residence that are mostly cosmetic. We suggest you view these yourself and repair as necessary.

Contact a qualified professional.

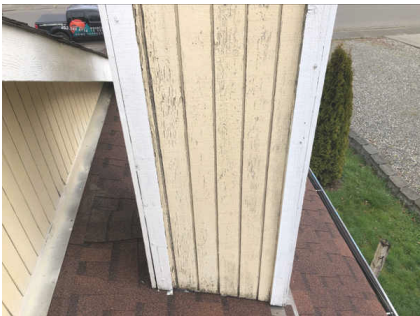
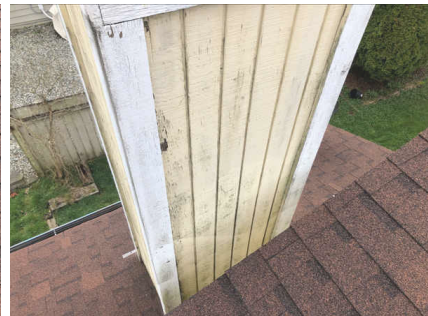
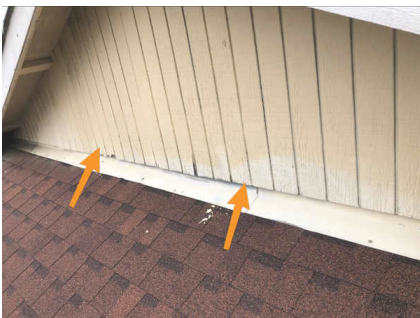
## 3.5.1 Exterior Siding Notes

The exterior siding is weathered. Maintenance, paint, and repairs are recommended.

Contact a qualified professional.

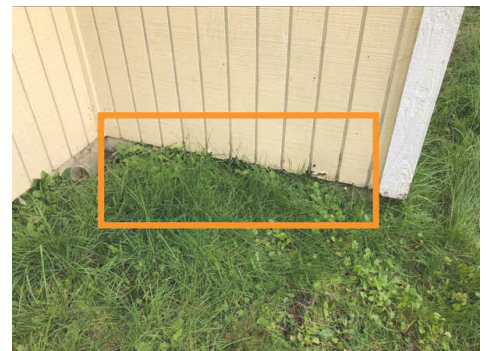
## 3.5.2 Exterior Siding Notes

**MOISTURE DAMAGE**

Portions of the siding were previously moisture damaged and should be further evaluated by a contractor.

Contact a qualified siding specialist.

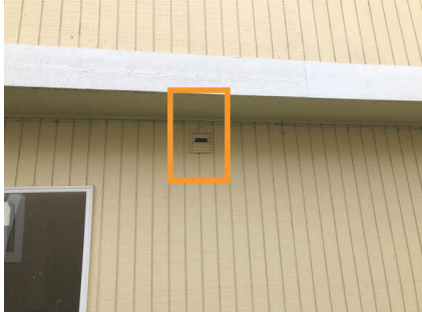
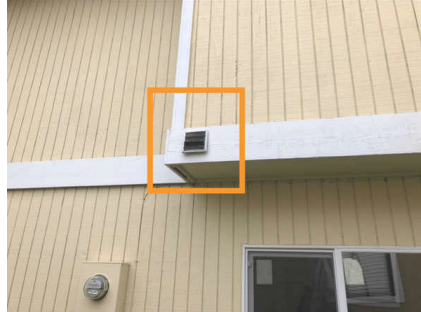
**EXTERIOR VENTS NEED REPAIR**

The vent is missing or damaged and is in need of replacement.

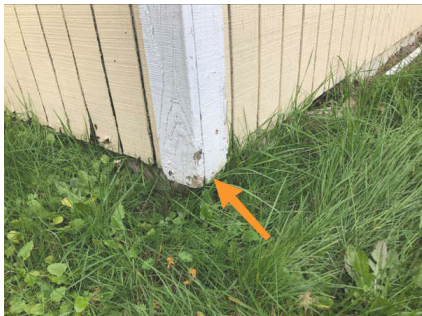
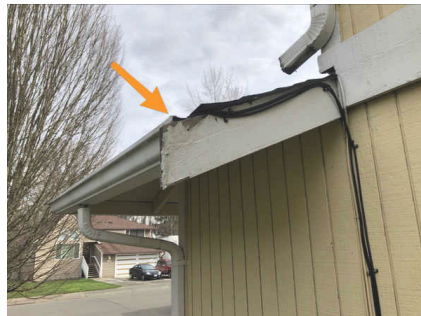
Sections of the fascia board or wood trim around the residence are slightly weathered, and should be serviced as necessary to prevent further deterioration. Service such as scraping, repainting and sealing.

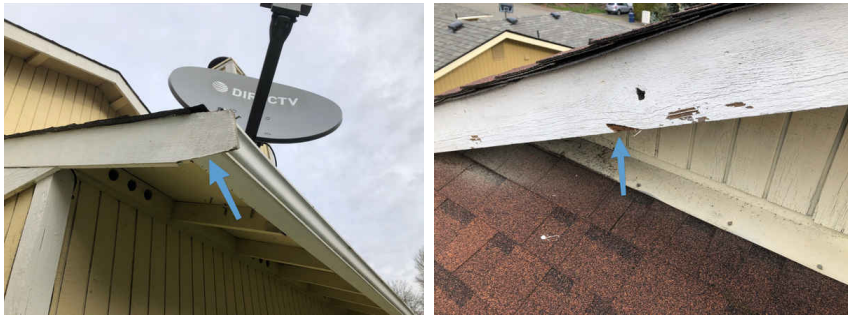
## 3.7.2 Fascia, Trim &amp; Eaves

**TRIM MISSING/DAMAGED**

A piece of trim is damaged or missing. Recommend repairs.

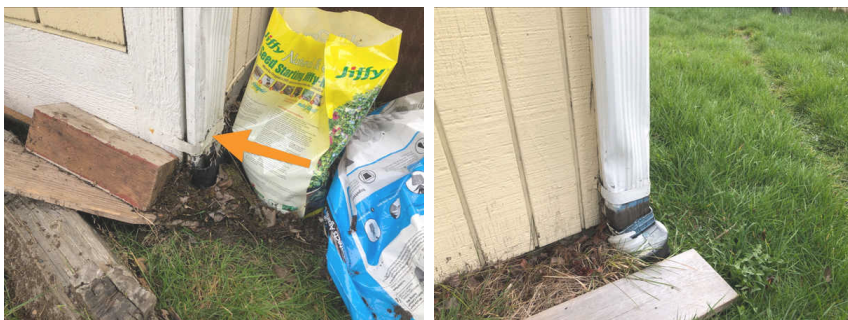
### 3.9.1 Downspouts

#### **DENTED/DAMAGED**

Some downspouts were dented/damaged. We recommend these are repaired or replaced.

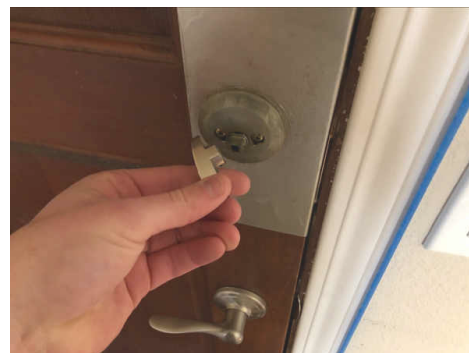
### 3.10.1 Exterior Doors

#### **EXTERIOR DOOR HARDWARE LOOSE OR MISSING**

Exterior door hardware was loose or missing or otherwise in need of repair. Recommend repairs be made.

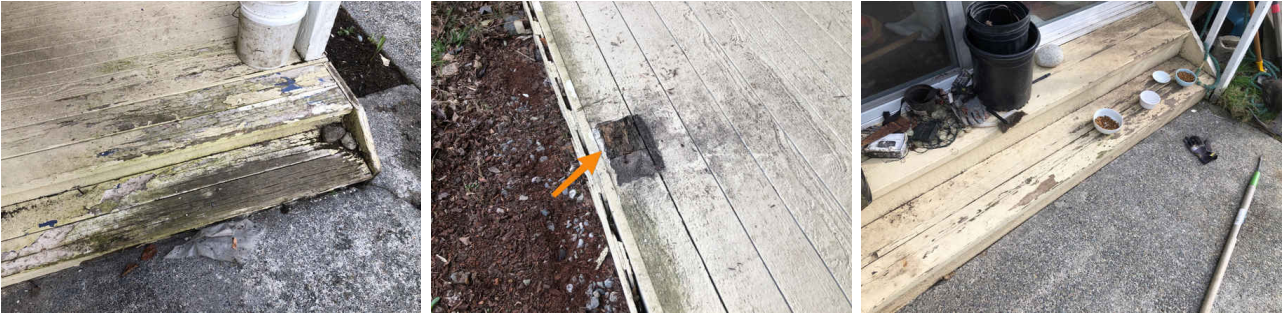
### 3.17.1 Deck

#### **DECK IS DETERIORATED**

One or more sections of the deck are damaged or deteriorated. Further evaluation and repair is recommended

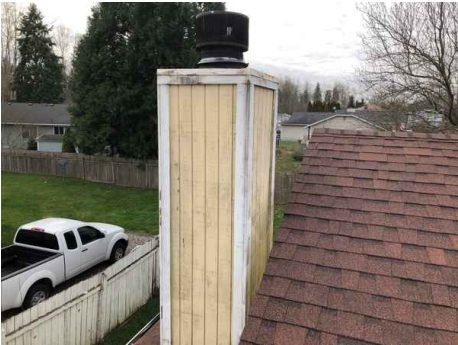
### Chimney On Roof & Photo: Chimney Photo

The chimney has a functional weather cap/spark arrestor.

The chimney flashings are in acceptable condition.

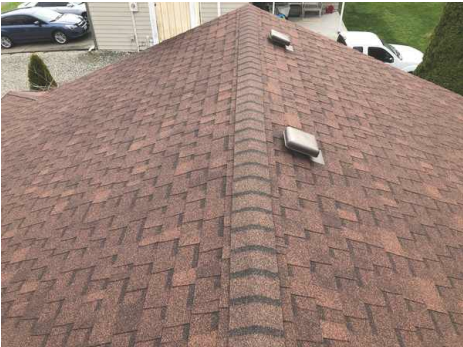
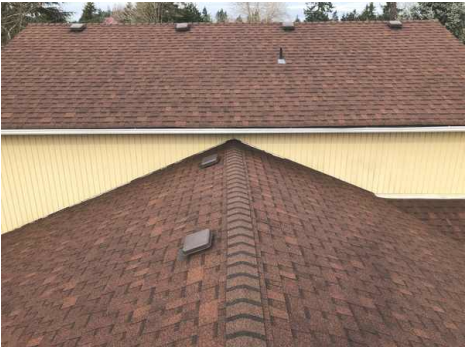
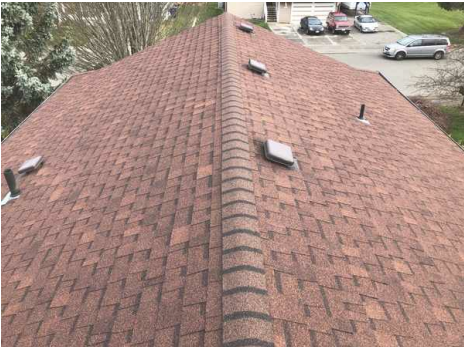
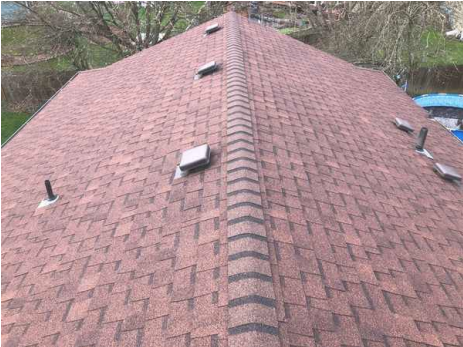
### Method of Evaluation & Photos: Method of Evaluation & Photos

Walking on its surface

The roof is in generally acceptable condition. Any exceptions will be noted below. NOTE: This is not guarantee against leaks.

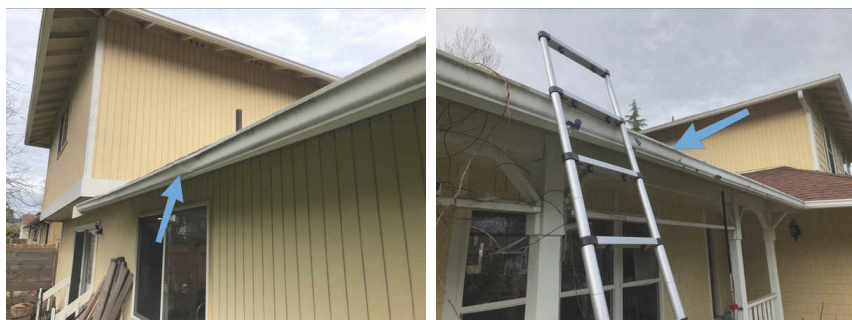
#### 4.5.3 Gutters & Drainage

### **GUTTERS DENTED/DAMAGED**

The gutters are dented or damaged. Recommend Servicing as needed.

Contact a qualified professional.

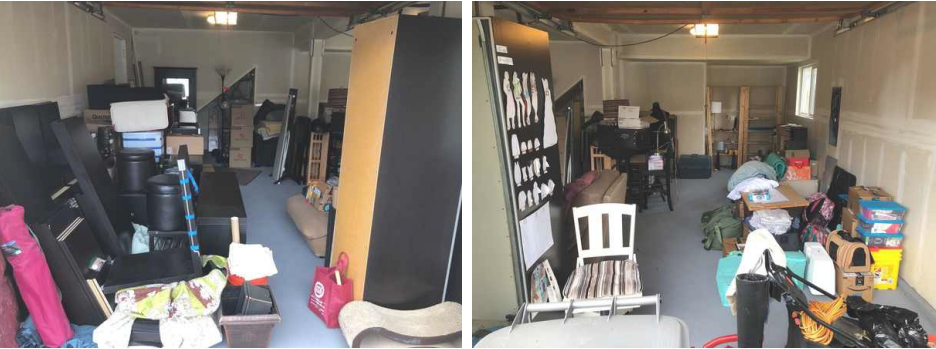
<b>Automatic Opener: Acceptable</b> The automatic garage door opener is acceptable.	<b>Automatic Opener: Safety lights - Acceptable</b> The garage door safety lights open the door when obstructed.	<b>Garage Door &amp; Hardware: Acceptable</b> The sectional garage door and its hardware are functional.
<b>Firewall Separation: Acceptable</b> The firewall separating the garage from the residence is functional.	<b>Walls and Ceiling: Acceptable</b> The visible walls and ceiling are in acceptable condition.	<b>Windows: Acceptable</b> The windows are functional.
<b>Garage Cabinets: Acceptable</b> The shelves are in satisfactory condition.	<b>Lights, Wall Switches: Acceptable</b> The wall switches are functional.	<b>Lights, Wall Switches: Acceptable</b> The ceiling lights are functional.
<b>Outlets, Electrical Observations: Acceptable</b> The outlets were in acceptable condition.		
<b>Picture and size of garage: Picture and size of garage</b> Double Car Garage The garage and its components were evaluated.

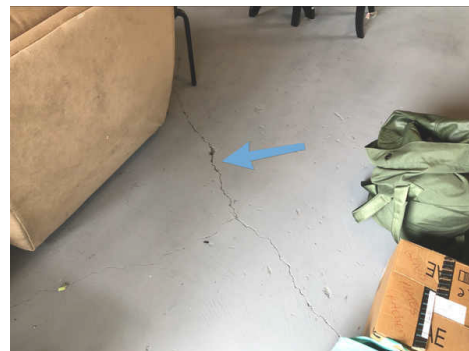
#### 5.5.1 Slab Floor

### **GARAGE FLOOR CRACKED - FURTHER EVALUATION**

The garage floor is cracked and further evaluation is recommended.

Contact a qualified concrete contractor.

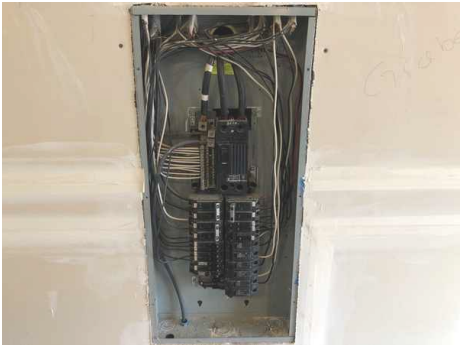
<b>Service Entrance: Main Lines</b> Underground	<b>Service Entrance: Main Lines</b> <b>Acceptable</b>  The electrical service entrances are acceptable.	<b>Panel Size, Location &amp; Photo:</b> <b>Panel Amps, Location and Picture</b> Garage, 200 AMP

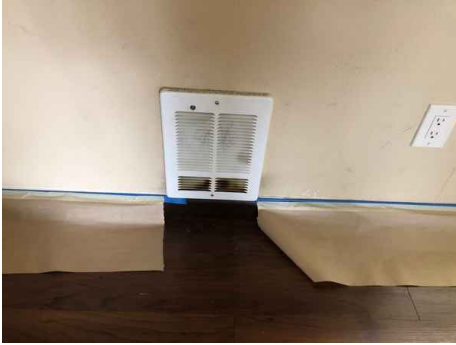
#### Electric Heating Notes: Equipment Photo

The resistance heaters were functional.

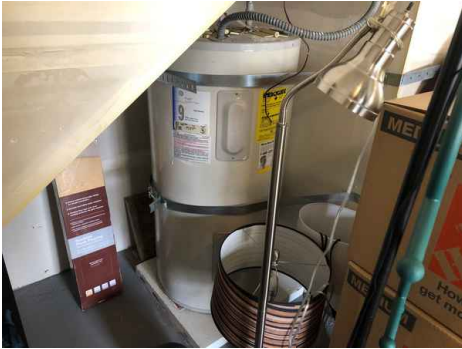
## Water Heating System: Manufacturer and picture

GE

I recommend flushing & servicing your water heater tank annually for optimal performance. Water temperature should be set to at least 120 degrees F to kill microbes and no higher than 130 degrees F to prevent scalding.

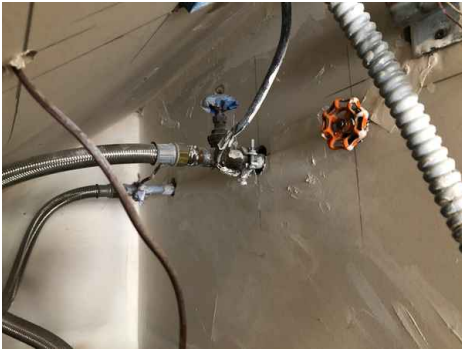
## Water Heating System: Water Shut-Off Valve & Connectors

The shut-off valve and water connectors appear functional, but was not tested.

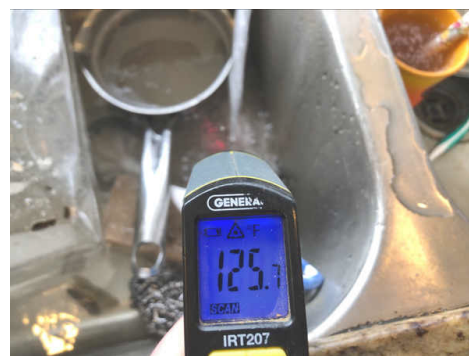
The water temperature is too high and is a potential hazard. Recommend water temperature be lowered not to exceed 120 degrees.

Recommended DIY Project

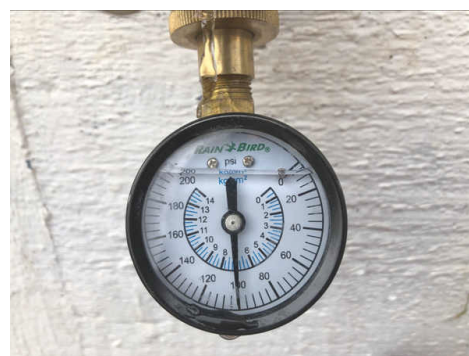
## 8.2.1 Main Water Shut-Off, Distribution &amp; Supply

The water pressure inside the residence exceeds 80 psi and will stress components of the system. Appliances and components such as water heaters, dishwashers, washing machines and most water using appliances will function better and last longer under lower water pressure (usually 40-80 psi). You may want a licensed plumber to evaluate this and adjust the water pressure. This evaluation and service is recommended before the close of escrow.

Contact a qualified plumbing contractor.

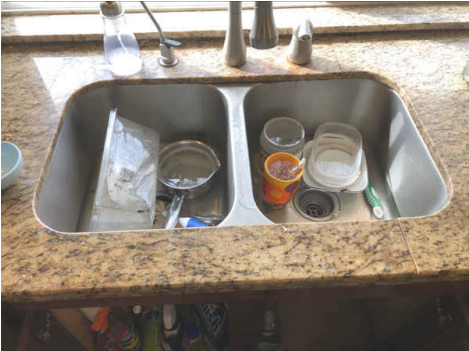
## 9.2.2 Trap and Drain

**LEAK AT DRAIN LINE BELOW THE SINK**

Contact a qualified professional.

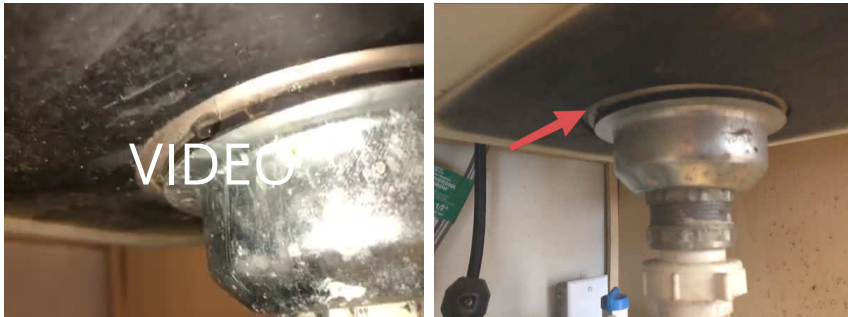
## 9.4.1 Countertop

**MISSING OR DETERIORATED CAULK/GROUT**

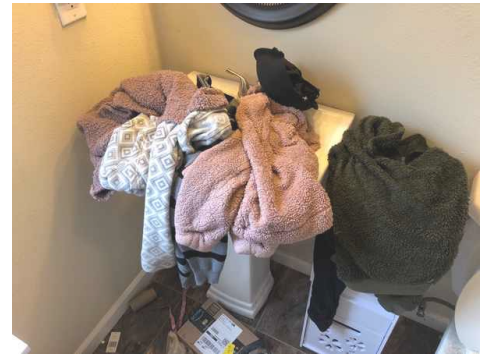
### SINK NOT INSPECTED

A sink was not inspected due to the sellers items. Recommend removing and having it inspected.

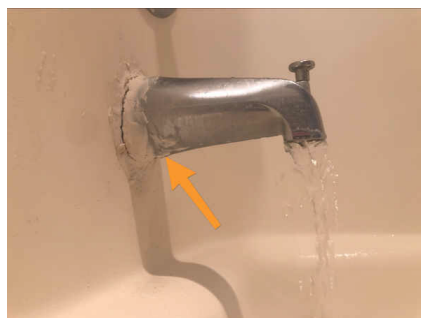
## 11.4.5 Tub-Shower

**MISSING OR DETERIORATED CAULK/GROUT**

Contact a qualified professional.

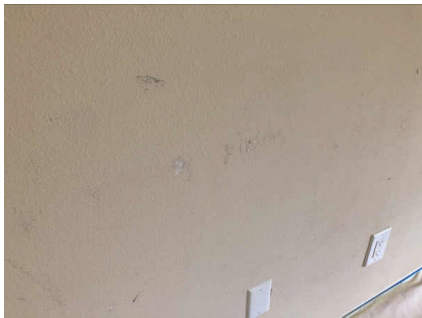
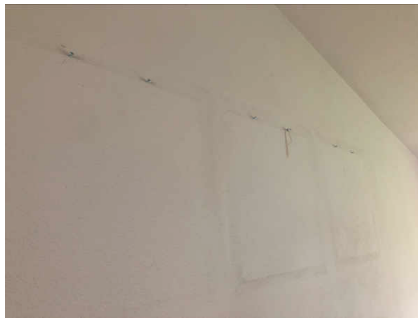
### 13.4.2 Walls and Ceiling

#### TYPICAL SETTLEMENT CRACKING/NAIL POPS

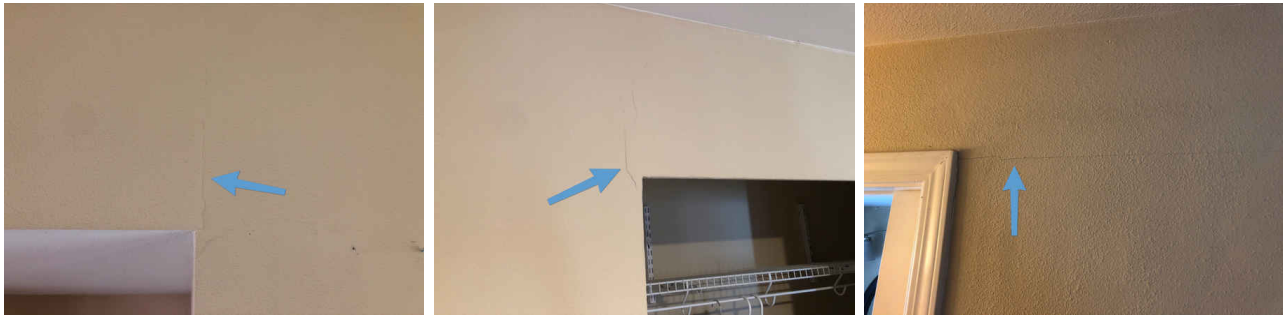
Observed typical settlement type cracking and nail pops on walls and ceilings. Recommend repairs as needed. Home owner to identify all areas for repair.

Recommend monitoring.

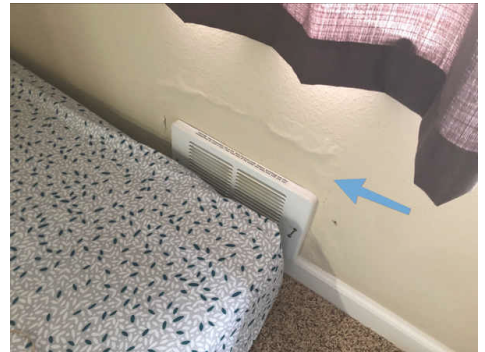
**PATCH/PAST REPAIR**

Patches or repairs were observed in the wall or ceiling. We could not determine the reason for the repairs. Recommend monitoring.

Low Priority

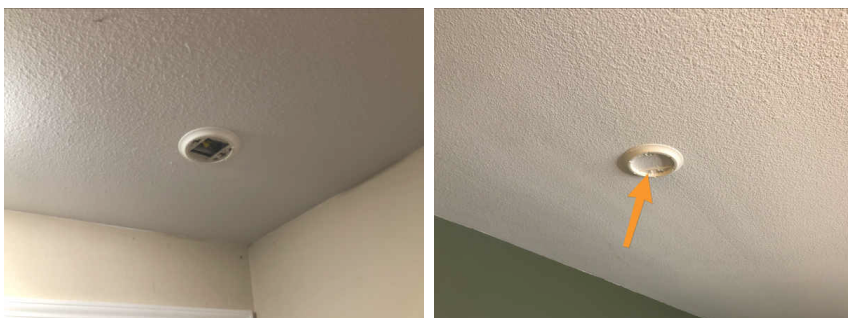
**THE SMOKE DETECTORS MISSING**

The smoke detector is missing and should be installed as a fire safety feature.

Contact a qualified handyman.

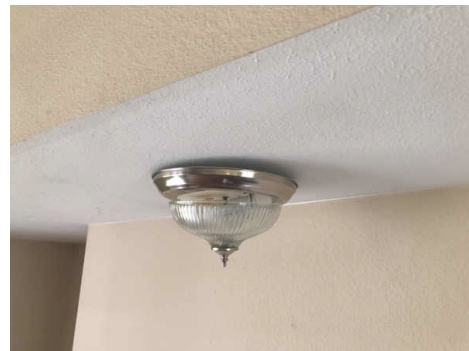
**LIGHT DAMAGED OR MISSING COMPONENTS**

The light was damaged or missing components. Recommend repair as needed.

Contact a qualified professional.

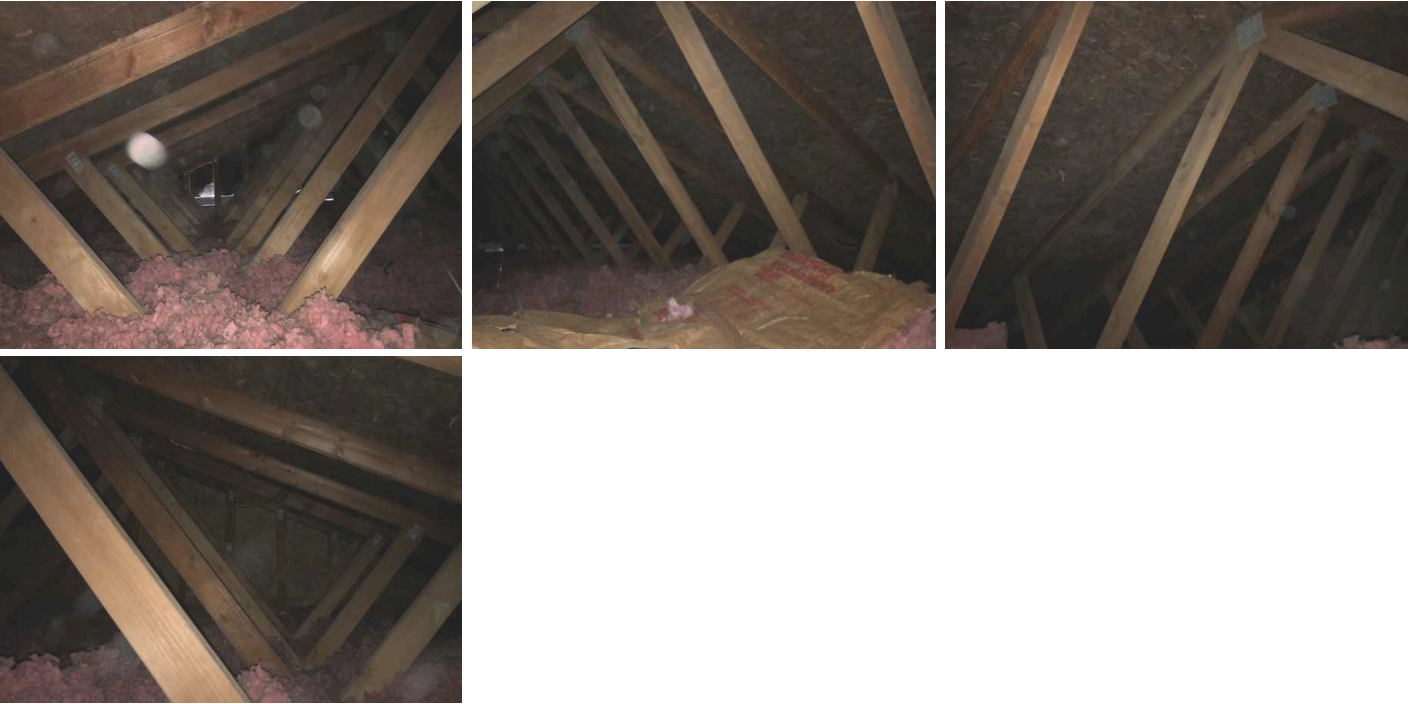
### Attic Photos

<b>Attic Access Location</b> Laundry Room	<b>Insulation Notes: Acceptable</b> Insulation is acceptable	<b>Insulation Notes: Insulation Type</b> Blown, Fiberglass
<b>Exhaust Ducts: Acceptable</b> The visible portions of the exhaust ducts appear to be functional.	<b>Plumbing Vents: Acceptable</b> The accessible plumbing vents were in acceptable condition.

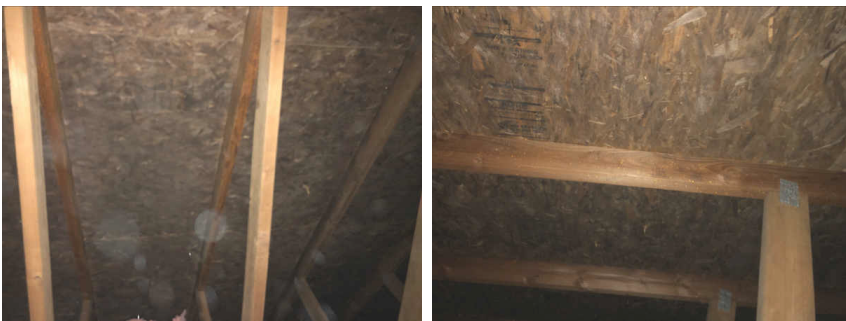
Medium Priority**DECK STAINING**

Discoloration and dark staining was observed on the roof sheathing. This is often caused by poor ventilation and is commonly considered a microbial growth. Recommend improving ventilation and cleaning.

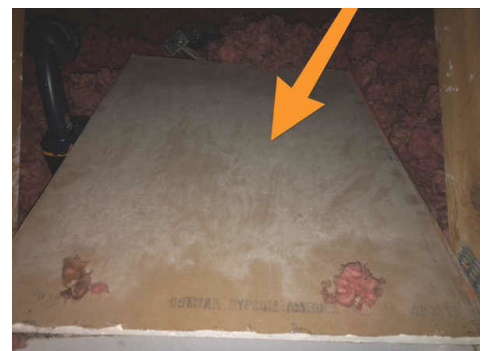
**HATCH MISSING INSULATION**

The attic access hatch was missing insulation. We recommend installing.

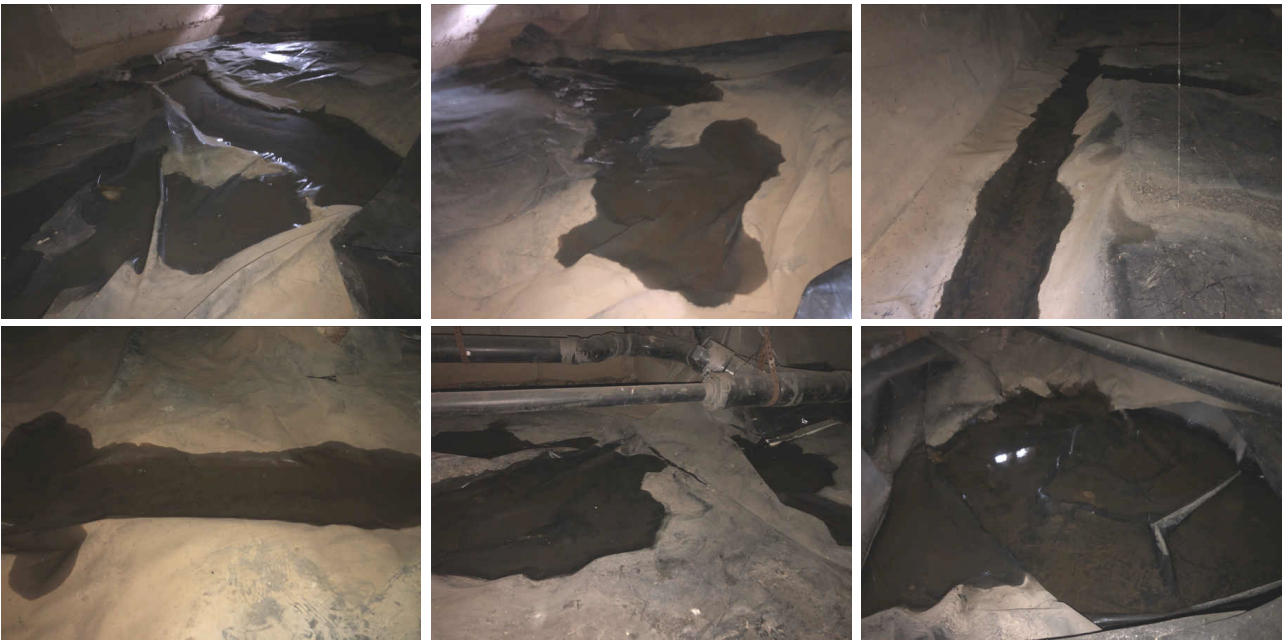
Observed standing water in the crawl space Recommend a qualified contractor evaluate and find potential source of moisture.

Contact a qualified professional.

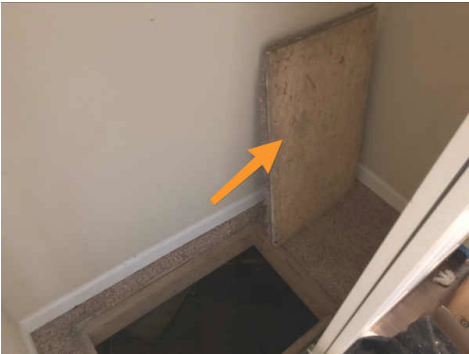
CRAWLSPACE HATCH MISSING INSULATION

The Crawlspace hatch is Missing insulation. We recommend installing.

Contact a qualified professional.

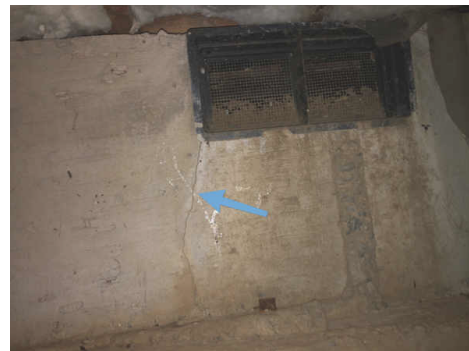
SMALL CRACKS

Hairline and/or small cracks, within normal tolerances were visible. This type of cracking is often a result of shrinkage of materials and/or minor settlement and usually does not affect the performance of the foundation.

Recommend monitoring.
