PRO SPEX CONDO INSPECTION REPORT

15503 Sample Report Rd
LAUREL MD 20707

JULY 10, 2018

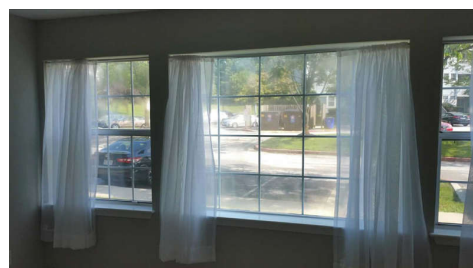
2.7.1 WINDOWS (Excluding
Storm Windows)

FAILED SEALS

Immediate, Costly or Safety Concern

The seal between glass panes are failing at several windows (3 found) resulting in condensation between the panes. Over time the condensation gets worse, turning into a milky white film until you cannot see thru the window. This condition typically requires replacement of the window. Replacement costs can be significant depending on the quality of the replacement and number of windows. There are companies that claim to be able to correct this problem without window replacement. Note: Others may have failed seals that may not be detected due to dry weather conditions or may fail at anytime. This condition cannot always be seen or future failure of the seal predicted. Consult a qualified window contractor for any further investigation and repair options.

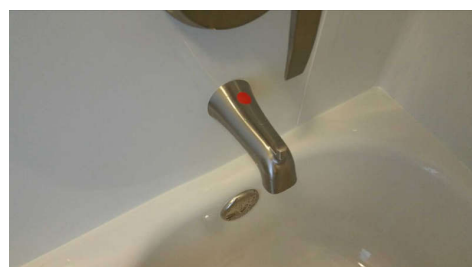
LOOSE TUB SPOUT

The tub spout is loose inside the wall and needs securing to prevent leaks and hidden damage.

Routine Repair/Replacement Item

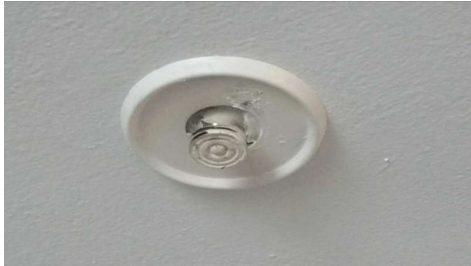
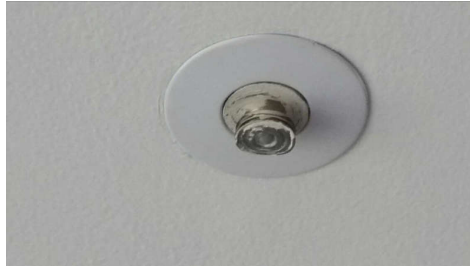
3.8.1 Fire Sprinkler System

PAINTED FIRE SPRINKLER HEAD

**Immediate, Costly or Safety Concern**

It is important not to paint sprinkler heads. They are designed to activate in the event of a fire. Paint can slow the response to high temperatures. Often painted fire sprinkler heads cannot be cleaned and must be replaced.

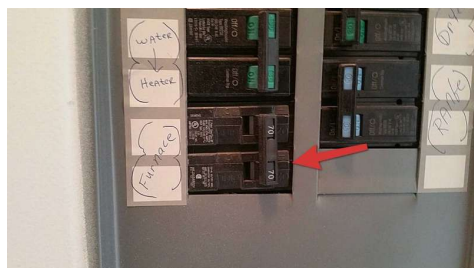
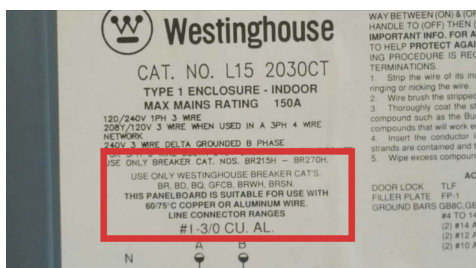
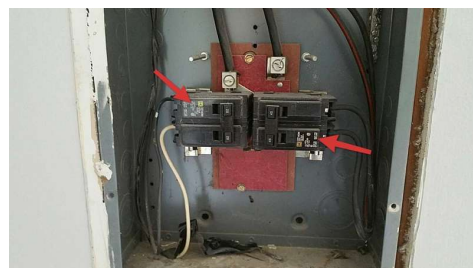
4.2.1 SERVICE AND GROUNDING EQUIPMENT, MAIN OVERCURRENT DEVICE, MAIN AND DISTRIBUTION PANELS

The problem(s) discovered in the panel such as breaker(s) are different brands, and any other problems that an electrician may discover while performing repairs need correcting. Unlike most electrical devices like switches and outlets, circuit breakers are brand specific. The manufacturer typically requires that you to only replace or add breakers specifically designed for that panel. Because of different mounting techniques, buss bar thicknesses, breaker contact tension specifications, and overall construction differences, breakers are typically not interchangeable. Placing another brand of breaker in a breaker panel could cause an electrical malfunction.

I recommend a licensed electrician inspect further to determine if these breakers are compatible and correct as needed.

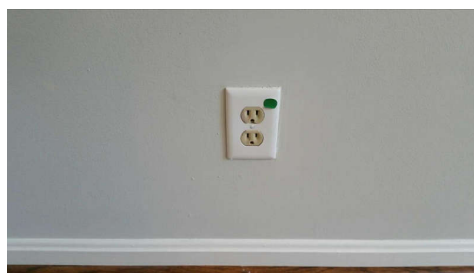
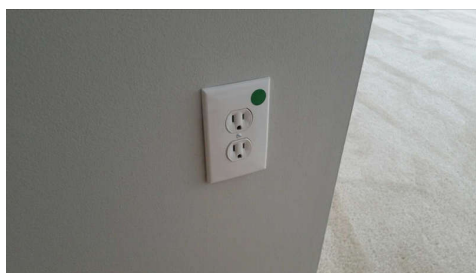
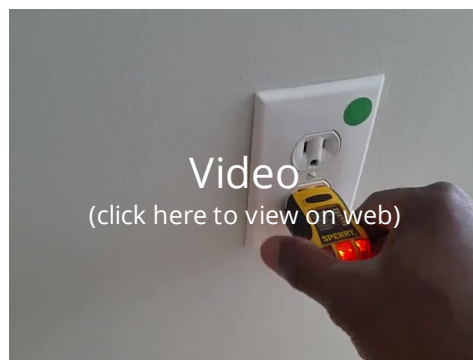
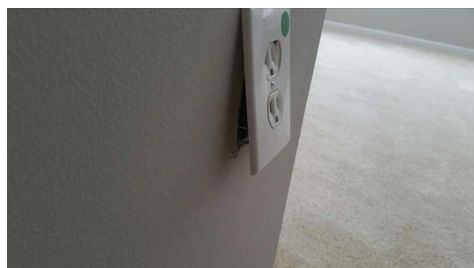
4.4.1 CONNECTED DEVICES AND FIXTURES (Readily Accessible permanently installed devices, fixtures, switches, outlets etc.)

Routine Repair/Replacement Item

LOOSE OUTLETS

Several "three-prong" outlets (see outlets with green dots for location) are loose in the property. Loose outlets can result in an electrical short inside the wall. Electrical issues are considered a hazard until repaired. All outlets should be properly secured, and should not move when inserting or removing a device.

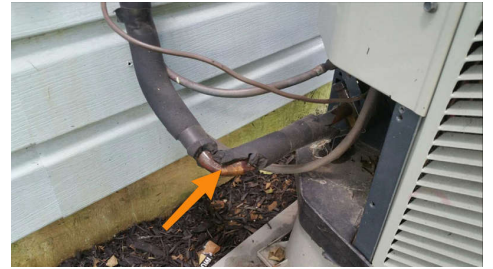
5.9.1 COOLING AND AIR
HANDLER EQUIPMENT (Excludes
Window Units)

Routine Repair/Replacement Item

MISSING FOAM SLEEVE

The foam sleeve on suction line is missing/deteriorated in some areas. The purpose of the foam insulation is too keep the refrigerant line cold until it reaches the condenser. Missing foam on suction line can cause energy loss, condensation and lower system performance. I recommend replacing missing or damaged foam sleeve so that the entire length of visible line is fully insulated.

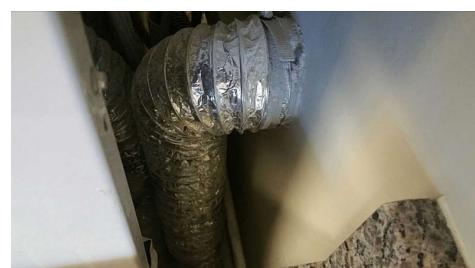
Proper clothes dryer venting is essential to your dryers operation, and for safety. Foil and vinyl accordion vents are known to choke and cause house fires. The dryer lint adheres to the walls of the vent, accumulating over time to reduce the vent size. When this happens, the dryer rate of exhaust is reduced, causing the dryer to overheat and ignite the lint in the vent. Recommend replacement and periodic cleaning to ensure safety.

Routine Repair/Replacement Item

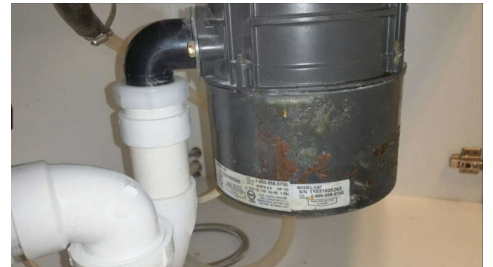
7.6.1 FOOD WASTE DISPOSER

CORRODED INTERIOR

The disposal is heavily corroded and likely to fail at any time. Replacement recommended due to age and wear.

Routine Repair/Replacement Item
