HOME INSPECTION REPORT

16416 NE 106th PI
Redmond WA 98052

MAY 11, 2020

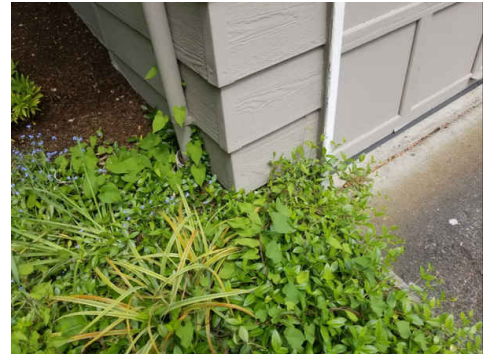
Vegetation is encroaching on the structure, and should be kept a minimum of twelve inches away for the general welfare of the walls and foundation.

Recommendation

Contact a qualified landscaping contractor

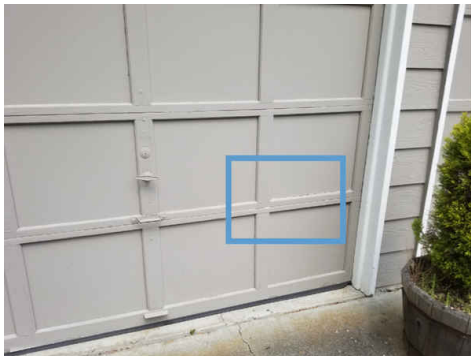
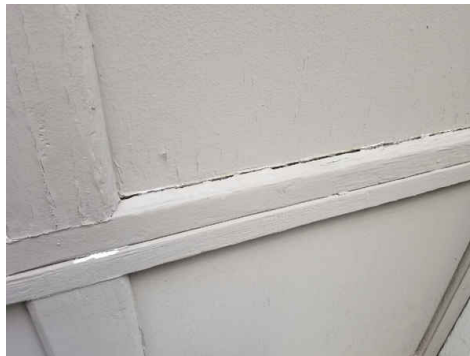
3.5.2 Exterior Siding Notes

GARAGE DOORS NEED PAINT TOUCH UP

The garage doors need service at some locations to prevent moisture intrusion.

Recommendation

Contact a qualified handyman.

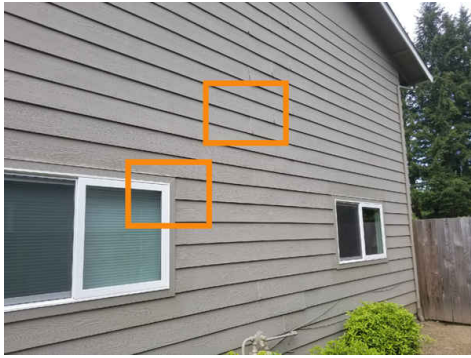
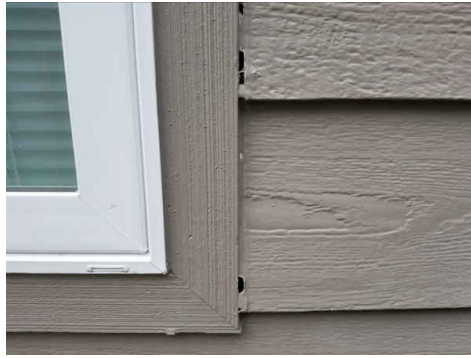
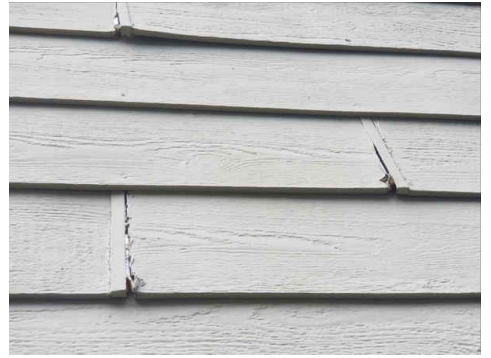
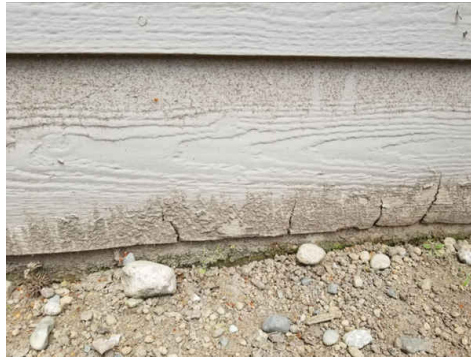
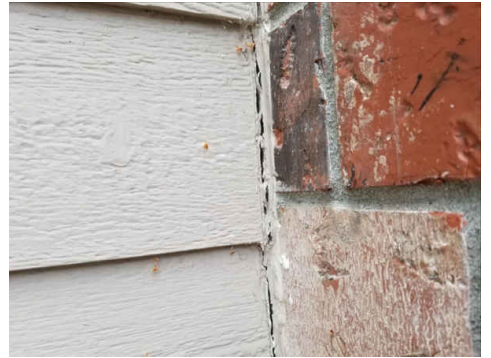
3.5.3 Exterior Siding Notes

DAMAGED SIDING**LEFT & RIGHT SIDES**

Observed areas of damaged siding around the residence that should be repaired to help prevent moisture intrusion issues. These damaged areas can allow moisture to penetrate the walls if not properly repaired.

Recommendation

Contact a qualified handyman.

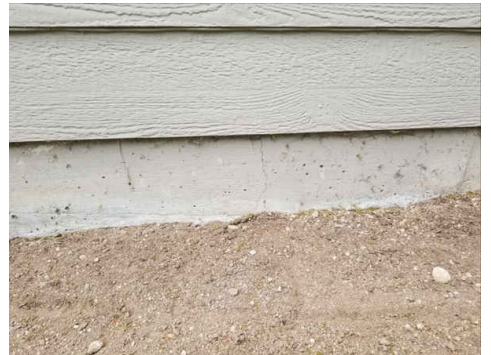
3.6.1 Foundation as Viewed from the Exterior

SMALL CRACK

A hairline and/or small crack within normal tolerances was visible. This type of cracking is often a result of shrinkage of materials and/or minor settlement and usually does not affect the performance of the foundation.

Recommendation

Recommend monitoring.

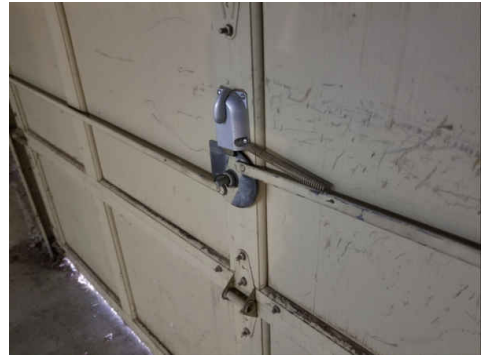
5.2.2 Garage Door & Hardware

HANDLE MISSING

The garage door functions properly, but the interior handle was missing. Recommend repairs.

Recommendation

Contact a qualified professional.

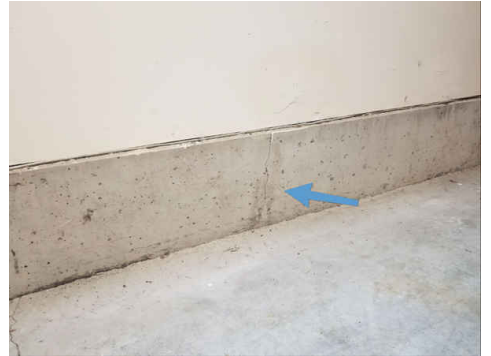
5.4.1 Slab Floor

SMALL CRACK IN THE STEM WALL

There are small crack in the garage stem walls of the garage footing that we do not regard as being structurally significant, which you may wish to view for yourself and decide whether or not you want a second opinion.

Recommendation

Recommend monitoring.

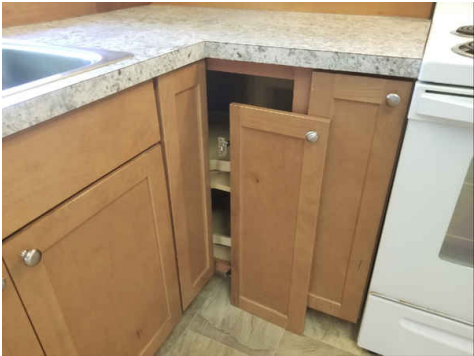
The cabinet door hardware needs adjustment or repair.

Recommendation

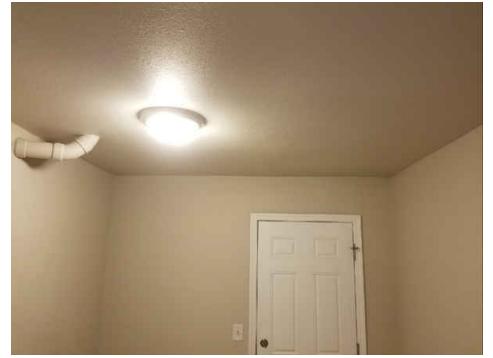
There is not a laundry exhaust fan or openable window installed within this laundry room. Adding one is recommended and typically required to help disperse excessive moisture from the laundry room.
