NOOKS & CRANNIES PROPERTY INSPECTIONS LLC

PROPERTY INSPECTION

8917 2nd Ave
Silver Spring MD 20910

Latoya Thomas
APRIL 6, 2021

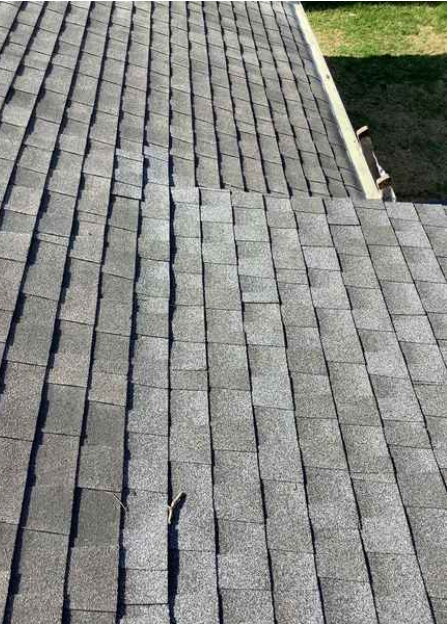
2.1.1 Coverings

Roof shingles were discolored, which can be caused by moisture, rust or soot. Recommend a qualified roofing contractor evaluate and remedy with a roof cleaning or repair.

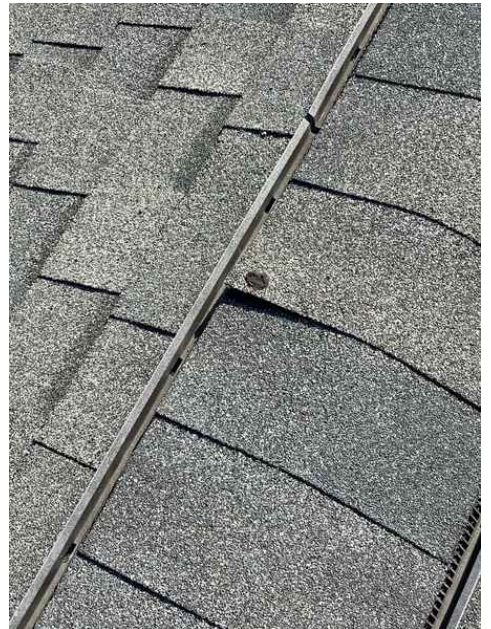
2.3.1 Flashings

LOOSE/SEPARATED

Flashings observed to be loose or separated, which can lead to water intrusion and/or mold. Recommend a qualified roofing contractor repair.

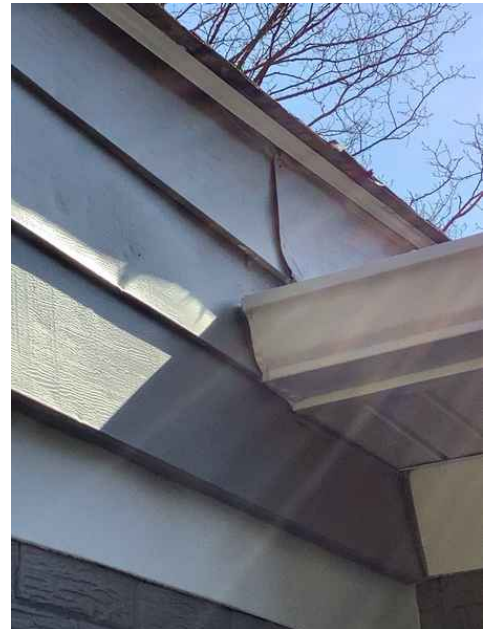
2.3.2 Flashings

MISSING

Kick out flashings were missing at time of inspection also missing J channel is several places. Flashings provide protection against moisture intrusion. Recommend a qualified roofing contractor evaluate and remedy.

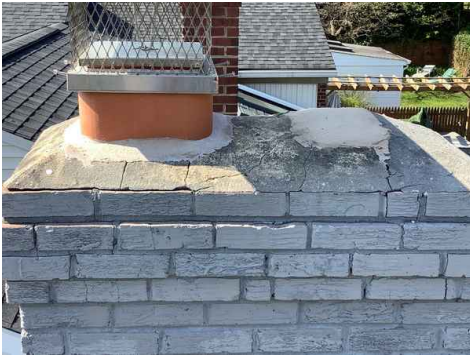
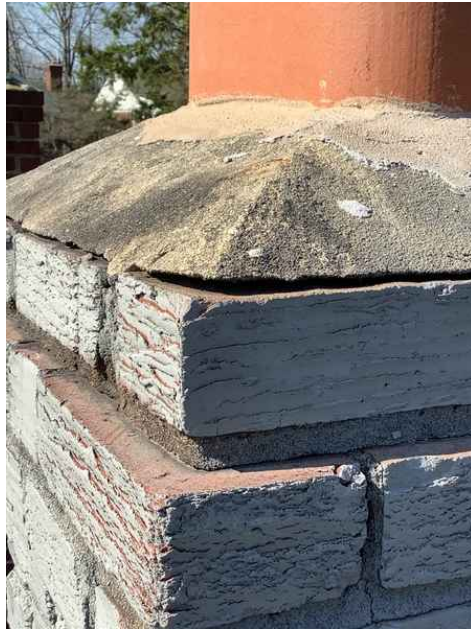
2.4.1 Skylights, Chimneys & Other Roof Penetrations

CHIMNEY CROWN CRACKED

The chimney crown had one or more cracks, which can lead to further damage to the chimney structure as well as water infiltration. Recommend a qualified contractor repair.

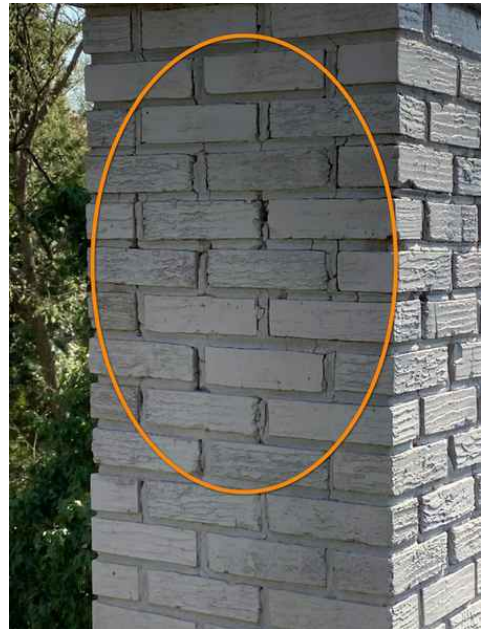
2.4.2 Skylights, Chimneys & Other Roof Penetrations

Joints in the masonry have deteriorated and should be repointed. (Repointing is the restoration of the mortar joints in the masonry).

Contact a qualified chimney contractor.

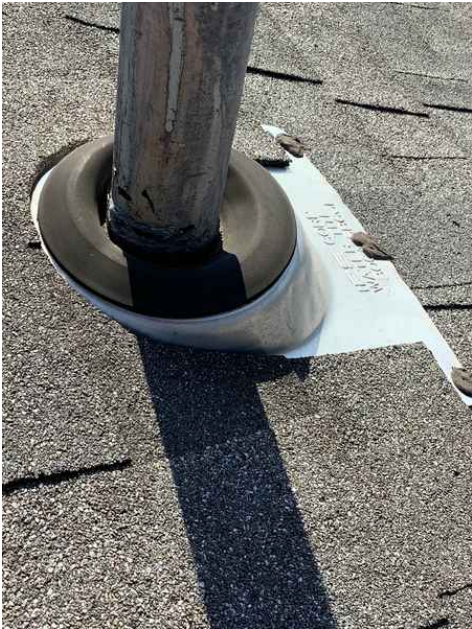
2.4.3 Skylights, Chimneys & Other Roof Penetrations

Vent boot shows signs of wear and pushed in, this could allow water to settle and make it's way down the pipe into the walls.

Contact a qualified professional.

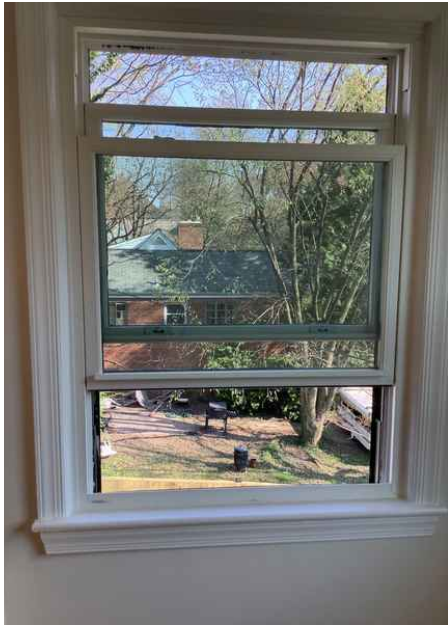
A representative number of windows from the ground surface was inspected. Missing screens in multiple windows. Screens found in basement.

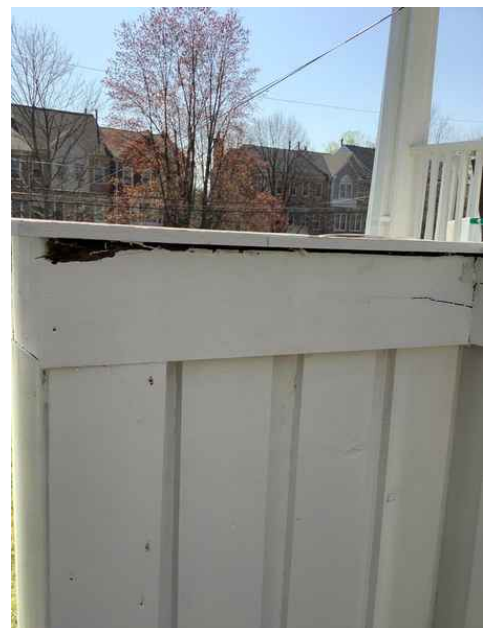
FENCE DEFECT

I observed that the condition of the fence in front gate area was in decay.

Contact a qualified fencing contractor

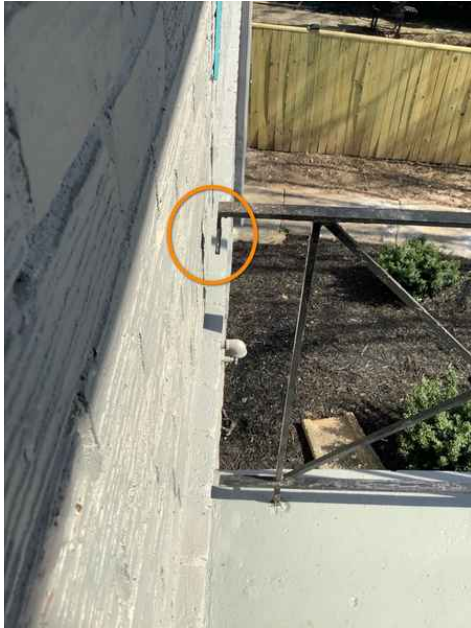
4.9.1 Railings, Guards & Handrails

LOOSE RAILING COMPONENT

I observed a loose railing component. This condition is a safety hazard. Correction and further evaluation is recommended.

Front door. Rail not connected to house

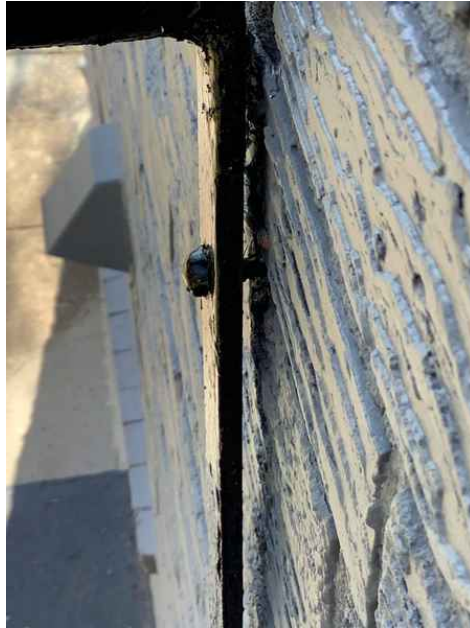
Right side door

WOOD ROT AT DOOR

I observed wood rot at the exterior door.

Correction and further evaluation is recommended.

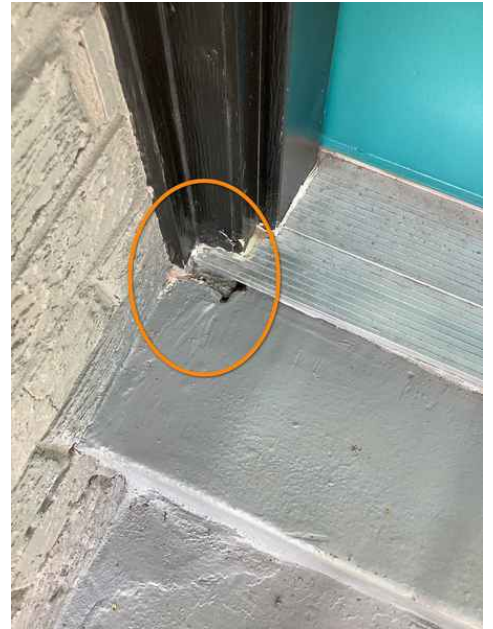
4.11.2 Exterior Doors

Void in concrete at threshold could allow pest and water to infiltrate and damage wood floor.

Contact a handyman or DIY project

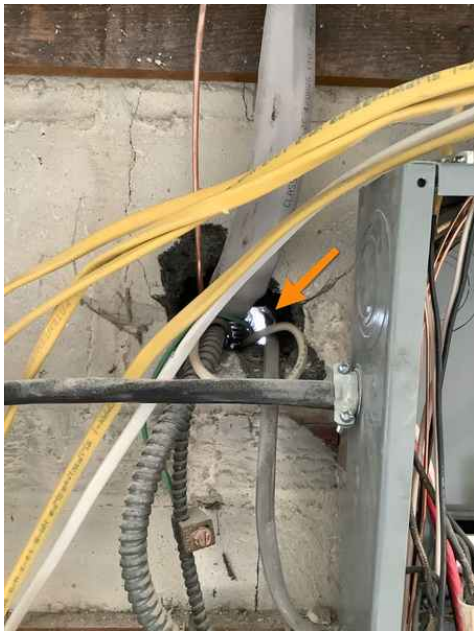
5.1.2 Foundation

OPEN HOLE
Open hole to outside will allow water and pest to enter.
Recommendation
Contact a handyman or DIY project

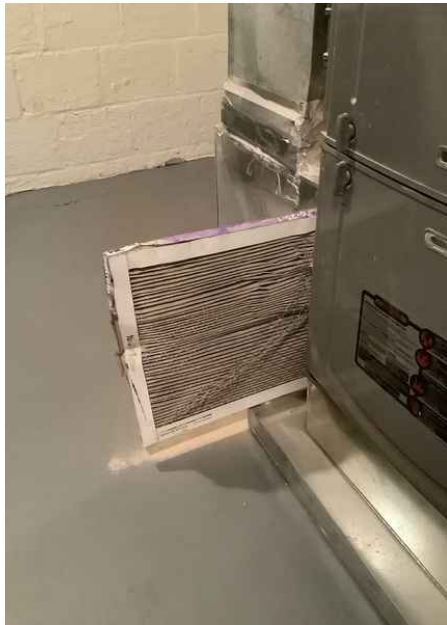
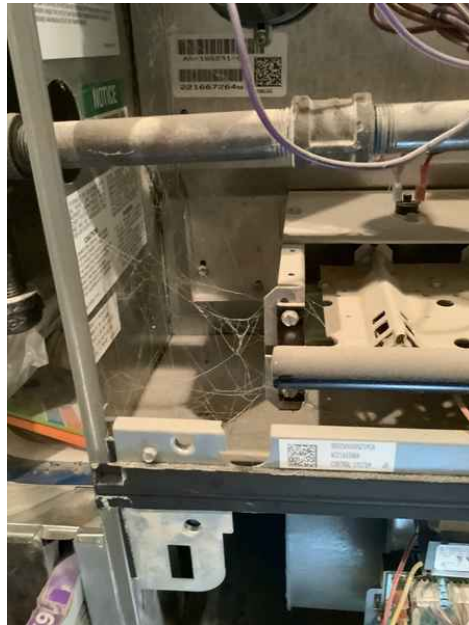
Monthly Filter replacement

Changing filter on a regular basis will keep the system running better and for a longer period. Recommend having ducts cleaned on a regular basis. Also recommend have furnace professionally cleaned before turning on. Lots of dust and cobwebs were noted.

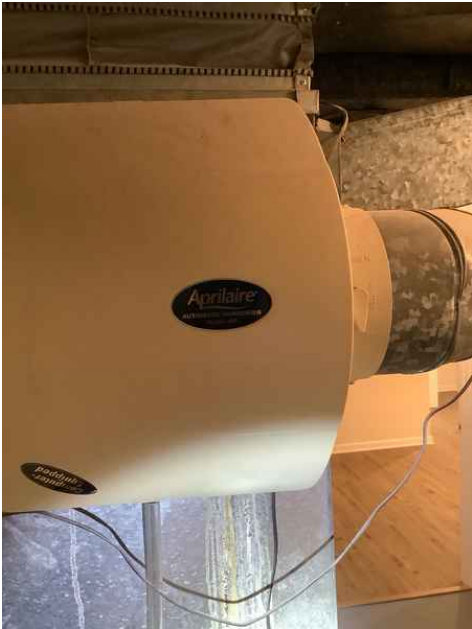
WHOLE HOUSE HUMIDIFIER

Recommend further inspection for serviceability. When unmaintained they become a source of possible mold and mildew growth

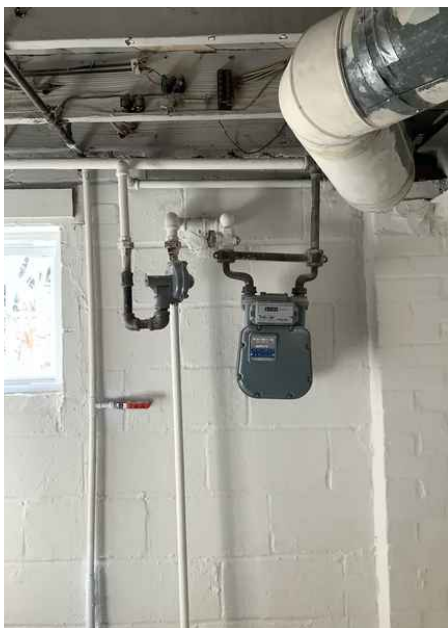
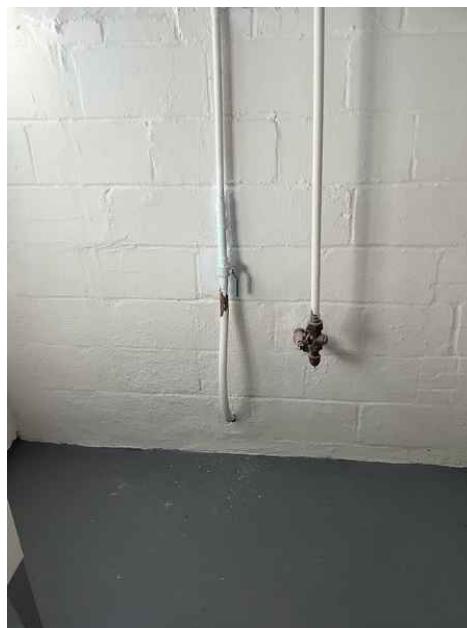
Water and gas shut offs. Laundry room in basement

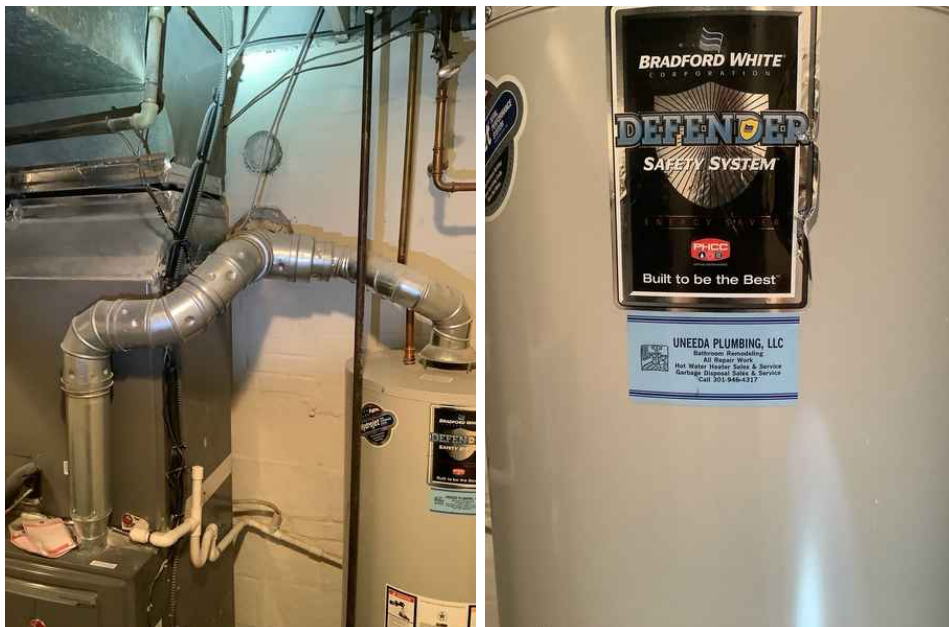
DEFECT AT VENT CONNECTION PIPE

I observed suspect vent connection pipe of the hot water source. Recommend contacting plumber who installed it for further guidance.

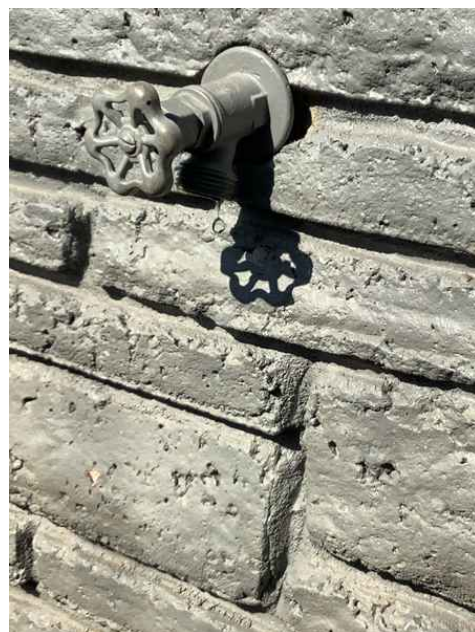
8.5.1 Water Supply & Distribution Systems

ACTIVE WATER LEAK AT WATER SHUT-OFF VALVE

I observed an active water leak at a water shut-off valve on the front right exterior of house.

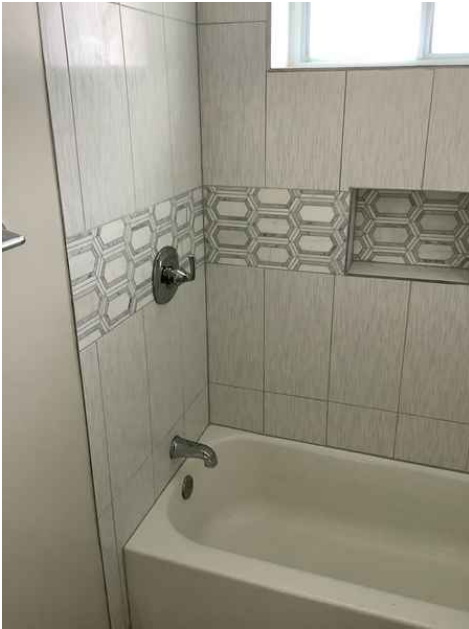
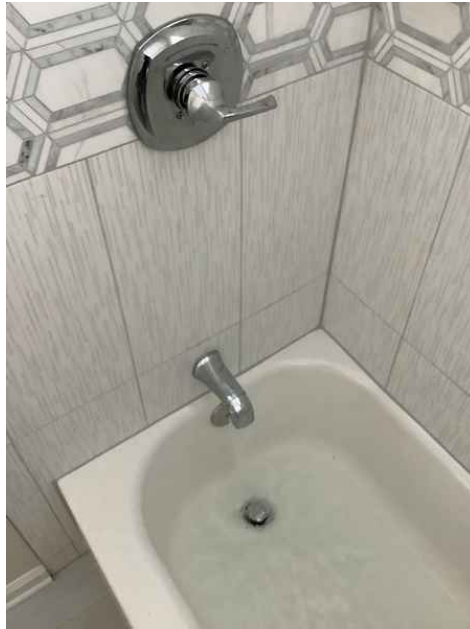
2nd Floor

FAUCET HANDLE NOT OPERATIONAL

Water in upstairs bathroom tub would not shut off. I eventually shut the water off at service valves in access panel in closet. Needs to be replaced or adjusted. This is a safety hazard.

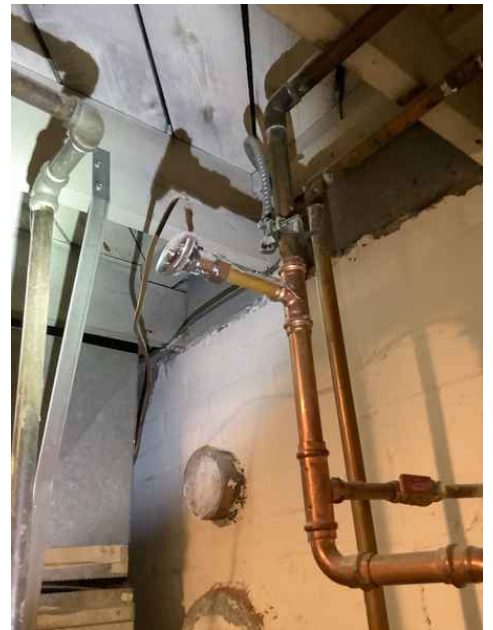
8.5.4 Water Supply & Distribution Systems

WSSC DISAPPROVED NOTICE FOUND

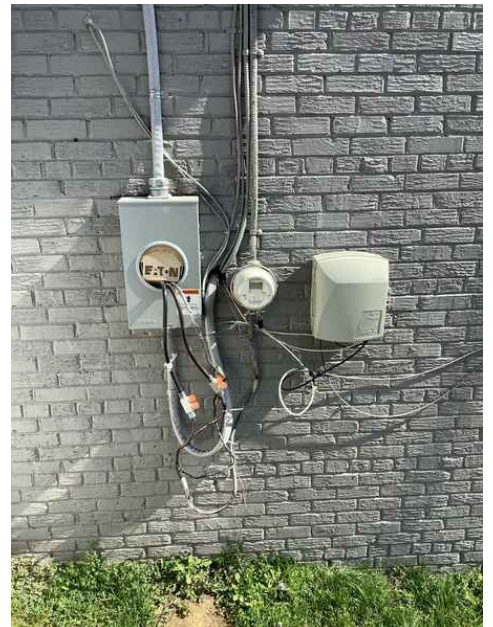
**Safety Hazard****MAJOR DEFECT**

I observed indications of a major defect during the inspection. Major defect. Hazard. Correction and further evaluation is recommended. Inquire with current owner where they are in the permitting process for better understanding.

Contact a qualified electrical contractor.

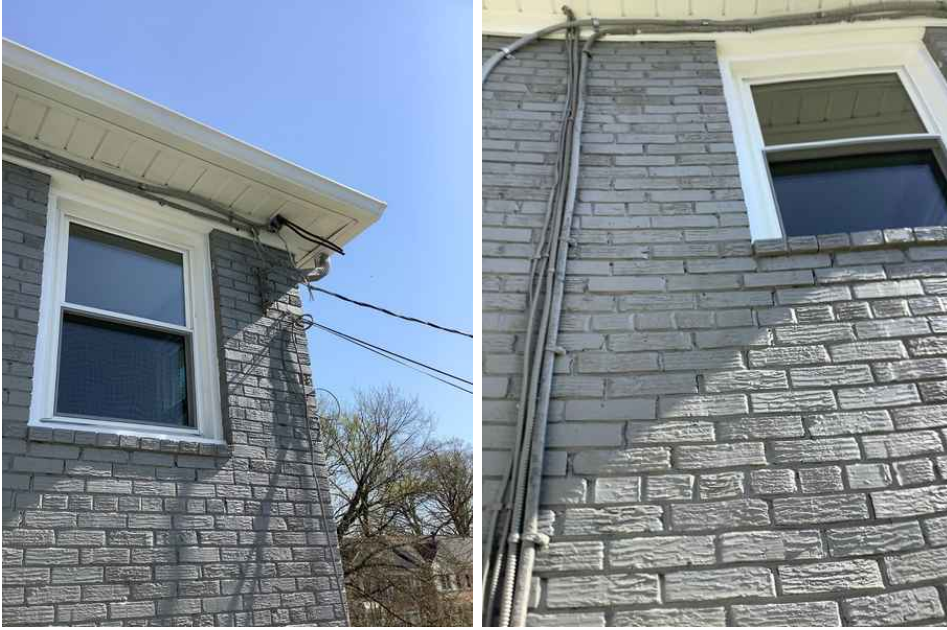
9.2.1 Service-Entrance Conductors

**Safety Hazard****MAJOR DEFECT**

I observed indications of a major defect during the inspection. Major defect. Hazard. Correction and further evaluation is recommended. Service cable is in close proximity to operable window. Contact local permitting for better clarity.

Contact a qualified electrical contractor.

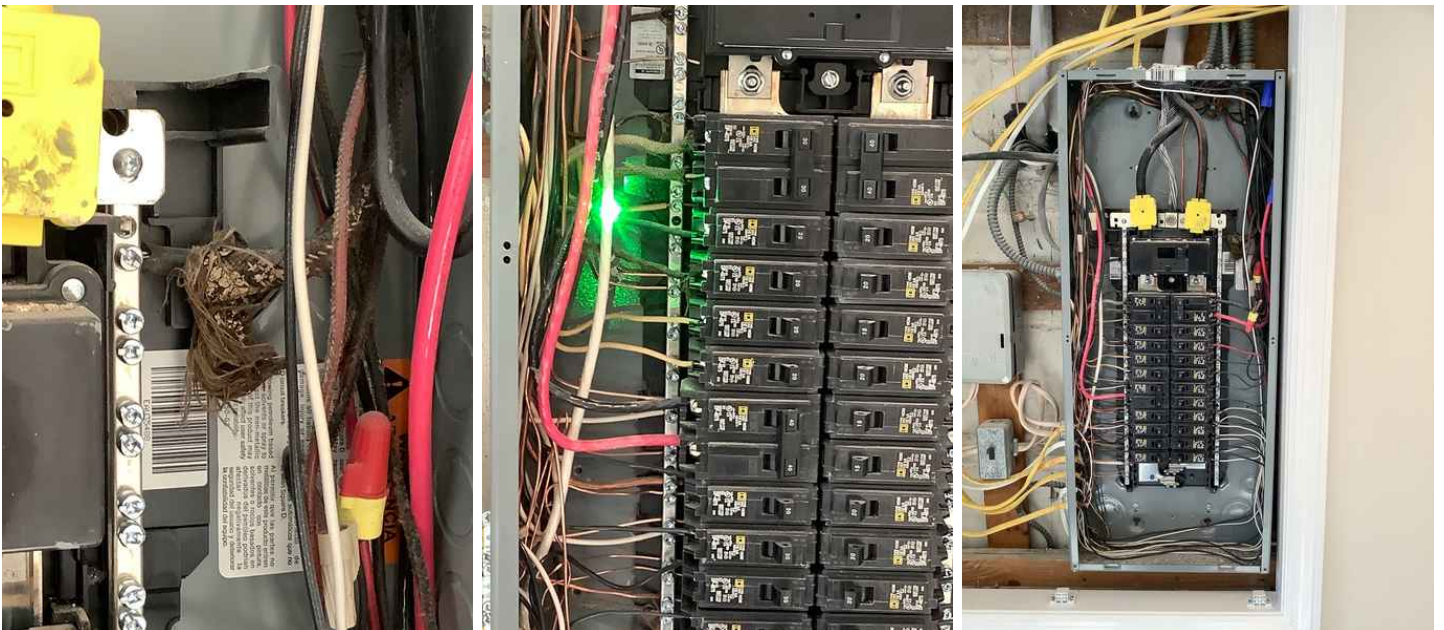
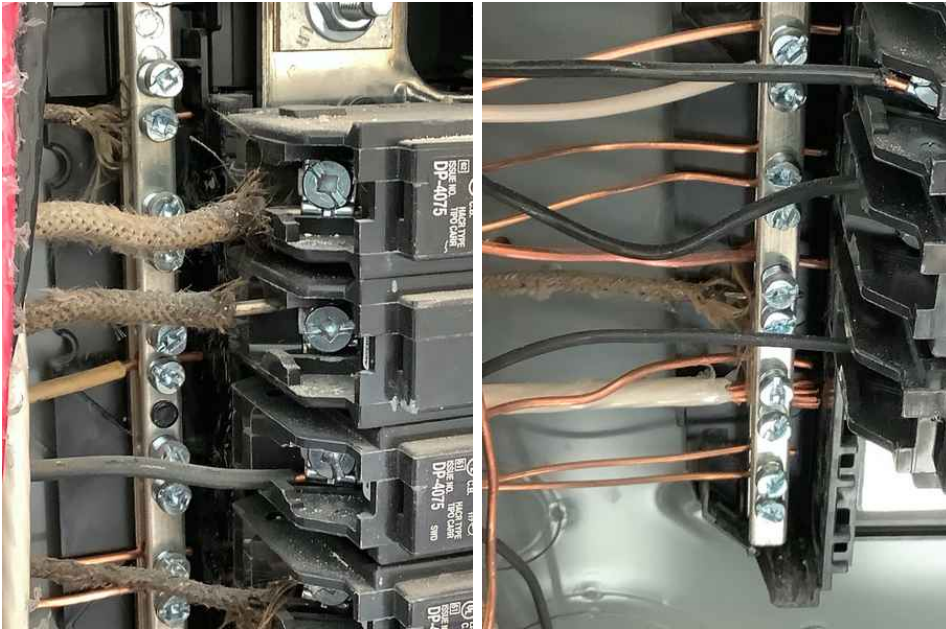
9.4.1 Electrical Wiring

MAJOR DEFECT

I observed indications of a major defect during the inspection. Major defect. Hazard. Correction and further evaluation is recommended. Cloth cover wire is extremely flammable. Contact a License electrical contractor for further evaluation

Contact a qualified electrical contractor.

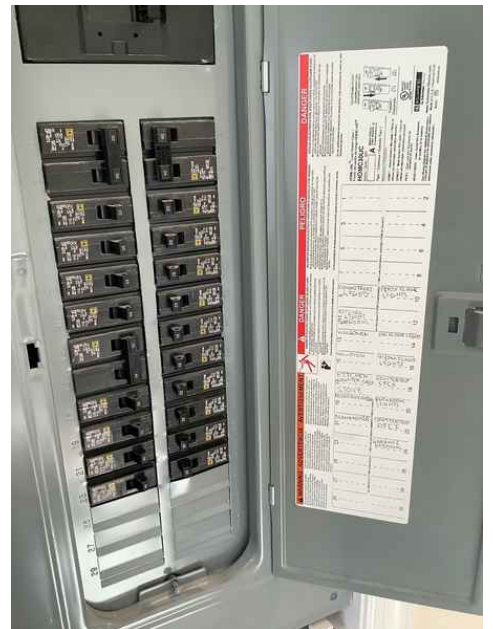
9.5.1 Panelboards & Breakers

MISSING IDENTIFICATION OF DISCONNECTS AT PANEL

I observed missing/inadequate identification of each circuit.

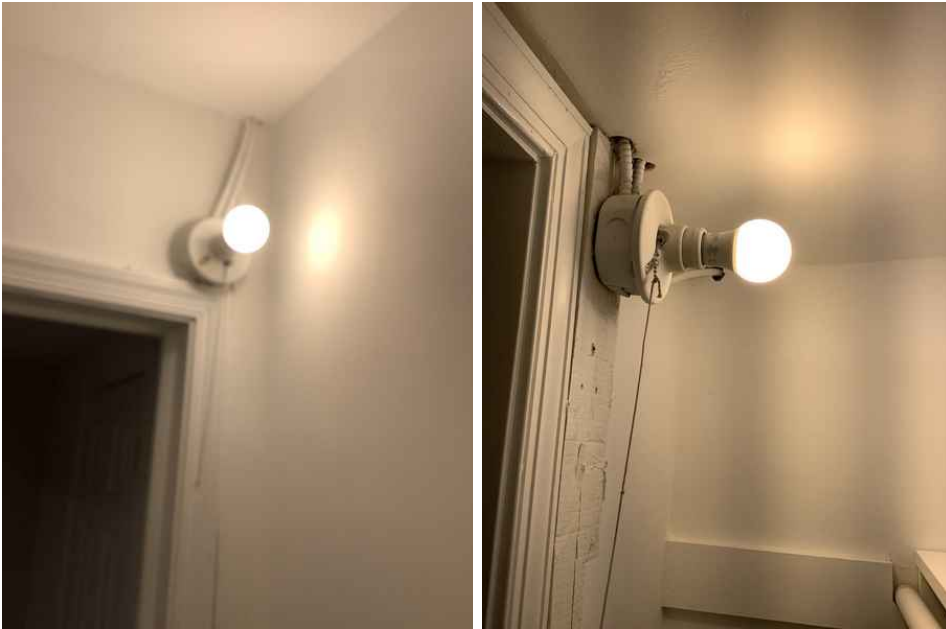
9.9.1 Electrical Defects

CLOSET LIGHT DEFECT

I observed indications of an improper location of a lighting fixture inside a clothes closet. Potential fire hazard.

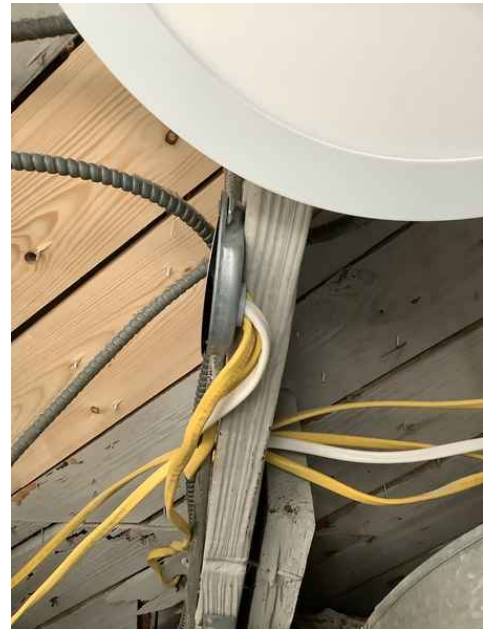
9.9.2 Electrical Defects

UNDERSIZED JUNCTION BOX

Junction box too small to hold the amount of wire entering it. Would not close properly. Potential fire and safety hazard. Contact Licensed electrical contractor for further evaluation.

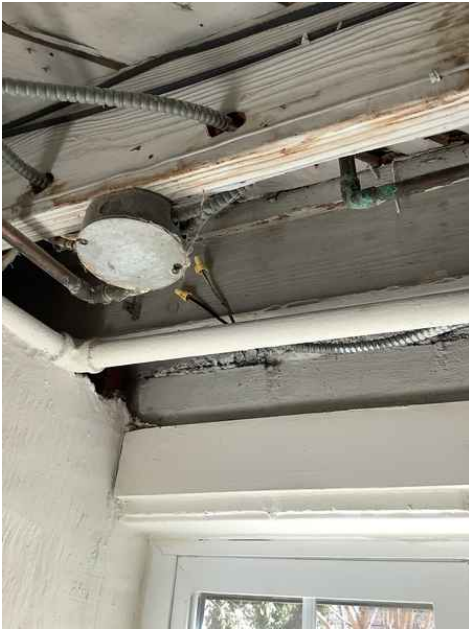
9.9.3 Electrical Defects

WIRES NOT TERMINATED IN PROPER JUNCTION BOX

Potential shock/fire hazard

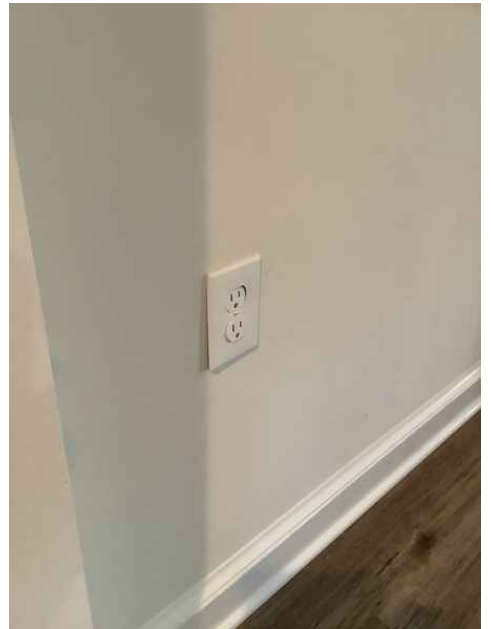
9.9.4 Electrical Defects

LOOSE / IMPROPER OUTLET BOX INSTALL

Several outlets in basement are loose and or possible installed incorrectly. Contact electrical contractor for further evaluation. Possible shock hazard.

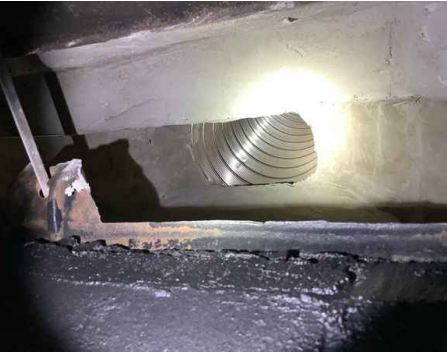
New Chimney Liner noted

New chimney liner noted. However recommend cleaning before use. Have it looked at when the crown is being repaired.

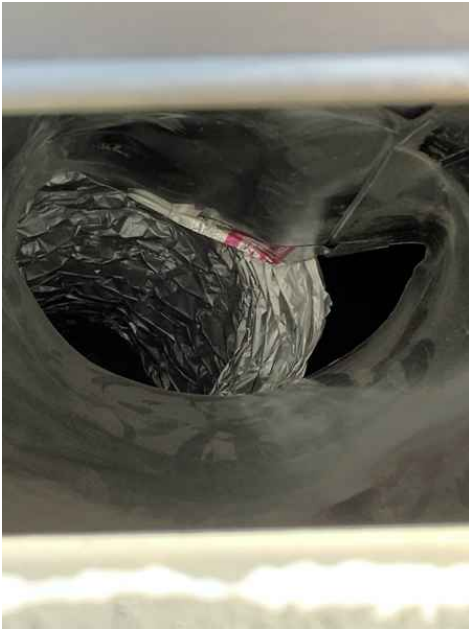
bathroom off downstairs office

IMPROPERLY EXHAUSTING

I observed that the bathroom fan is improperly exhausting air from the bathroom.

Contact a qualified general contractor.

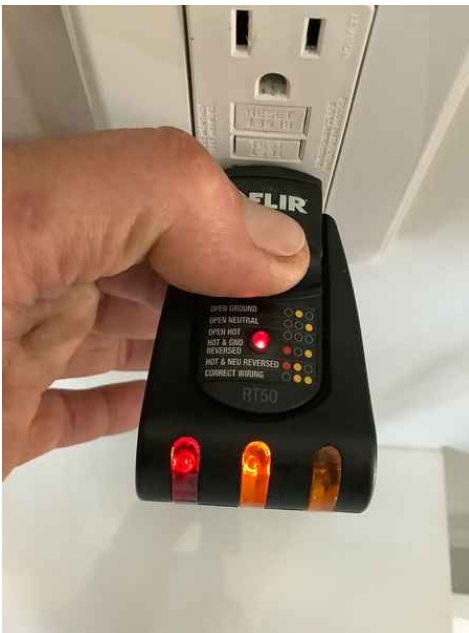
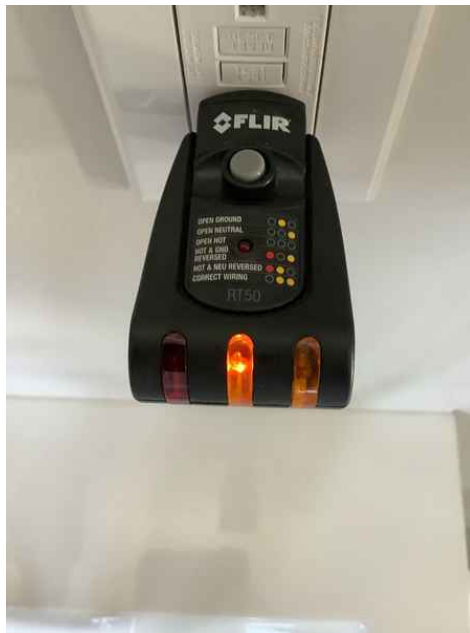
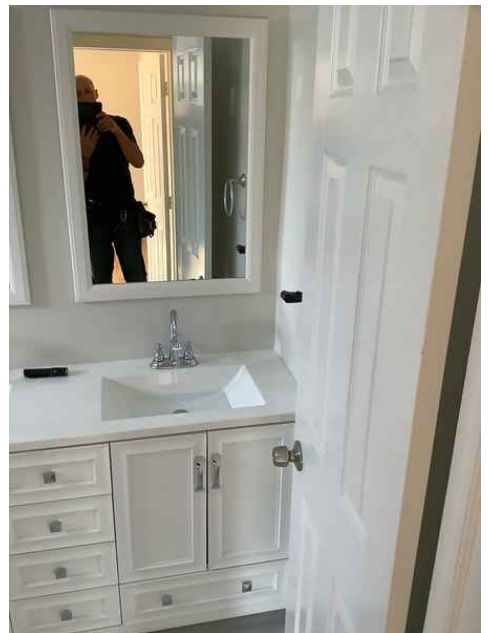
12.4.1 GFCI & Electric in Bathroom

GFCI IMPROPERLY WIRED

I observed a defect at the GFCI in the bathroom. It was not properly wired.

Contact a qualified electrical contractor.

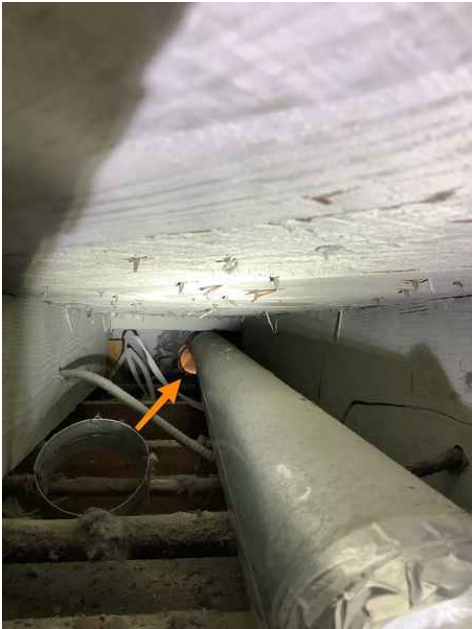
I observed indications that the clothes dryer is not exhausting outside due to disconnected pipe. Venting into floor cavity. This is a fire and potential mold hazard

Contact a qualified handyman.

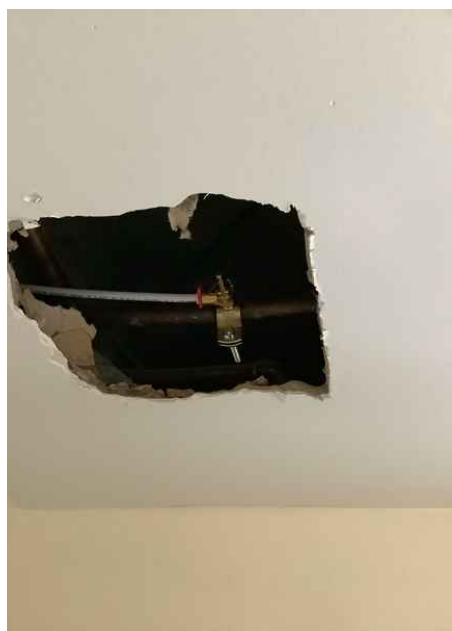
Basement bathroom ceiling

No leaks were detected at the time of inspection. However the use of saddle valves are common practice but need to be monitored from time to time as they are notorious for leaks.
