MOUNTAINS TO SOUND HOME INSPECTION LLC

HOME INSPECTION REPORT

17208 NE 45th St
Redmond WA 98052

Trong Dang
MARCH 4, 2019

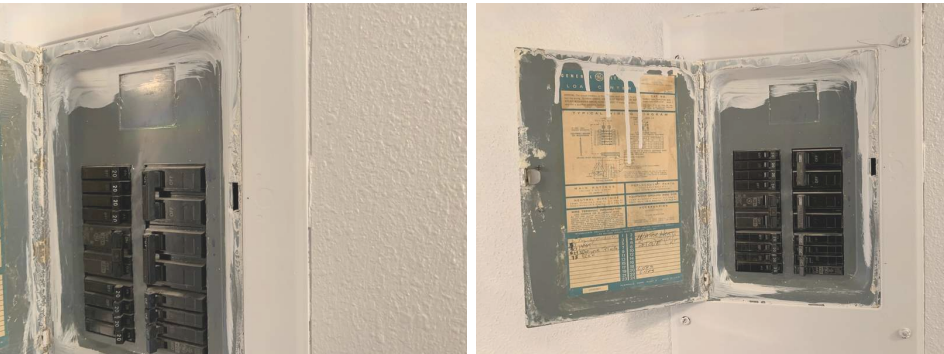
Panel Size, Location & Photo

PAINTED SHUT

The screws and/or panel was painted shut. This made it impossible to inspect the panel without damaging the surrounding surfaces. Recommend that the paint be removed and the panel be accessed and inspected.

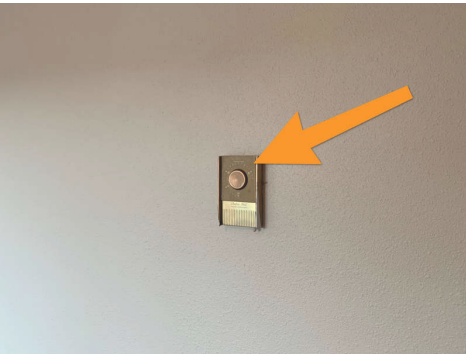
4.2.1 Thermostats

THERMOSTAT IS LOOSE

The thermostat is loose on the wall, which could affect its function, and it should be serviced as necessary by a qualified technician

Recommendation

Contact a qualified handyman.

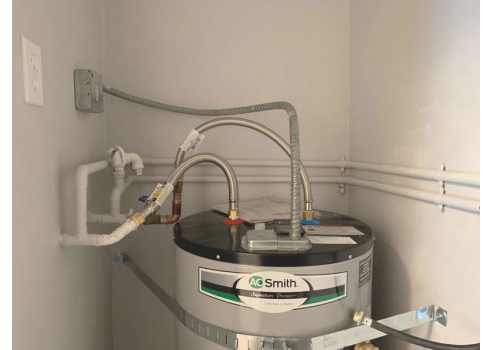
A thermal expansion tank was not installed. We recommend installation

Recommendation

Contact a qualified professional.

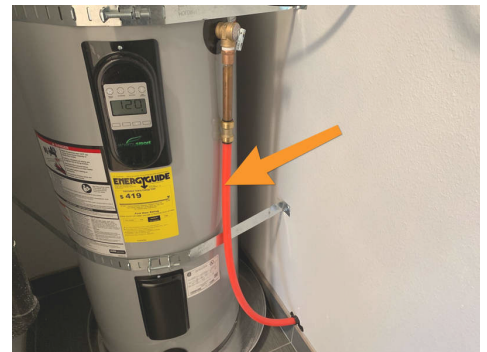
5.1.2 Water Heating System

The discharge pipe from the relief valve includes a flexible line and should be replaced with a solid copper discharge pipe. This is because flexible lines can become kinked and possibly prevent the relief valve from working properly in the event it needs to release temperature or pressure and may cause a dangerous situation.

Recommendation

Contact a qualified plumbing contractor.

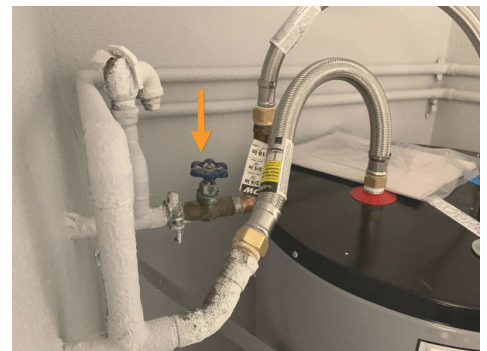
5.1.3 Water Heating System

The water heater shut off valve is an older style and less reliable gate type valve. These valves are known to get stuck in place from lack of use and can eventually stop working or begin leaking over time. I recommend evaluating this valve and having it serviced or replaced as you feel necessary.

Recommendation

Contact a qualified plumbing contractor.

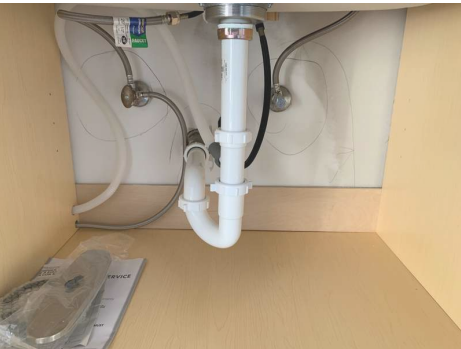
Under Sink Photos

The presence of seller's items limited our view of the cabinet and plumbing below the sink.

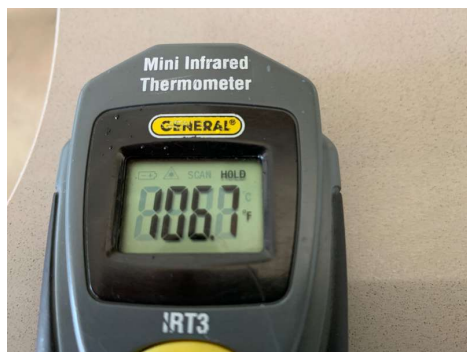
Sink and Faucet: Water temp

The Water temp at the Kitchen Faucet is Currently noted in the photo below. The U.S. Consumer Product Safety Commission (CPSC) urges all users to keep their water heater temps at 120 degrees Fahrenheit to prevent scalding and bacteria prevention reasons.

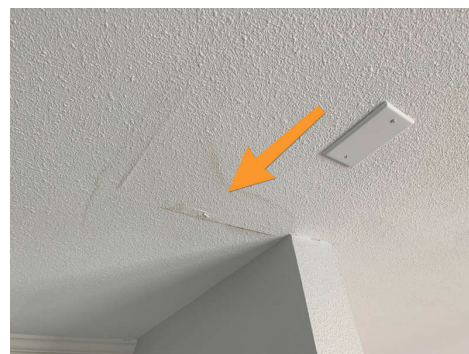
SMALL MOISTURE STAIN ON THE CEILING

There is a small moisture stain on the ceiling that should be further evaluated and serviced as necessary. I recommend at least locating and correcting the leak source and repairing affected areas as necessary.

Recommendation

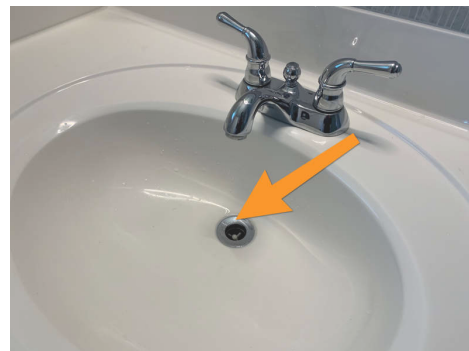
Master bathroom sink

The sinkstopper does not work properly and repair is recommended.

Recommendation

Contact a qualified handyman.

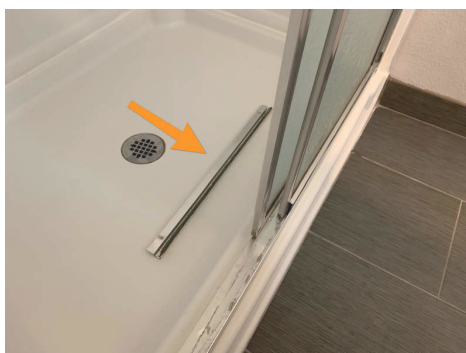
8.4.1 Tub-Shower

SHOWER DOOR IN NEED OF REPAIR

The shower door is in need of repair. Recommend repairs.

Master bathroom shower

Recommendation

Contact a qualified professional.

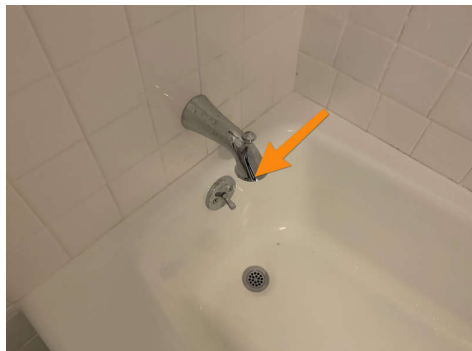
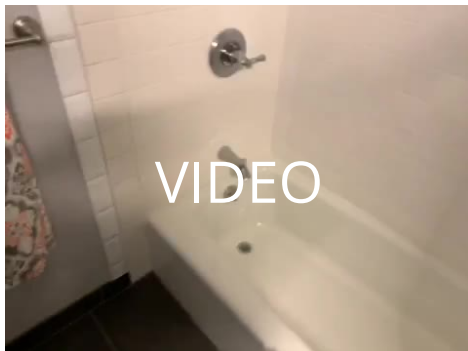
8.4.2 Tub-Shower

In the master bathroom the water temperature at the tub/shower is___ and may be low for a warm shower. Its lower than at the faucet. A temperature limit stop most likely needs to be adjusted and you may want it turned up or the shower repaired by a licensed plumber.

Recommendation

Contact a qualified plumbing contractor.

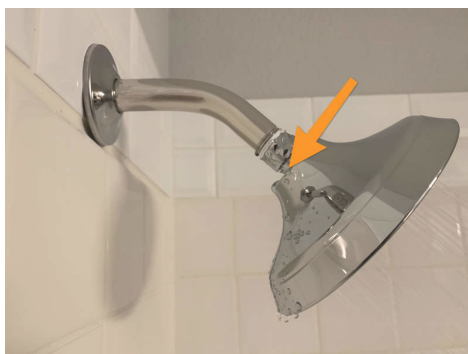
8.4.3 Tub-Shower

SHOWER HEAD LEAK

The shower head leaked at the base of the head or hose. The joint should be tightened or sealed to prevent leakage.

Recommendation

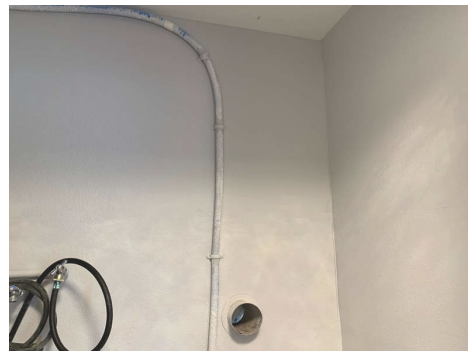
Medium Priority**NO EXHAUST FAN OR OPENABLE WINDOW**

There is not a laundry exhaust fan or openable window installed within this laundry room. Adding one is recommended and typically required to help disperse excessive moisture from the laundry room.

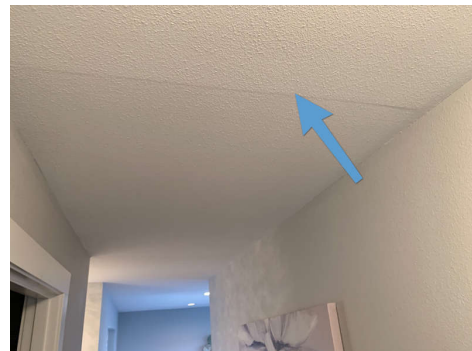
Hallway

TYPICAL SETTLEMENT CRACKING/NAIL POPS

Observed typical settlement type cracking and nail pops on walls and ceilings. Recommend repairs as needed. Home owner to identify all areas for repair.

Recommendation

Recommend monitoring.
