SUPREME INSPECTIONS LLC

RESIDENTIAL INSPECTION REPORT (SAMPLE)

Oklahoma OK 12345

DECEMBER 31, 2020

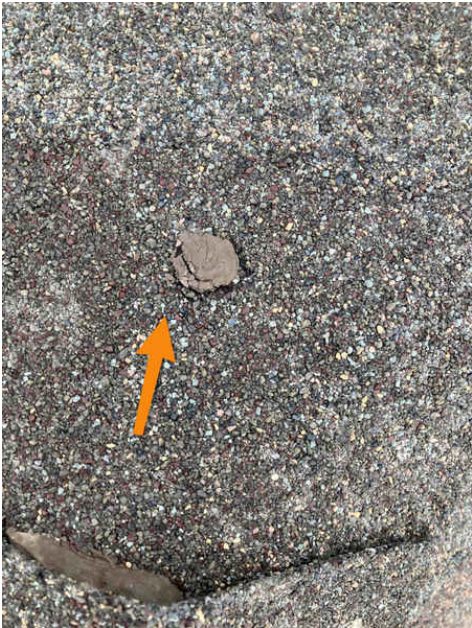
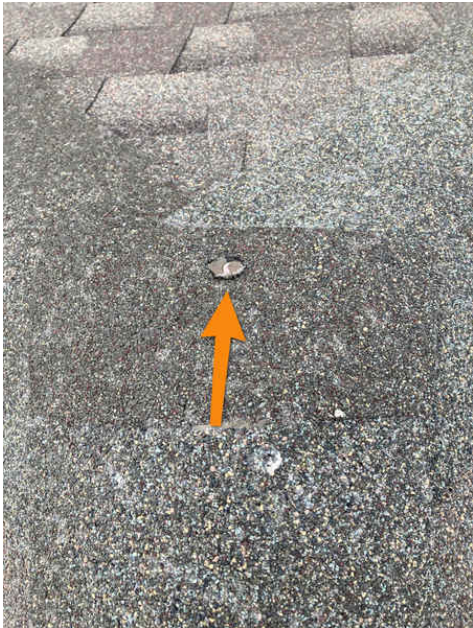
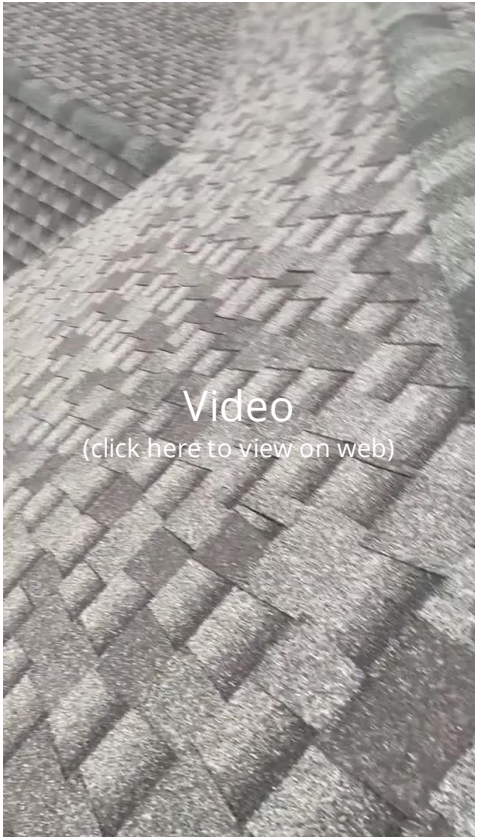
The inspector recommends to consult a qualified contractor to properly seal and correct the issue observed at the time of inspection.

Contact a qualified professional.

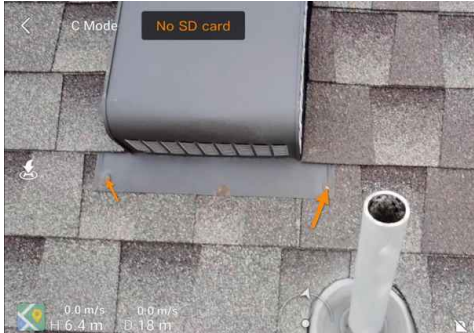
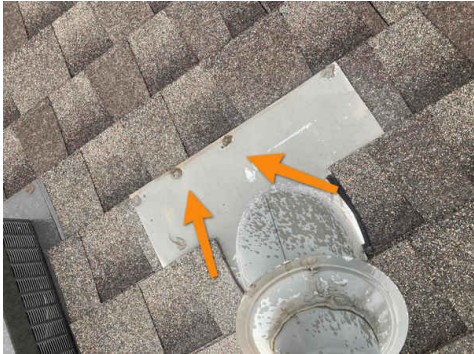
2.2.2 Flashing

LOOSE FLASHING

Major Defect

Loose flashing was observed in this area. Loose flashing can cause roof leaks in these areas. All flashing is supposed to be water-tight or designed to divert water away from certain areas.

The inspector recommends the proper installation of flashing by a qualified roofing contractor.

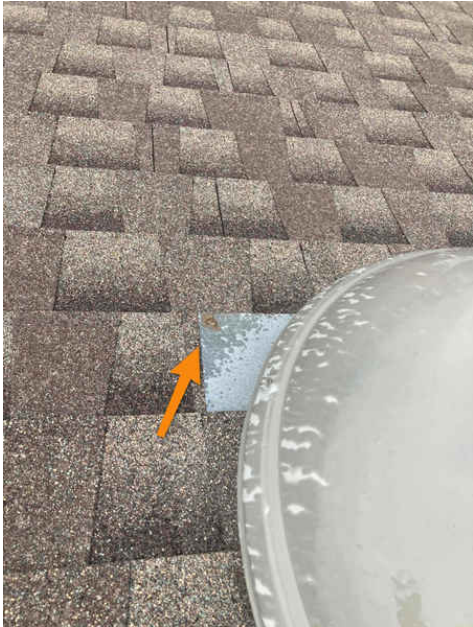
2.2.1 Flashing

EXPOSED FASTENERS (FLASHING)

The flashing had nails visible that increase the chances of roof leakage with the potential for damage to home materials or the roof structure. The inspector recommends application of a sealant at these fasteners.

Contact a qualified professional.

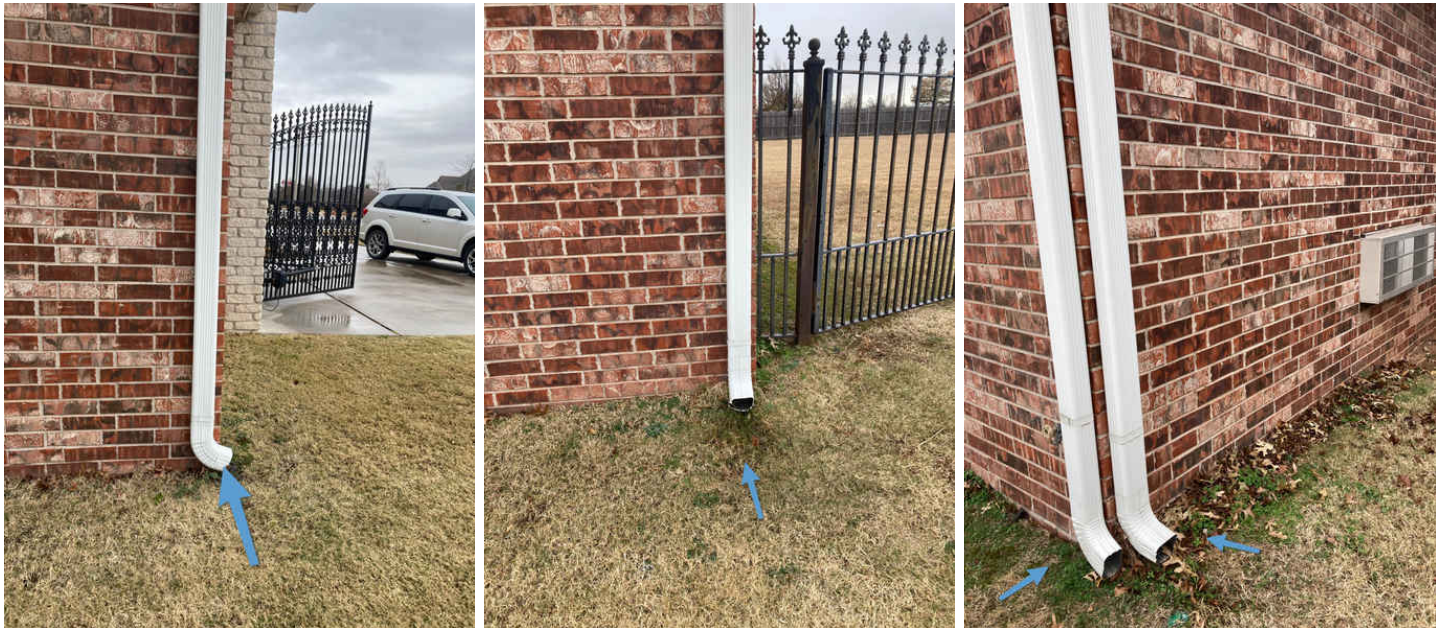
2.5.1 Gutters & Downspouts

One or more downspouts discharged roof drainage next to the foundation.

This condition can result in excessively high moisture levels in soil at the foundation and can cause damage related to soil/foundation movement. Excessive moisture levels in soil near the foundation can effect the ability of the soil to support the weight of the structure above and can cause damage related to soil/foundation movement.

The Inspector recommends the installation of downspout extensions to discharge roof drainage a minimum of 6 feet from the foundation.

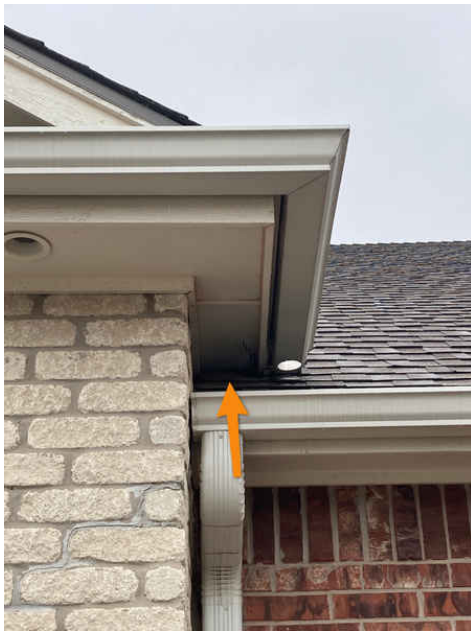
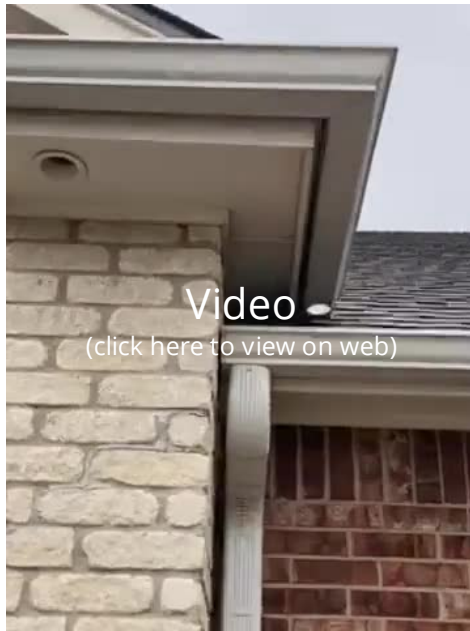
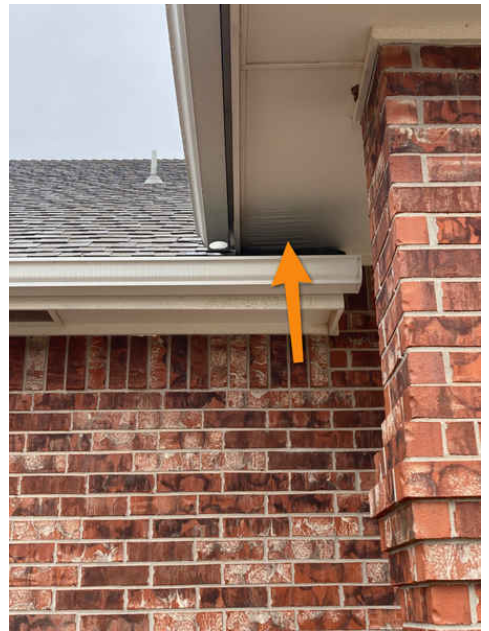
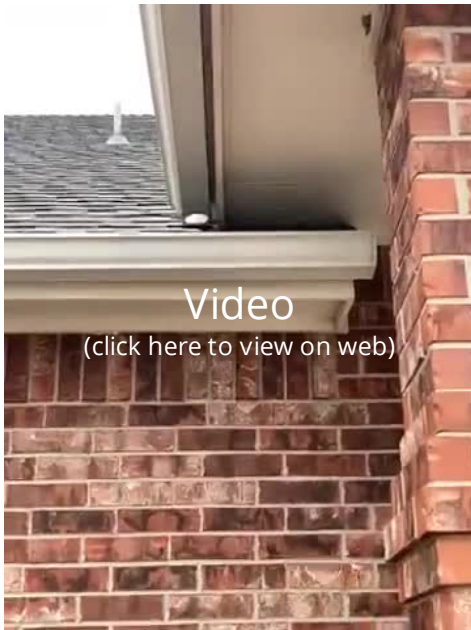
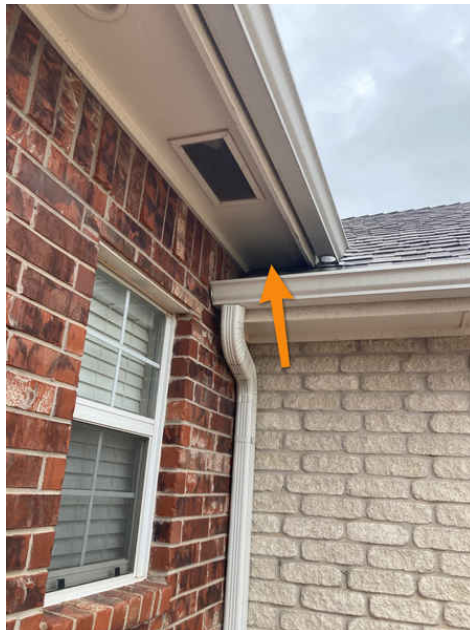
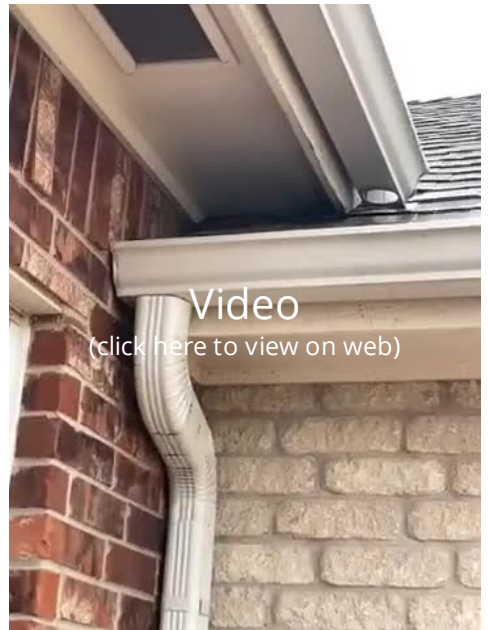
DAMAGE OBSERVED AT SOFFIT

I observed indications that one or more areas of the soffit were damaged.

Correction is recommended.

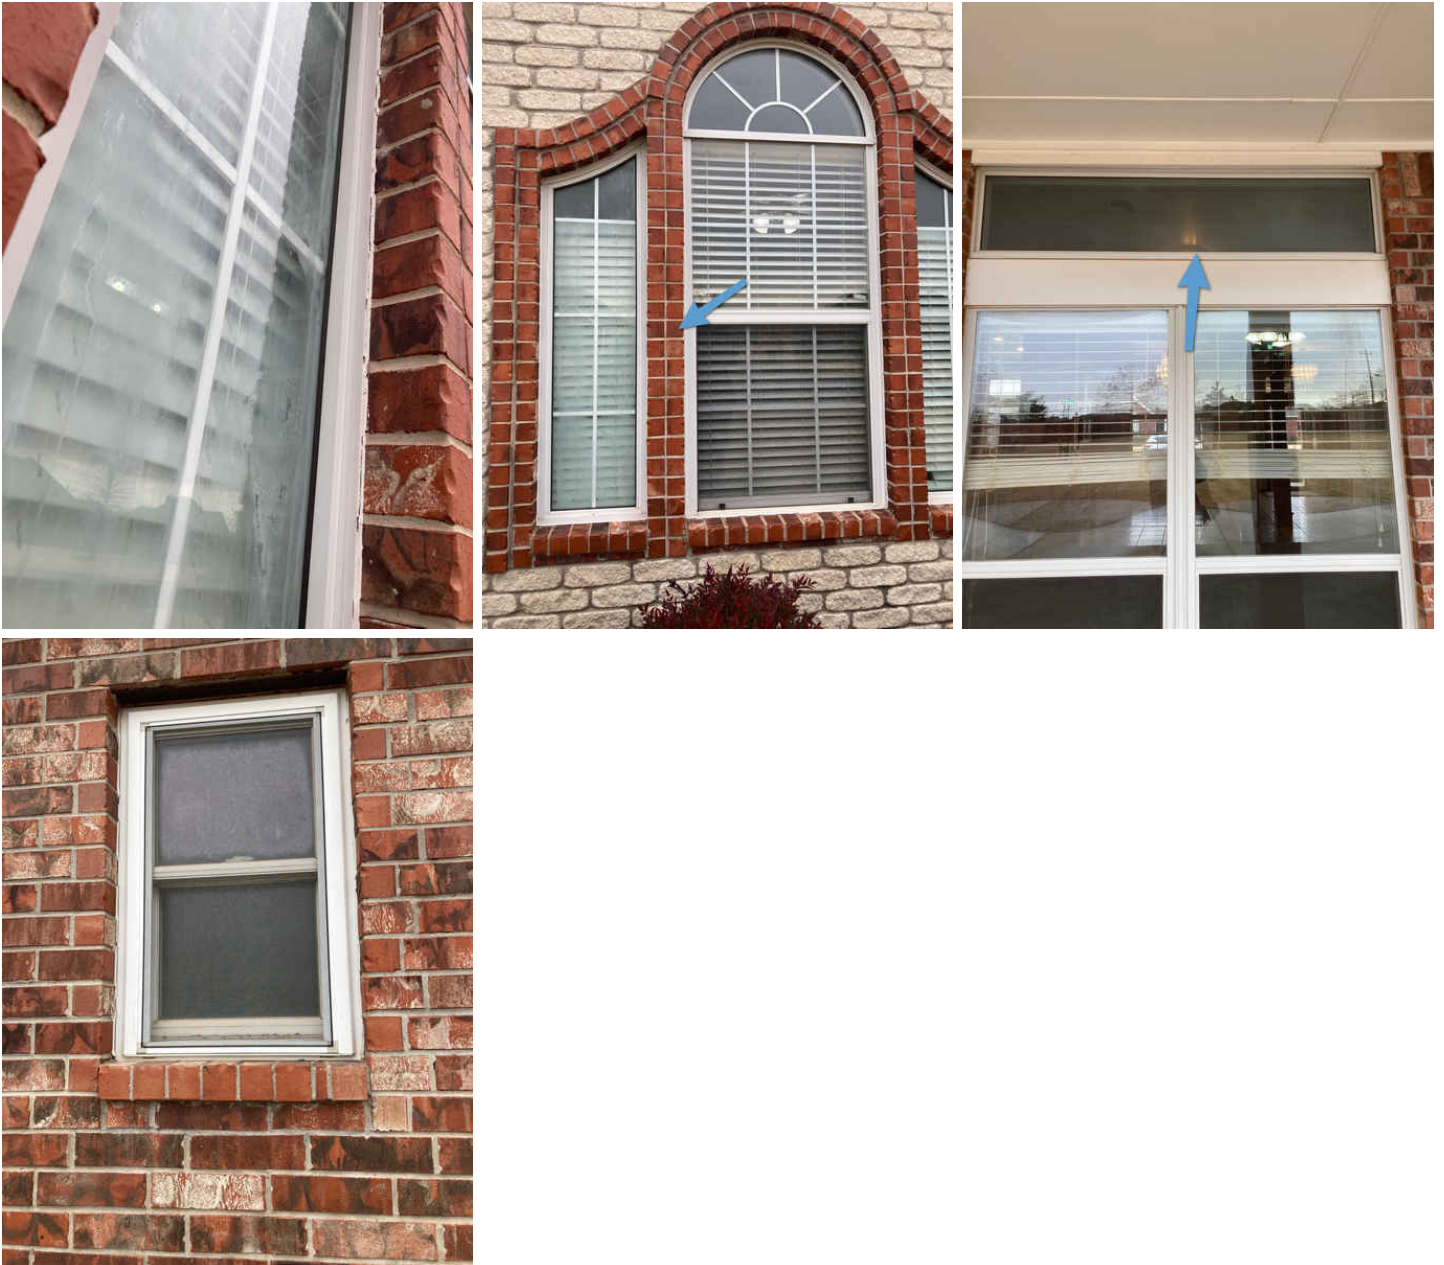
3.4.1 Windows

FOGGED WINDOWPANE

I observed a fogged windowpane (a lost seal) at a window.

If multiple-pane windows appear misty or foggy, it means that the seal protecting the window assembly has failed, and condensation has formed in between the two panes of glass. Condensation in double-paned windows indicates that the glazing assembly has failed and needs repair or replacement. Visible condensation can damage glazing and is the main indication of sealant failure. Condensation is not always visible. If the failure is recent, a failed window may not be obvious, since condensation doesn't usually form until the window is heated by direct sunlight. Windows in the shade may show no evidence of failure, so it is nearly impossible to observe and report all failed double-paned windows.

Contact a qualified window repair/installation contractor.

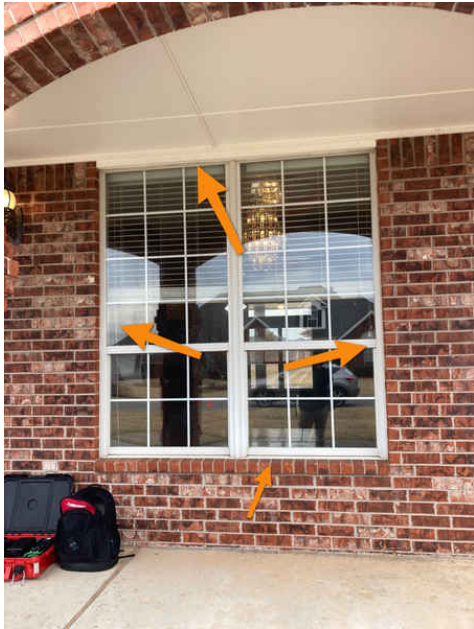
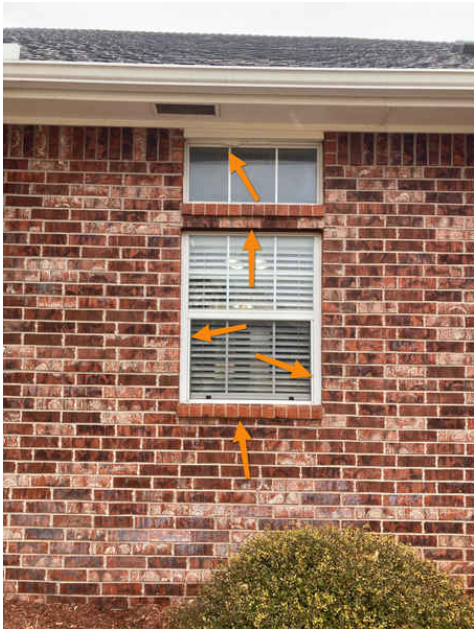
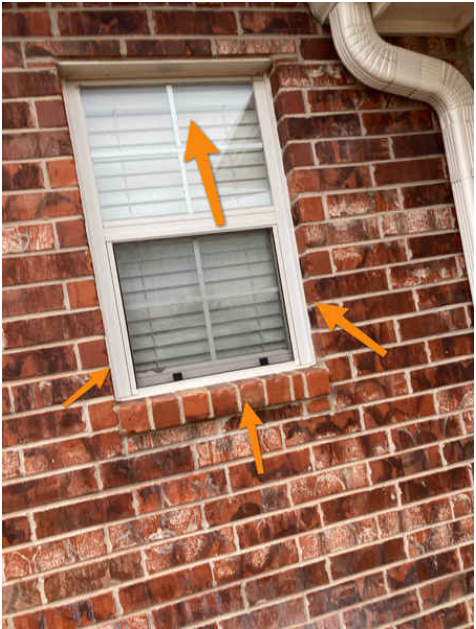
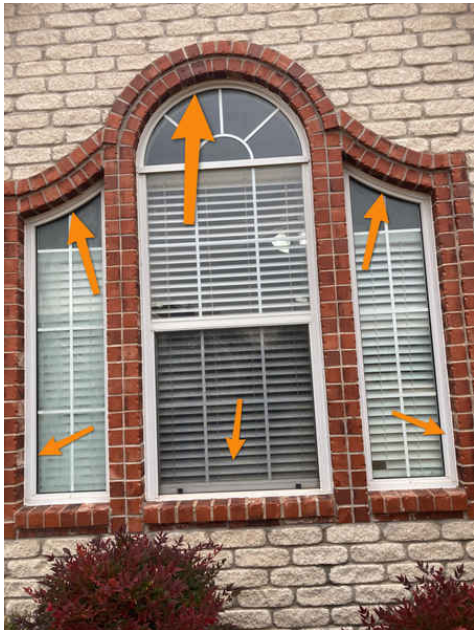
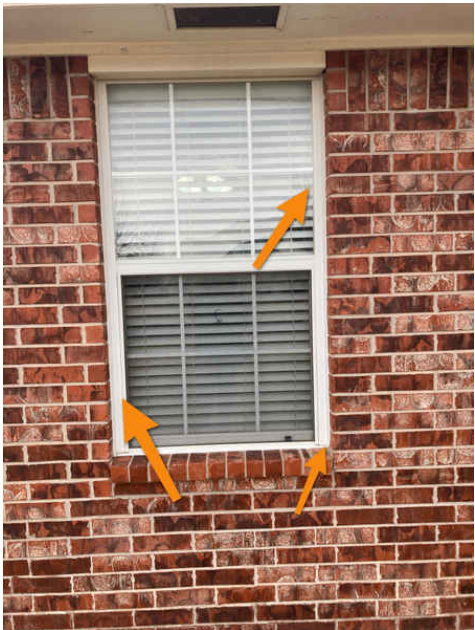
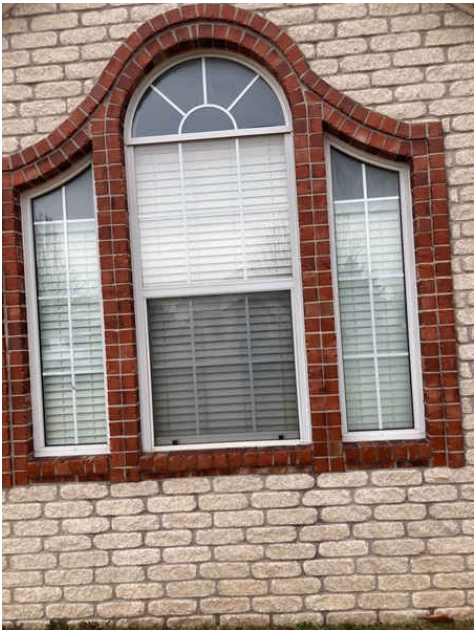
3.4.2 Windows

SEALANT MAINTENANCE

Sealant around windows was old, discolored, cracked, and needed maintenance to avoid potential moisture intrusion.

The Inspector recommends maintenance be performed by a qualified contractor.

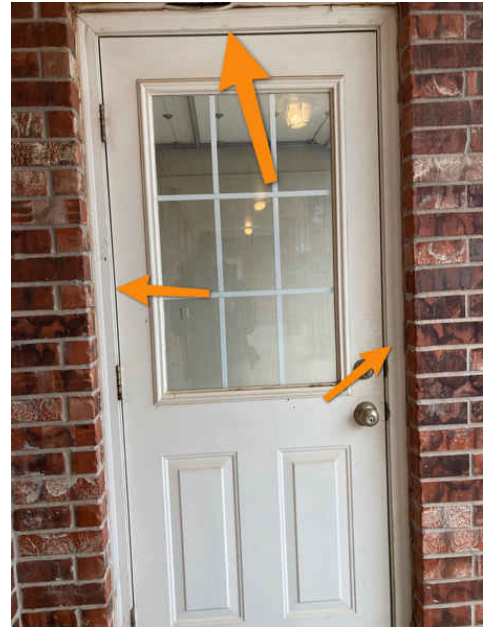
3.5.1 Exterior Doors

SEALANT MAINTENANCE

Sealant around doors was old, discolored, cracked, and needed maintenance to avoid potential moisture intrusion. The Inspector recommends maintenance be performed by a qualified contractor.

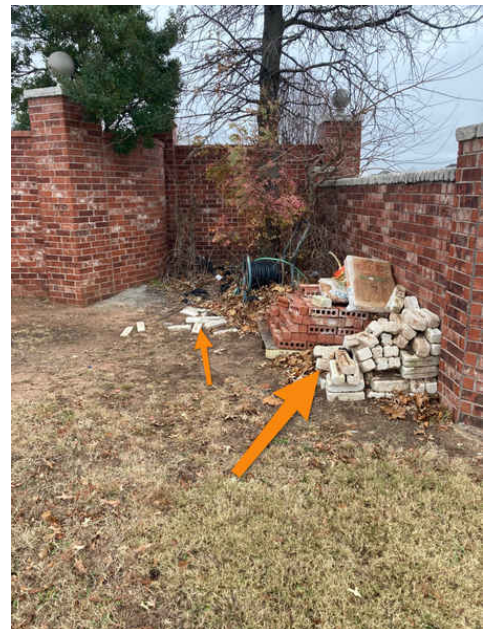
3.8.1 Vegetation, Surface Drainage, Retaining Walls & Grading

DEBRIS

I observed dense debris around the house in areas. This condition limited and restricted my visual inspection. Dense vegetation and debris up against or near the fence foundation and exterior walls may be prone to water penetration and insect infestation.

Removal is recommended.

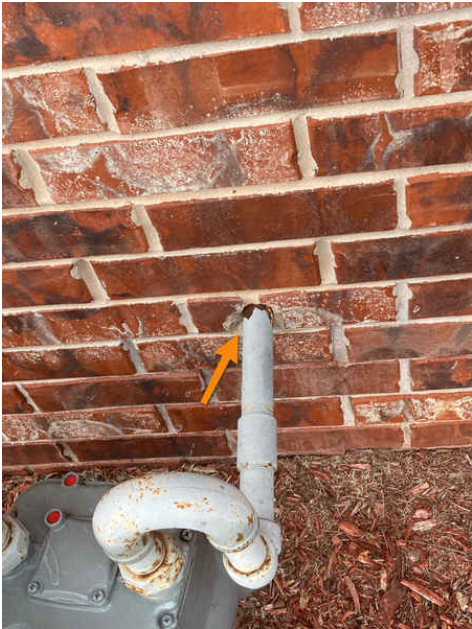
3.14.1 Wall Penetrations

SEAL PENETRATIONS

Pipes penetrating exterior walls left gaps that needed to be sealed with an appropriate sealant to prevent moisture and insect entry.

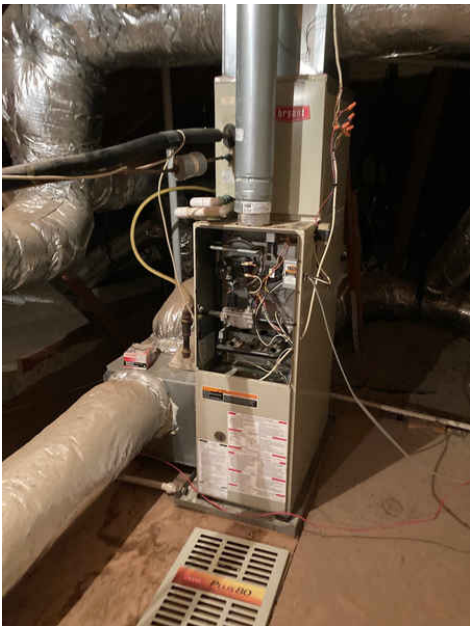
(Garage Furnace) Cover was off before the inspection

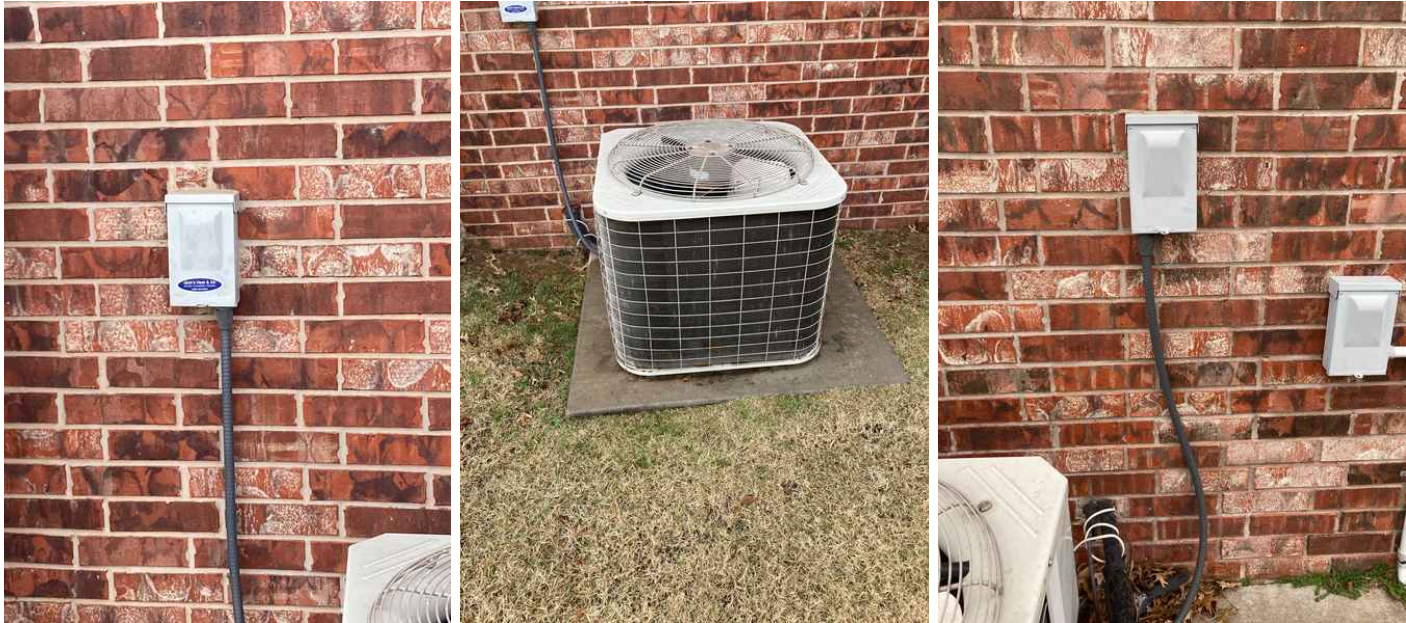
Cooling System Information: Service Disconnect Inspected

I observed a service disconnect within sight of the cooling system.

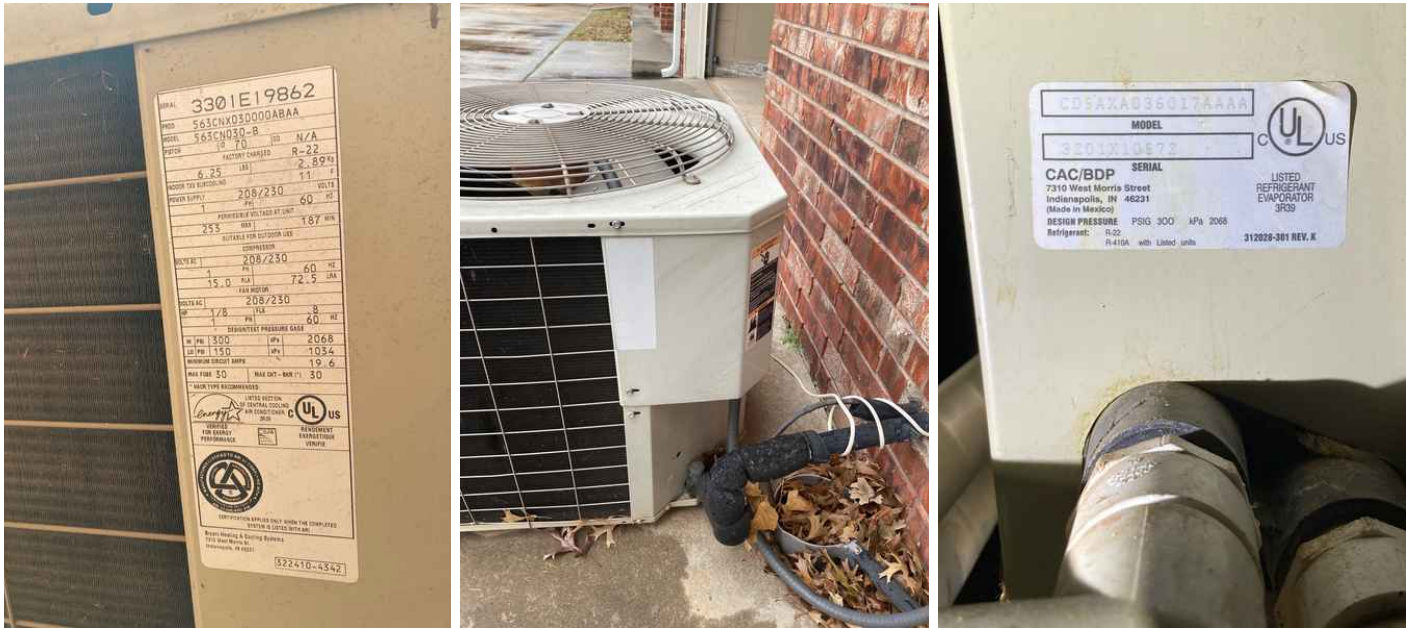
Cooling System Information: A/C System Estimated Age (Compressor)

10-20 yrs

*These are only estimates on the age of the system.

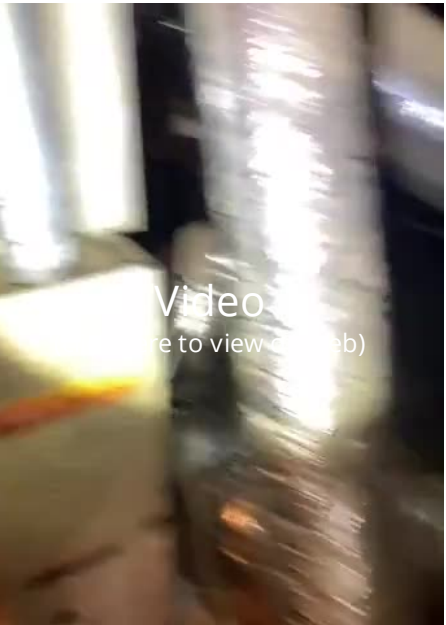
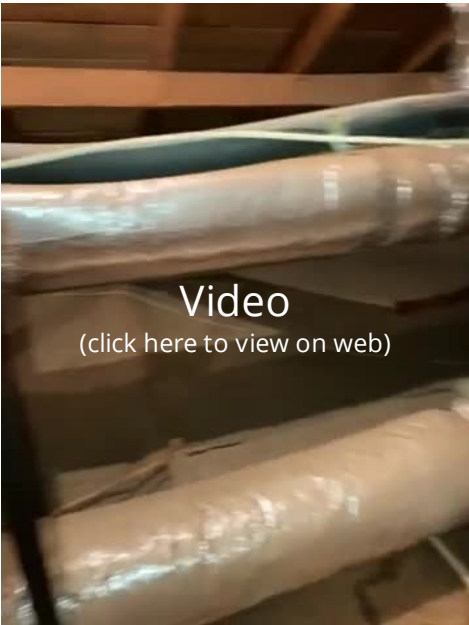
Ductwork: Ductwork Installed
Insulated

I observed ductwork in the house. Air conditioning (cooling) systems, including heat pump systems, use ductwork to distribute the cooled, conditioned air throughout the house. I will attempt to determine if the each room has a cooling source or conditioned-air supply, but I may not be able to find every duct register.

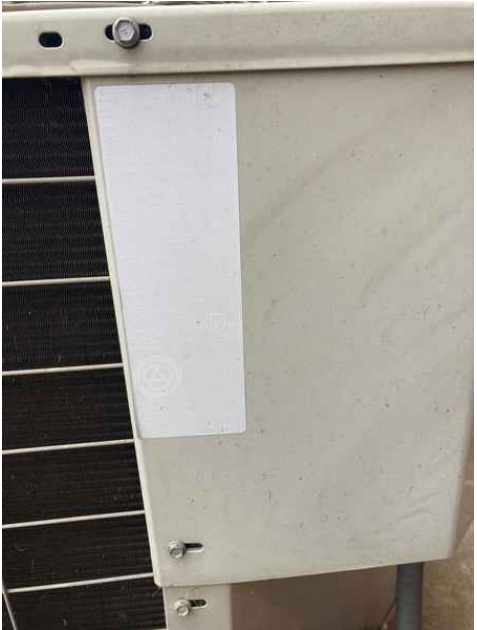
LABEL WORN OUT

I observed that the manufacturing label on the system was worn out and illegible. This is an indication of old age.

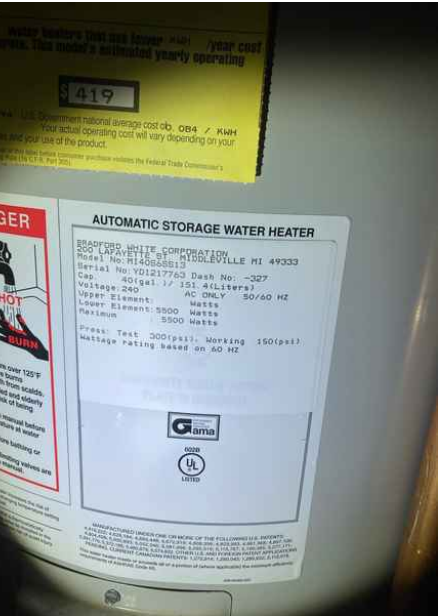
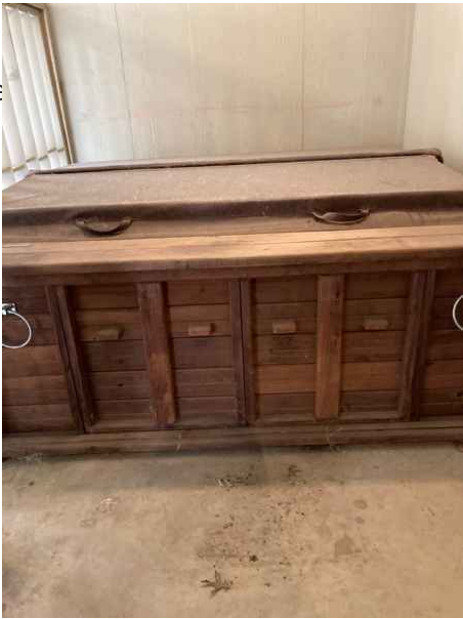
Hot Water Source: Estimated Age of Hot Water Tank
5-10yrs

*These are only estimates on the age of the system.

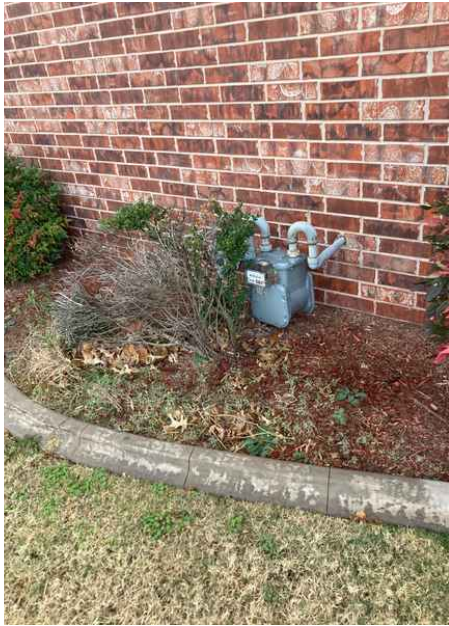
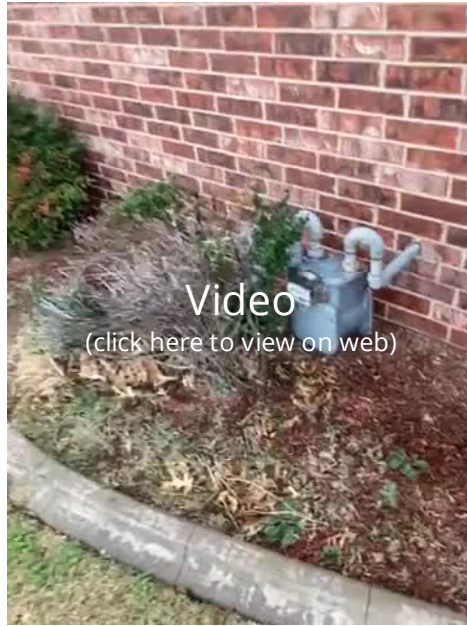
Main Fuel Supply Shut-Off Valve: Location of Main Shut-Off Valve

Side of House

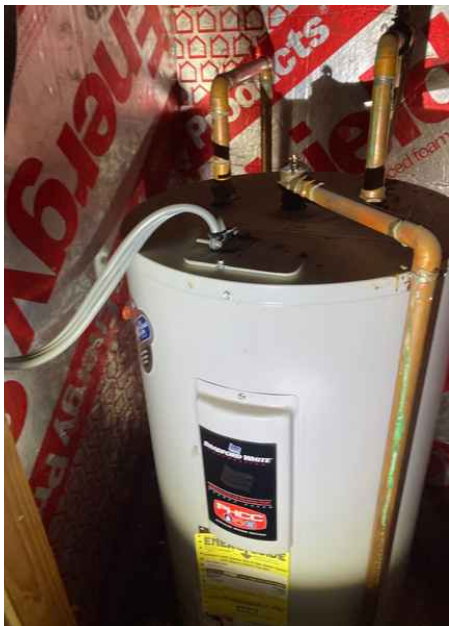
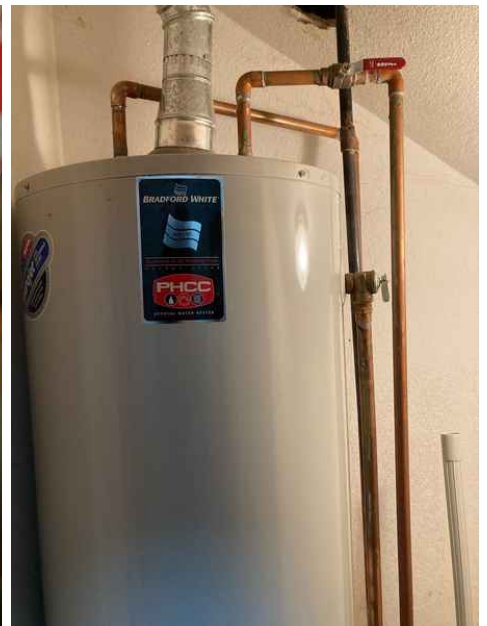
Hot Water Source: Type of Hot Water Source

Electric Hot Water Tank, Gas-Fired Hot Water Tank

I inspected for the main source of the distributed hot water to the plumbing fixtures (sinks, tubs, showers). I recommend asking the homeowner for details about the hot water equipment and past performance.

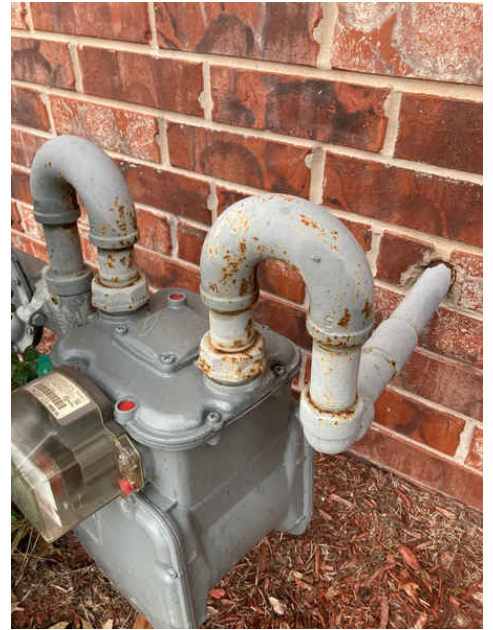
MINOR RUST AT METER

I observed some minor surface rust at the gas meter components. Monitoring recommended.

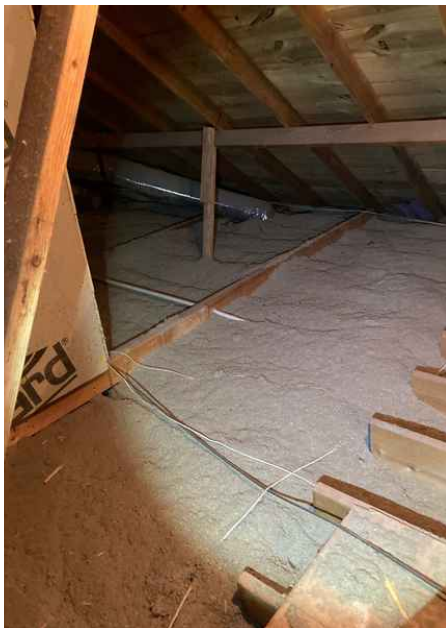
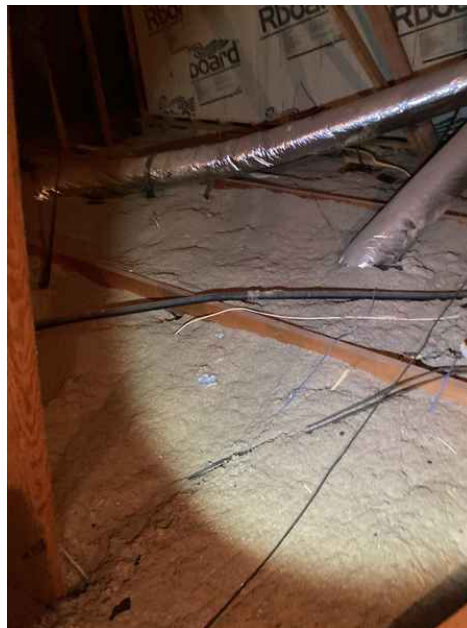
Insulation in Attic: Type of Insulation Observed

Loose Fill

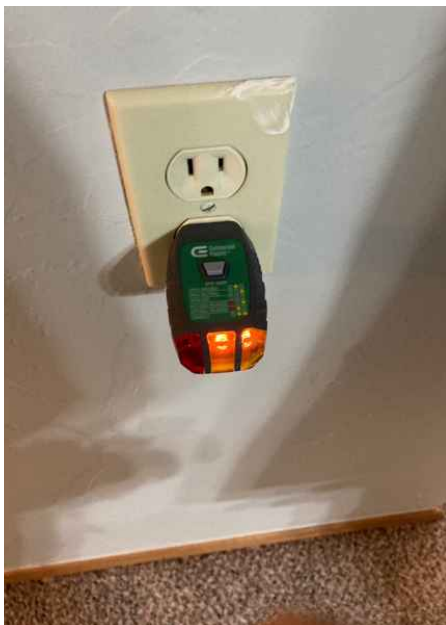
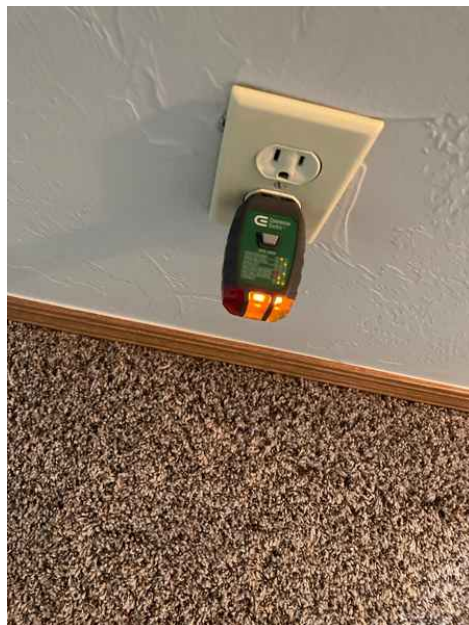
Switches, Fixtures & Receptacles: Inspected a Switches, Fixtures & Receptacles

I inspected a representative number of switches, lighting fixtures and receptacles.

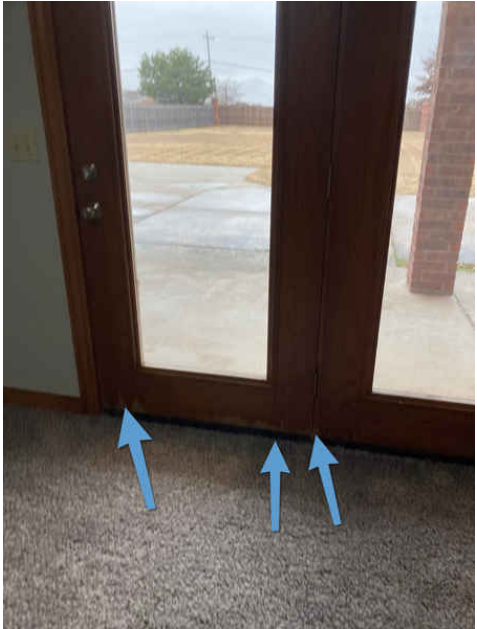
DETERIORATION

Minor Deterioration and an air gap on the door was observed at the time of the inspection. Correction and further evaluation is recommended.

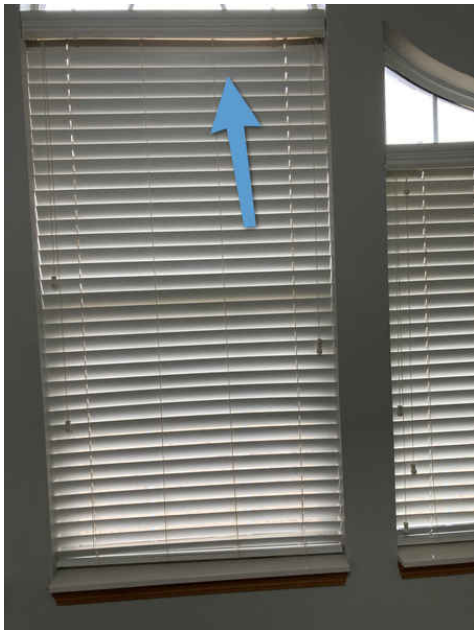
13.2.1 Windows

The blinds to these windows were not functional at the time of the inspection. Correction and further evaluation is recommended.

Recommendation
Contact a qualified professional.

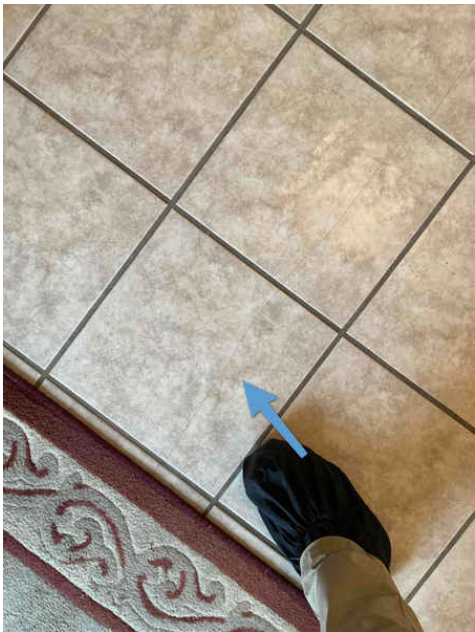
TILES CRACKING (MODERATE)

Minor cracks were observed on the floor tiles at the time of inspection.

Recommendation
Contact a qualified professional.

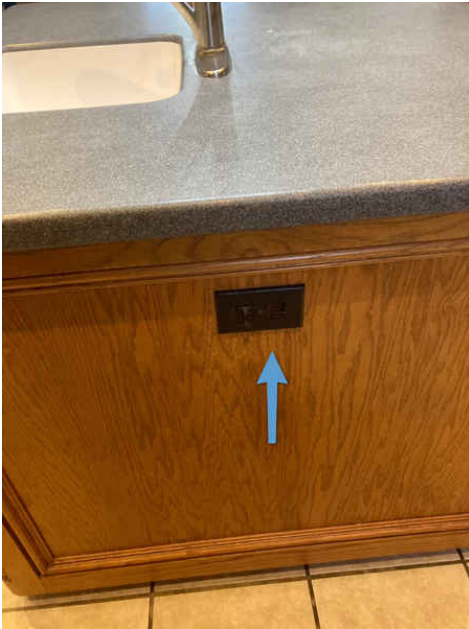
13.6.1 Switches, Fixtures & Receptacles

POWER NOT PRESENT AT RECEPTACLE

I observed indications that power was not present at a receptacle.
(Kitchen Island)

Recommendation
Contact a qualified electrical contractor.

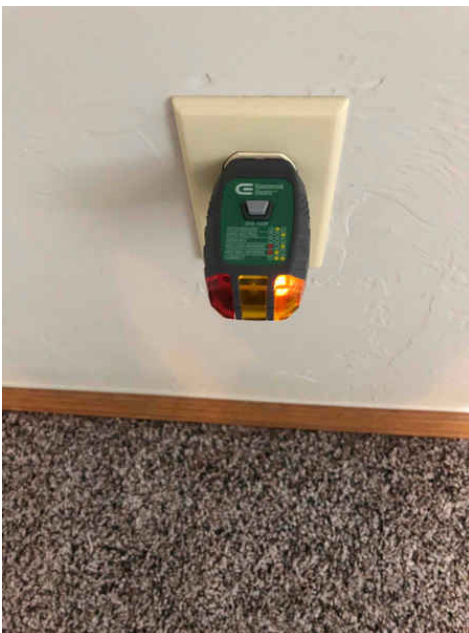
13.6.2 Switches, Fixtures & Receptacles

Major Defect**OPEN NEUTRAL**

An **open neutral outlet** is an **outlet** with a loose or missing **neutral** wire. The **neutral** wire is important because it completes a circuit by returning electricity back to the source. **Open neutral** outlets can allow an electrical device to store excess electricity potentially electrocuting someone that touches the device.

Correction and further evaluation is recommended.

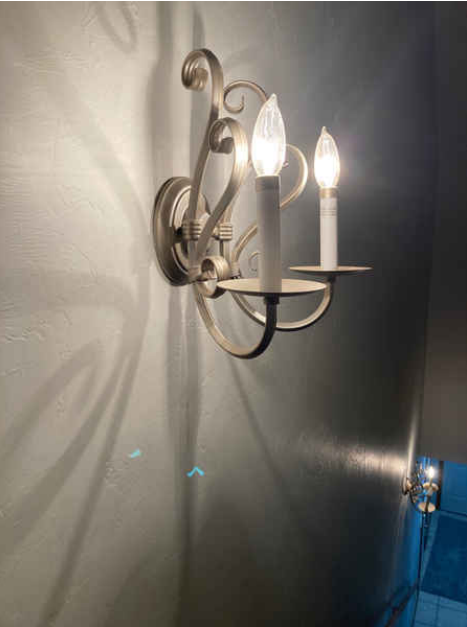
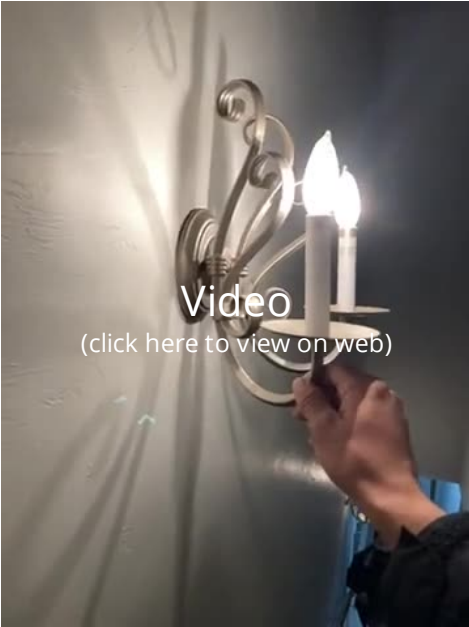
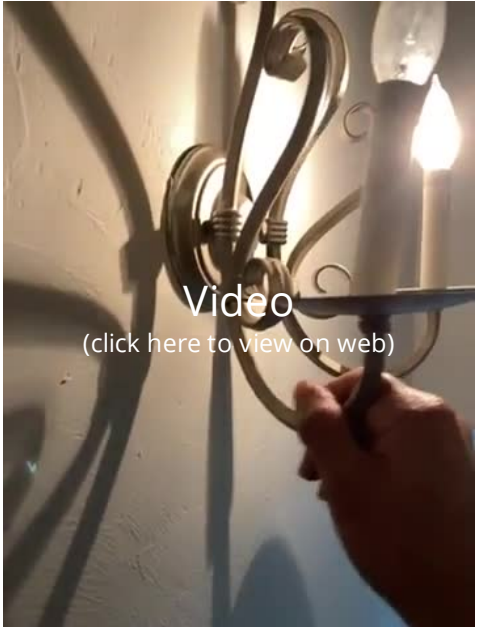
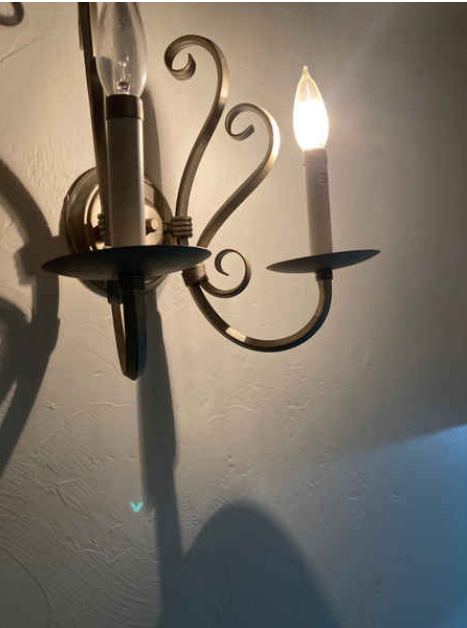
13.8.1 Lighting

LOOSE FIXTURE

The light fixtures going up the stairs were loosely attached at the time of inspection. Correction and further evaluation is recommended.

Contact a qualified professional.

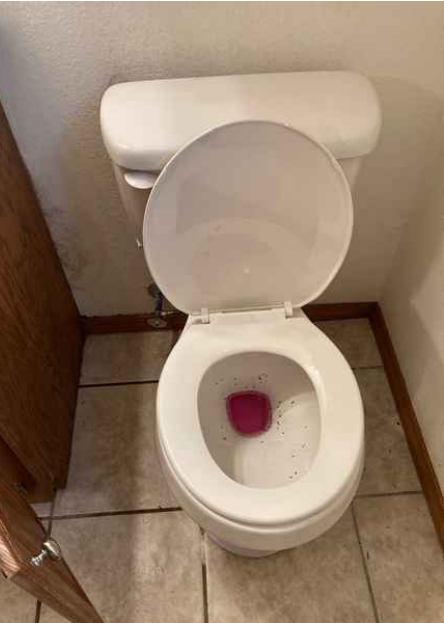
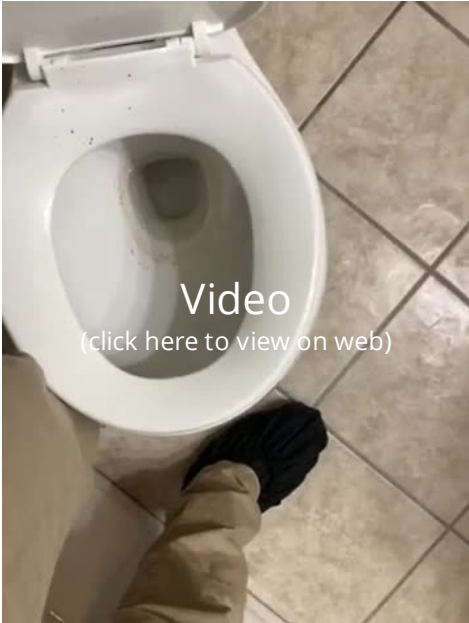
Bathroom Toilets: Toilets Inspected

I flushed all of the toilets.

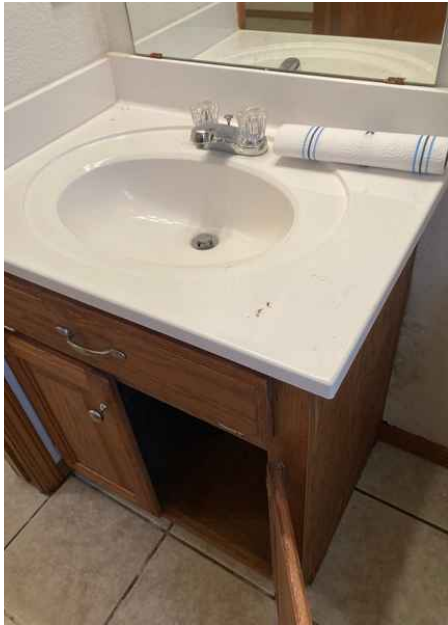
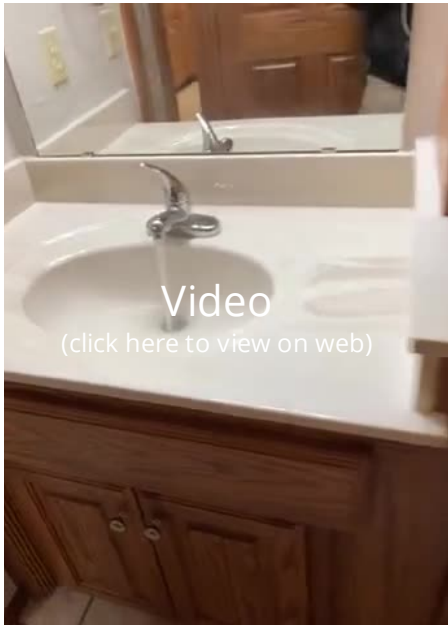
Sinks, Tubs & Showers: Ran Water at Sinks, Tubs & Showers

I ran water at all bathroom sinks, bathtubs, and showers. I inspected for deficiencies in the water supply by viewing the functional flow in two fixtures operated simultaneously.

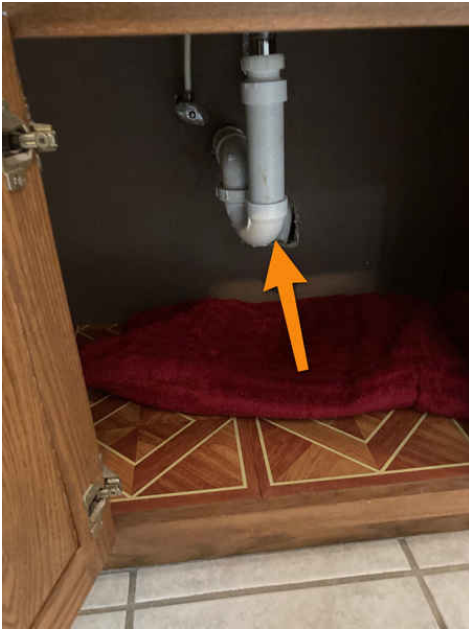
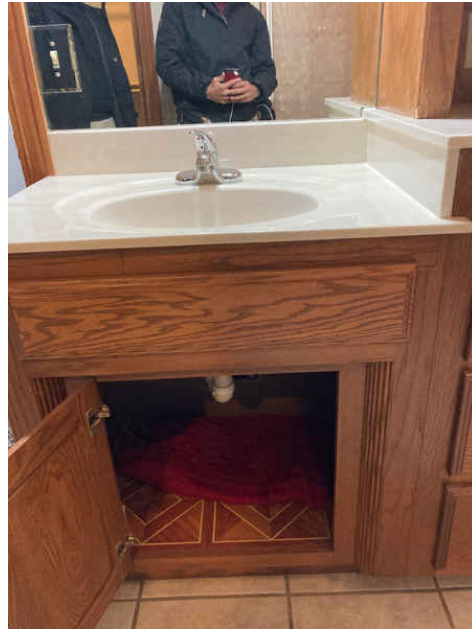
ACTIVE WATER LEAK

I observed indications of an active water leak.

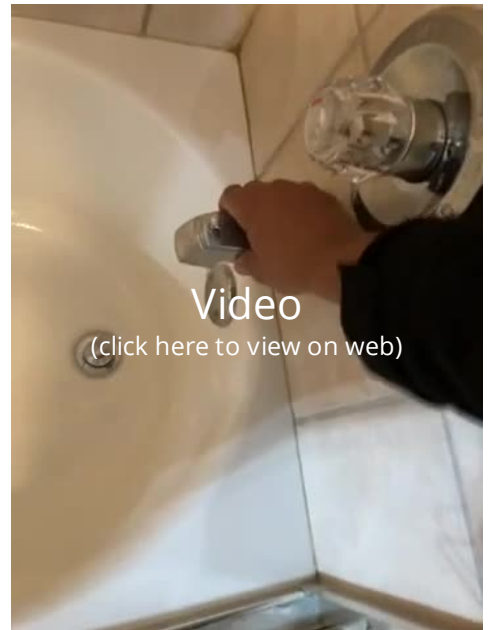
14.3.2 Sinks, Tubs & Showers

LOOSE FIXTURE

I observed indications that the fixture is loose. Not secure. Not installed properly. Loose.

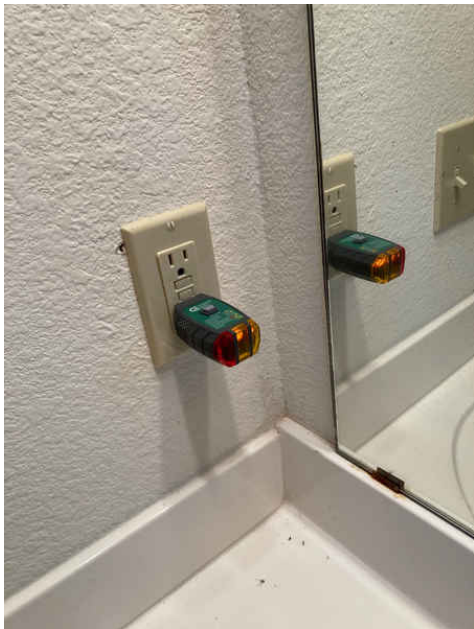
14.5.1 GFCI & Electric in Bathroom

GFCI NOT TESTING AS FUNCTIONAL

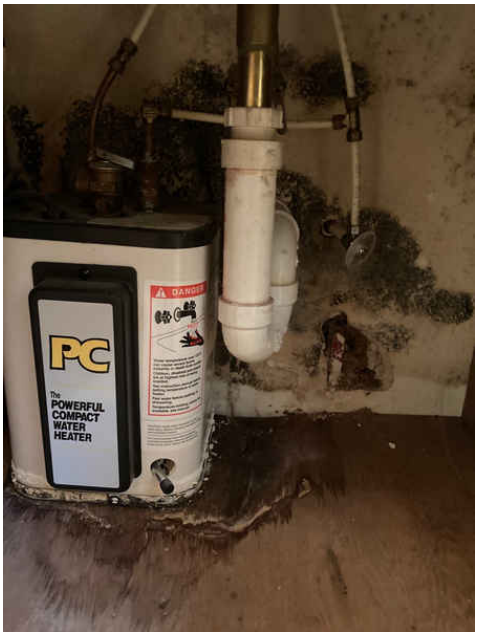
WATER DAMAGE AT CABINET

I observed indications of water damage at the bottom shelf of the bathroom cabinet, under the sink. Indication of a prior water leak.

Recommendation

Recommended DIY Project

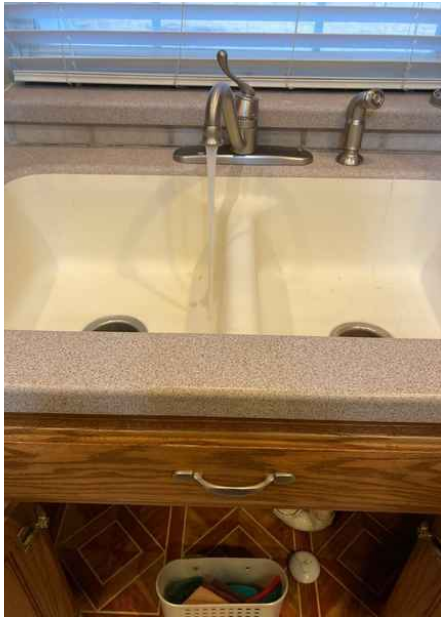
Kitchen Sink: Ran Water at Kitchen Sink

I ran water at the kitchen sink.

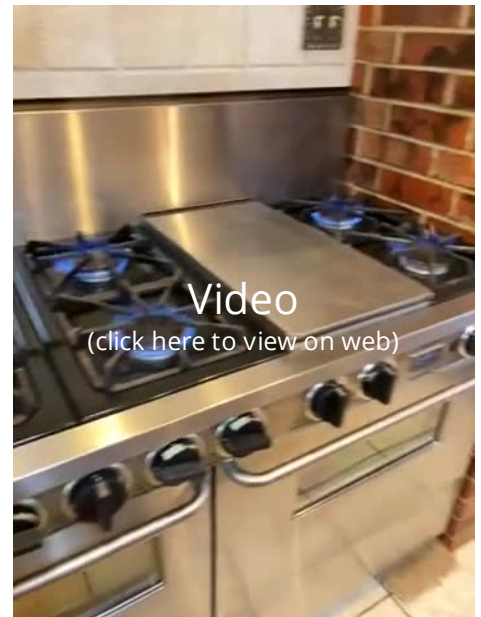
Range/Oven/Cooktop: Turned On Stove & Oven

I turned on the kitchen's stove and oven.
