SUPREME INSPECTIONS LLC

RESIDENTIAL INSPECTION REPORT (SAMPLE)

Oklahoma OK 12345

DECEMBER 31, 2020

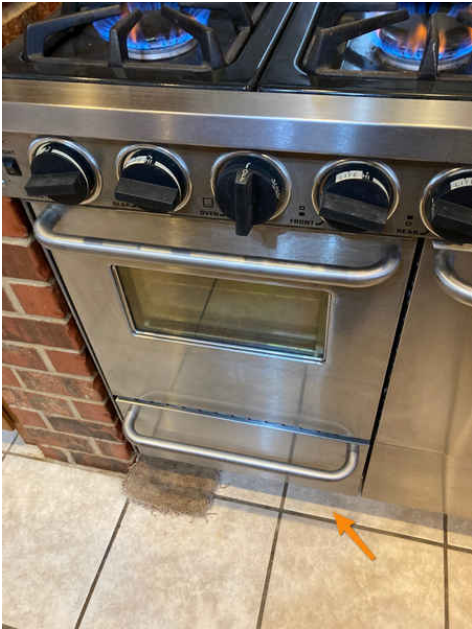
The oven on the left hand side was not operating at the time of the inspection. Correction and further evaluation is recommended.

Recommendation

Contact a qualified professional.

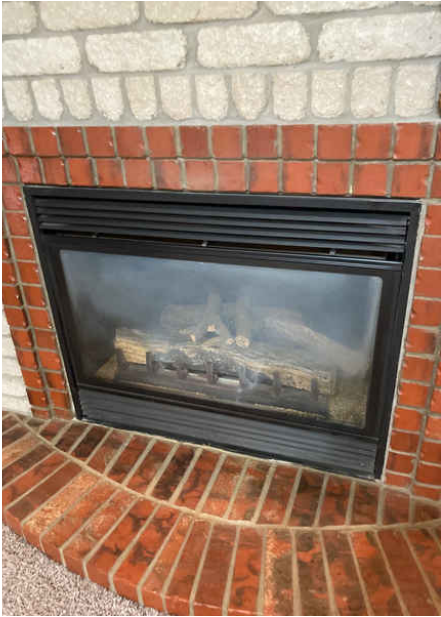
Fireplace Insert

I tried to describe the type of fireplace.
