REDLION HOME INSPECTIONS

## INSPECTION REPORT BY MICHAEL PENDLETON

24 SW 92nd PI  
Oklahoma City OK 73139

Jim Earp  
MAY 11, 2021

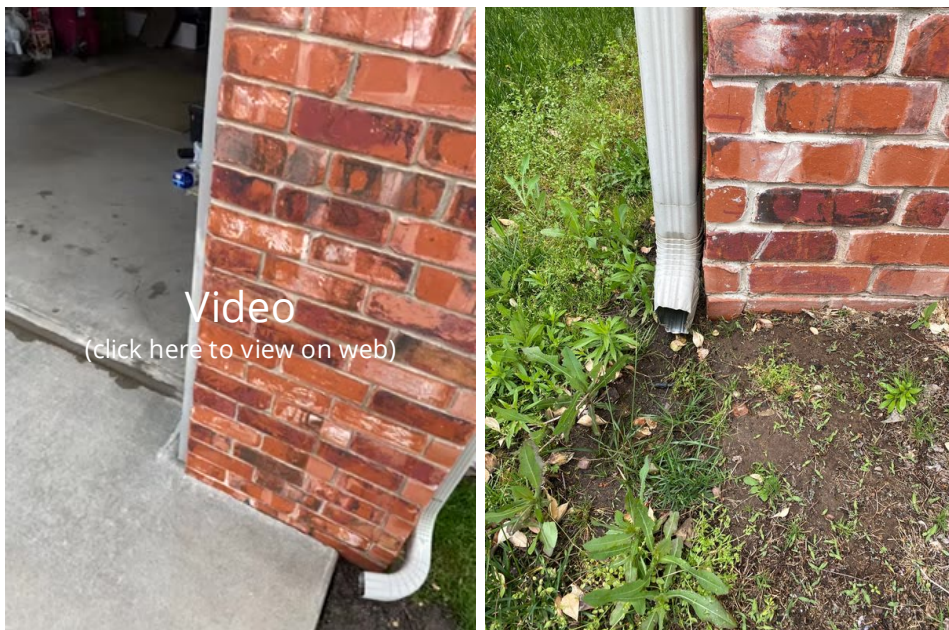
One or more downspouts drain too close to the home's foundation. This can result in excessive moisture in the soil at the foundation, which can lead to foundation/structural movement. Recommend a qualified contractor adjust downspout extensions to drain at least 6 feet from the foundation. A handy homeowner should be able to do this project.

## Recommended DIY Project

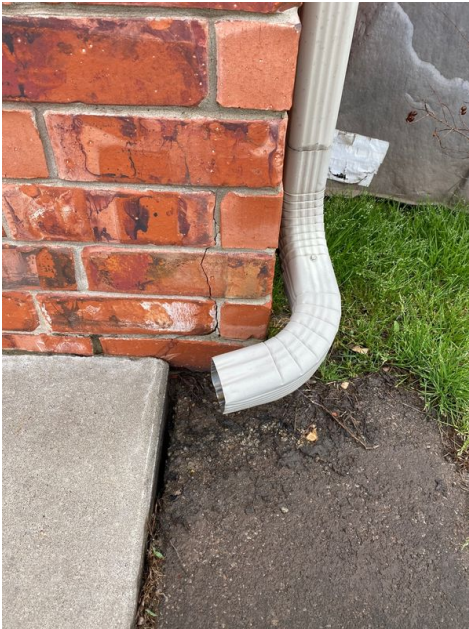
### **CRACKING - MINOR**

Siding showed cracking in one or more places. Recommend monitoring.

Recommended DIY Project

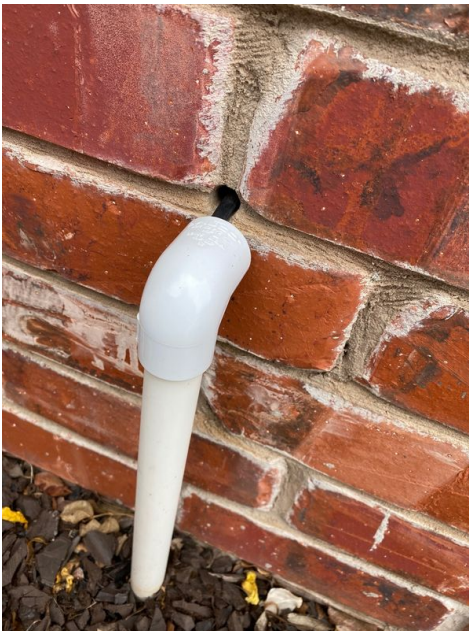
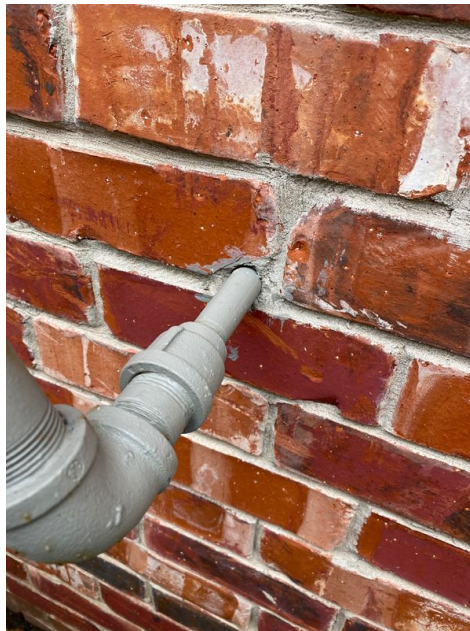
#### 4.3.2 Wall-Covering, Flashing & Trim

### **WALL COVERING PENETRATIONS NOT SEALED**

At the time of inspection, there were penetrations that were not sealed that could lead to moisture penetration and damage. Recommend sealing around the entire penetration.

Recommended DIY Project

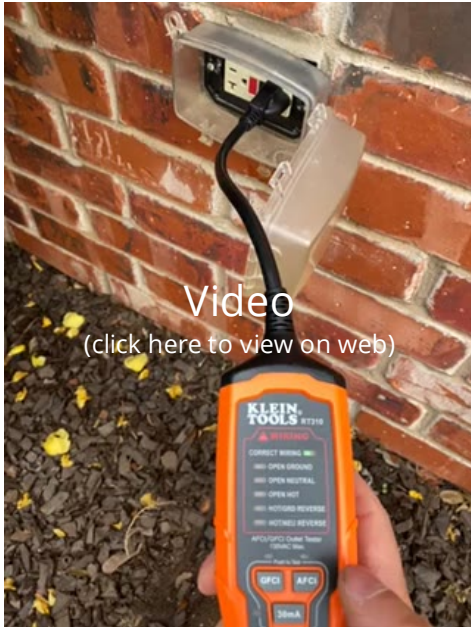
#### 4.5.1 Exterior Outlets

### **IMPROPER INSTALLATION OF GFCI**

I observed indications of improper installation at the GFCI device.

Contact a qualified electrical contractor.

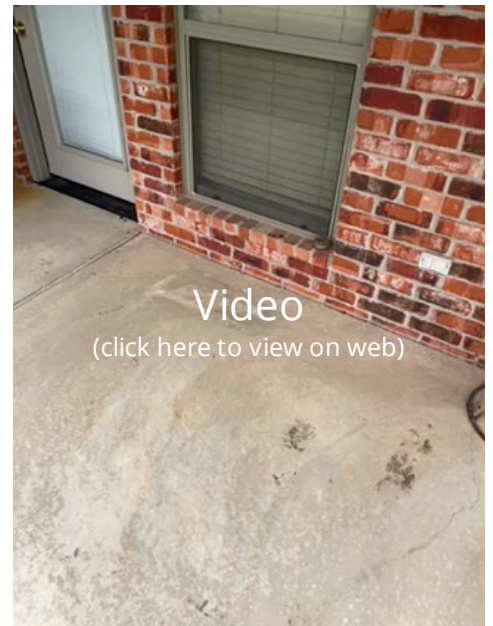
#### 4.6.1 Walkways & Driveways

### MINOR CRACKING AT WALKWAY

I observed minor cracking and no major damage at the walkway.

Monitoring is recommended.

Contact a handyman or DIY project

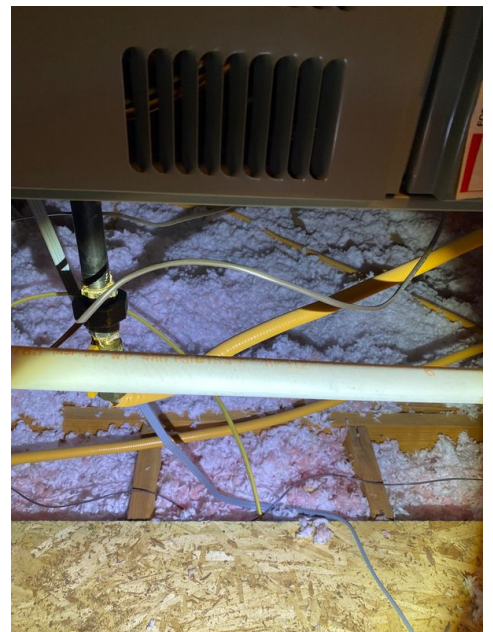
### 6.1.1 Heating System Information

#### **YELLOW CORRUGATED STAINLESS STEEL TUBING PRESENT**

Manufacturers believe the product is safer if properly bonded and grounded as required by the manufacturer's installation instructions. Proper bonding and grounding of the product can only be determined by a licensed electrical contractor. Pursuant to OAC 158:70-1-3

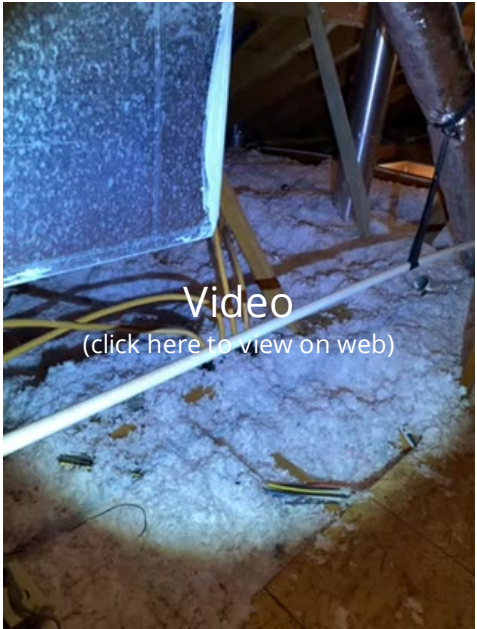
7.3.1 Condensate

**DEFECT AT CONDENSATE**

I observed a defect at the air conditioner's condensate drainage.

Recommended DIY Project

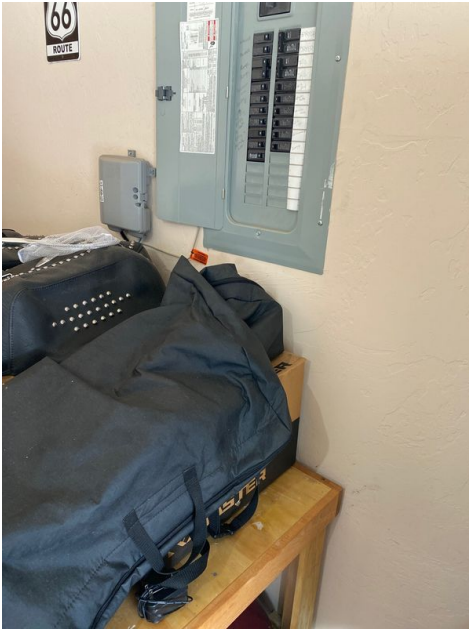
INADEQUATE WORKSPACE AT PANELBOARD

I observed inadequate workspace at the panelboard.

A clear working space for accessing all of the electrical equipment is needed. A clear space that is 3 feet deep, 30 inches wide, and 6' 6" in height should be provided in front of the equipment.

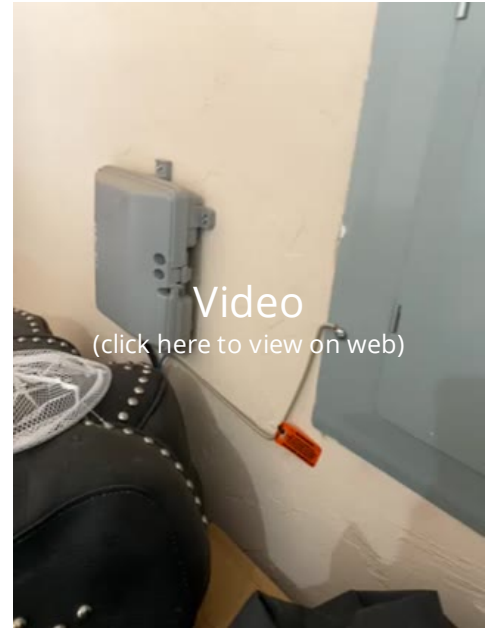
#### **IMPROPER WIRING**

I observed indications of improper wiring. Electrical hazard.

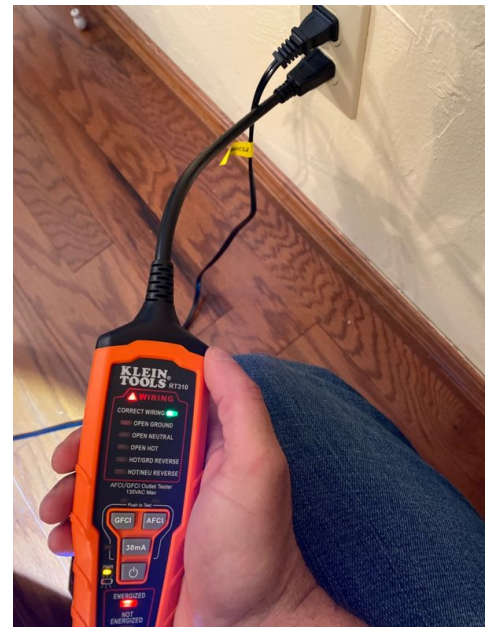
### 9.7.1 AFCIs

#### **MISSING AFCI PROTECTION IN DINING & LIVING ROOMS**

I observed missing AFCI protection for receptacles in the dining and living rooms.

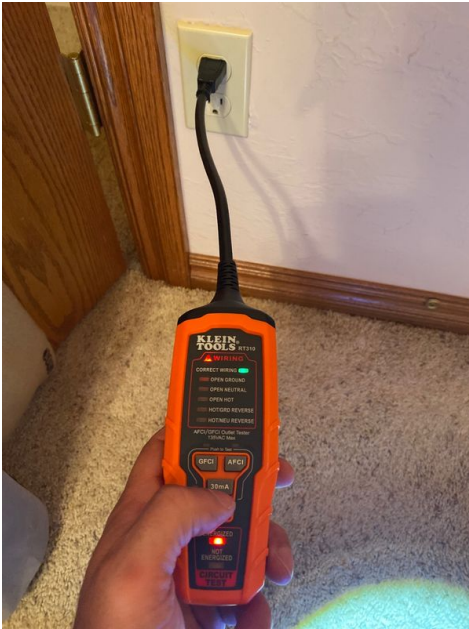
### 9.7.2 AFCIs

#### **MISSING AFCI PROTECTION AT BEDROOMS**

I observed missing AFCI protection for receptacles in the bedrooms.

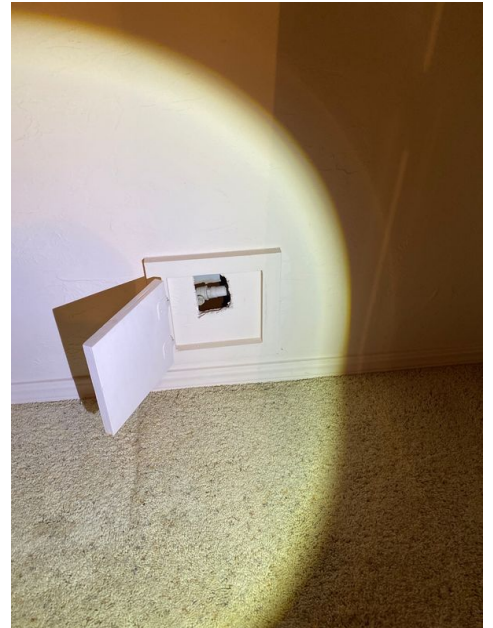
BEDROOM

I observed that the plumbing access panel was sealed shut. Inspection restriction.

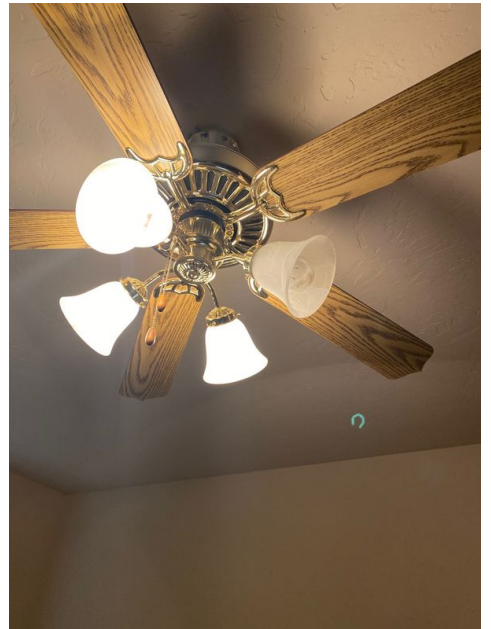
### 12.3.2 Switches, Fixtures & Receptacles

#### **LIGHT INOPERABLE, COULD BE BULB**

Contact a qualified electrical contractor.

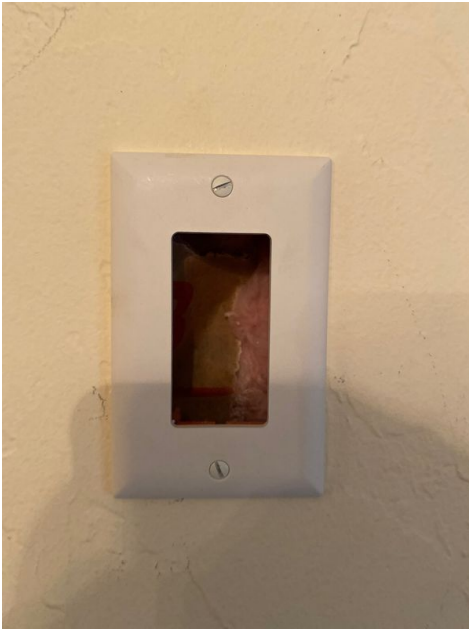
### 12.4.1 Floors, Walls, Ceilings

#### **OPEN WALL PENETRATION**

Recommended DIY Project

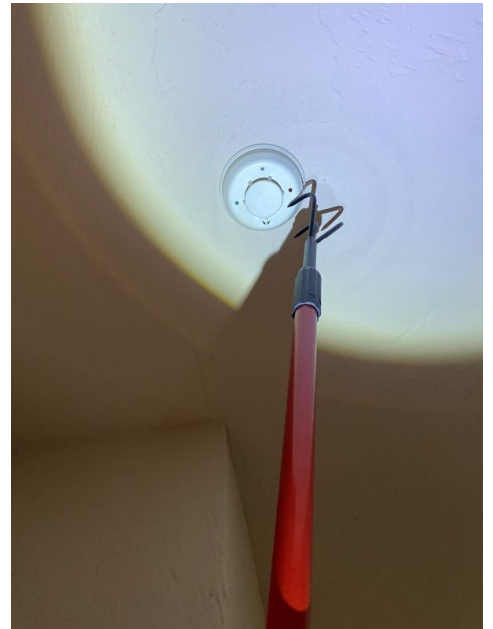
#### 12.5.1 Presence of Smoke and CO Detectors

### **SMOKE DETECTOR DID NOT TEST FUNCTIONAL**

Contact a qualified professional.

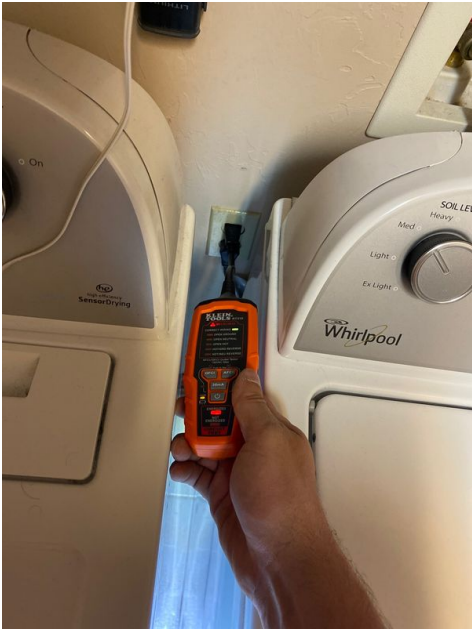
13.1.2 Clothes Washer

### **MISSING GFCI PROTECTION IN LAUNDRY**

Contact a qualified electrical contractor.

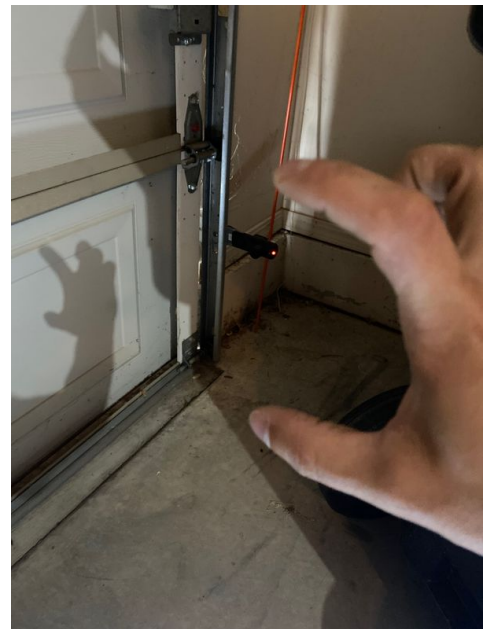
#### 14.3.2 Garage Vehicle Door Opener

##### **PHOTO-ELECTRIC EYES WERE TOO HIGH**

Contact a qualified garage door contractor.

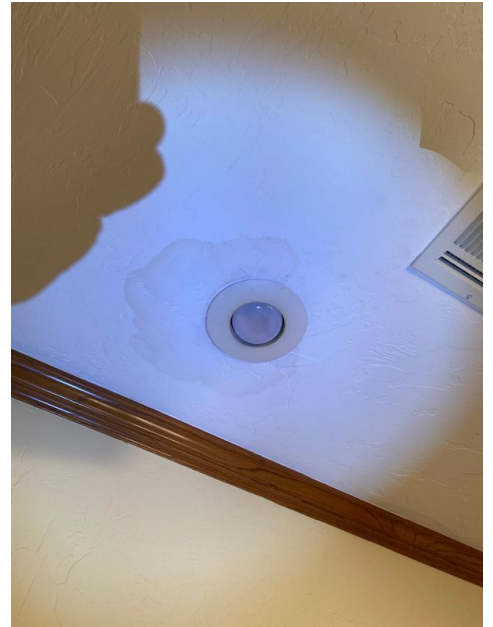
## 15.8.1 Floors, Walls, Ceilings

**MOISTURE DAMAGE**

Contact a qualified professional.
