RESIDENTIAL INSPECTION REPORT COPY

Third Sample
96067

Lori Colombo
MAY 11, 2019

Inspector
Michael Colombo
CMI, CPI, CCI
530-598-7856
mike@shastapremier.com

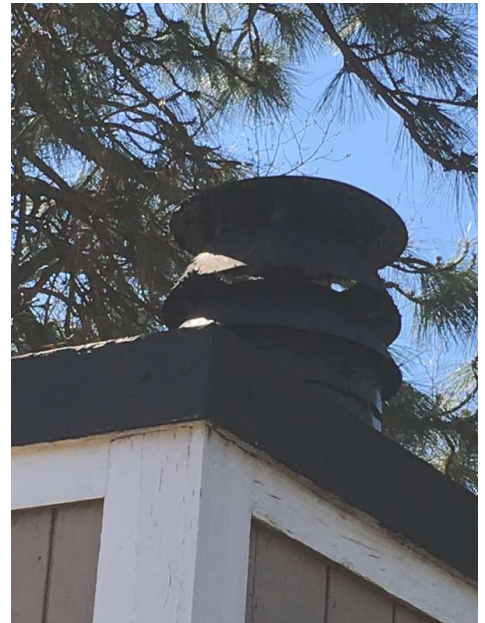
Roof

The flue serving the wood stove was observed to have excessive creosote buildup. Creosote buildup is a primary cause of chimney fires. Recommend professional cleaning, to include any necessary maintenance as recommended by technician.

Contact a qualified chimney sweep.

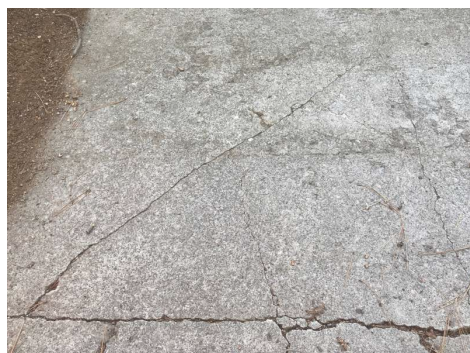
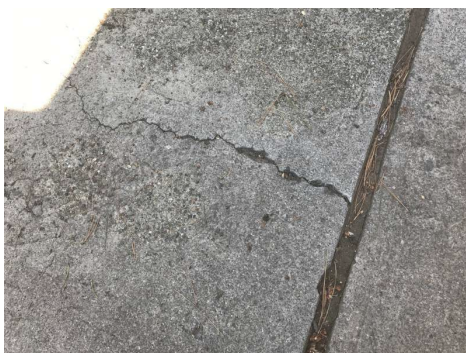
West (Crack)

The cement driveway/apron was observed to be in good condition, with some damage that appeared to be caused by settling. This does not impact the house foundation and the slab appeared to be serviceable; however, the concrete was observed to have full width cracks with or without displacement. This could be caused by the method of preparation of the ground under the concrete, construction methods of the slab, the presence of moisture in the soil and the freeze/thaw cycle, tree roots, age, and other reasons. These cracks can be repaired if desired; and repair is recommended to extend service life and help arrest current damage.

Contact a handyman or DIY project

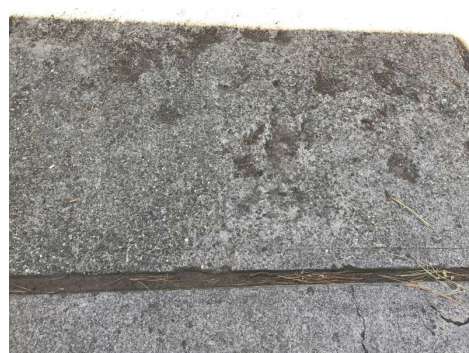
West (Spalling)

Spalling was observed in the cement driveway. Spalling occurs when water in the capillaries of the concrete freezes, creating pressure. Over time, repeated freeze/thaw cycles breaks away the top surface of the concrete, leaving pit marks and exposing the coarse aggregate. De-icing chemicals aggravate the already stressed concrete, thus increasing the damage when a freeze occurs. De-icing chemicals are picked up from the road drip onto the surface. Polymer-modified cementitious overlay may be applied to repair spalled areas and prevent further deterioration. Once the overlay cures, apply a waterproofing sealer to prevent the problem from reoccurring.

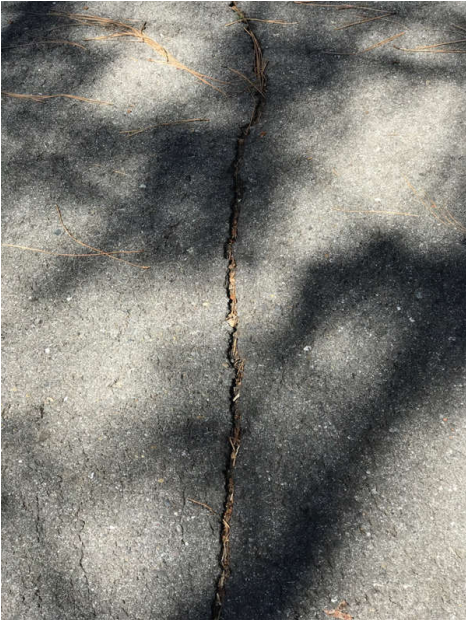
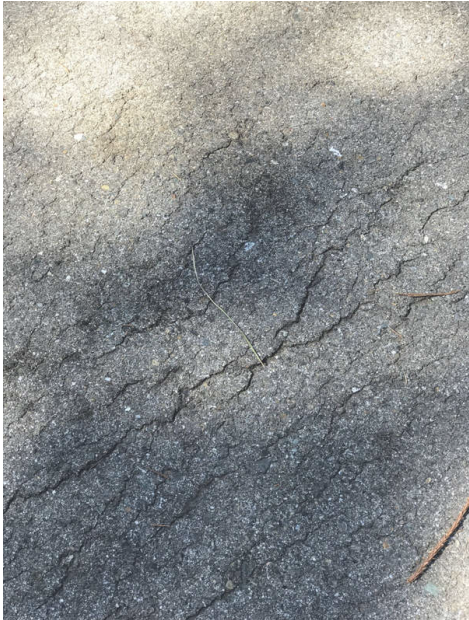
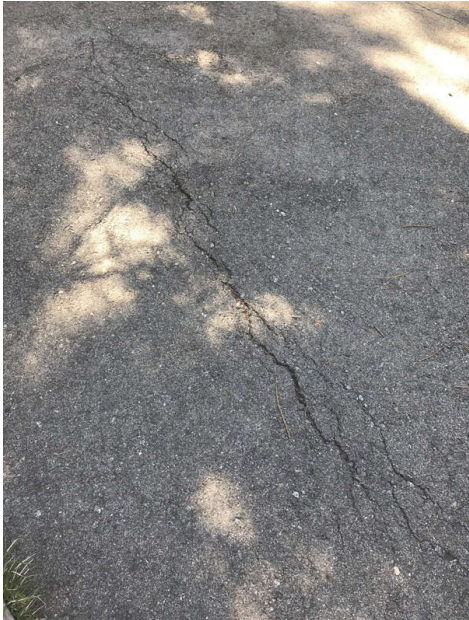
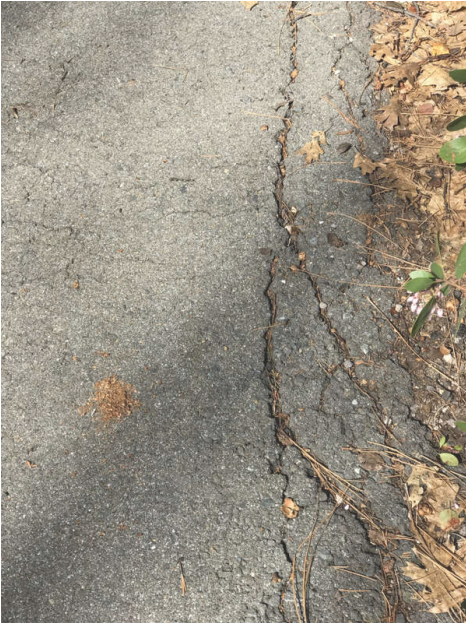
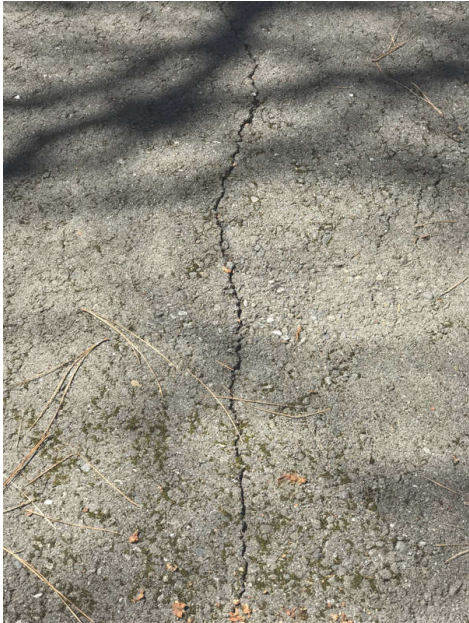
3.3.2 Driveway

The asphalt driveway was observed to be in good condition, with some minor cracking/deterioration observed. Cracking is a normal occurrence in asphalt driveways; however, in cold climates, water seeps in and further destroys the asphalt when it expands and contracts during freeze/thaw cycle. Asphalt driveway cracks may be sealed to prevent further damage to the asphalt and extend service life.

[Follow this link](#) for a helpful article on how to repair asphalt driveways.

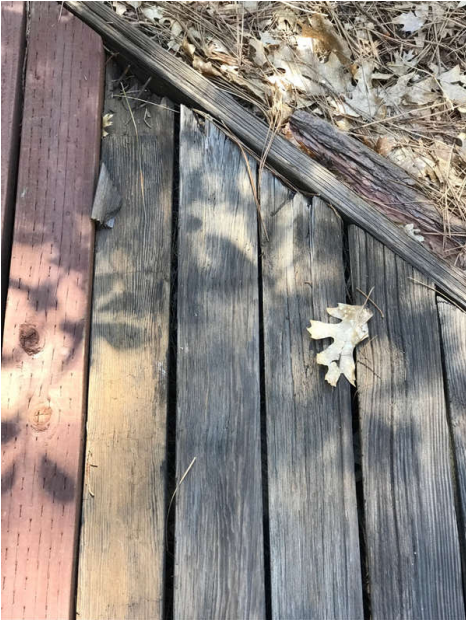
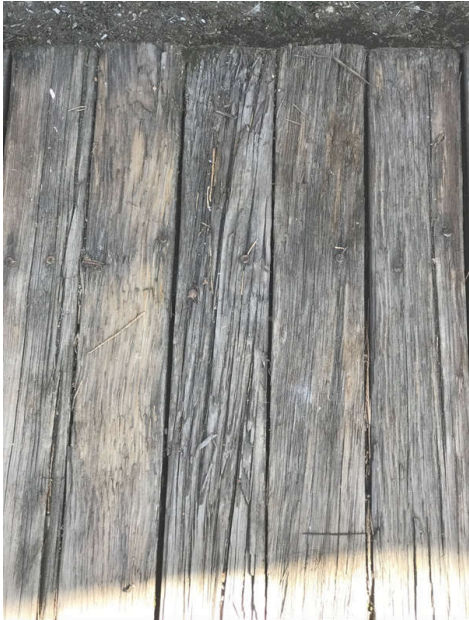
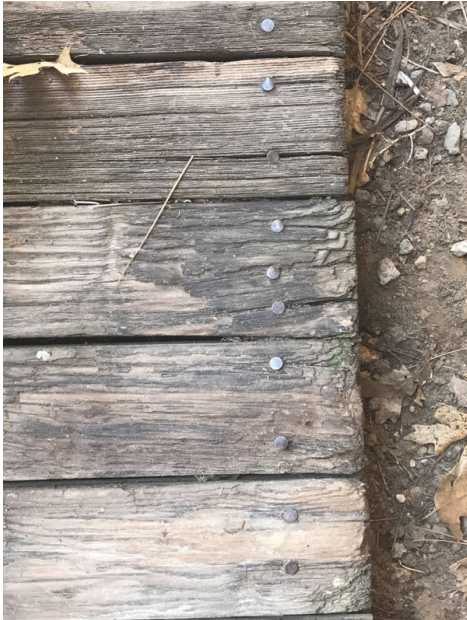
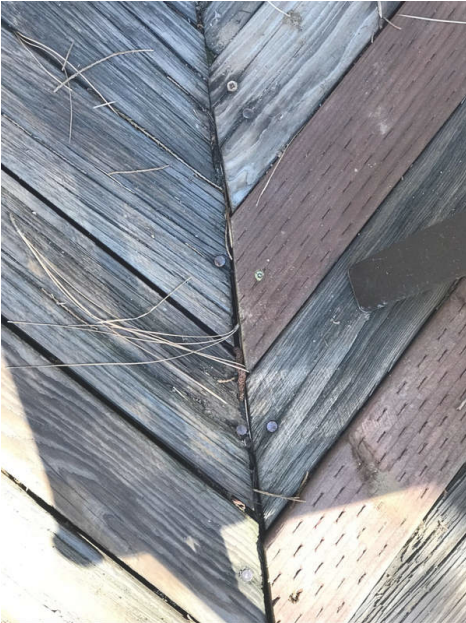
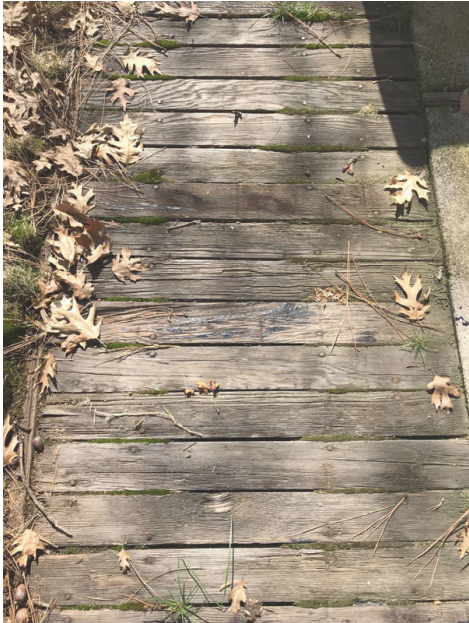
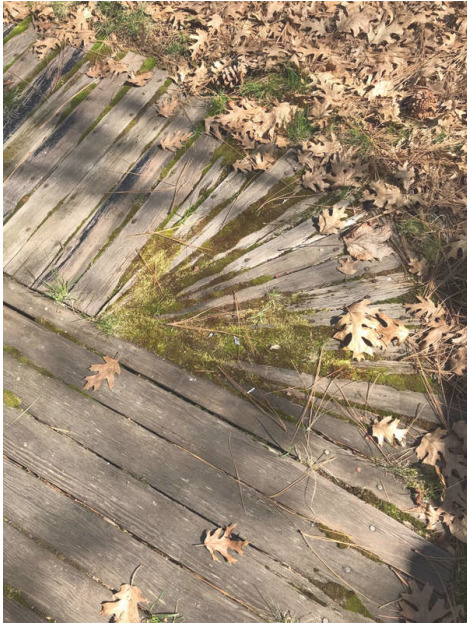
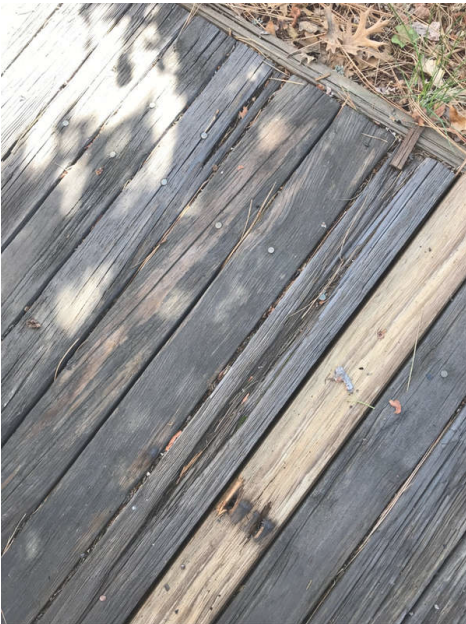
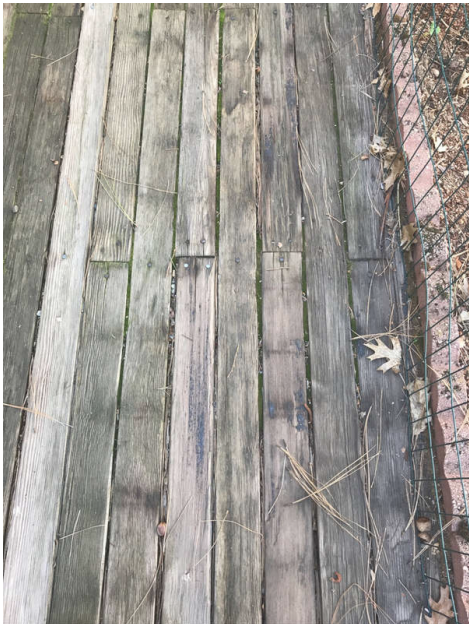
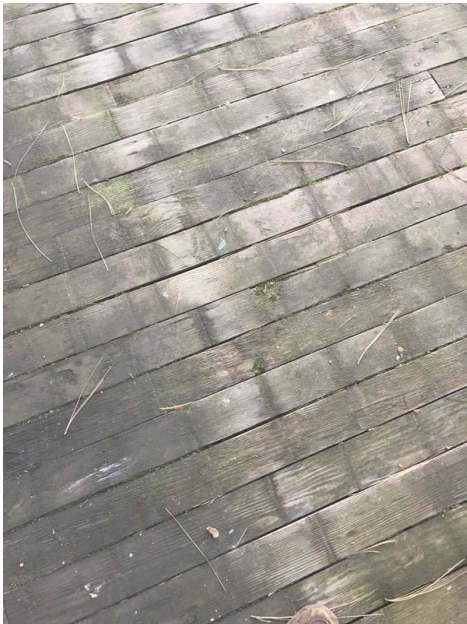
3.4.1 Walkways

The "boardwalks" were observed to be badly deteriorated with wood rot (dry rot) present. This is due to wood being placed on the ground and drawing moisture. These walkways will eventually need to be replaced. Monitor for worsening condition, as deteriorated boards will eventually become unable to support weight when walked upon.

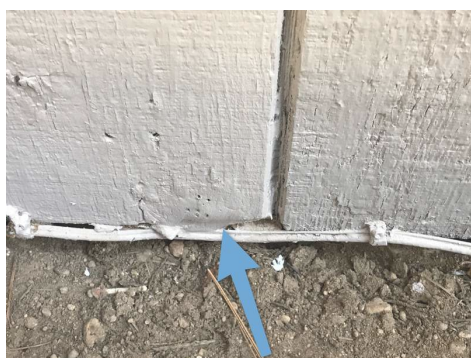
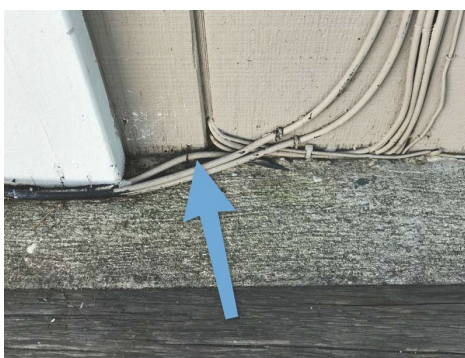
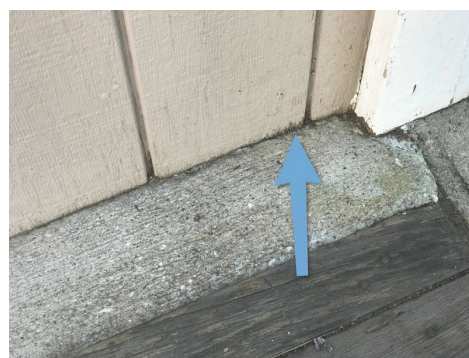
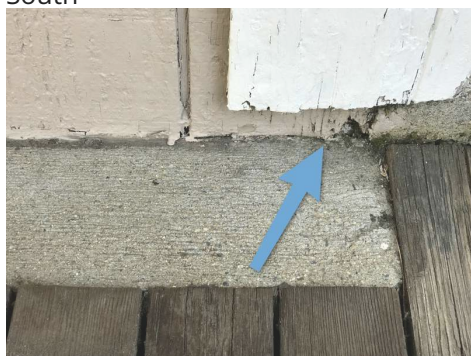
3.6.1 Siding

Siding was observed to have one or more small areas of minor moisture damage, deterioration, and/or wood rot (dry rot.) Recommend repair or replacement.

Dry Rot: Wood rot/dry rot is caused by biological fungal organisms that require a certain amount of moisture to thrive. The fungus digests the parts of the wood that give the wood strength and stiffness. Scraping/painting only will not stop dry rot from continuing to infiltrate the wood.

Treating and preventing dry rot is a three step process. Step 1 is to locate and stop the source of the moisture. Step 2 is to remove and replace any damaged wood that has become structurally weakened. Step 3 is to treat new and existing wood with a borate wood preservative to prevent growth of the dry rot fungus and kill any fungus already in the wood.

Contact a handyman or DIY project

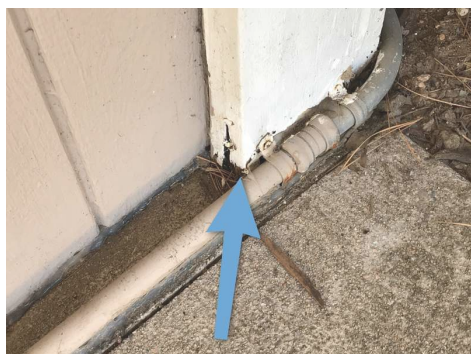
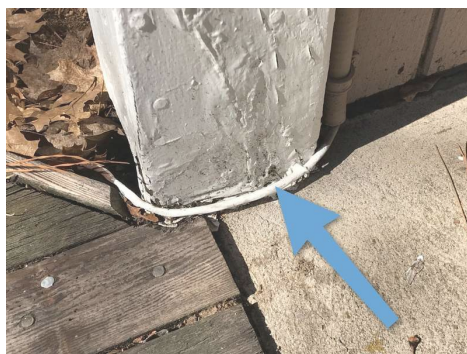
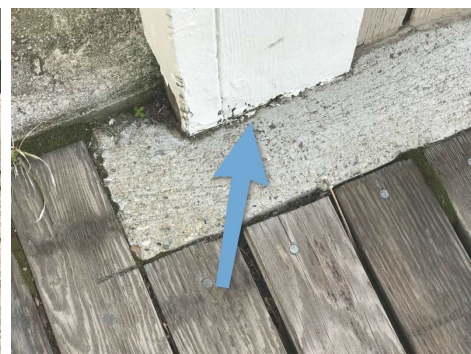
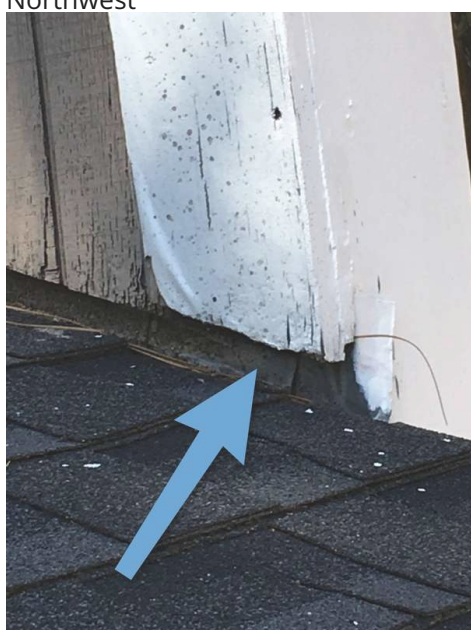
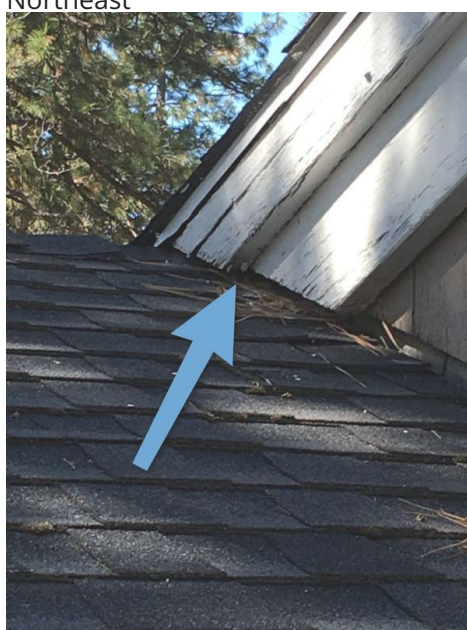
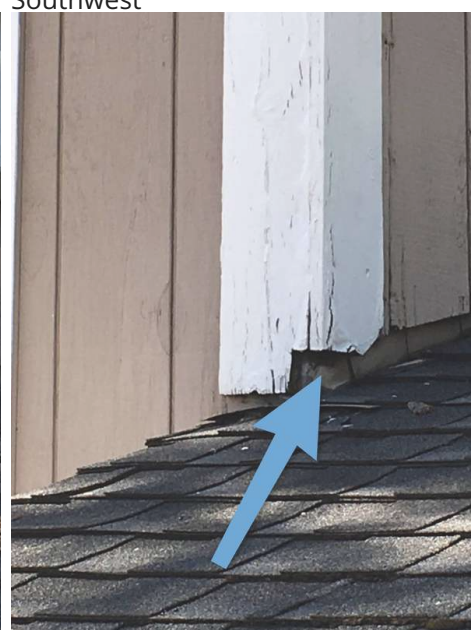
3.7.1 Trim

Trim was observed to have one or more small areas of minor moisture damage, deterioration, and/or wood rot (dry rot.) Recommend repair or replacement.

Dry Rot: Wood rot/dry rot is caused by biological fungal organisms that require a certain amount of moisture to thrive. The fungus digests the parts of the wood that give the wood strength and stiffness. Scraping/painting only will not stop dry rot from continuing to infiltrate the wood.

Treating and preventing dry rot is a three step process. Step 1 is to locate and stop the source of the moisture. Step 2 is to remove and replace any damaged wood that has become structurally weakened. Step 3 is to treat new and existing wood with a borate wood preservative to prevent growth of the dry rot fungus and kill any fungus already in the wood.

Contact a handyman or DIY project

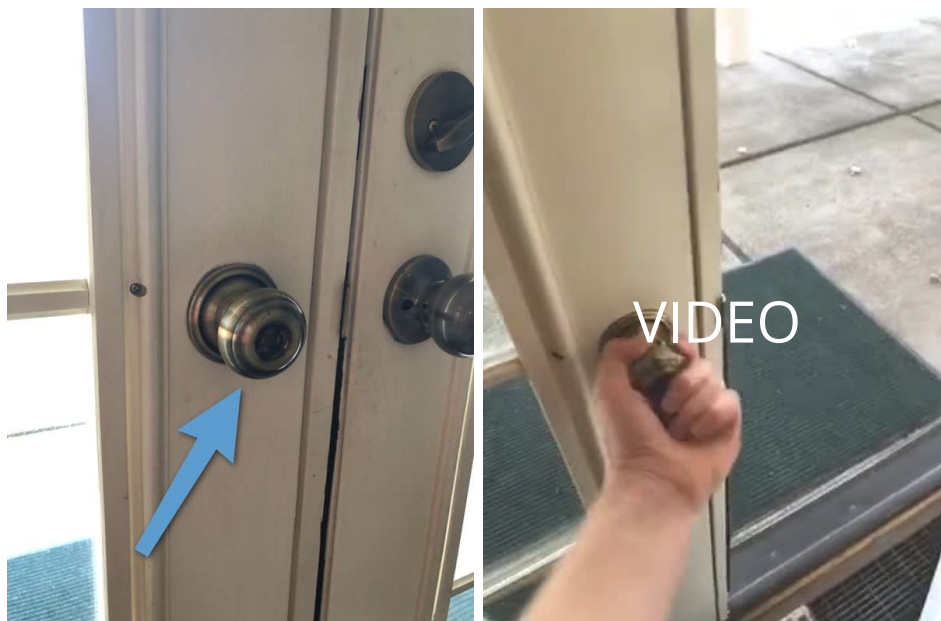
Interior Office

One or more pieces of door hardware was observed to be damaged or not operating correctly. Recommend repair or replacement.

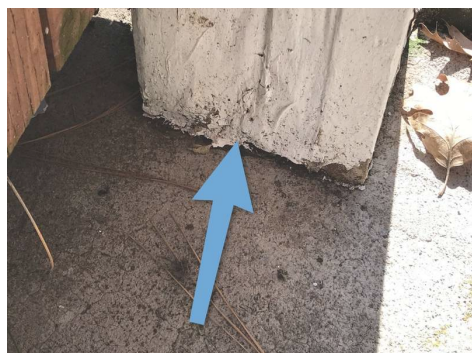
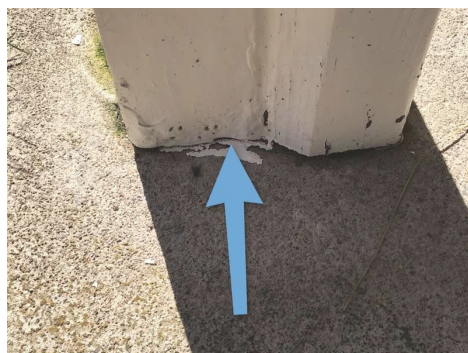
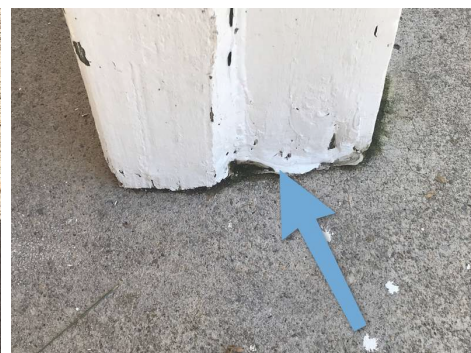
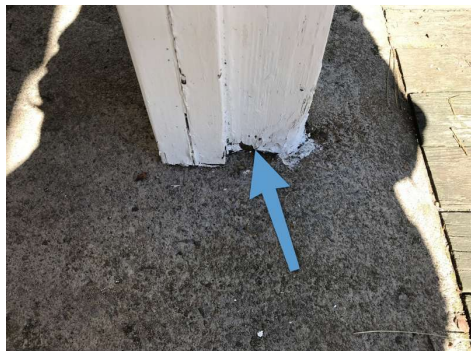
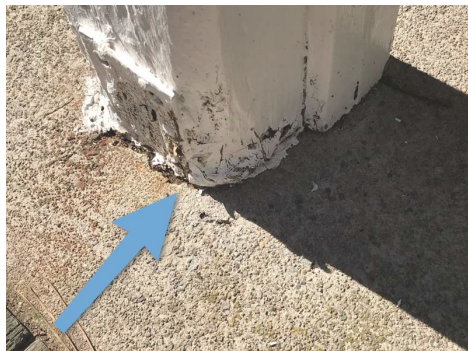
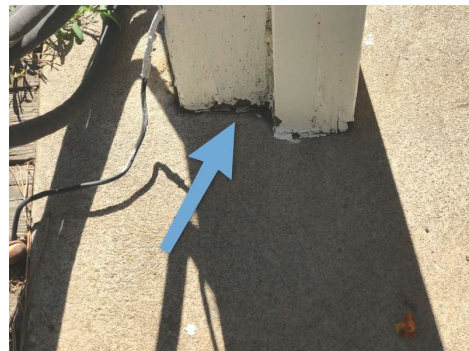
3.13.1 Balcony or Veranda

Evidence of some minor moisture damaged areas were observed in the balcony structure. These areas may be categorized as either a maintenance item or a deficiency, depending upon location and extent of damage. The damage was observed at the base of the support posts. These areas should be correctly repaired and treated, as necessary to inhibit further damage.

Dry Rot: Wood rot/dry rot is caused by biological fungal organisms that require a certain amount of moisture to thrive. The fungus digests the parts of the wood that give the wood strength and stiffness. Scraping/painting only will not stop dry rot from continuing to infiltrate the wood.

Treating and preventing dry rot is a three step process. Step 1 is to locate and stop the source of the moisture. Step 2 is to remove and replace any damaged wood that has become structurally weakened. Step 3 is to treat new and existing wood with a borate wood preservative to prevent growth of the dry rot fungus and kill any fungus already in the wood.

Contact a qualified professional.

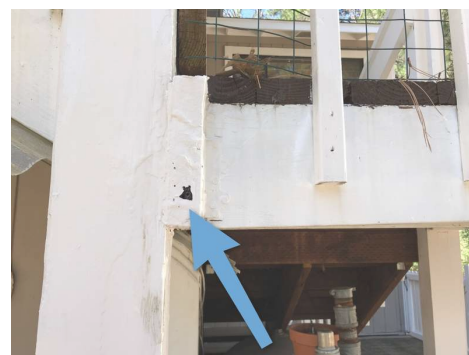
North

Evidence of some minor moisture damaged areas were observed in the stair structure. These areas may be categorized as either a maintenance item or a deficiency, depending upon location and extent of damage. These areas should be correctly repaired and treated, as necessary to inhibit further damage.

Dry Rot: Wood rot/dry rot is caused by biological fungal organisms that require a certain amount of moisture to thrive. The fungus digests the parts of the wood that give the wood strength and stiffness. Scraping/painting only will not stop dry rot from continuing to infiltrate the wood.

Treating and preventing dry rot is a three step process. Step 1 is to locate and stop the source of the moisture. Step 2 is to remove and replace any damaged wood that has become structurally weakened. Step 3 is to treat new and existing wood with a borate wood preservative to prevent growth of the dry rot fungus and kill any fungus already in the wood.

Contact a qualified professional.

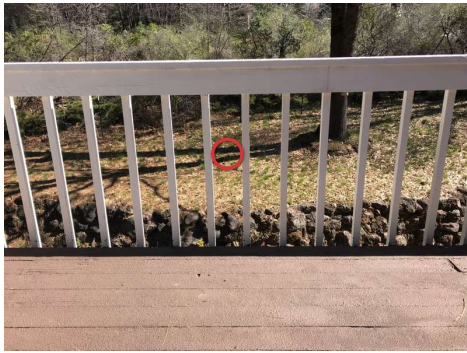
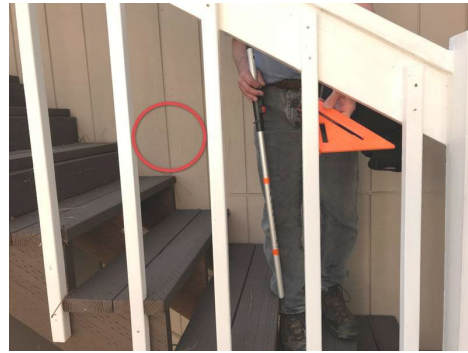
3.16.1 Railing & Handrails

The balusters of the railing and/or handrails were observed to be over-spaced for safety. Requirements vary among states and municipalities; however, the Uniform Building Code states that the balusters cannot be spaced more than 4 inches apart. This spacing is to prevent young children from squeezing between them and falling from the stairway, or getting their heads stuck between balusters. This can also be a pet safety concern for some. Consider modification to ensure safety.

Contact a qualified carpenter.

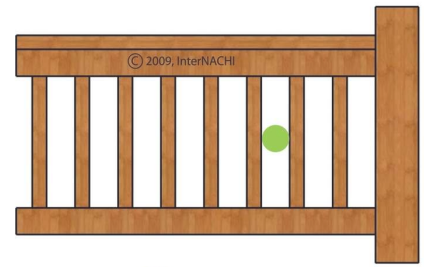
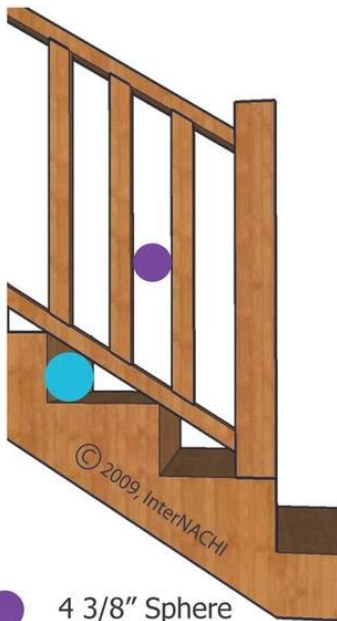
REFERENCE DRAWING

4" Sphere

Stair Railing

4 3/8" Sphere

6" Sphere
