MOUNTAINS TO SOUND HOME INSPECTION LLC

HOME INSPECTION REPORT

19319 NE 172nd St
Woodinville WA 98077

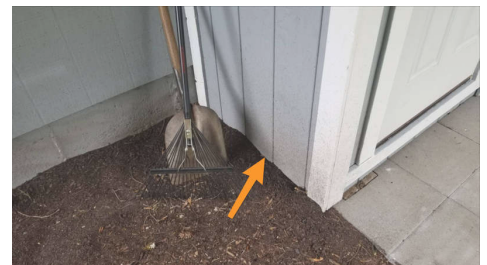
3.5.1 Exterior Siding Notes

The siding was in contact with or nearly contacting soil or mulch or concrete. This is a condition conducive to deterioration and wood destroying organism infestation. We recommend removing soil a six-inch space between any siding material and soil where possible and repairs to any damaged or deteriorated siding.

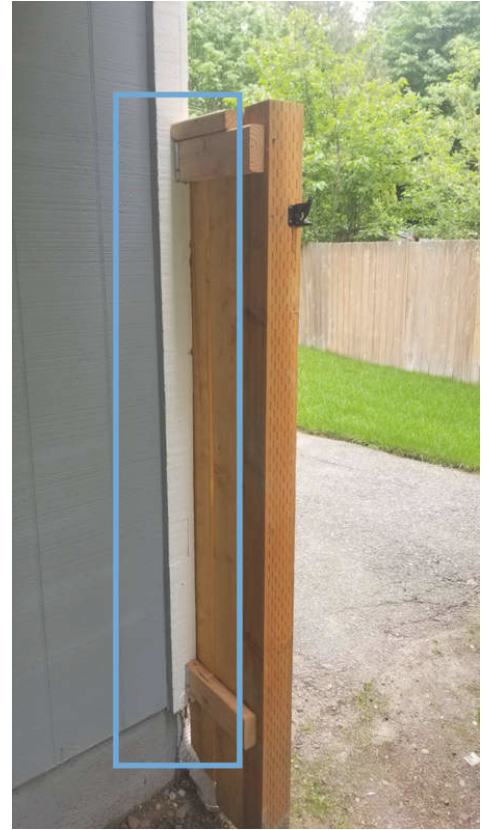
3.5.2 Exterior Siding Notes

FENCE ATTACHED TO HOUSE

Fence(s) were attached to or in contact with the building exterior. Such attachments can serve as a pathway for wood-destroying insects and can retain moisture against the exterior after it rains. We recommend repairs as necessary so there is at least a 2-inch gap between rails and building exteriors.

Contact a qualified professional.

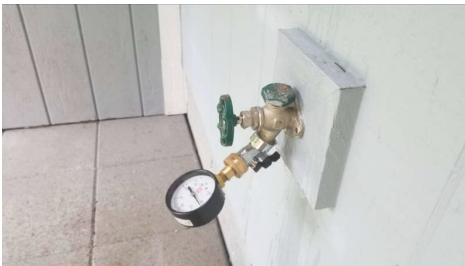
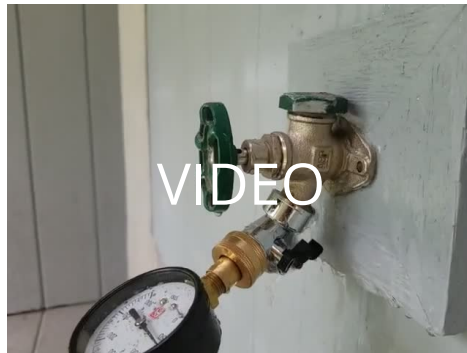
3.8.1 Exterior Plumbing

LEAKING VACUUM BREAKER

There is a leaking vacuum breaker, on the property irrigation system, that needs evaluation and service as necessary from a qualified technician.

Contact a qualified plumbing contractor.

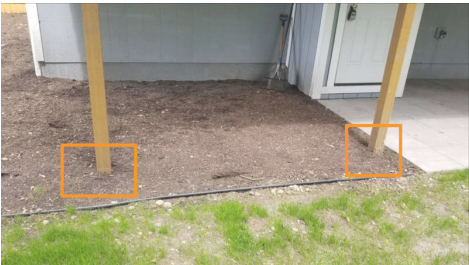
The deck has Earth to wood contact. This can't accelerate deterioration. We recommend removing soil from contacting any wood components.

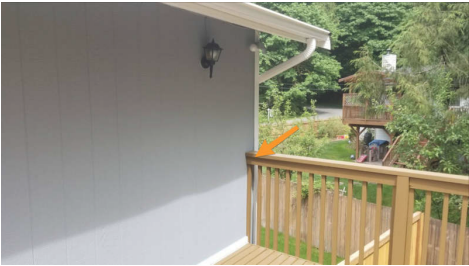
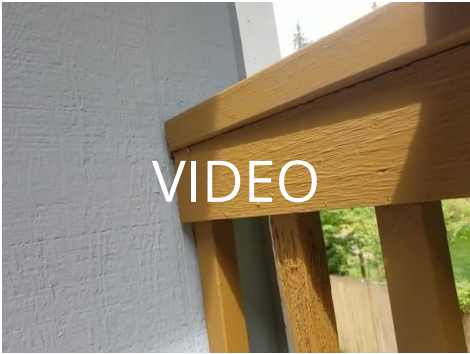
3.15.2 Deck

DECK RAIL LOOSE OR WOBBLY

The deck rail was loose or wobbly. Recommend repairs secure.

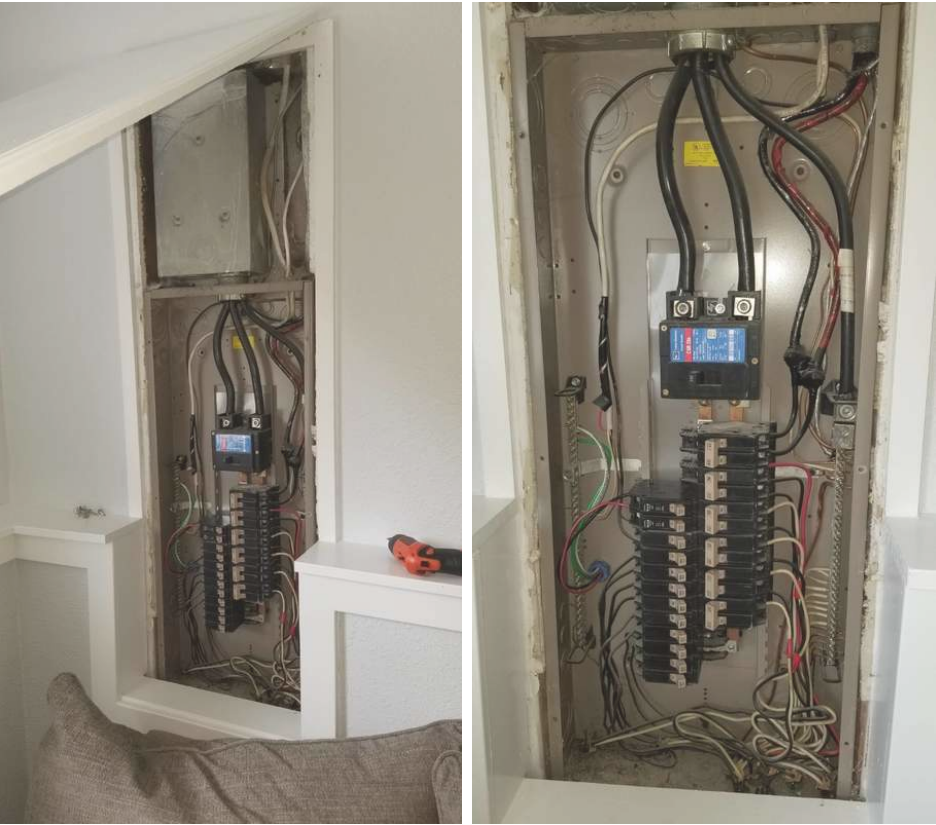
Panel Size, Location & Photo: Panel Amps, Location and Picture
1st Floor Family Room

Panel Size, Location & Photo: Earth Ground
Earth Ground Rod
The main panel grounding was observed and found to be in good repair and of adequate function at the time of the inspection.

Main Panel Notes: Acceptable
The panel and its components have no visible deficiencies. Any exceptions will be noted below.

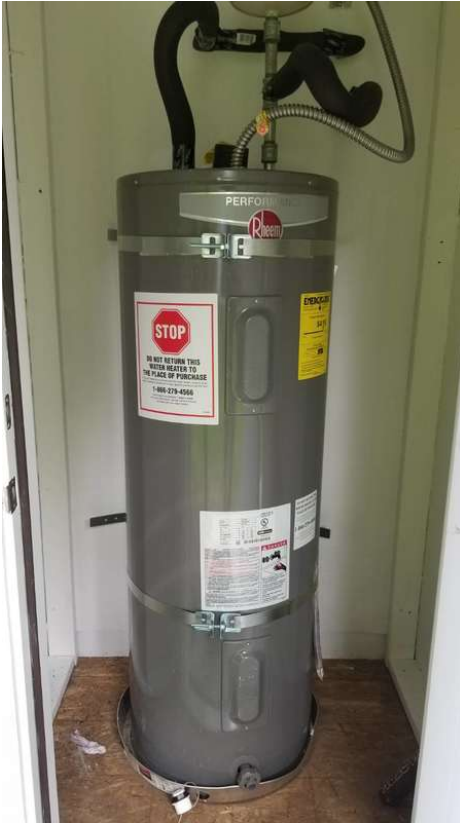
**Water Heating System: Water Shut-Off Valve & Connectors**

The shut-off valve and water connectors appear functional but was not tested.

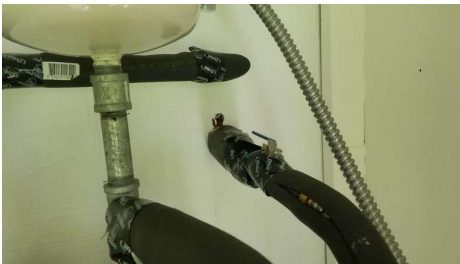
**Water Heating System: Relief Valve & Discharge Pipe-Acceptable**

The water heater is equipped with a mandated pressure-temperature relief valve and pipe.

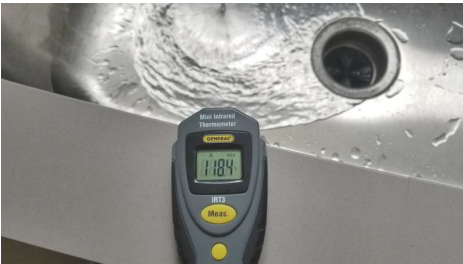
Sink and Faucet: Water temp

The Water temp at the Kitchen Faucet is Currently noted in the photo below. The U.S. Consumer Product Safety Commission (CPSC) urges all users to keep their water heater temps at 120 degrees Fahrenheit to prevent scalding and bacteria prevention reasons.

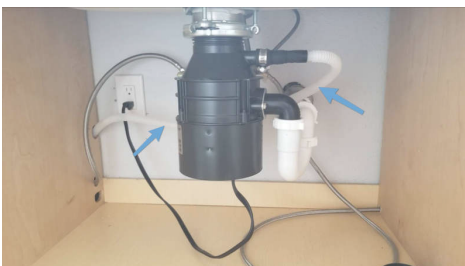
Dishwasher drain pipe was installed without an air gap/high loop to prevent cross contamination. Recommend a qualified licensed professional evaluate and or repair.

Recommended DIY Project

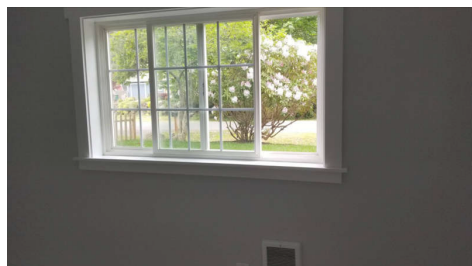
SCREENS DAMAGED/MISSING

Window screens were missing or damaged in one or more areas. We recommend repair or replacement as needed.
