HOME INSPECTION REPORT

2003 Nielson Ave
Enumclaw WA 98022

Robert Brugh
JULY 30, 2019

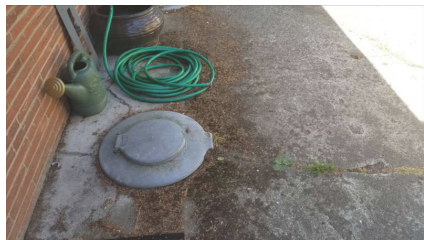
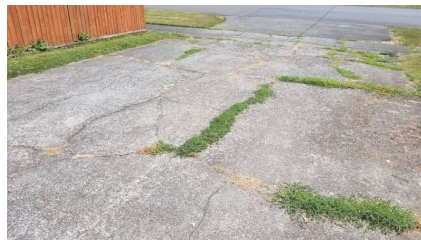
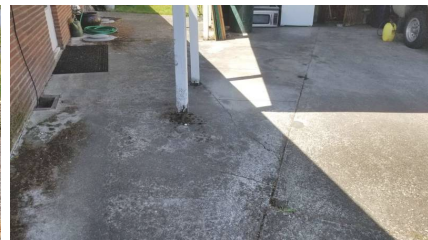
**PATIO FLOOR CRACKS**

There are cracks in the rear patio floor and driveway that you should view for yourself and correct as desired.

Contact a qualified concrete contractor.

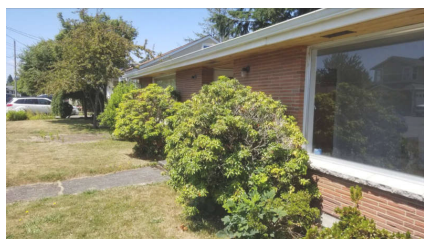
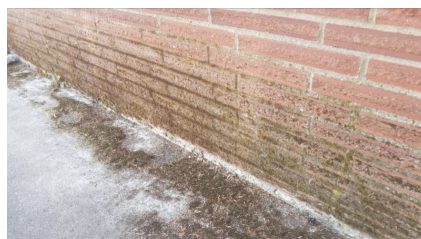
3.5.1 Exterior Siding Notes

Vegetation is encroaching on the structure, and should be kept a minimum of twelve inches away for the general welfare of the walls and foundation.

Contact a qualified landscaping contractor

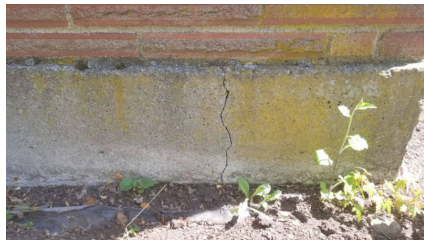
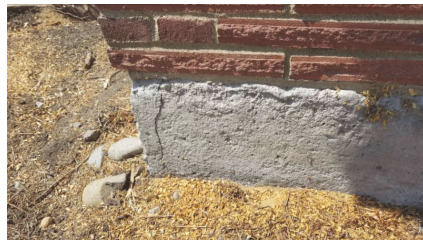
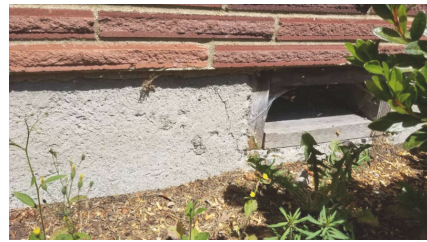
3.6.1 Foundation as Viewed from the Exterior

MINOR CRACKS

Minor cracks were observed. Monitor.

Recommend monitoring.

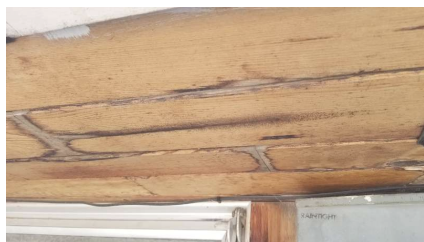
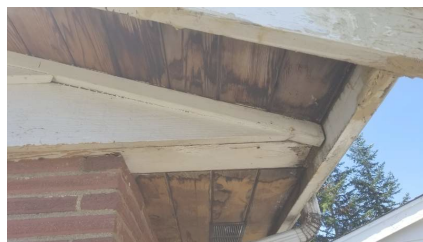
3.7.1 Fascia, Trim & Eaves

SECTIONS OF FASCIA & TRIM MOISTURE DAMAGED

Sections of the fascia board or wood trim are weathered, moisture damaged and should be serviced or replaced as necessary by a qualified professional contractor to help prevent further wear or deterioration.

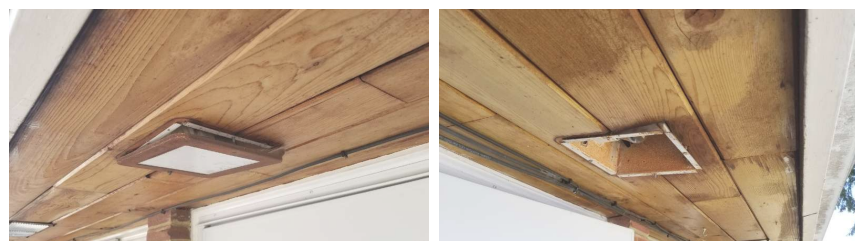
3.14.2 Lights

LIGHT FIXTURE DAMAGED/MISSING COVER

A light fixture was damaged or missing a cover and repair is recommended.

Contact a qualified handyman.

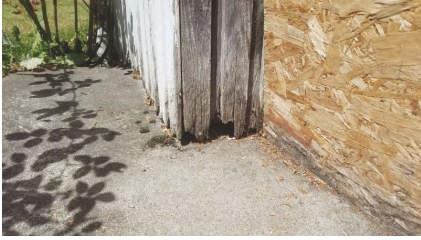
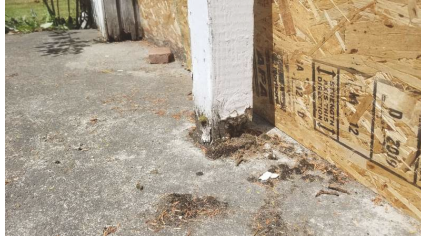
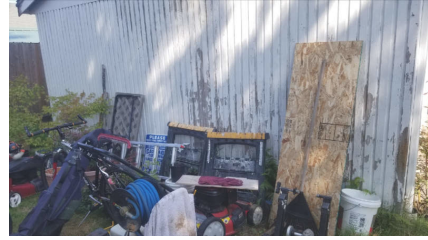
3.15.1 Carport

SUPPORTS AND SIDING DAMAGED/EARTH TO WOOD CONTACT

Some supports and areas of siding on the carport had damage where earth to wood contact was present. Recommend evaluation and repair by a qualified professional.

Contact a qualified professional.

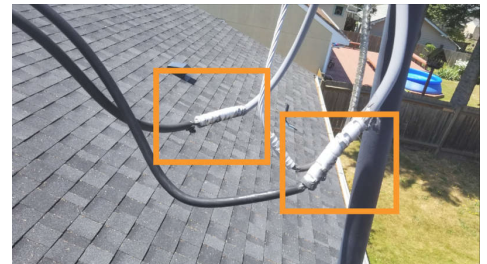
ELECTRICAL DROP/STRIKE MISSING INSULATION

The electrical strike had places where insulation was worn/missing. Recommend repair by a licensed professional.

Contact a qualified professional.

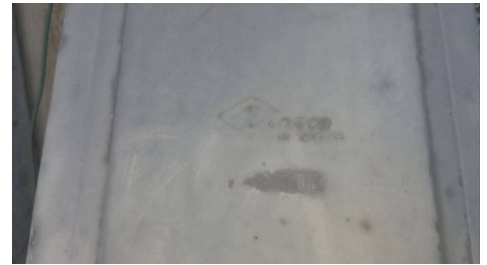
The panel was manufactured by Zinsco/Sylvania and has been alleged to be defective. However, in the interests of safety, the backs of the breakers should be properly evaluated and serviced as necessary by a electrician to ensure that there is no scorching or evidence of overheating. This service is recommended at least before the close of escrow and preferably within the inspection period. Ultimately, our recommendation is to replace this panel with a modern panel.

Contact a qualified electrical contractor.

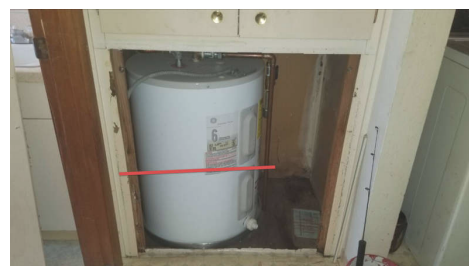
SEISMIC STRAPS - MISSING/INSUFFICIENT

The hot water heater was missing seismic straps or was insufficiently anchored. Recommend two straps to properly secure water heater in the case of an earthquake.

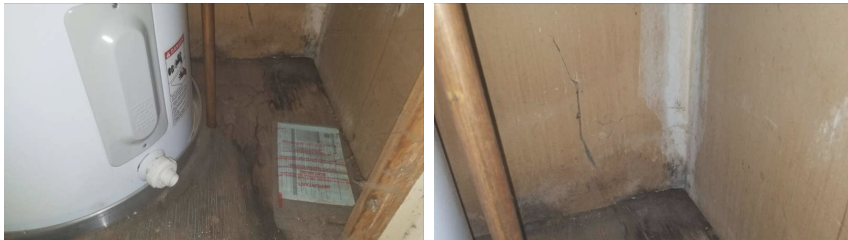
Medium Priority**MOISTURE DAMAGE WALL/FLOOR**

There was apparent moisture damage to the drywall and plywood flooring around the water heater. No leaking was detected during the inspection. Recommend evaluation and repair by a qualified professional.

Contact a qualified professional.

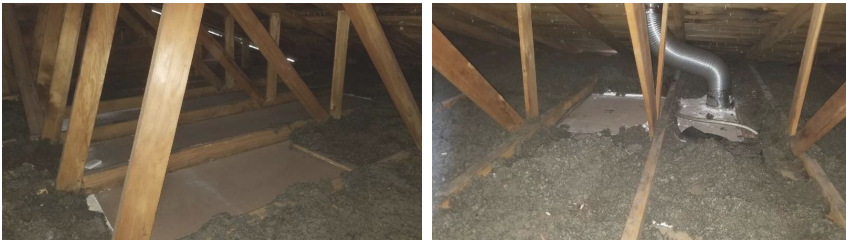
15.5.1 Insulation Notes

Medium Priority**DISPLACED OR REMOVED INSULATION**

There is an area of displaced or removed insulation, that should be replaced to conserve energy and prevent heating and cooling loss.

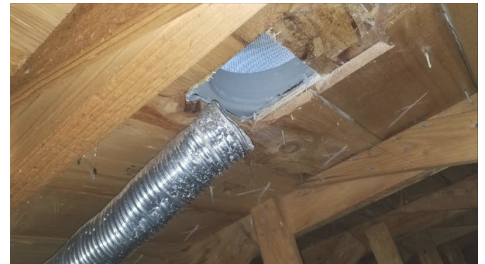
15.7.1 Exhaust Ducts

Medium Priority**BATHROOM EXHAUST SEPARATED NEEDS REPAIR**

The bathroom exhaust duct is separated, and should be repaired.
