# MOUNTAINS TO SOUND HOME INSPECTION LLC

## HOME INSPECTION REPORT

3043 Christianson Ave  
Enumclaw WA 98022

MAY 22, 2020

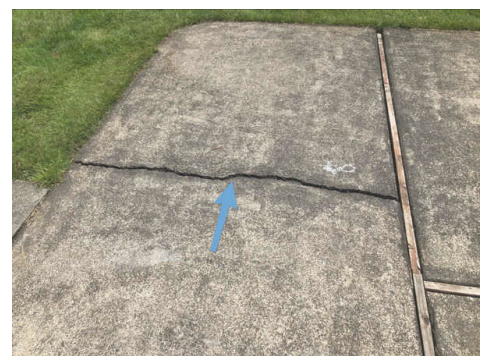
**PATIO FLOOR CRACKS**

There are cracks in the rear patio floor that you should view for yourself and correct as desired.

Low Priority

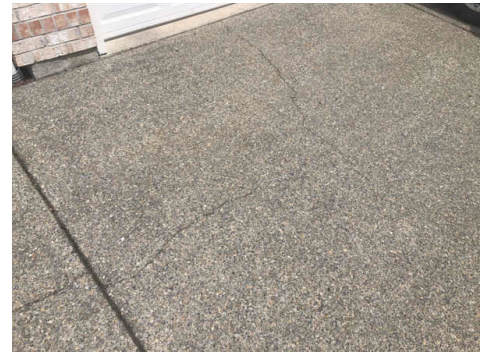
## 3.2.2 Driveway, Walkways &amp; Patio

**SMALL CRACKS IN DRIVEWAY**

There are common cracks in the driveway that would not necessarily need to be serviced.

Recommend monitoring.

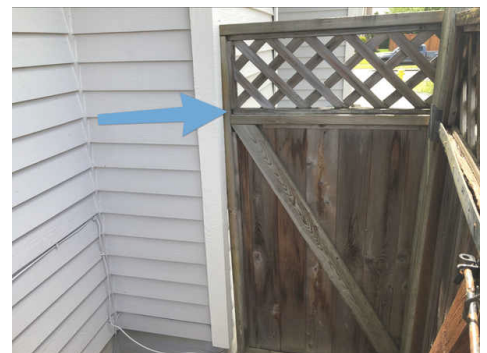
Fence(s) were attached to or in contact with the building exterior. Such attachments can serve as a pathway for wood-destroying insects and can retain moisture against the exterior after it rains. We recommend repairs as necessary so there is at least a 2-inch gap between rails and building exteriors.

Low Priority

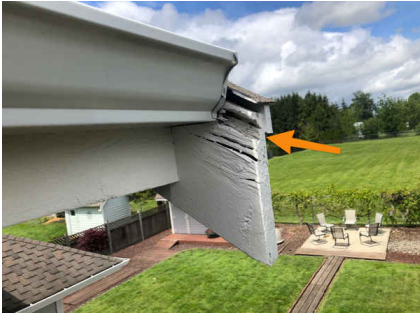
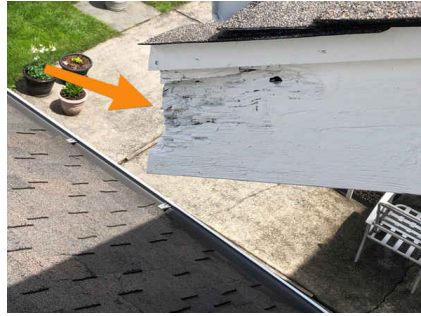
### 3.7.1 Fascia, Trim & Eaves

#### SECTIONS OF FASCIA & TRIM MOISTURE DAMAGED

Sections of the fascia board or wood trim are weathered, moisture damaged and should be serviced or replaced as necessary by a qualified professional contractor to help prevent further wear or deterioration.

Medium Priority

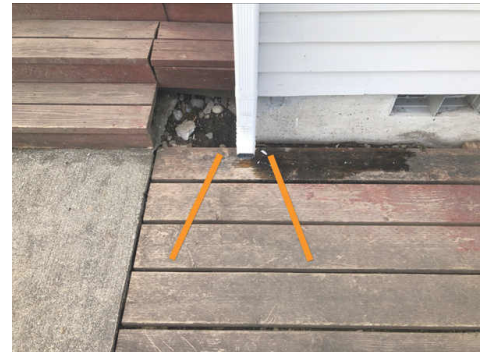
### 3.9.1 Downspouts

## **DOWNSPOUTS MISSING COMPONENTS**

The downspouts are missing parts. Recommend repairs to allow for proper drainage away from the structure.

Medium Priority

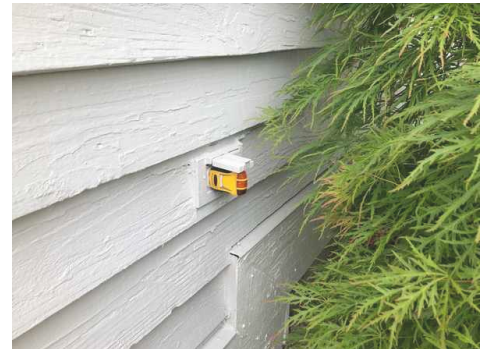
### 3.17.1 Outlets, Electrical Observations

## **OPEN GROUNDED OUTLET**

Medium Priority

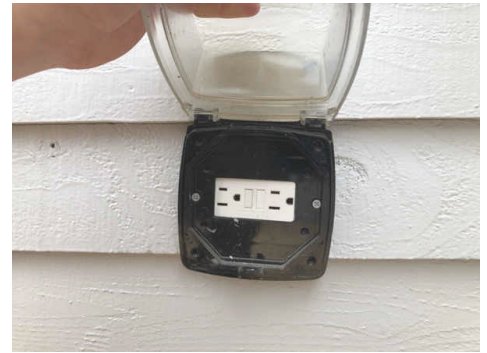
### 3.17.3 Outlets, Electrical Observations

## **NO POWER**

A outlet does not have power and should be demonstrated or repaired.

Contact a qualified electrical contractor.

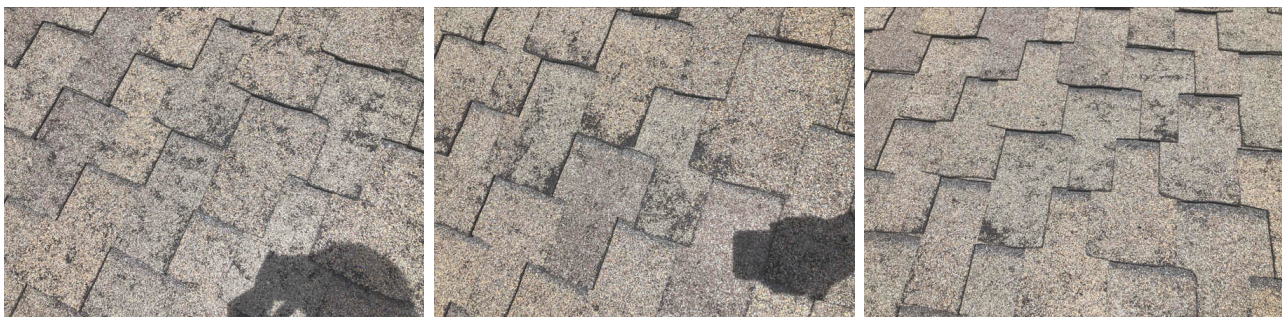
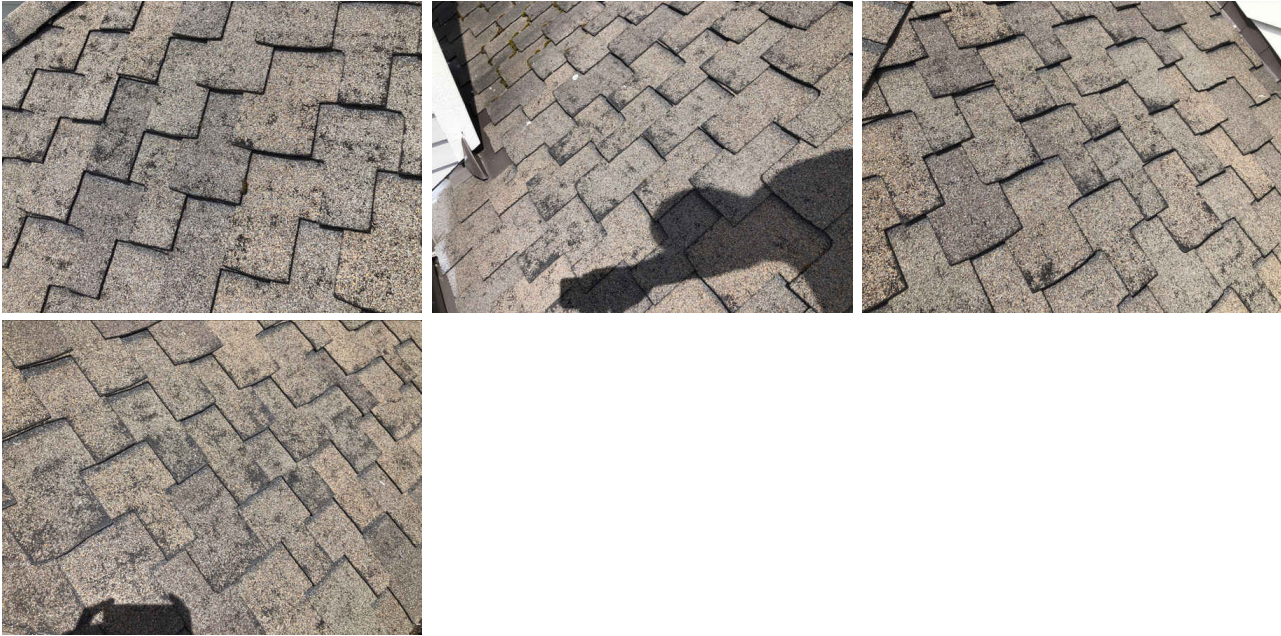
#### WORN SHINGLES

Portions of the roof have worn shingles where granules are missing/washed away and the shingles fibers are visible. This shows the roof is in the primary stages of decomposition in some areas. Recommend monitoring these areas and have a licensed roofer further evaluate.

Contact a qualified roofing professional.

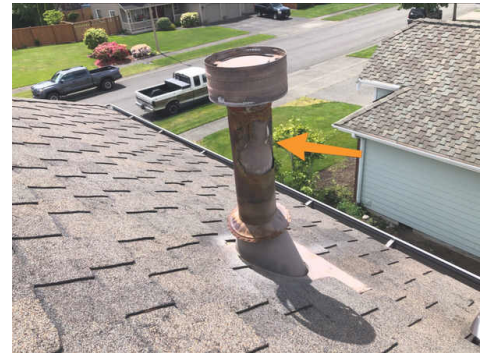
#### 4.4.1 Vents & Flashings

### EXHAUST VENT DETERIORATED

The gas Appliance exhaust vent was cracked or deteriorated. We recommend repair or replacement of the vent.

Medium Priority

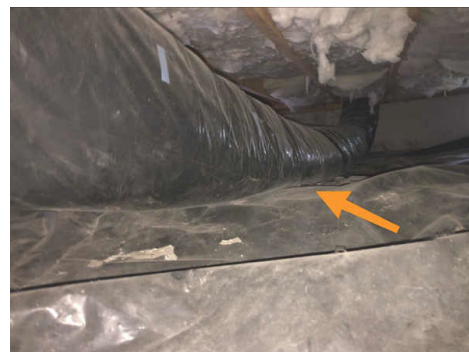
One or more of the heating ducts were in contact with the ground. We recommend A minimum of 4" of clearance be maintained.

Contact a qualified professional.

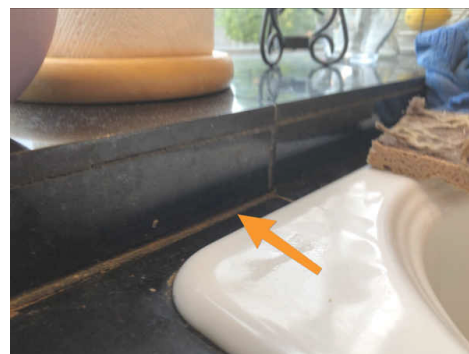
#### MISSING OR DETERIORATED CAULK/GROUT

Recommended DIY Project

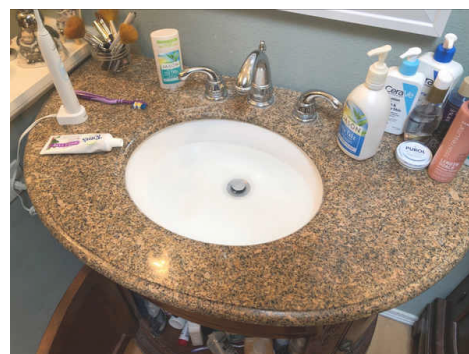
## 11.2.1 Trap and Drain

**SLOW DRAIN**

Medium Priority

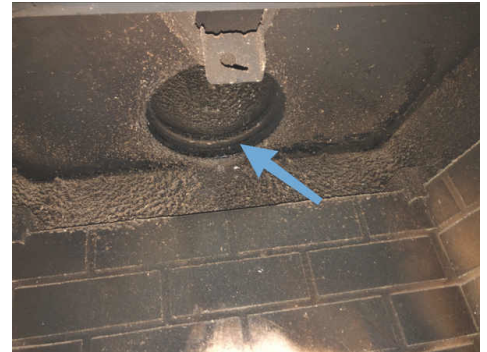
## 13.9.1 Fireplace Notes

**DAMPER MISSING**

Contact a qualified professional.

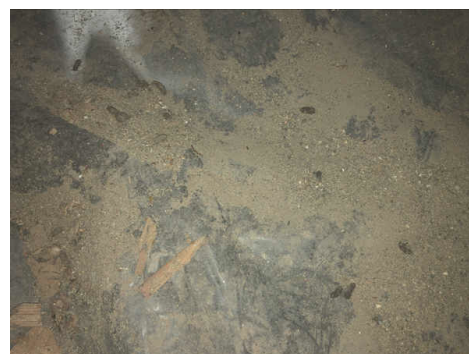
### 15.1.2 Crawlspace Notes

#### RODENT ACTIVITY

Contact a qualified pest control specialist.

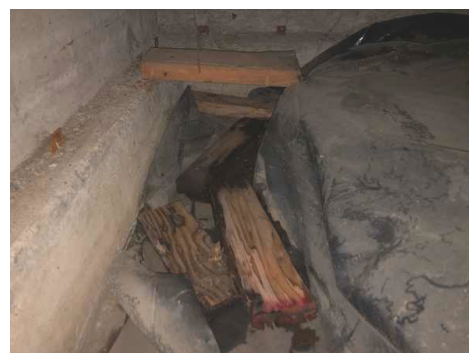
### 15.1.3 Crawlspace Notes

#### WOOD DEBRIS

Contact a qualified professional.
