HOME INSPECTION REPORT

2630 S 362nd Pl
Federal Way WA 98003

AUGUST 3, 2018

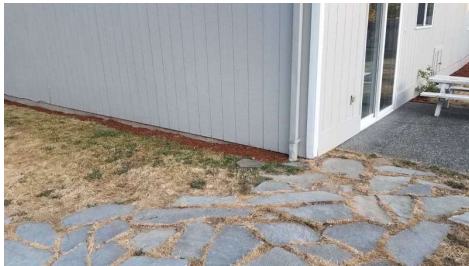
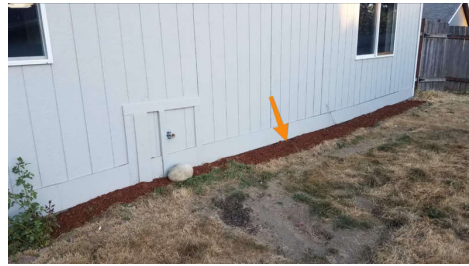
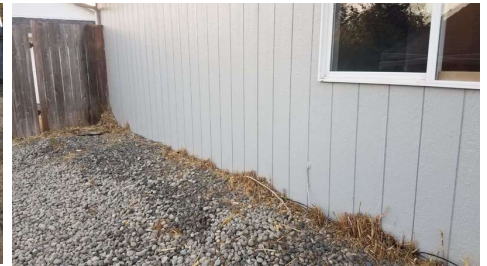
**EARTH TO WOOD CONTACT**

The siding was in contact with or nearly contacting soil or mulch or concrete. This is a condition conducive to deterioration and wood destroying organism infestation. We recommend removing soil a six-inch space between any siding material and soil where possible and repairs to any damaged or deteriorated siding.

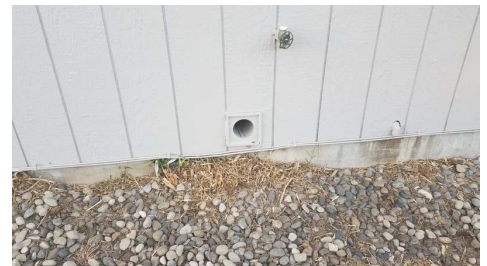
3.5.2 Exterior Siding Notes

EXTERIOR VENTS NEED REPAIR**LEFT SIDE**

The vent is missing or damaged and is in need of replacement.

Contact a qualified professional.

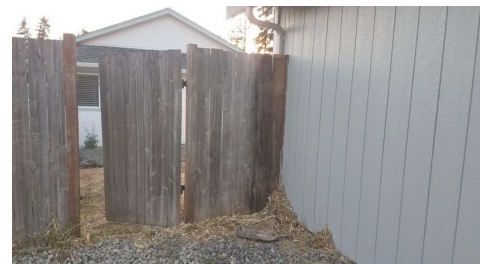
3.5.3 Exterior Siding Notes

FENCE ATTACHED TO HOUSE

Fence(s) were attached to or in contact with the building exterior. Such attachments can serve as a pathway for wood-destroying insects and can retain moisture against the exterior after it rains. We recommend repairs as necessary so there is at least a 2-inch gap between rails and building exteriors.

Contact a qualified professional.

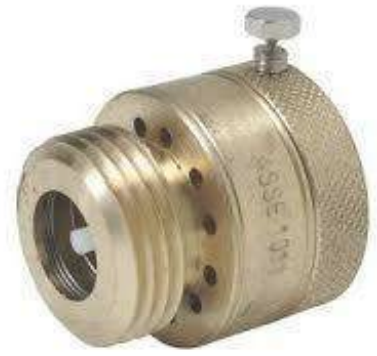
Anti Siphon

DAMAGED ANTI-SIPHON VALVES

The hose bib anti-siphon valve is damaged. Recommend repair.

Contact a qualified handyman.

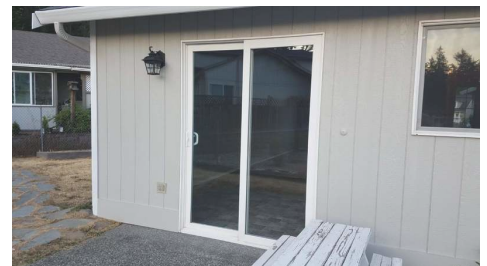
3.10.1 Exterior Doors

SLIDING DOOR SCREEN MISSING/DAMAGED

The rear sliding screen is missing or needs work. Have it repaired by a qualified contractor.

Contact a qualified handyman.

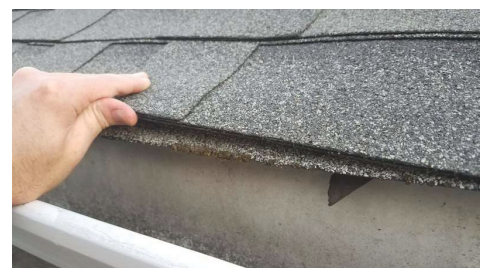
ROOF HAS BEEN LAYERED

The roof has been layered, which is never sensibly recommended because it adds weight to the roof framing, and reduces the design life of the new roof by several years and requires a regular maintenance of its flashings.

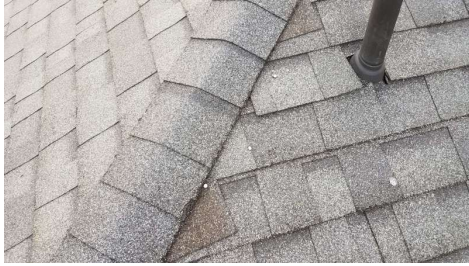
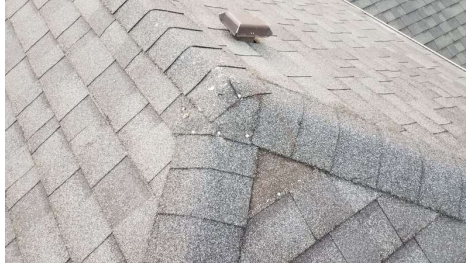
4.2.2 Composition Shingle Roof Notes

SHINGLES NAILED, STAPLED

Some of the shingles have been nailed down which can lead to leaks these spots should be sealed to prevent moisture intrusion.

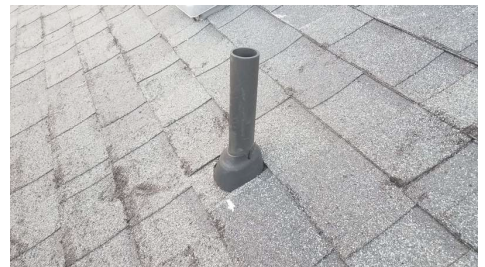
4.4.1 Vents & Flashings

RUBBER BOOTS DETERIORATED

The rubber boots around Plumbing vents for cracked or deteriorated. We recommend replacement.

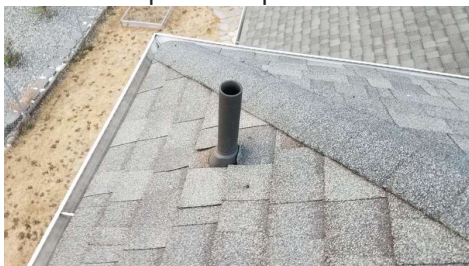
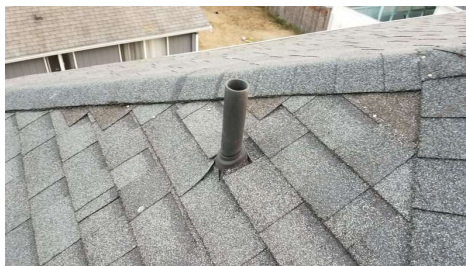
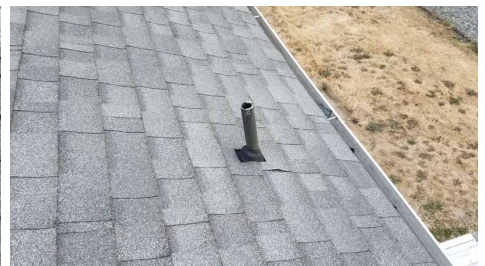
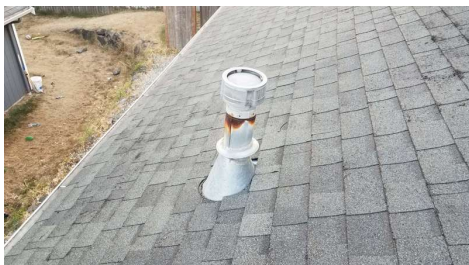
4.4.2 Vents & Flashings

IMPROPER FLASHING INSTALLATION

Some of the flashing was improperly installed. Recommend repairs or sealing.

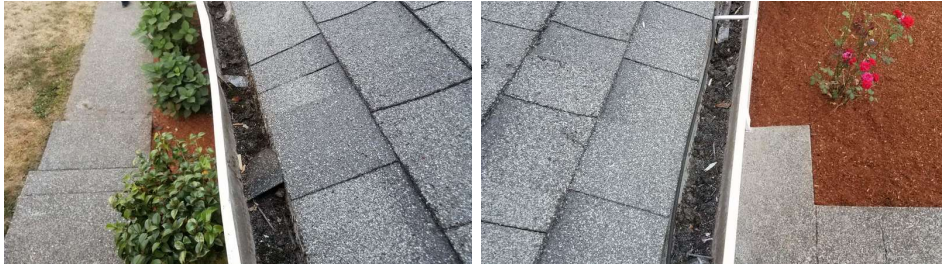
4.5.1 Gutters & Drainage

GUTTERS NEED TO BE CLEANED OF DEBRIS

Contact a qualified roofing professional.

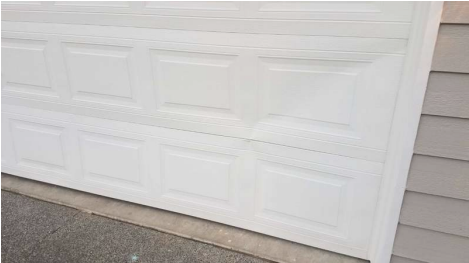
GARAGE DOOR COSMETIC DAMAGE

The main garage door is functional, but has cosmetic damage. You may want to have this repaired by a licensed contractor.

Contact a qualified garage door contractor.

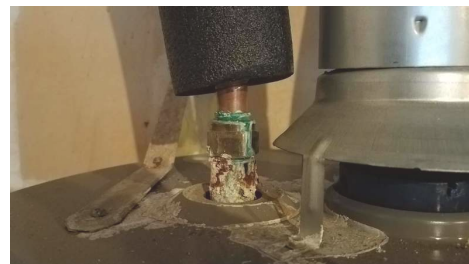
LEAKING PIPE

There was one or more leaking pipes at the time of the inspection. Recommend evaluation and or repair by a qualified licensed professional.

Contact a qualified professional.

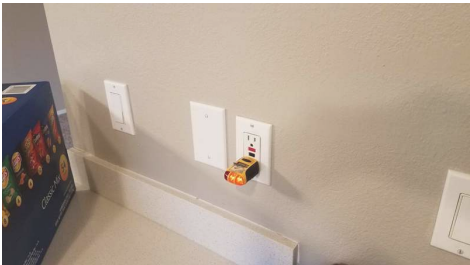
The GFCI outlet worked but didn't trip when tested. Recommend replacement of the outlet.

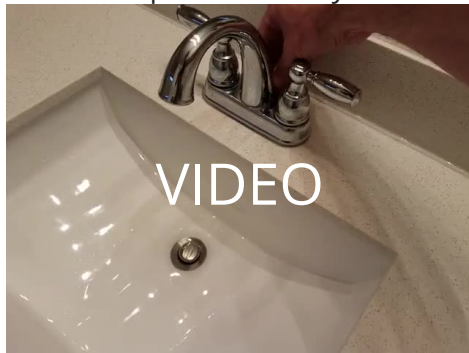
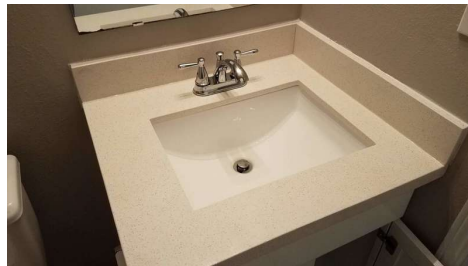
The sinkstopper does not work properly and repair is recommended.

Contact a qualified handyman.

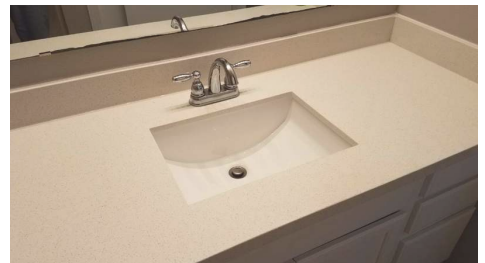
11.2.1 Trap and Drain

SLOW DRAIN

Contact a qualified handyman.

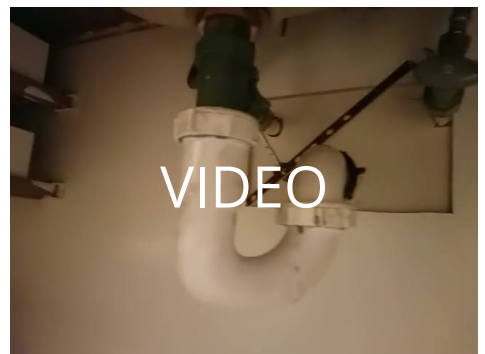
11.2.2 Trap and Drain

LEAK AT DRAIN LINE BELOW THE SINK

There is a leak at the drain line below the sink which should be repaired as necessary.

Contact a qualified professional.

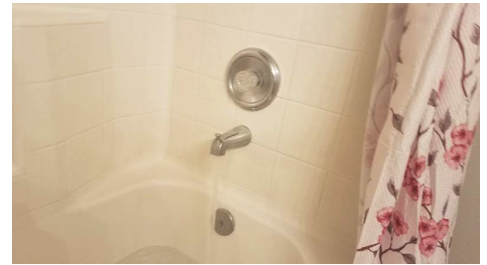
11.4.1 Tub-Shower

**HOT AND COLD
REVERSED**

The tub/shower the hot and cold water lines are reversed and should be serviced or correctly labeled as you feel necessary. Hot water is on the right side and cold water is on the left side; this is opposite of the usual set up. I recommend correcting this issue to help prevent the possibility of a scalding type injury. This may be as easy as turning the cartridge 180 degrees but you should consult with a plumber.

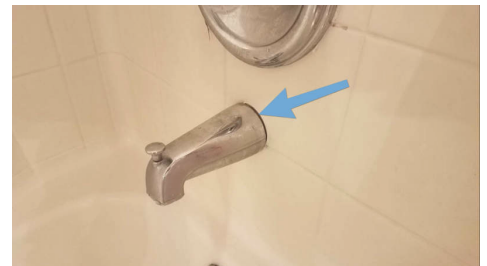
11.4.2 Tub-Shower

CAULKING OR SEALING

I recommend caulking or sealing around shower valves and faucets etc to help prevent moisture intrusion behind or into the walls. Monitoring these areas is also recommended to help ensure an adequate seal is in place.

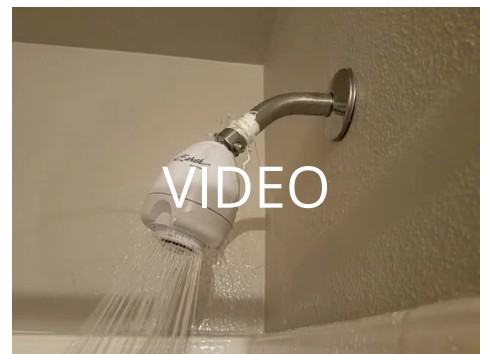
11.4.3 Tub-Shower

SHOWER HEAD LEAK

The shower head leaked at the base of the head or hose. The joint should be tightened or sealed to prevent leakage.

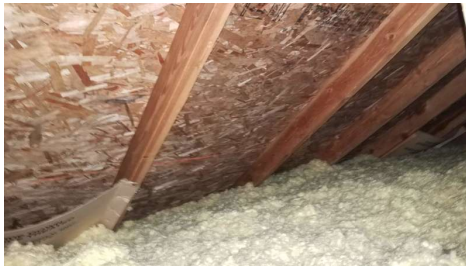
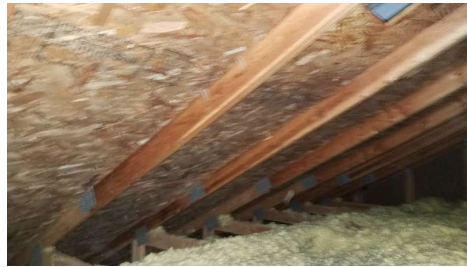
Discoloration and dark staining was observed on the roof sheathing. This is often caused by poor ventilation and is commonly considered a microbial growth. Recommend improving ventilation and cleaning.
