HOME INSPECTION REPORT

5230 Nathan Loop
Auburn WA 98092

Carolyn Bass
JULY 26, 2019

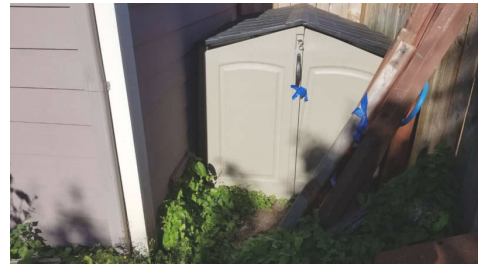
3.3.2 Site & Other Observations

FOUNDATION / SIDING BLOCKED

There were items blocking access to parts of the siding/foundation at the time of inspection. These areas were not able to be inspected at this time. Recommend further evaluation when access is available.

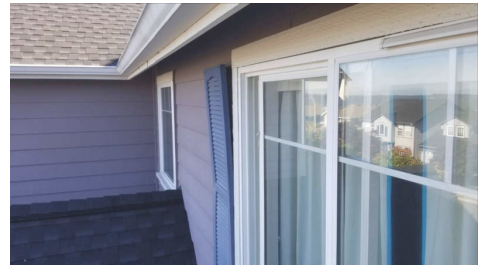
3.5.4 Exterior Siding Notes

DECORATIVE SHUTTER LOOSE

A decorative shutter appearwd to have come partway loose. Recommend securing.

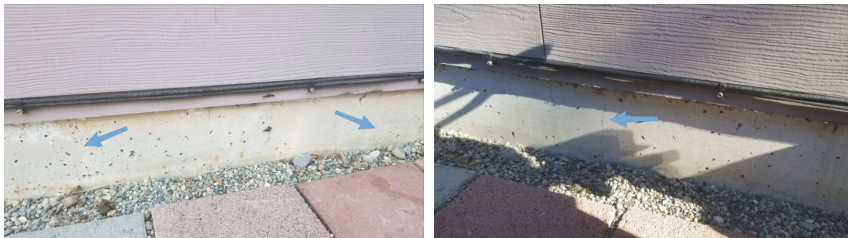
3.6.1 Foundation as Viewed from the Exterior

SMALL CRACKS

Hairline and/or small cracks, within normal tolerances were visible. This type of cracking is often a result of shrinkage of materials and/or minor settlement and usually does not affect the performance of the foundation.

Recommend monitoring.

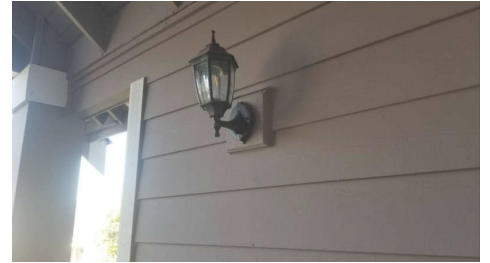
Observed exterior lights that did not work on demand and should be serviced as necessary or demonstrated. Maybe just bad bulbs?

Contact a qualified handyman.

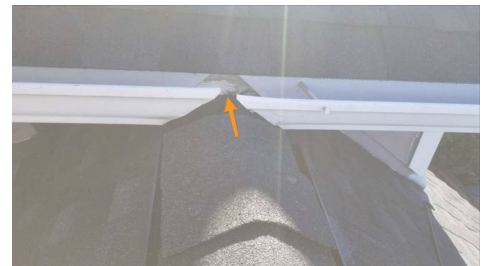
The siding or trim material is in contact with or very close to the roof surface. This may lead to water damaged siding. Recommend proper installation by leaving a 1-1.5' roof/siding gap and use of sidewall flashing.

Contact a qualified roofing professional.

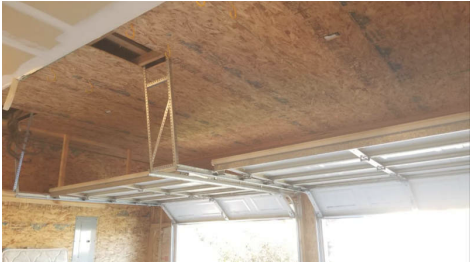
There was not a garage door opener present during the inspection. Recommend installing as desired.

Recommendation
Contact a qualified garage door contractor.

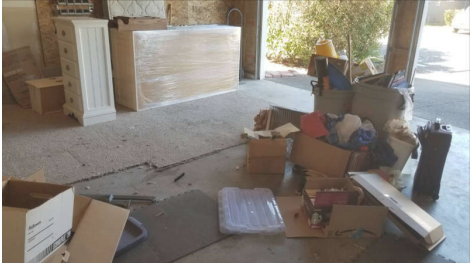
5.5.1 Slab Floor

The garage is too full of storage to permit a clear view of the entire slab. I recommend evaluating the floor yourself once the storage is removed.

Recommendation
Recommended DIY Project

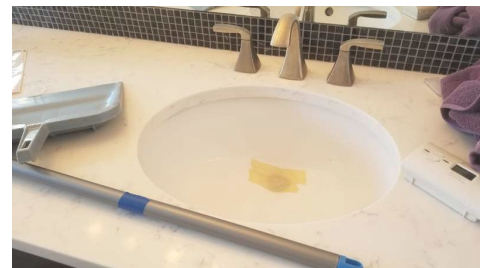
SINK DRAIN TAPED/NOT TESTED

A bathroom sink drain was taped off. Recommend testing

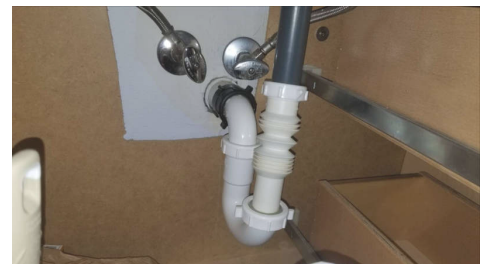
11.2.1 Trap and Drain

Flexible drainpipes clog more often than traditional rigid piping. I recommend monitoring and repairing as needed.

Contact a qualified professional.

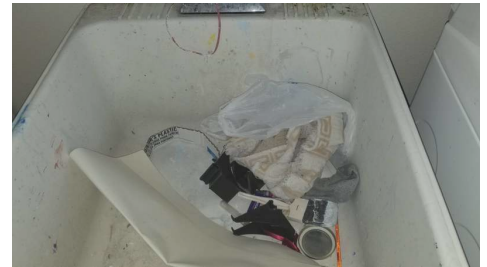
Laundry sink was not tested as it was full of sellers items.

Recommend running it for a duration and checking for leaks during or before final walkthrough.

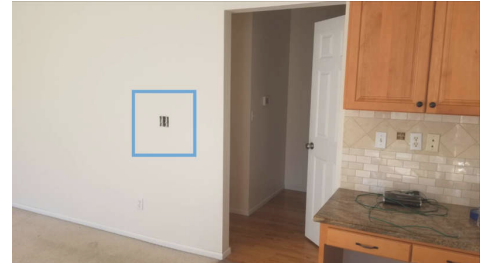
13.13.1 Outlets, Electrical

MISSING COVERS

Contact a qualified handyman.

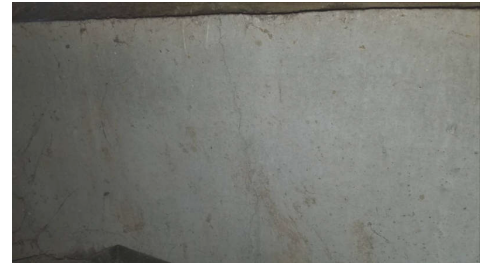
15.2.1 Foundation

MINOR CRACKS

Recommend monitoring.
