MOUNTAINS TO SOUND HOME INSPECTION LLC

HOME INSPECTION REPORT

10314 Mt Tacoma Dr SW
Tacoma WA 98498

Bertha Smith
FEBRUARY 20, 2019

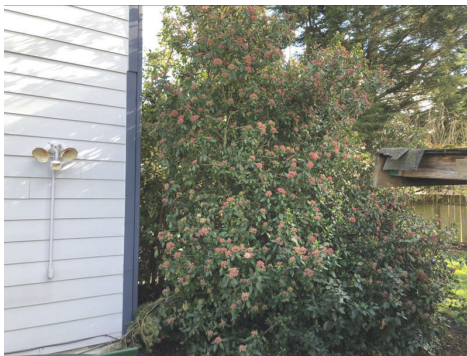
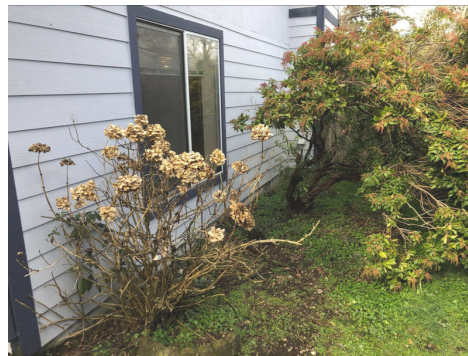
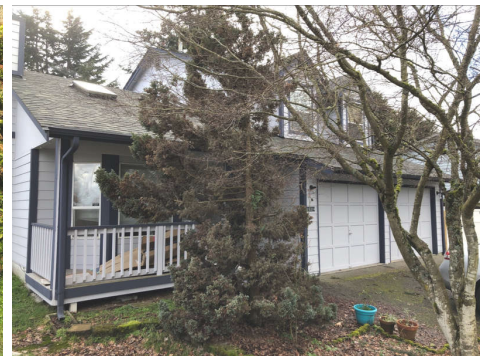
3.5.1 Exterior Siding Notes

VEGETATION IS ENCROACHING

Vegetation is encroaching on the structure, and should be kept a minimum of twelve inches away for the general welfare of the walls and foundation.

Contact a qualified landscaping contractor

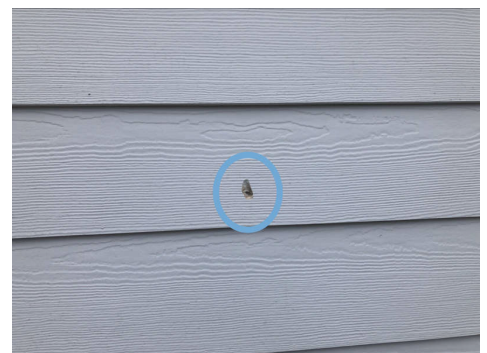
3.5.2 Exterior Siding Notes

MINOR DAMAGE

Contact a qualified professional.

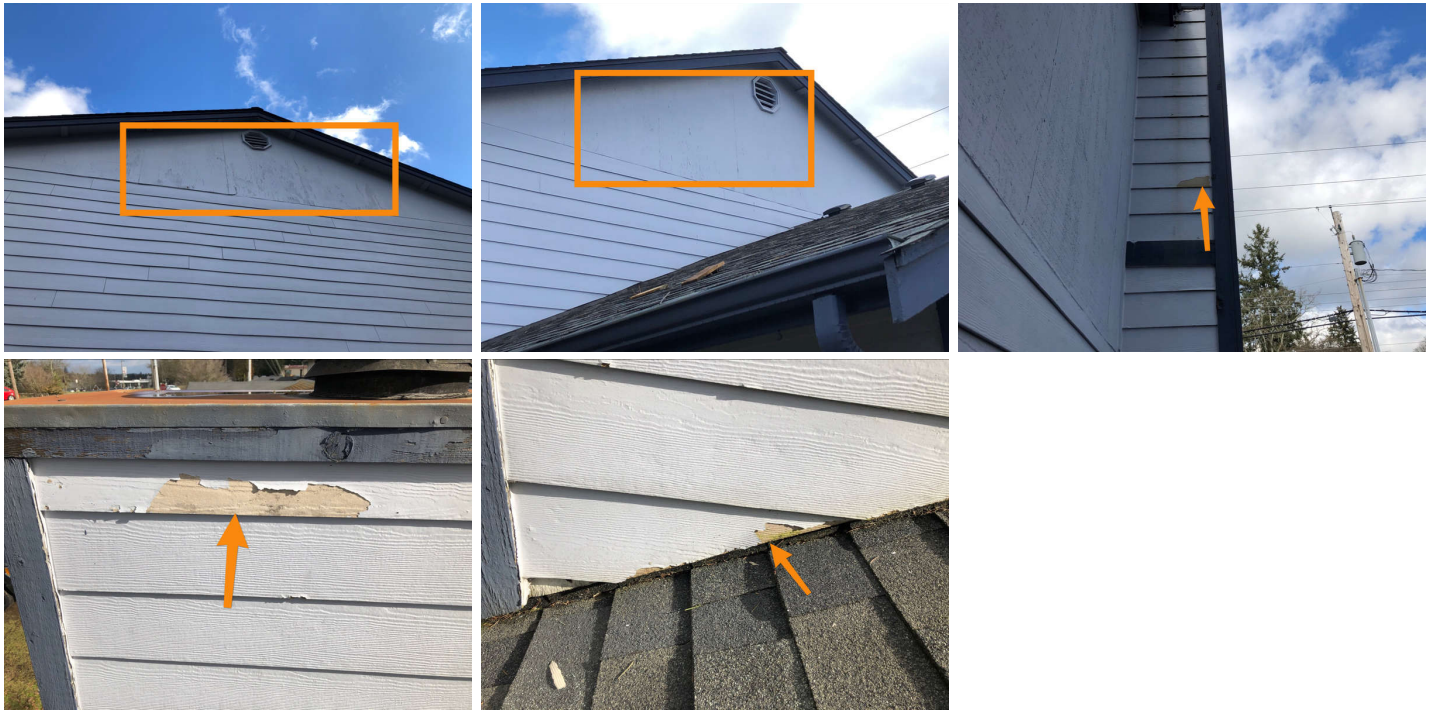
3.5.3 Exterior Siding Notes

WEATHERED SIDING

The exterior siding is weathered. Maintenance and minor repairs are recommended.

Contact a qualified professional.

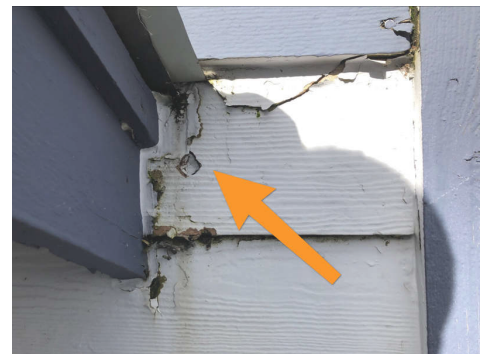
3.5.4 Exterior Siding Notes

SIDING MOISTURE DAMAGED

Portions of the siding are moisture damaged and should be further evaluated by a contractor.

Contact a qualified siding specialist.

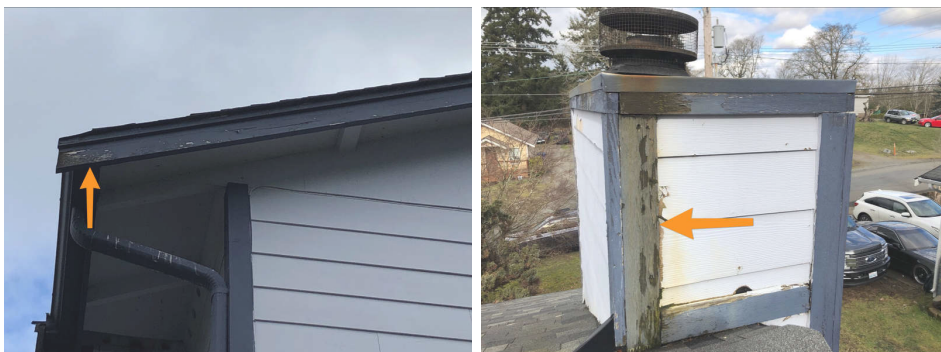
3.7.1 Fascia, Trim & Eaves

SECTIONS OF FASCIA OR WOOD TRIM ARE WEATHERED

Sections of the fascia board or wood trim around the residence are slightly weathered, and should be serviced as necessary to prevent further deterioration. Service such as scraping, repainting and sealing.

Contact a qualified handyman.

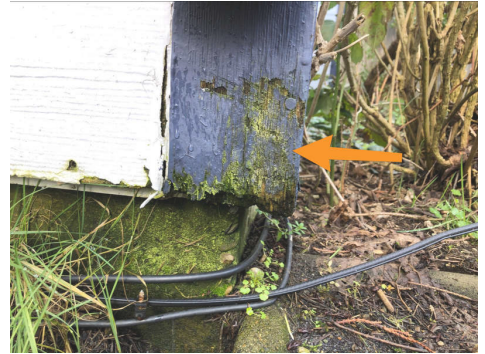
3.7.2 Fascia, Trim & Eaves

**SECTIONS OF FASCIA & TRIM
MOISTURE DAMAGED**

Sections of the fascia board or wood trim are weathered, moisture damaged and should be serviced or replaced as necessary by a qualified professional contractor to help prevent further wear or deterioration.

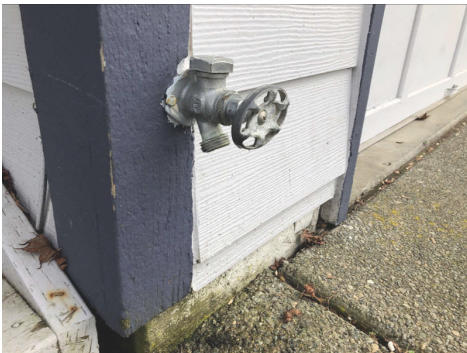
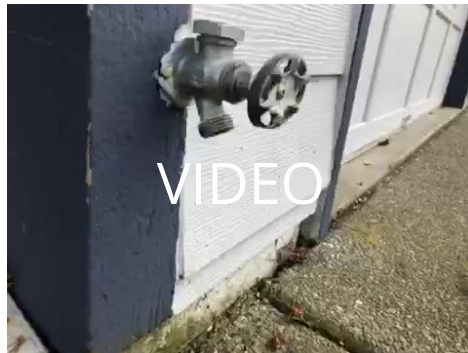
3.8.1 Exterior Plumbing

DRIPPING HOSE BIB

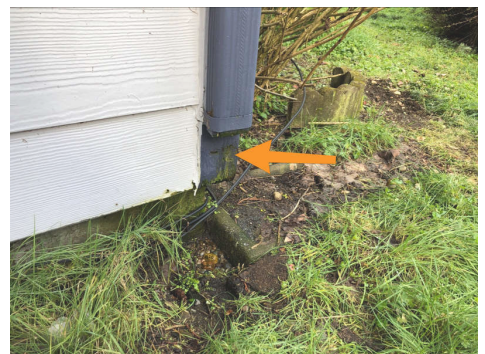
3.9.1 Downspouts

**DOWNSPOUTS MISSING
COMPONENTS**

The downspout are missing parts. Recommend repairs to allow for proper drainage away from the structure.

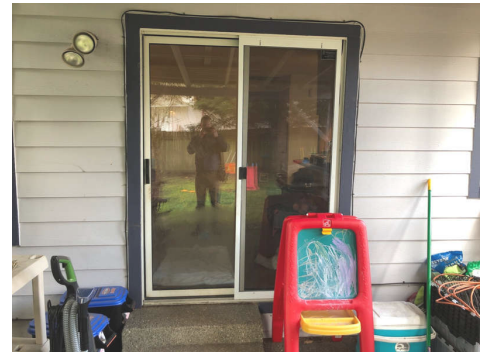
3.10.1 Exterior Doors

**SLIDING DOOR DOES NOT ROLL
SMOOTHLY**

Contact a qualified handyman.

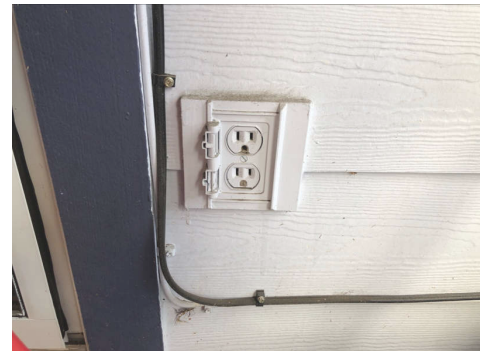
3.16.1 Outlets, Electrical Observations

MISSING OUTLET COVERS

There are missing outlet covers that should have a weather cover for safety reasons.

Contact a qualified handyman.

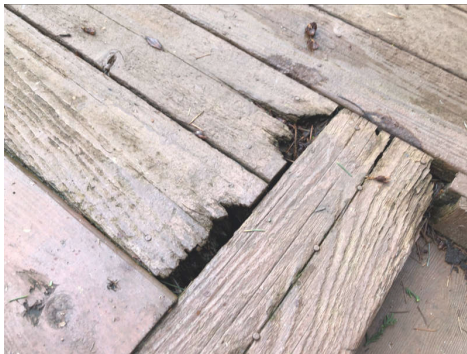
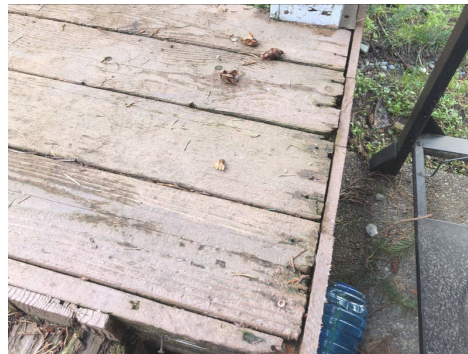
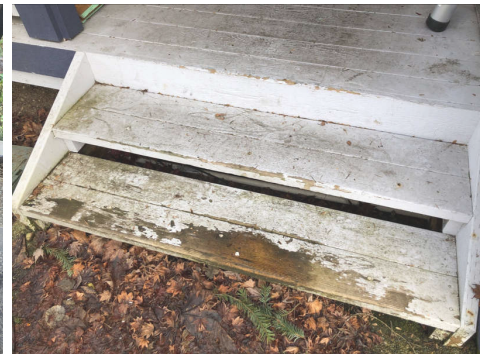
3.17.1 Deck

WEATHERED/DETERIORATED

Portions of the deck we're weathered and deteriorated and in need of repairs and maintenance.

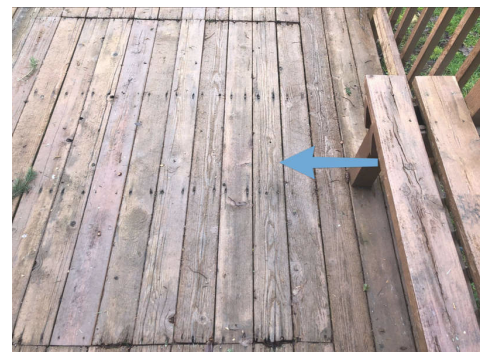
3.17.2 Deck

LOOSE DECK BOARD

One or more deck boards are loose. We recommend securing to prevent it potential trip hazard.

Contact a qualified professional.

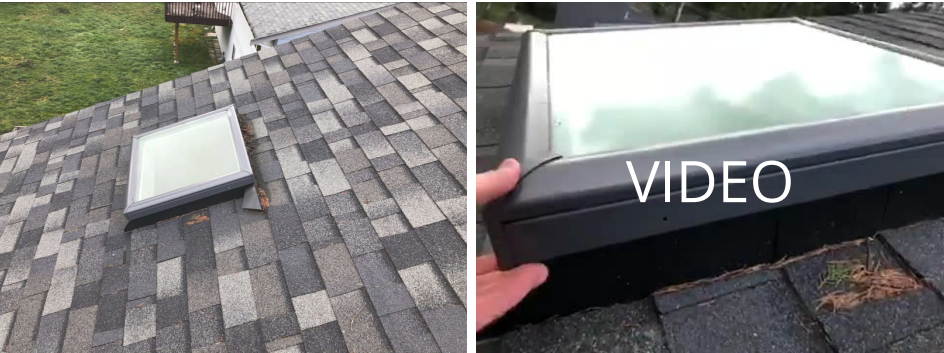
4.6.1 Skylights

LOOSE SKYLIGHT

The skylight is loose. We recommend securing.

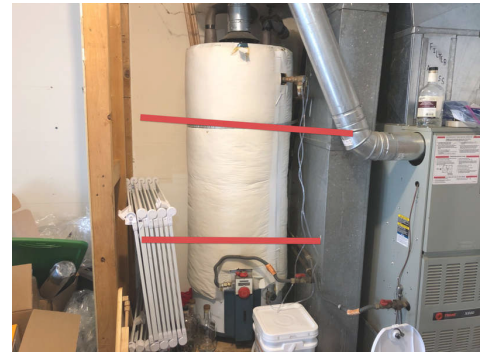
**SEISMIC STRAPS -
MISSING/INSUFFICIENT**

The hot water heater was missing seismic straps or was insufficiently anchored. Recommend two straps to properly secure water heater in the case of an earthquake.

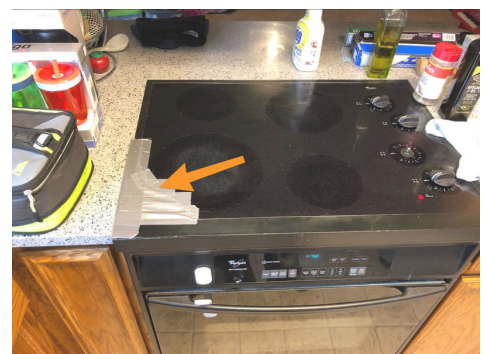
10.3.2 Range

RANGE DAMAGE
