# MOUNTAINS TO SOUND HOME INSPECTION LLC

## HOME INSPECTION REPORT

7122 Husky Way SE  
Olympia WA 98503

JUNE 5, 2020

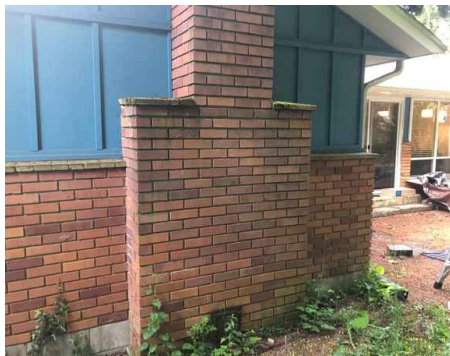
**Exterior Chimney: Serviceable Condition**

The exterior chimney was in serviceable condition. See additional notes in the roofing section of this report.

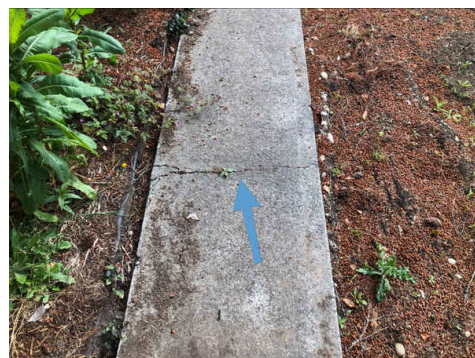
## 3.2.2 Driveway, Walkways &amp; Patio

**CRACKS IN WALKWAYS**

There are a few cracks in the walkways around the residence that are mostly cosmetic. We suggest you view these yourself and repair as necessary.

Contact a qualified professional.

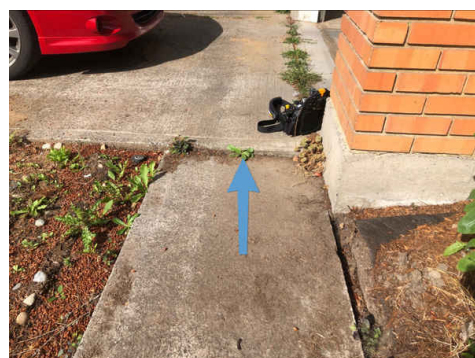
## 3.2.3 Driveway, Walkways &amp; Patio

**WALKWAY-TRIP HAZARD**

There is an offset in a walkway that could prove to be a trip-hazard. I recommend using caution when walking in this area.

Contact a qualified concrete contractor.

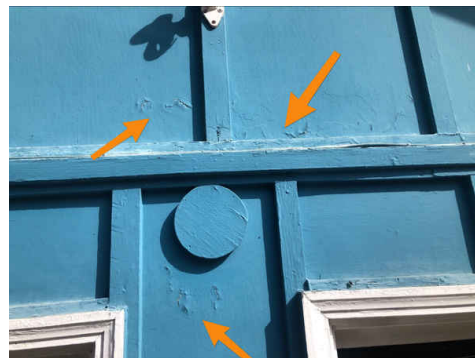
## 3.5.1 Exterior Siding Notes

The exterior siding is weathered. Maintenance, paint and minor repairs are recommended.

Contact a qualified professional.

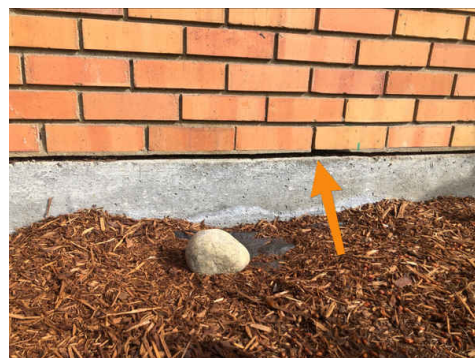
## 3.5.2 Exterior Siding Notes

**MISSING/DETERIORATED MORTAR**

There are areas in the brick siding where mortar is missing or deteriorated. Recommend repairs by a licensed professional.

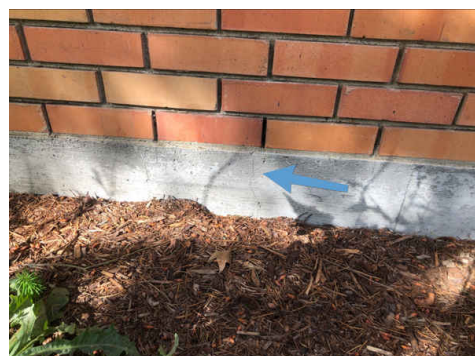
## 3.6.1 Foundation as Viewed from the Exterior

**SMALL CRACKS**

Hairline and/or small cracks, within normal tolerances were visible. This type of cracking is often a result of shrinkage of materials and/or minor settlement and usually does not affect the performance of the foundation.

Recommend monitoring.

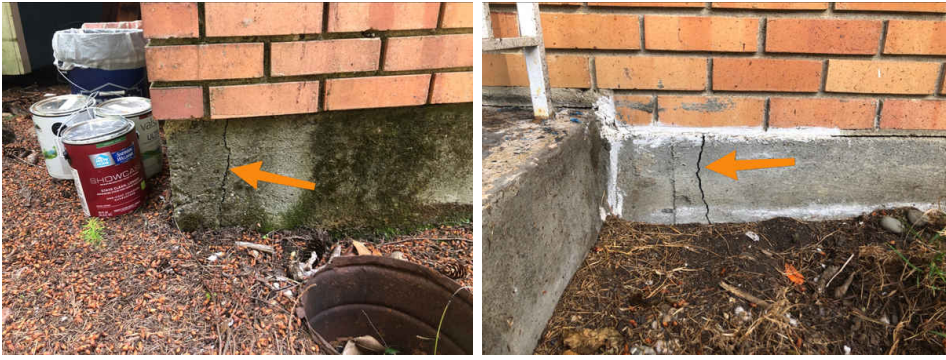
## 3.6.2 Foundation as Viewed from the Exterior

**CRACKS MODERATE**

Moderate sized cracks were observed on the Exterior foundation. This suggests unstable or settling soils. Recommend a soil or structural engineer should be consulted for corrective repairs. This may include sealing the pieces back together with a concrete or similar patch. Sealing is to deny possible moisture entry. a structural engineer evaluate and provide a report on course of action and remedy.

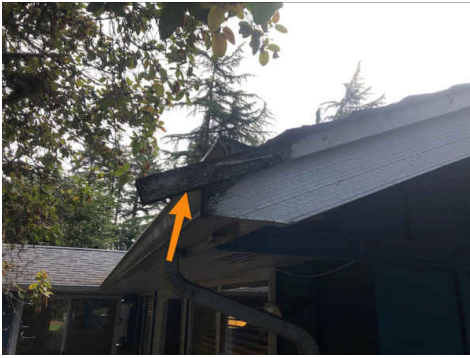
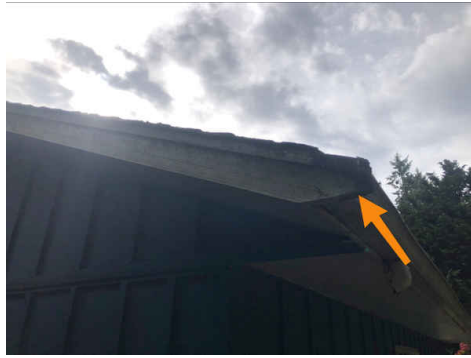
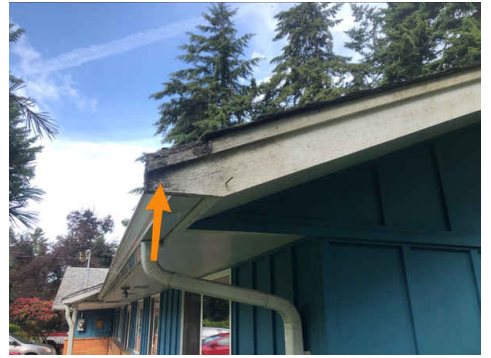
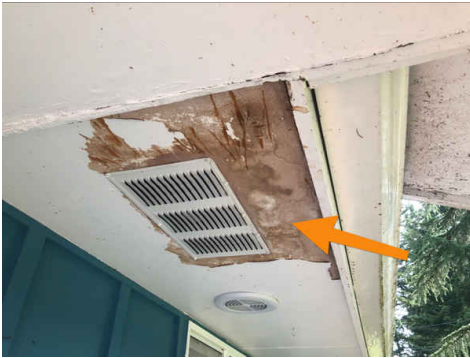
Sections of the fascia board or wood trim around the residence are slightly weathered, and should be serviced as necessary to prevent further deterioration. Service such as scraping, repainting and sealing.

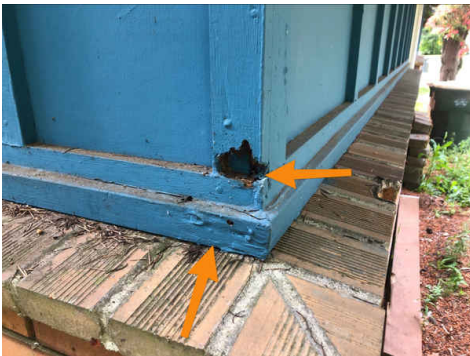
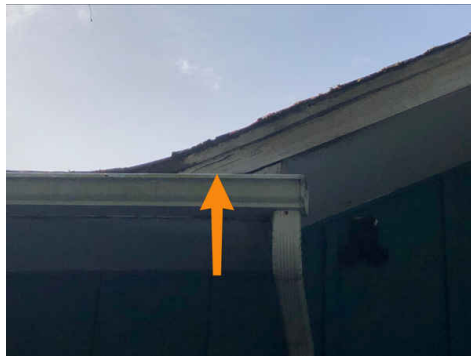
### 3.7.4 Fascia, Trim & Eaves

#### **SECTIONS OF FASCIA & TRIM MOISTURE DAMAGED**

Sections of the fascia board or wood trim are weathered, moisture damaged and should be serviced or replaced as necessary by a qualified professional contractor to help prevent further wear or deterioration.

Contact a qualified handyman.

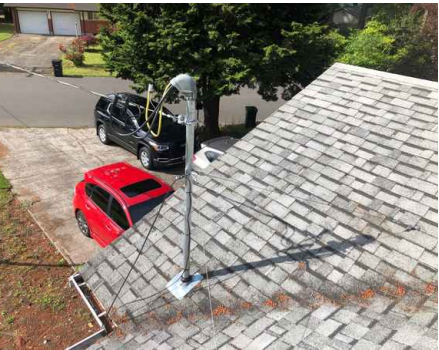
### Roof Electrical : Electrical Strike Photo

The electrical strike and mast were in acceptable condition.

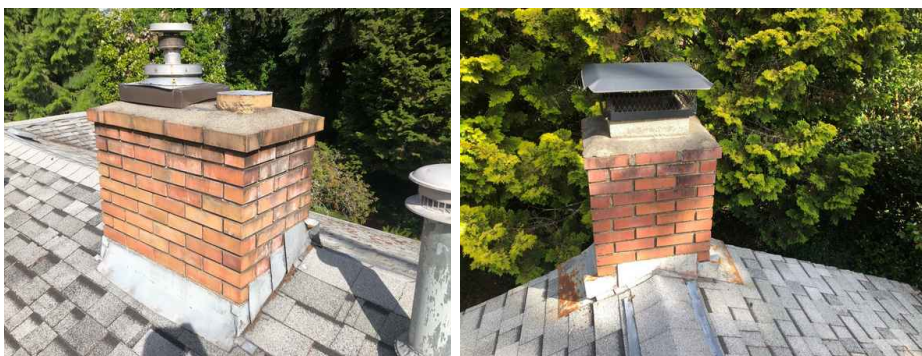
## Chimney On Roof & Photo: Chimney Photo

The the chimney above the roof is in acceptable condition. Any exceptions will be noted.

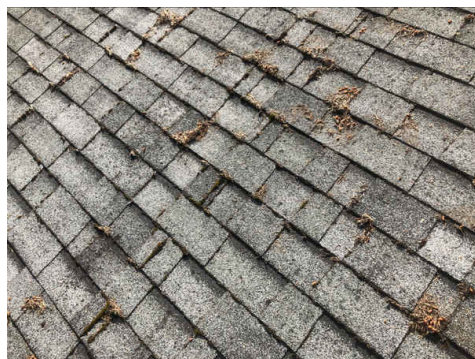
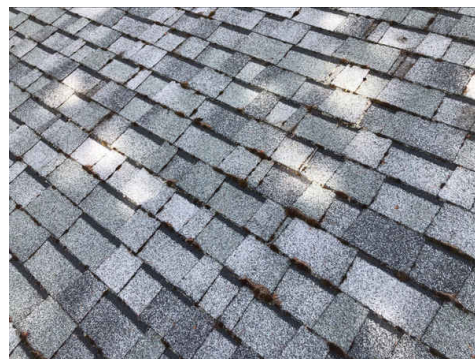
Parts of the roof need to be cleaned of moss and/or debris. This can restrict drainage and lead to moisture intrusion and moisture damage if not corrected.

Contact a qualified professional.

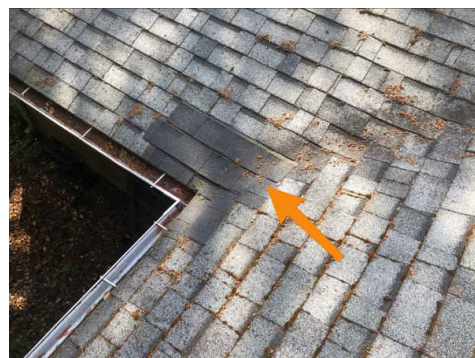
## 4.3.3 General Observations

**ROOF PATCH**

Repairs and/or patches have been made to the roofing material in several areas. We cannot determine the reason or condition of the repairs. Monitoring is advised for future issues or conditions. An additional evaluation of the roof would be appropriate.

Contact a qualified professional.

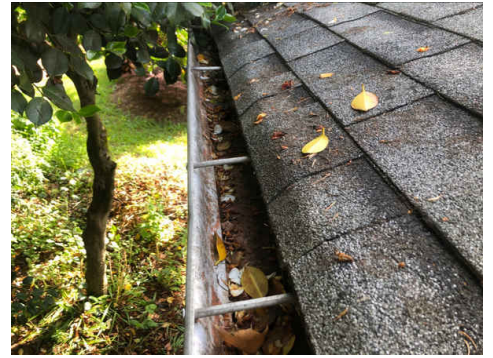
## 4.5.1 Gutters &amp; Drainage

**GUTTERS NEED TO BE CLEANED OF DEBRIS**

Contact a qualified roofing professional.

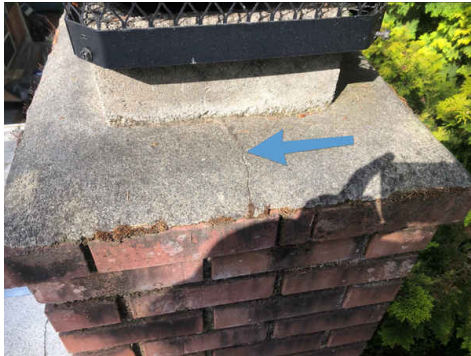
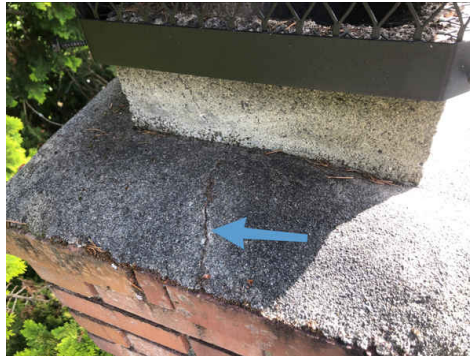
#### 4.6.1 Chimney On Roof & Photo

### **THE CROWN IS CRACKED AND SHOULD BE SEALED TO HELP PREVENT FURTHER WEAR AND MOISTURE INTRUSION**

The crown, which is designed to seal the chimney wall and shed rainwater, has minor cracks and should be sealed to help prevent further wear and moisture intrusion.

Contact a qualified handyman.

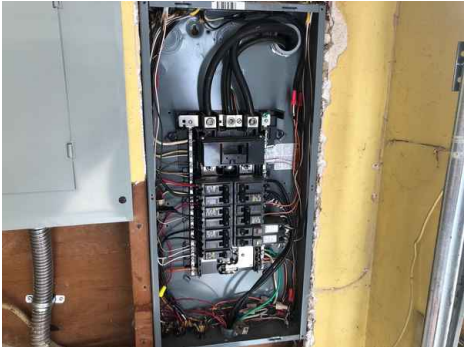
<b>Service Entrance: Main Lines</b> Overhead	<b>Service Entrance: Main Lines</b> <b>Acceptable</b>  The electrical service entrances are acceptable.	<b>Panel Size, Location &amp; Photo:</b> <b>Panel Amps, Location and Picture</b> Garage, 200 AMP

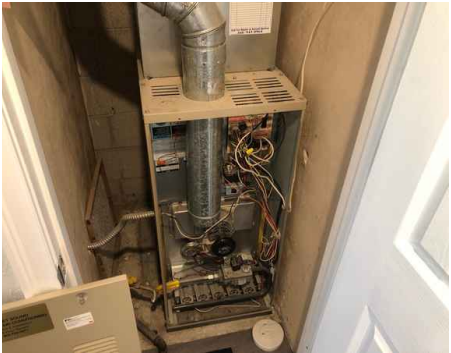
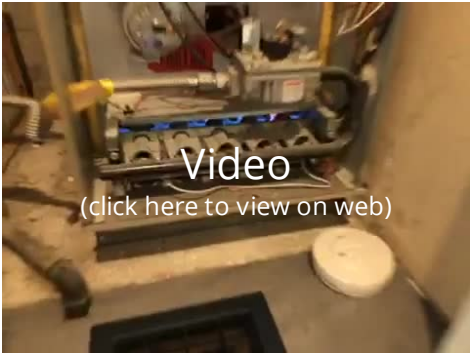
### General Notes & Photos: Equipment Photos

<b>General Notes &amp; Photos: Energy Source/Type</b> Gas	<b>Furnace Notes: Year</b> 2000	<b>Furnace Notes: Power Source/Type</b> Gas
<b>Furnace Notes: Limit switches</b> The safety switches for the gas furnace were acceptable.	<b>Vent Pipe: Acceptable</b> The gas furnace vent pipe is in acceptable condition.	<b>Thermostats: Acceptable</b> The thermostats were functional at the time of the inspection.
<b>Registers: Acceptable</b> The air supply registers are reasonably clean and appear functional.

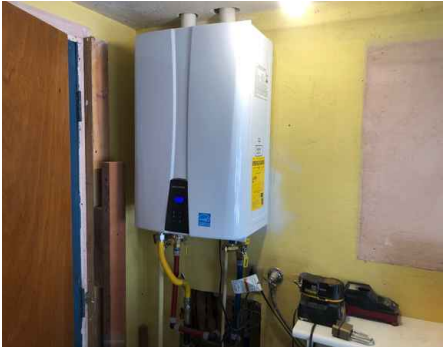
<b>Tankless Water Heaters: Location &amp; Photo</b>	<b>Main Water Shut-Off, Distribution &amp; Supply: Main Water Shut off Location</b>	<b>Main Water Shut-Off, Distribution &amp; Supply: Water Meter Location</b>
Garage	Not found	Front
Hot water is provided by a tankless, water heater that is wall-mounted.

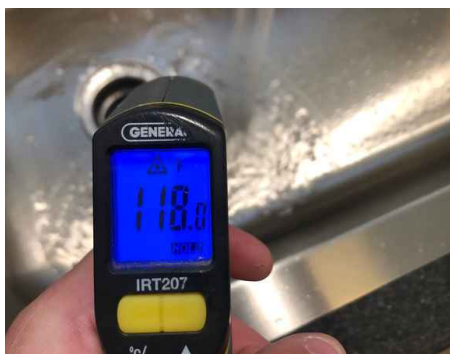
#### Sink and Faucet: Water temp

The Water temp at the Kitchen Faucet is Currently noted in the photo below. The U.S. Consumer Product Safety Commission (CPSC) urges all users to keep their water heater temps at 120 degrees Fahrenheit to prevent scalding and bacteria prevention reasons.

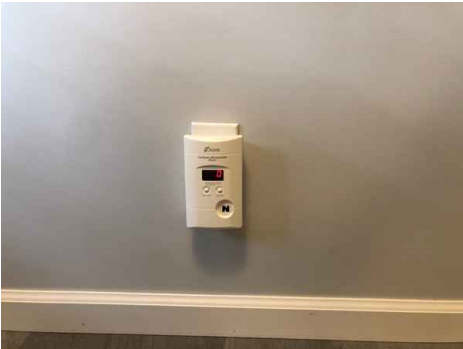
**Smoke & CO Detectors Notes:  
Carbon monoxide detectors present**

Carbon monoxide detectors were present where required.

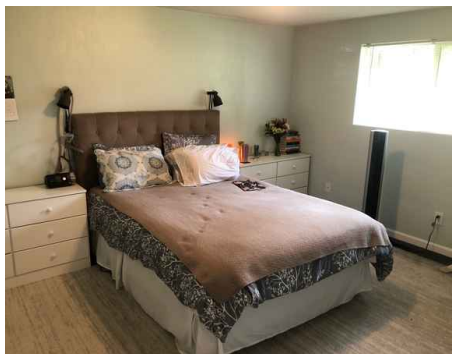
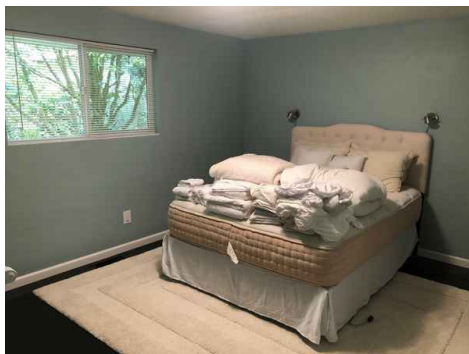
## General Notes: Bedrooms Photos

These photos are to show the condition of the bedrooms at the time of the inspection.

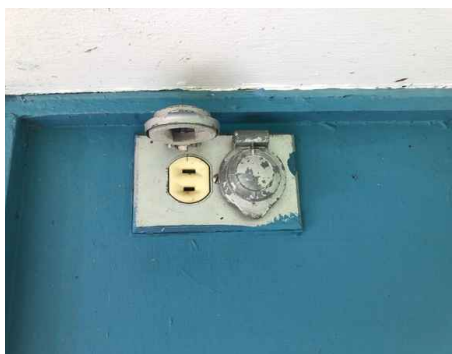
## General Notes: Obsolete two prong ungrounded type

Many outlets throughout the residence are an obsolete, two prong, ungrounded type that are recommended to be evaluated by an electrician, before the close of escrow, and upgraded to have ground-fault protection as a modern safety feature.

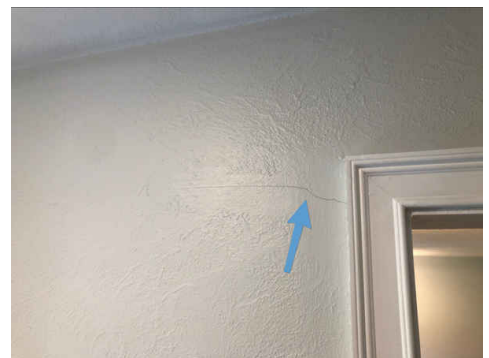
**TYPICAL SETTLEMENT CRACKING/NAIL POPS**

Observed typical settlement type cracking and nail pops on walls and ceilings. Recommend repairs as needed. Home owner to identify all areas for repair.

Recommend monitoring.

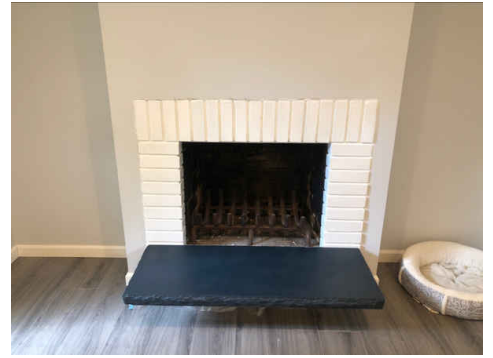
**DOORS/SCREEN MISSING**

No doors or screen or installed at the fireplace. We recommend the door or screen be installed.

Contact a qualified professional.

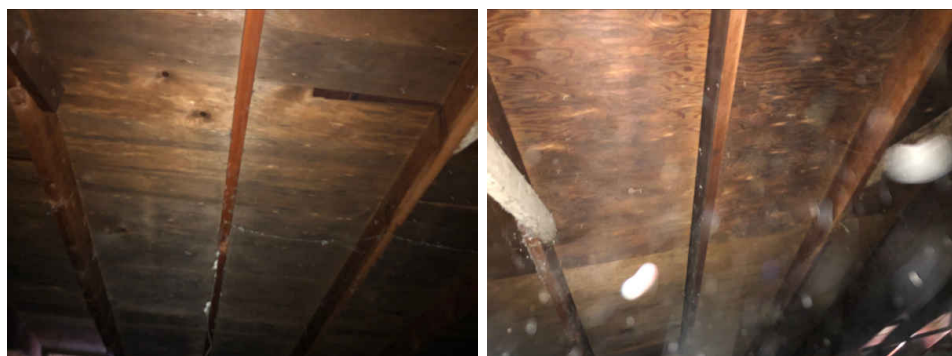
#### DECK STAINING

Discoloration and dark staining was observed on the roof sheathing. This is often caused by poor ventilation and is commonly considered a microbial growth. Recommend improving ventilation and cleaning.

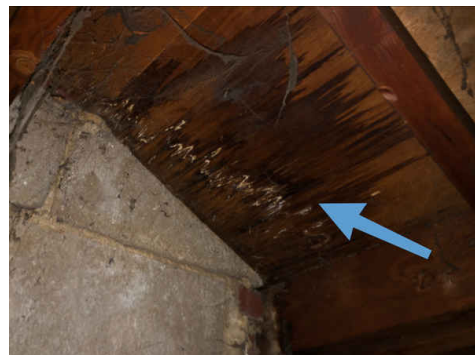
## 15.3.2 Roof Decking Notes

**MOISTURE STAINS ON THE UNDERSIDE DECKING.**

There are obvious moisture stains on the underside of some wood decking, which is predictable and would not necessarily confirm an active roof leak. However, the possibility of an active leak could not be ruled out either. Therefore, you are recommended to have a qualified roof specialist evaluate further, before the close of escrow.

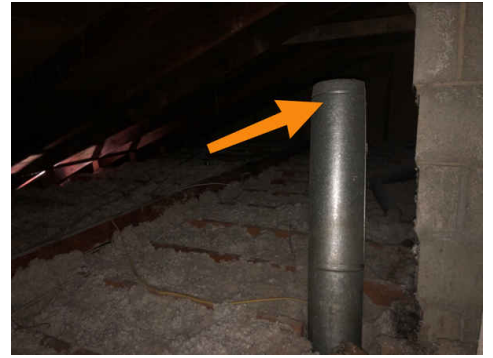
The kitchen exhaust duct should be extended to an exterior vent port.

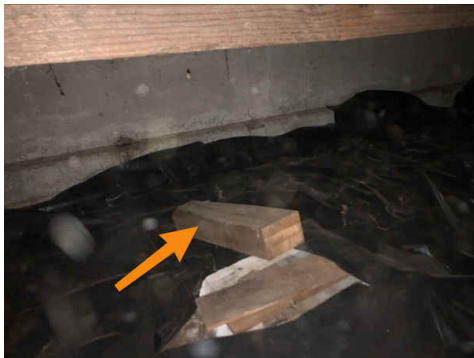
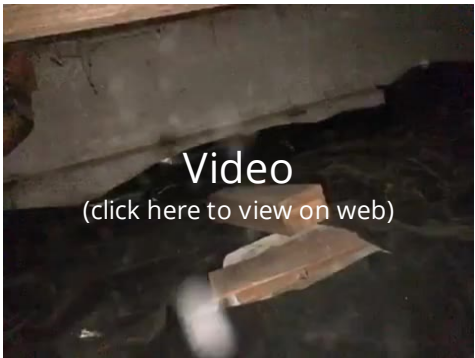
16.3.1 Sub-floor Structure

**PIERS HAVE SHIFTED OR SETTLED**

Contact a qualified professional.

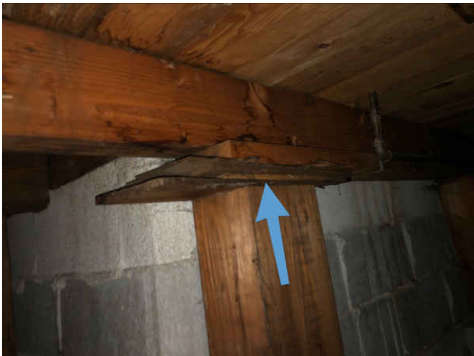
16.3.2 Sub-floor Structure

**EXCESSIVE SHIMMING AT POSTS**

Contact a qualified professional.
