PRO SPEX DECK SAFETY INSPECTION

15503 Sample Report Rd
LAUREL MD 20707

JULY 10, 2018

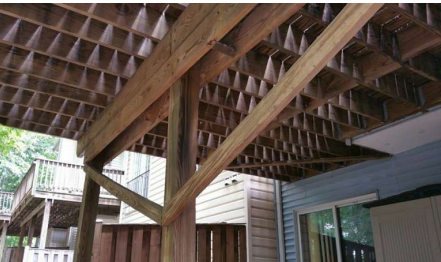
6 x 6 Posts used

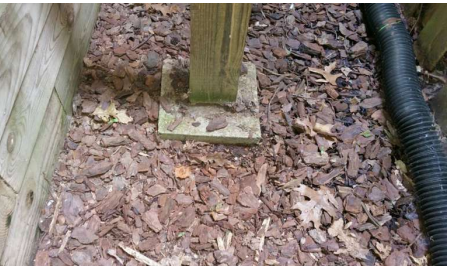
Visible footing

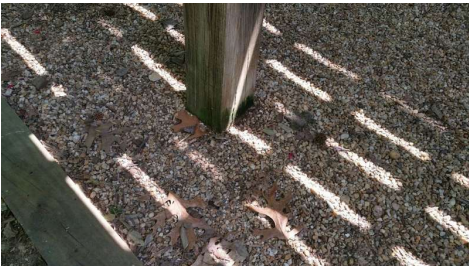
Footing not visible

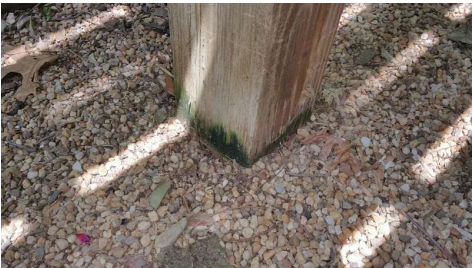
2.1.1 Footings

FOOTING NOT FOUND

Probing of the ground around the base of the column did not reveal the presence of a footing. Consult a qualified contractor to investigate further and correct as needed.

Contact a qualified deck contractor.

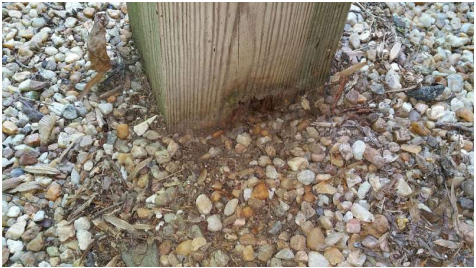
2.2.1 Support Posts (Columns)

ROT AT POST BASE

Probing the base of the posts indicate the presence of severe wood rot. The posts should be replaced.

Contact a qualified deck contractor.

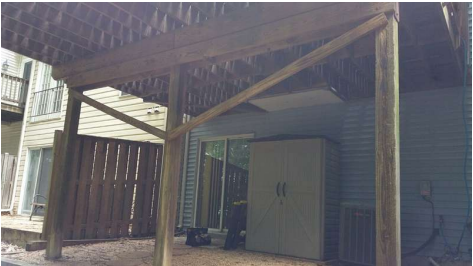
2.3.1 Bracing

BRACING INSTALLATION

Diagonal bracing is not properly installed. Proper installation is required to prevent lateral movement under extreme loads. Failure to correct can lead to deck failure.

Figure 10. Diagonal Bracing.

Contact a qualified deck contractor.

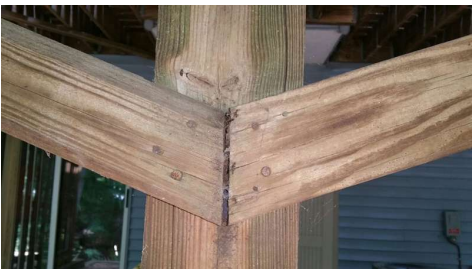
2.3.2 Bracing

BRACING SCREWS

Screws/Nails used at bracing. Minimum 1/2" lag screws should be used at diagonal bracing.

Figure 10. Diagonal Bracing.

Contact a qualified deck contractor.

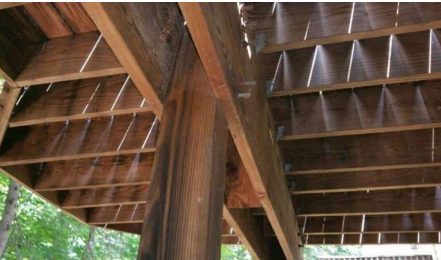
Deck Beam Assembly

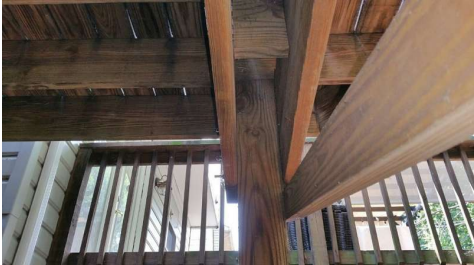
3.1.1 Beams Condition

POST TO BEAM SIDE MOUNT

The post and beam connections are incorrect. The deck posts should be 6x6 posts with a notch (shoulder) cut out to rest the post. Side mounting can cause the beam to split. This deck is unsafe and should not be used until corrections are made.

Figure 9. Prohibited Post-to-Beam Attachment Condition.

Figure 8A. Post-to-Beam Attachment Requirements.

Recommendation
Contact a qualified deck contractor.

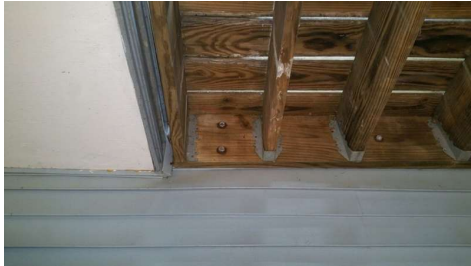
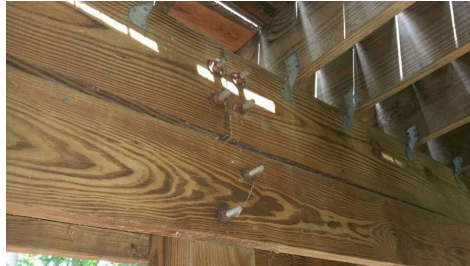
3.3.1 Fasteners (Hangers, ties etc.)

CORRODING BOLTS

The bolts are corroding, an indication the wrong type of bolts were used. Failure to address this could lead to separation and failure.

Contact a qualified deck contractor.

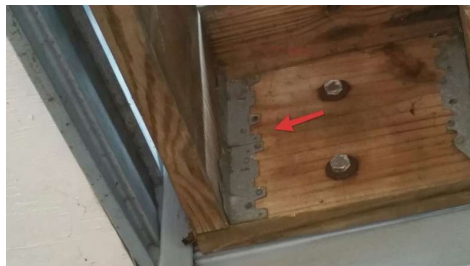
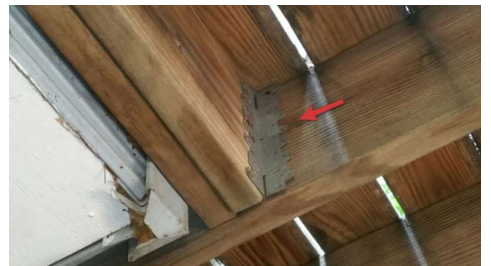
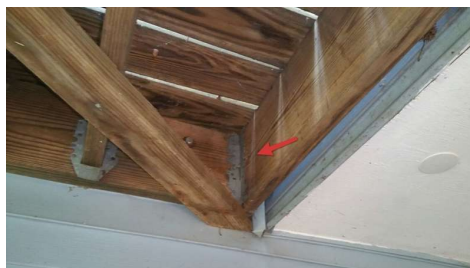
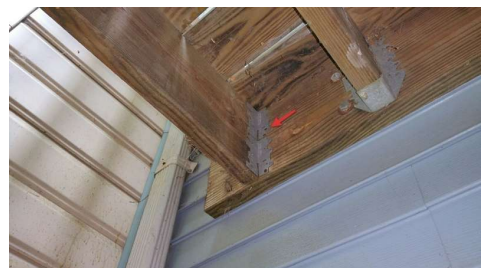
3.3.2 Fasteners (Hangers, ties etc.)

END JOIST TO LEDGER CONNECTION

The joist hangers to connect the outer deck joists (only the joists at each end of the deck) to the ledger board are missing, and the joist is nailed to the cut end of the ledger board. The joist should be attached to the ledger with a proper joist hanger to prevent the joist from rotating

Figure 7. Typical Joist Hangers.

Contact a qualified deck contractor.

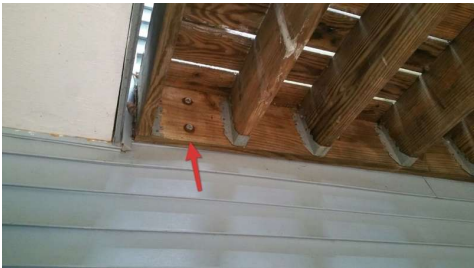
4.1.1 Ledger Board Attachment

CORRODING BOLTS

The washers are corroding, an indication the wrong type were used. Failure to address this could lead to separation and failure.

Contact a qualified deck contractor.

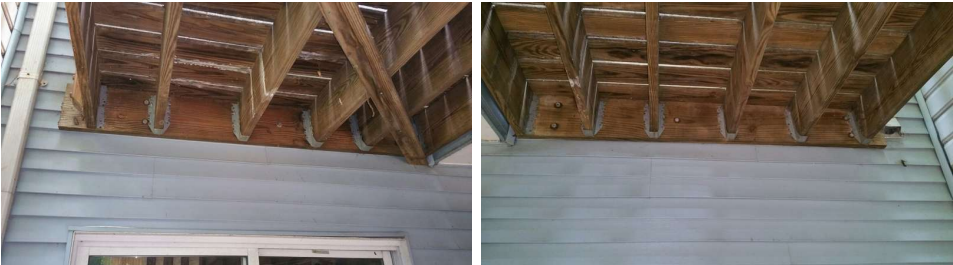
4.1.2 Ledger Board Attachment

STAGGERED BOLTS

The ledger board bolts should be staggered, alternating between joists. Failure to address this could lead to separation and failure.

Contact a qualified deck contractor.

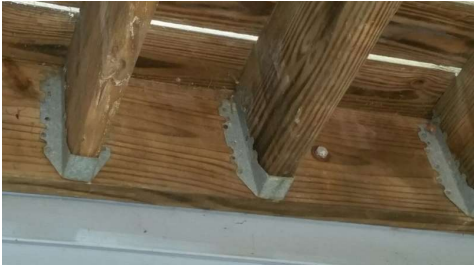
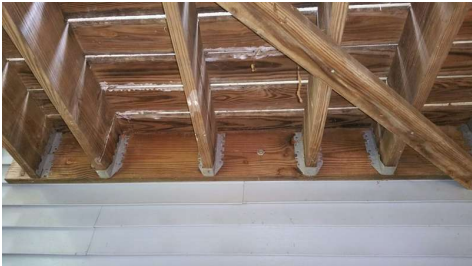
4.2.1 Ledger Board Flashing

MISSING FLASHING AT DECK

Decks attached to homes using the old standards, bolting to house frame, have been known to fail. This has often been traced to missing flashing where the deck attaches to the wall. There is no visible flashing at this deck. Recent changes to deck construction requirements call for interior posts and beam to provide independent support.

Independent post and beam at the interior side of the deck

Recommendation
Contact a qualified deck contractor.

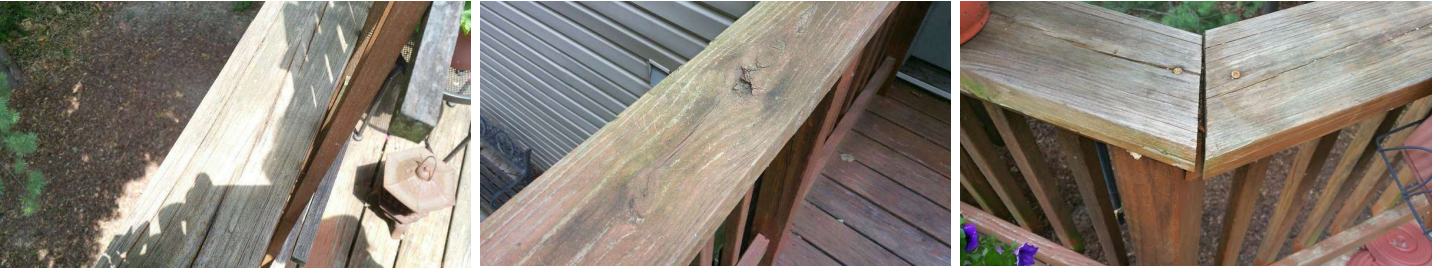
6.1.2 Guard Rails (34-38" AFF)

WORN RAIL

The rail caps are worn. Have replaced to improve safety.

Contact a qualified deck contractor.

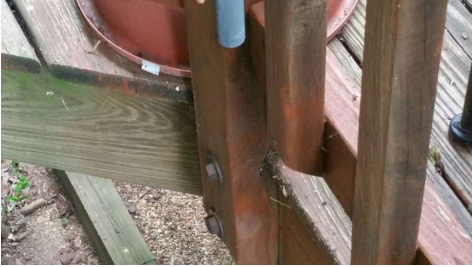
6.2.1 Guard Rails Posts

NOTCHED POST

The guardrail posts are notched at the connections to the rim board. This notch weakens the integrity of the guardrail.

Contact a qualified deck contractor.
