HOME INSPECTION REPORT

14410 215th Ave E
Bonney Lake WA 98391

JULY 14, 2021

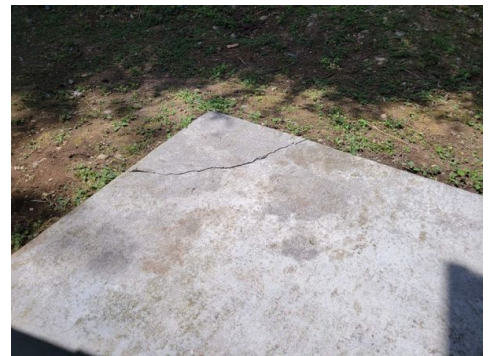
PATIO FLOOR CRACKS

There are cracks in the rear patio floor that you should view for yourself and correct as desired.

Contact a qualified concrete contractor.

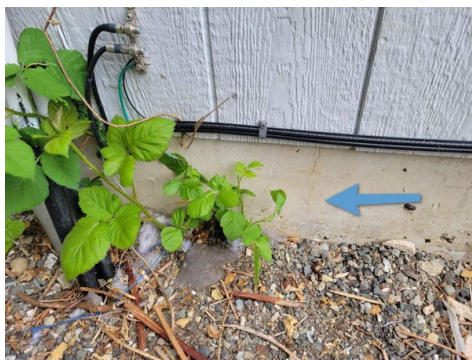
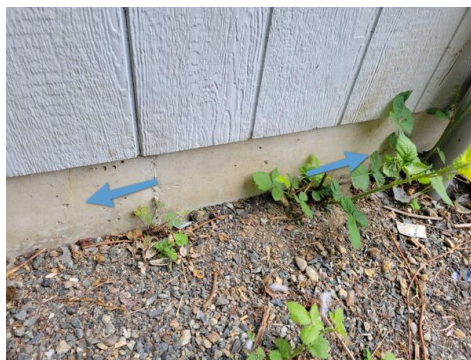
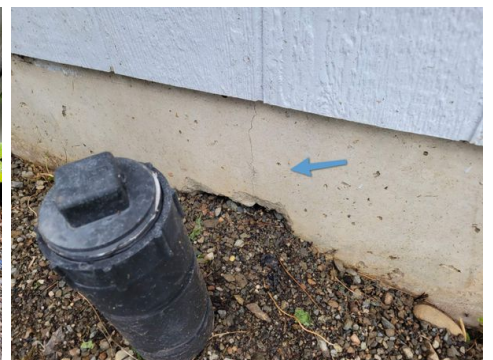
3.6.1 Foundation as Viewed from the Exterior

SMALL CRACKS

Hairline and/or small cracks, within normal tolerances were visible. This type of cracking is often a result of shrinkage of materials and/or minor settlement and usually does not affect the performance of the foundation.

Recommend monitoring.

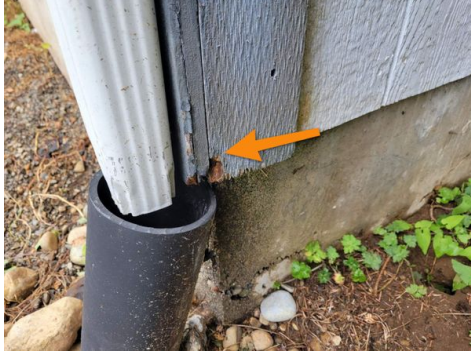
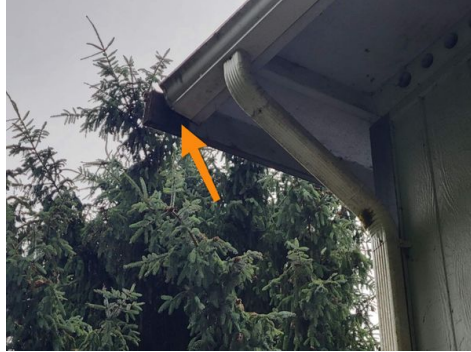
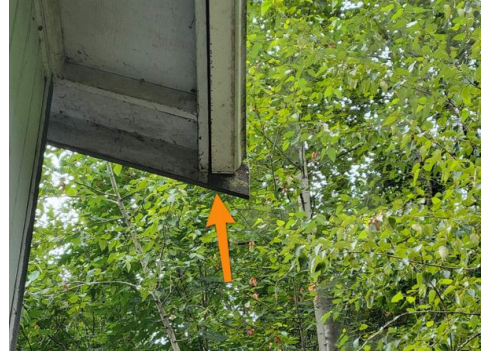
3.7.1 Fascia, Trim & Eaves

FASCIA AND TRIM NEED TYPICAL MAINTENANCE

Contact a qualified handyman.

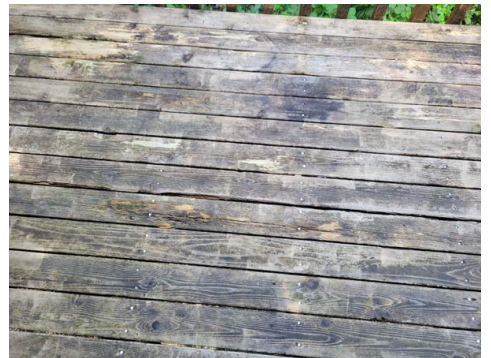
3.15.1 Deck

WEATHERED

REAR

Portions of the deck we're weathered and in need of minor repairs and maintenance.

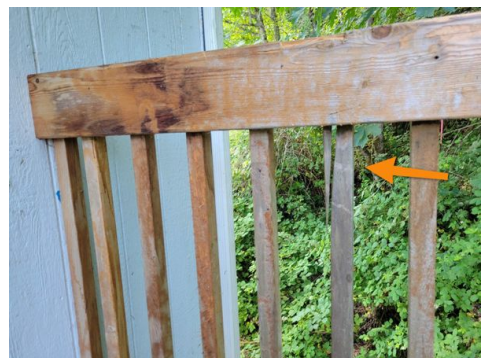
3.15.2 Deck

BALUSTERS BROKEN

Balusters on the deck rail are broken. Recommend replacement.

Contact a qualified professional.

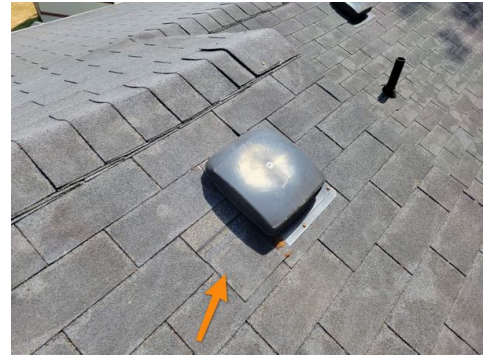
DAMAGED SHINGLES

There were one or more shingles that had damage. Recommend repairs by a licensed roofer.

Contact a qualified roofing professional.

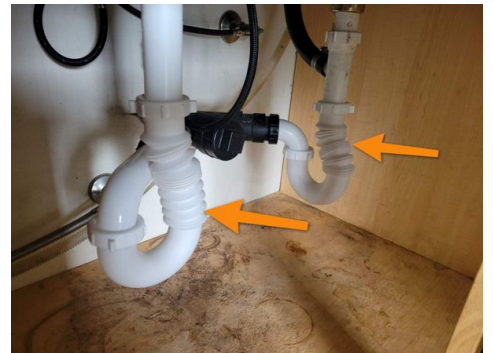
Flexible drainpipes clog more often than traditional rigid piping. I recommend monitoring and repairing as needed.

Contact a qualified professional.

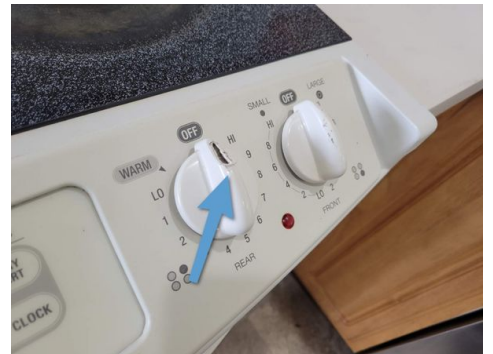
ONE OR MORE CONTROL KNOBS NEEDS REPAIR-REPLACED

A control knob on the range needs to be repaired or replaced.
Cosmetic damage

Recommended DIY Project

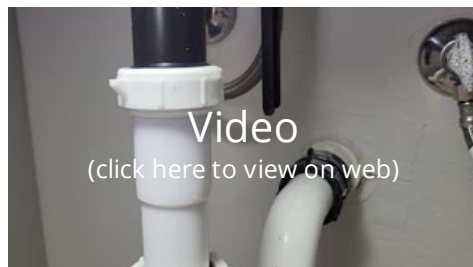
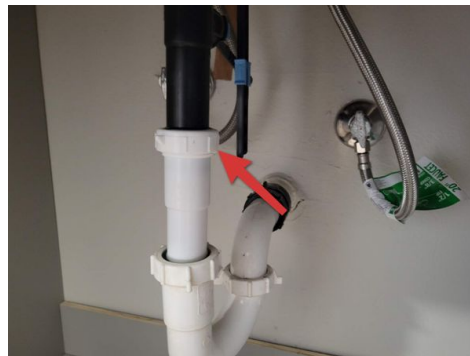
LEAK AT DRAIN LINE BELOW THE SINK

There is a leak at the drain line below the sink which should be repaired as necessary.

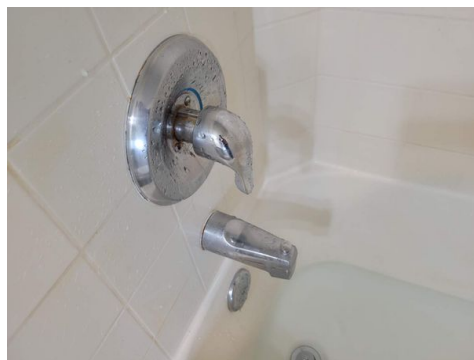
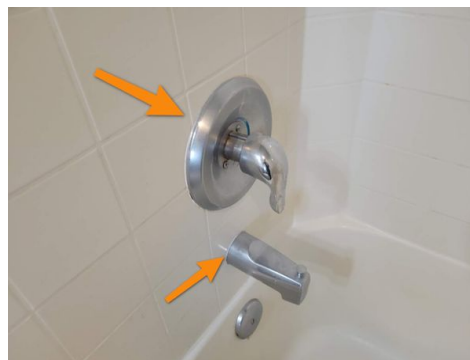
11.4.1 Tub-Shower

CAULKING OR SEALING

I recommend caulking or sealing around shower valves and faucets etc to help prevent moisture intrusion behind or into the walls. Monitoring these areas is also recommended to help ensure an adequate seal is in place.

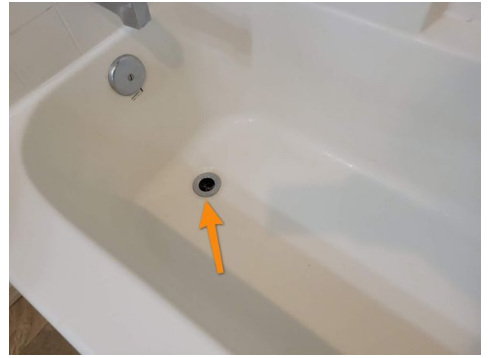
11.4.2 Tub-Shower

TUB STOPPER IS MISSING

The mechanical tub stopper is missing or incomplete and should be repaired or replaced.

Recommended DIY Project

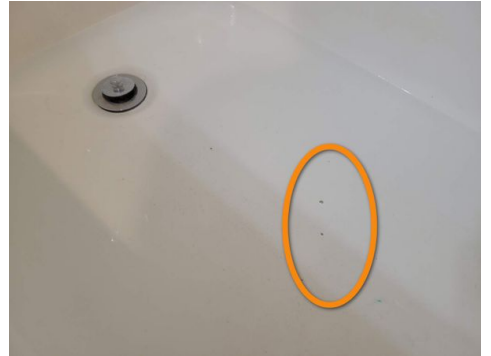
11.4.3 Tub-Shower

FEW DINGS IN TUB/SHOWER

There are a few dings in the tub or shower that should be repaired for safety reasons and to prevent moisture intrusion.

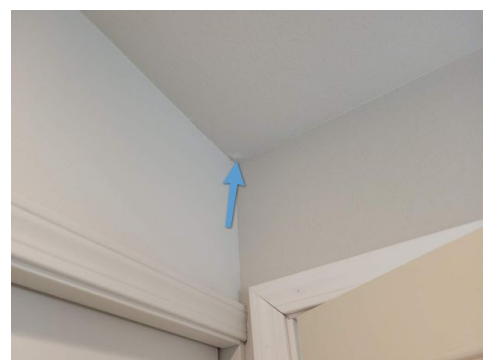
13.4.1 Walls and Ceiling

TYPICAL SETTLEMENT CRACKING/NAIL POPS

Observed typical settlement type cracking and nail pops on walls and ceilings. Recommend repairs as needed. Home owner to identify all areas for repair.

Recommend monitoring.

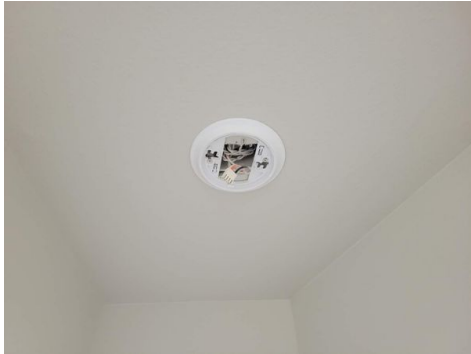
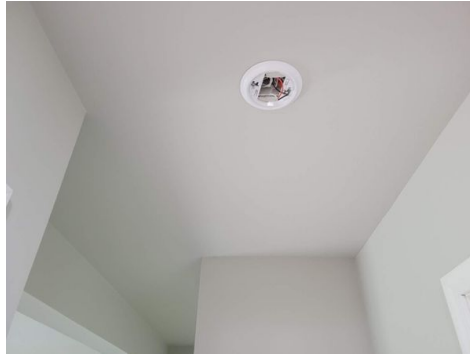
THE SMOKE DETECTORS MISSING

The smoke detector is missing and should be installed as a fire safety feature.

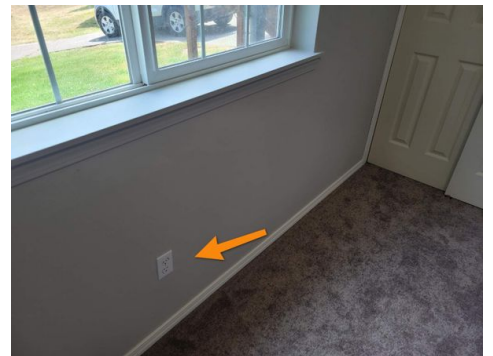
13.11.1 Outlets, Electrical

DAMAGED OUTLET

A damaged Outlet was observed. Recommend replacement.
