# MOUNTAINS TO SOUND HOME INSPECTION LLC

## HOME INSPECTION REPORT

24209 29th Ave W  
Brier WA 98036

JUNE 25, 2020

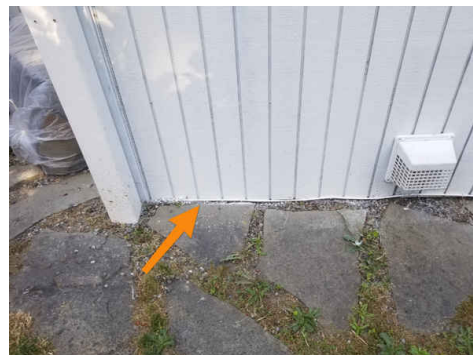
The siding was in contact with or nearly contacting soil or mulch or concrete. This is a condition conducive to deterioration and wood destroying organism infestation. We recommend removing soil a six-inch space between any siding material and soil where possible and repairs to any damaged or deteriorated siding.

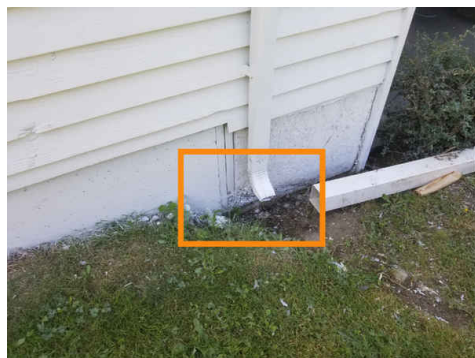
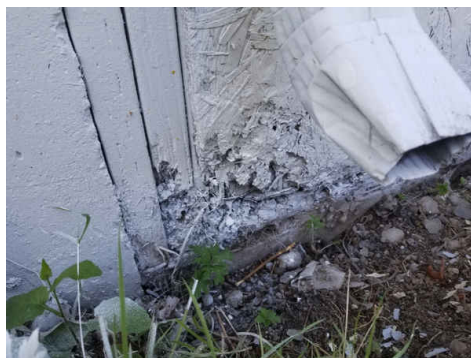
## 3.5.2 Exterior Siding Notes

**MOISTURE DAMAGE**

Portions of the siding were previously moisture damaged and should be further evaluated by a contractor.

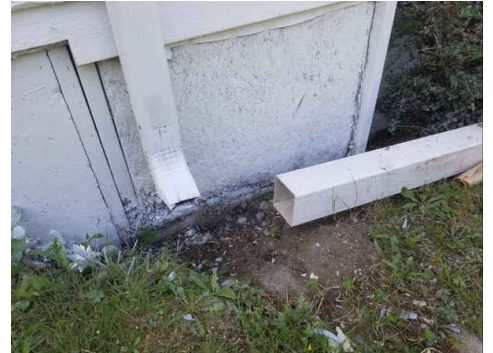
### 3.9.1 Downspouts

#### **SOME DOWNSPOUTS ARE MISSING OR NEED TO BE RECONNECTED OR SERVICED**

Some downspouts are missing parts or need to be reconnected or serviced.

Contact a qualified roofing professional.

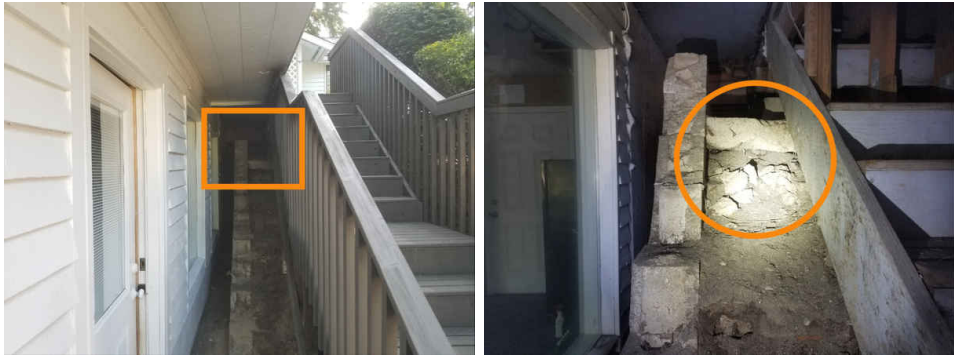
### 3.12.1 Deck

A section of the porch cement/concrete was undermined. No adverse effects were observed. Recommended monitoring and filling with structural filler for additional support

Contact a qualified professional.

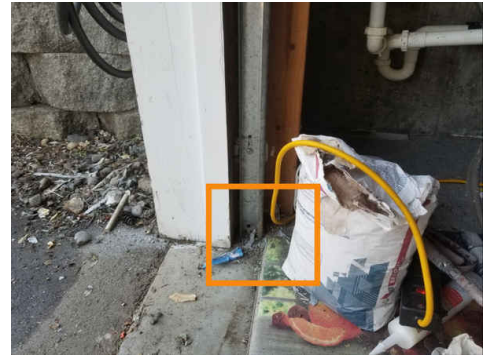
### 5.5.1 Slab Floor

The garage is too full of storage to permit a clear view of the entire slab. I recommend evaluating the floor yourself once the storage is removed.

Recommended DIY Project

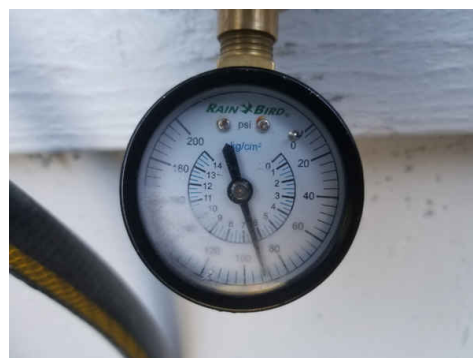
The water pressure inside the residence exceeds 80 psi and will stress components of the system. Appliances and components such as water heaters, dishwashers, washing machines and most water using appliances will function better and last longer under lower water pressure (usually 40-80 psi). You may want a licensed plumber to evaluate this and adjust the water pressure. This evaluation and service is recommended before the close of escrow.

Contact a qualified plumbing contractor.

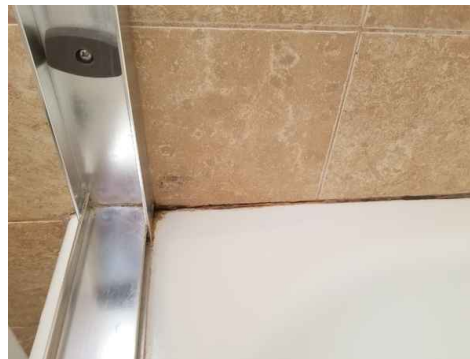
### 11.4.2 Tub-Shower

#### **MISSING OR DETERIORATED CAULK/GROUT**

The tub surround is has missing or deteriorated caulk/grout. Recommend caulking or sealing to prevent moisture intrusion.

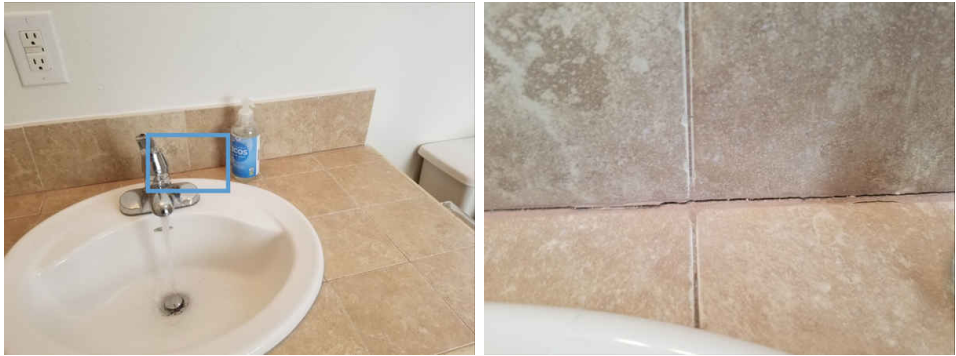
### 11.6.1 Countertop

#### **MISSING OR DETERIORATED CAULK/GROUT**

The caulking or grout for the backsplash is missing, has gaps and/or not installed properly. We advise caulking/grout be installed and/or gaps filled to prevent possible water intrusion.

Recommended DIY Project

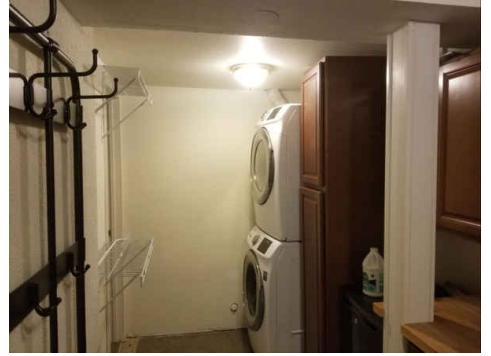
There is not a laundry exhaust fan or openable window installed within this laundry room. Adding one is recommended and typically required to help disperse excessive moisture from the laundry room.
