4 i omi mopec				
Insured/Applicant Name: Billings Home Inspe	ections	Application	n / Policy #:		
Address Inspected: 2753 Vista Parkway , West Palm Beach, FL 33411					
Actual Year Built: 1956	ı	Date Inspected: 01/2	20/2019		
Minimum Photo Requirements  ☑ Dwelling: Each side ☑ Roof: Each slope ☑ Plumbing: Water heater, under cabinet plumbing/drains, exposed valves ☑ Main electrical service panel with interior door label ☑ Electrical box with panel off ☑ All hazards or deficiencies noted in this report  A Florida-licensed inspector must complete, sign and date this form.					
Be advised that Underwriting will rely on the information in this sample form, or a similar form, that is obtained from the Florida licensed professional of your choice. This information only is used to determine insurability and is not a warranty or assurance of the suitability, fitness or longevity of any of the systems inspected.

# **Photos, Additional Comments or Observations**

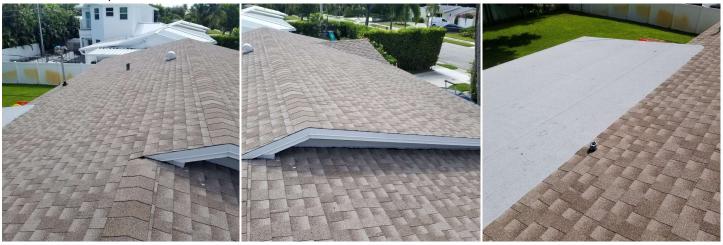
Photos of Each Slope

Visible signs of damage / deterioration

Minor deterioration are the shingles at the front right appears to be from tree before it was trimmed
