ELEVATE HOME INSPECTION

123 Curl Dr
Columbus, OH 43221

James DeGraw
NOVEMBER 8, 2021

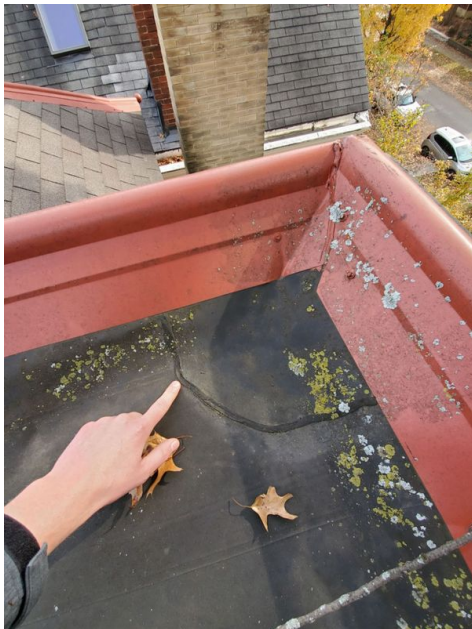
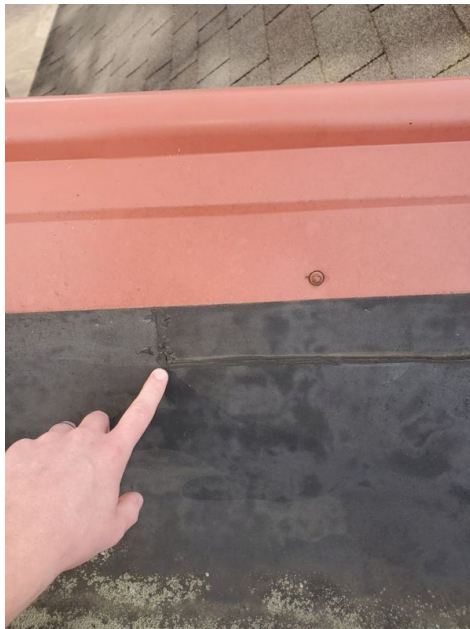
SEALANT NEEDED

We observed exposed fasteners and/or loose seams on the roof-covering materials. Fasteners & seams should be sealed because they are potential water entry points.

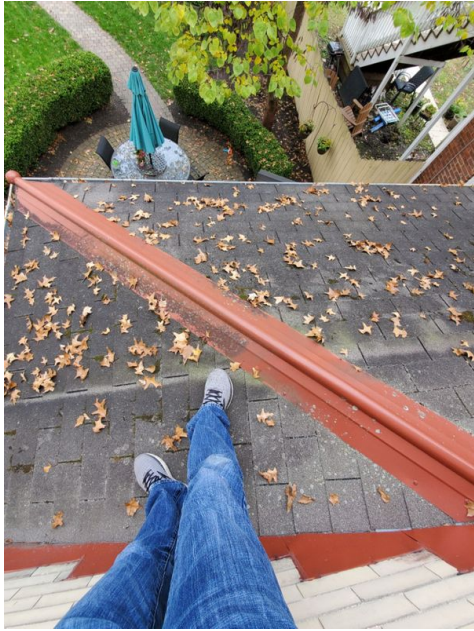
We observed staining and discoloration on the roof-covering materials. This condition seemed to be caused from a moss or algae-like plant growth. When environmental conditions are right, the problem can spread quickly across a roof. This condition may shorten the lifespan of your roof-covering materials. Algae bonds itself tightly to the shingle, which can make it difficult to remove without damaging the roof. [Here is a helpful article](#) on common roof stains and ideas on how to deal with them.

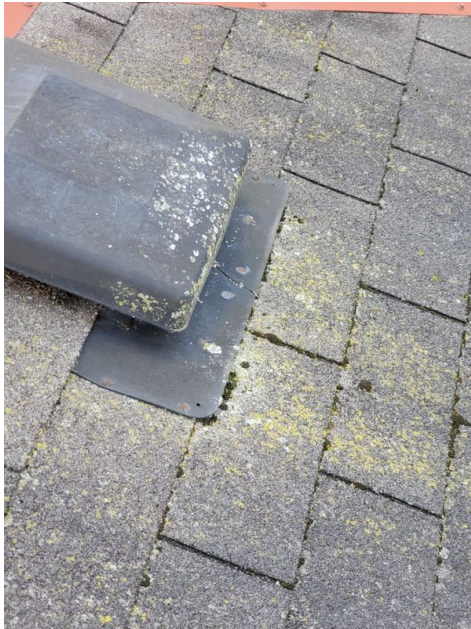
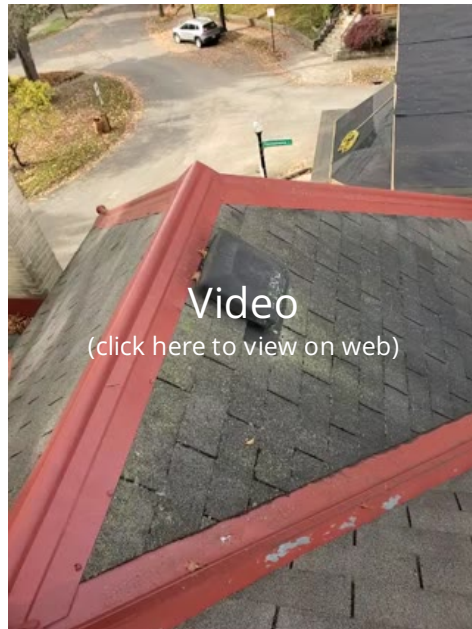
We observed flashing with exposed fasteners and/or seams. These should be sealed to prevent water intrusion.

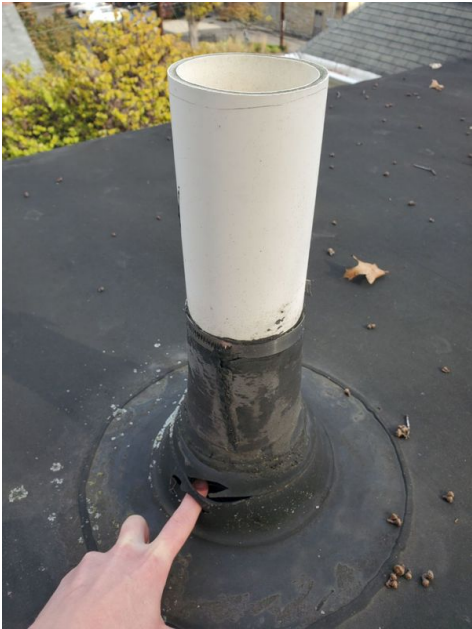
3.3.1 Plumbing Vent Pipes

FLASHING DAMAGED

We observed that the rubber membrane flashing boot around the vent pipe was cracked and damaged, making this area prone to water penetration.

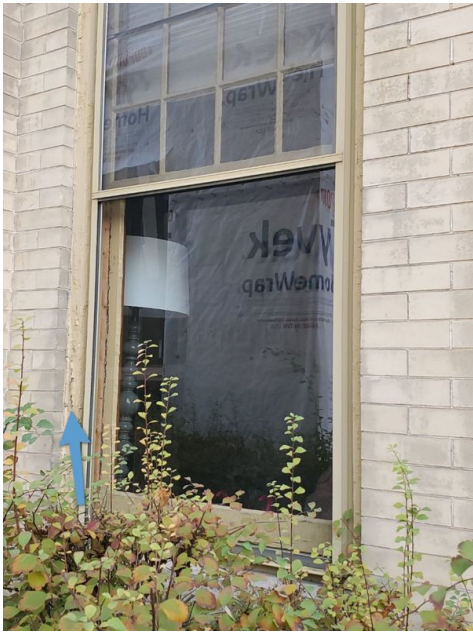
Left Side

We observed paint in poor condition. This should be corrected to avoid further damage to wall-covering/trim materials.

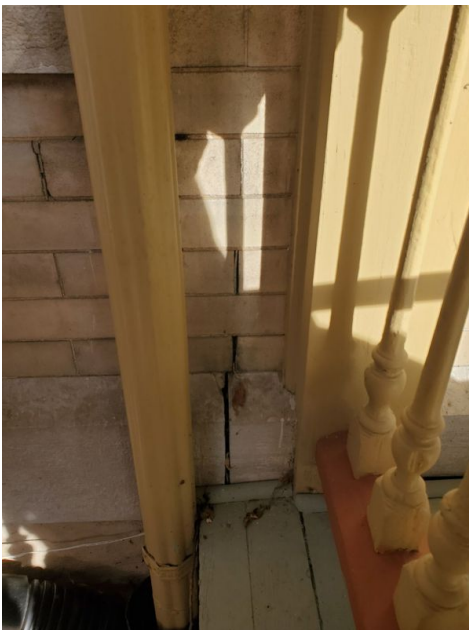
Front

We observed degraded mortar, which could allow moisture to penetrate into the house. We recommend installing appropriate mortar/sealant and inspecting these conditions regularly to help prevent moisture and insect entry.

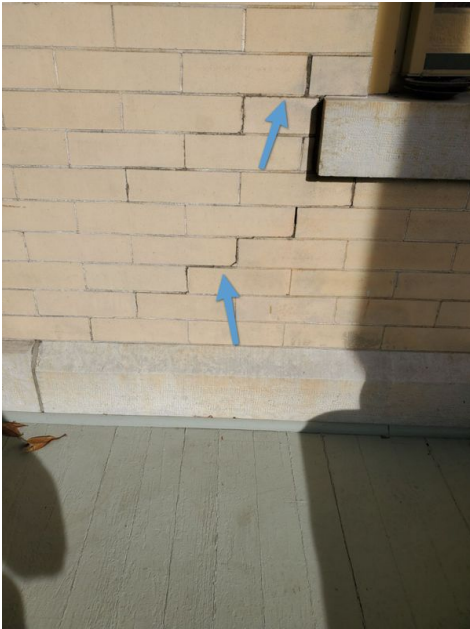
Front

We observed cracks in the wall covering-materials in one or more places. We recommend monitoring the area for additional cracking/expansion and sealing the cracks to avoid moisture entry.

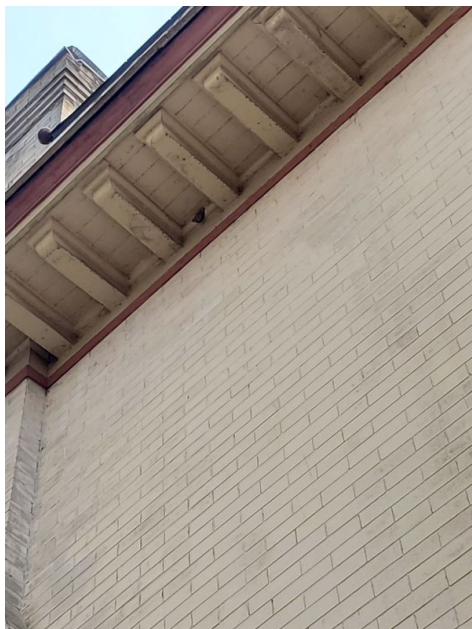
Left Side

We observed that one or more areas of the eaves was damaged.

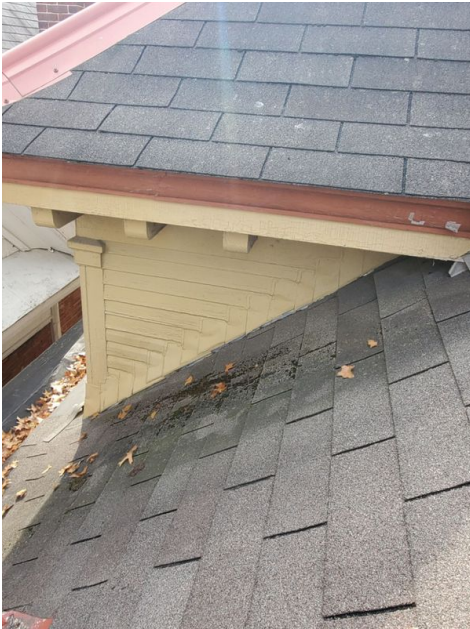
Right Side

We observed paint in poor condition. This should be corrected to avoid further damage to eave/soffit/fascia materials.

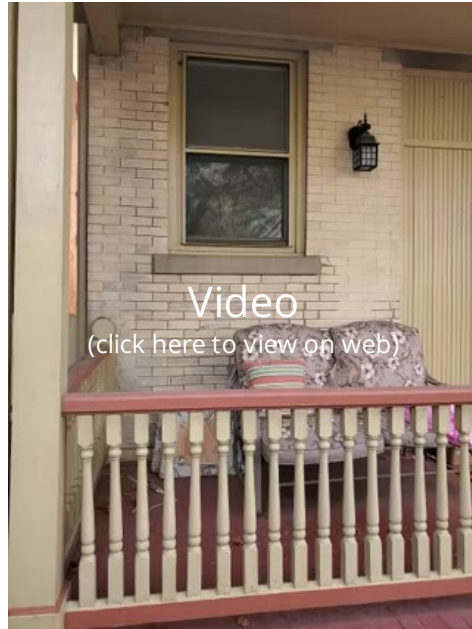
5.8.1 Stairs, Ramps, & Handrails

TRIP HAZARD

We observed a trip hazard, which we consider for cracks on walking surfaces with vertical displacement 1 inch or more, or improper riser heights of steps. This condition is a safety concern.

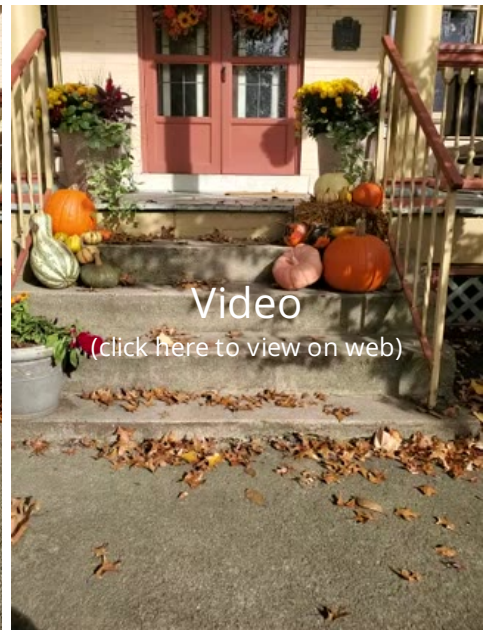
5.8.2 Stairs, Ramps, & Handrails

HANDRAIL LOOSE

We observed a loose handrail. This is a safety concern.

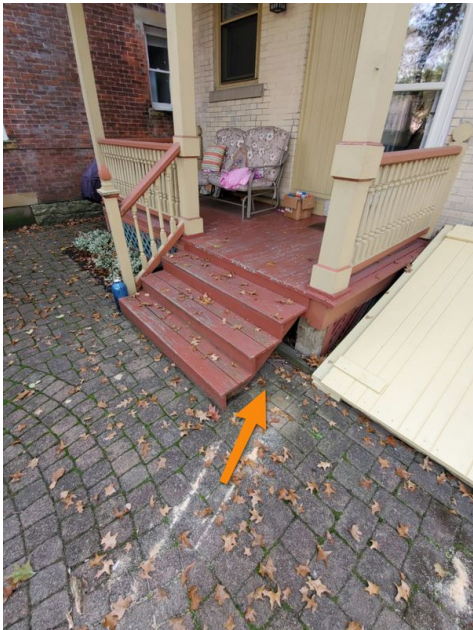
Back

HANDRAIL MISSING

We observed a missing handrail at exterior steps. Steps with 4 or more risers require a handrail. This is a safety concern.

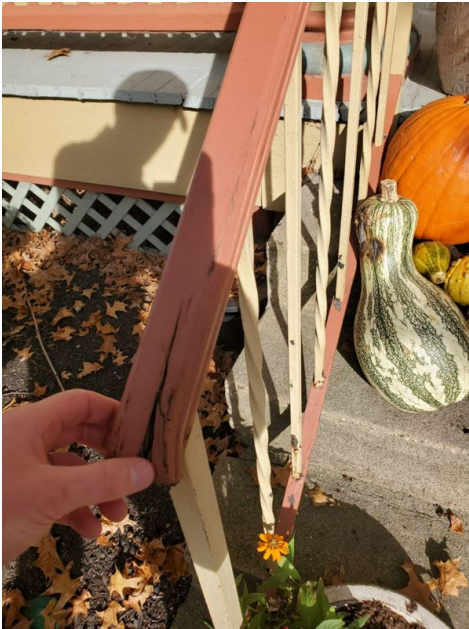
Front

WOOD ROT

We observed wood rot at a deck component. This is a safety concern since the component is falling apart.

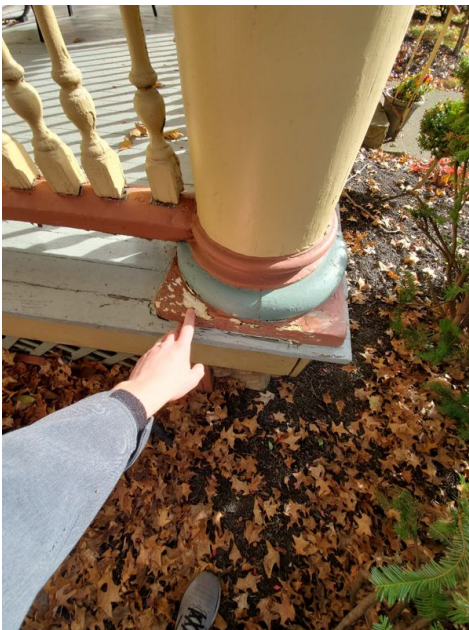
Front

DETERIORATED SURFACES

We observed indications of worn out surfaces. Paint, stain, or sealant is recommended to avoid further deterioration of the components.

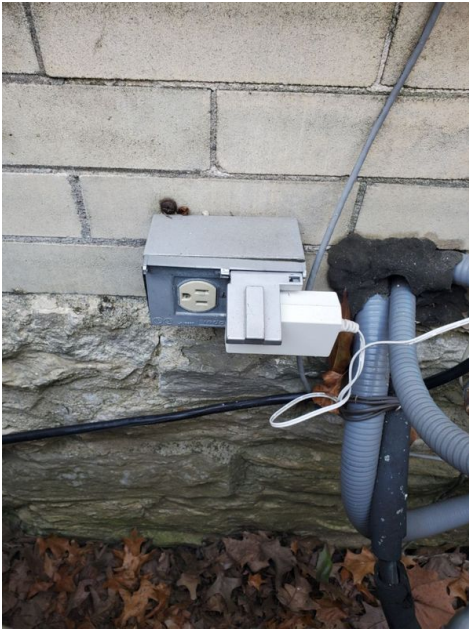
Back

MISSING WET PROTECTION

We observed an exterior receptacle without a waterproof cover. We recommend a cover that is rated for wet locations and that protects the receptacle even when a cord is in use.

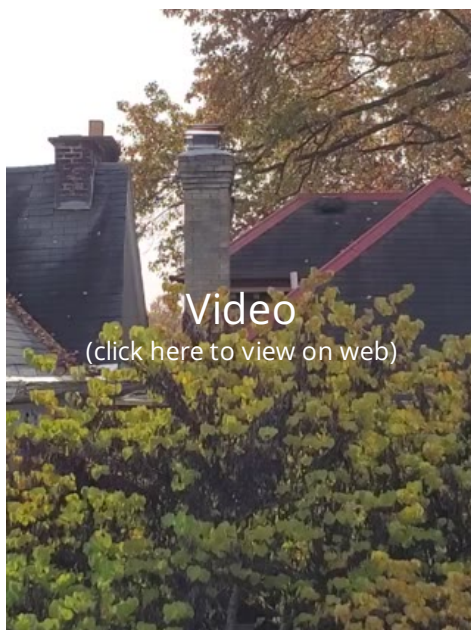
STRUCTURAL CONCERN

We observed a structural concern at the chimney system that may pose a future hazard to the house's structure or its occupants. This should be further evaluated and corrected by a qualified professional and/or structural engineer.

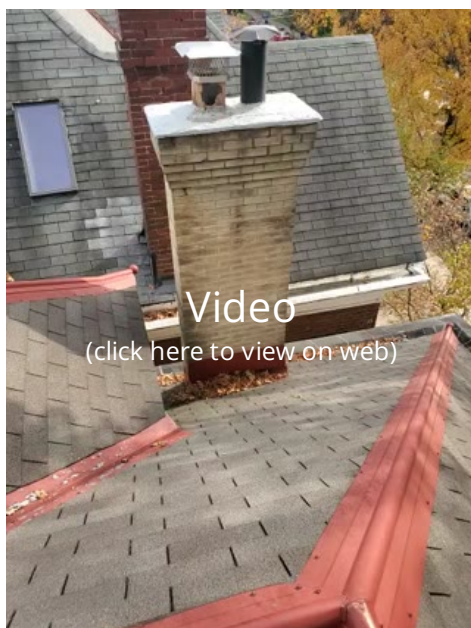
MISSING CRICKET/SADDLE

When a large chimney intersects the roof, it can trap water & debris from reaching the gutters. This area is especially prone to leaks and structural damage over time. If the chimney is 30 inches or wider, it needs a cricket/saddle installed in the roof system.

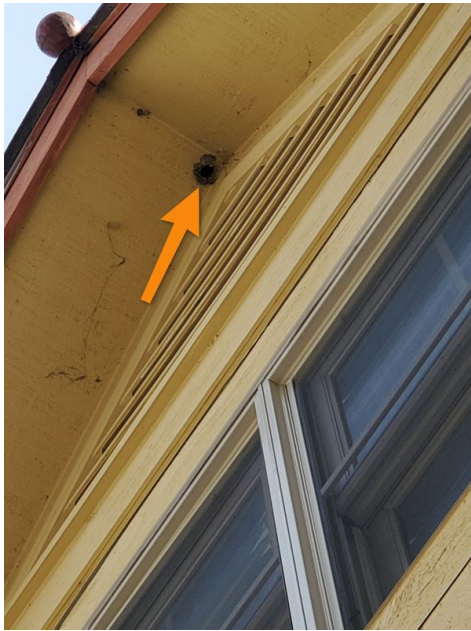
Left Exterior

We observed bees and/or wasps active on the exterior of the house. This is a safety concern.

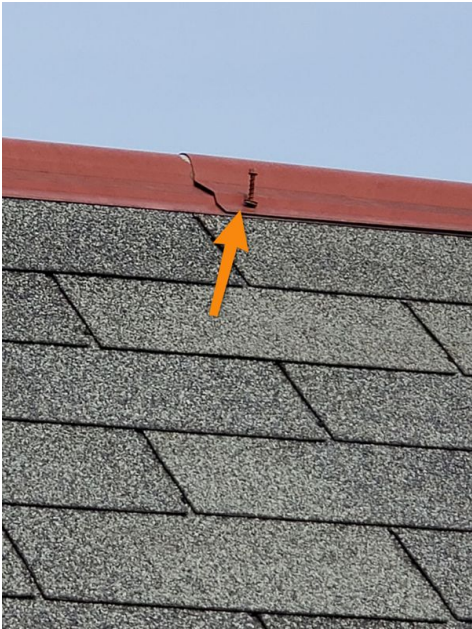
LOOSE FLASHING

We observed loose flashing, which can cause roof leaks. All flashing should be water-tight and designed to divert water away from undesired areas.

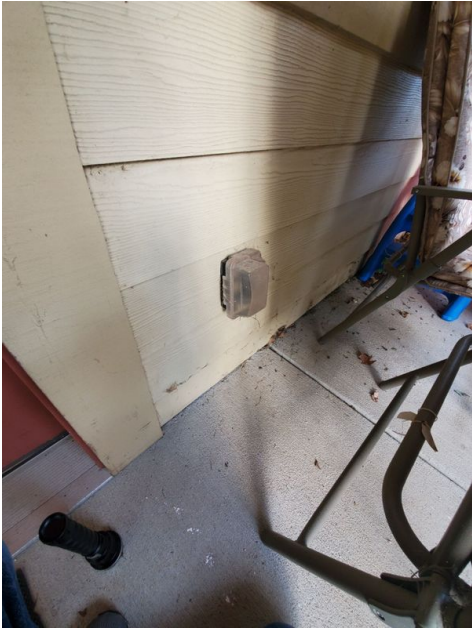
LOOSE RECEPTACLE

We observed one or more receptacles that wasn't properly secured.

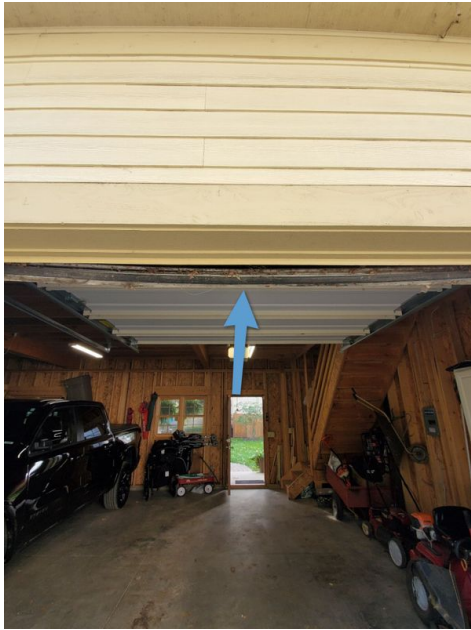
DAMAGE AREA

We observed damage to the garage vehicle door. At the time of the inspection it did not affect the operation of the door.

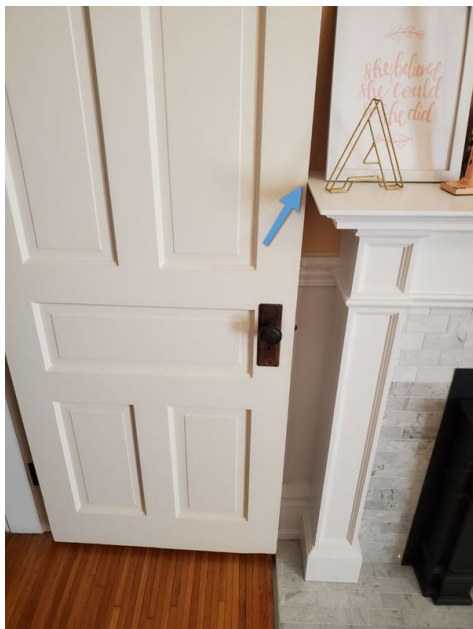
2nd Floor Bedroom

We observed a door that didn't have enough clearance to fully open.

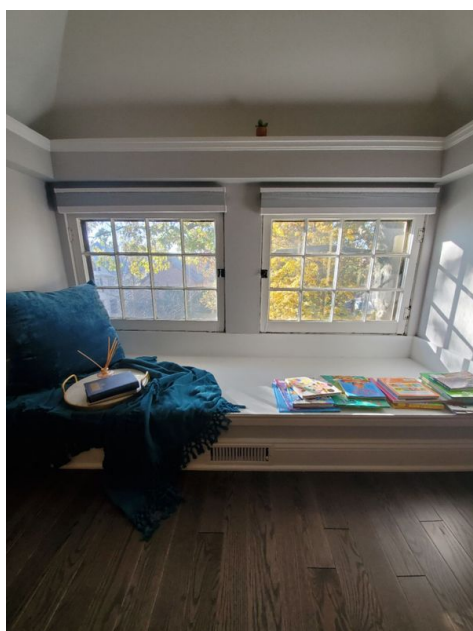
Master Bedroom

We observed wood-frame windows with advanced age throughout the home. They may not perform as efficiently or as easily as a modern vinyl window.

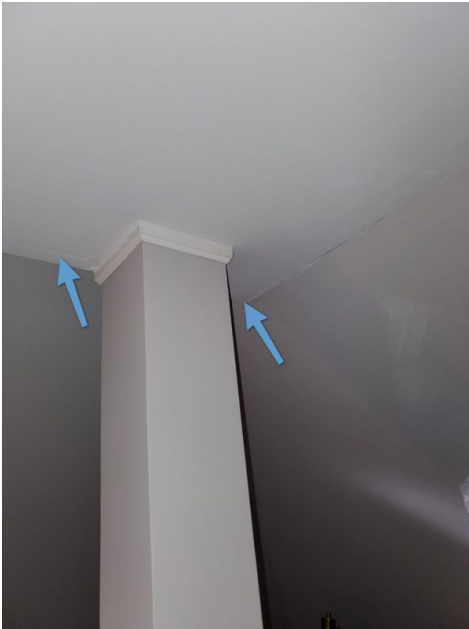
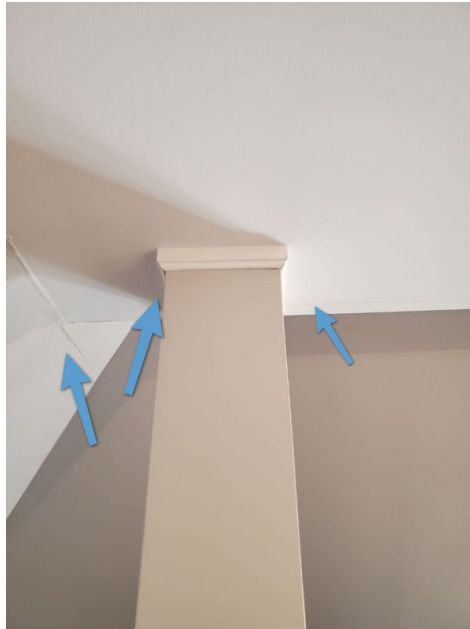
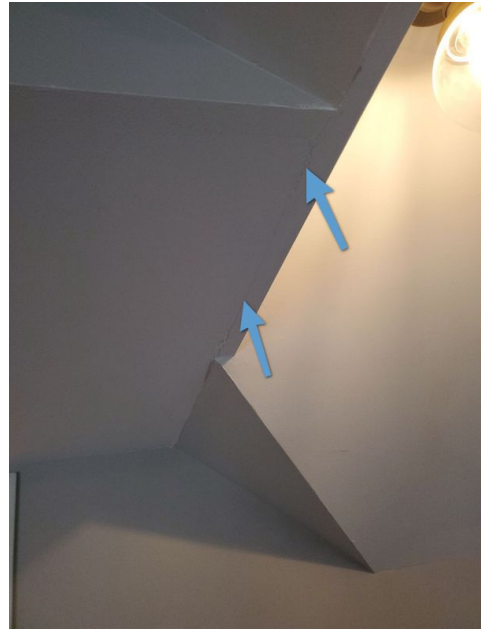
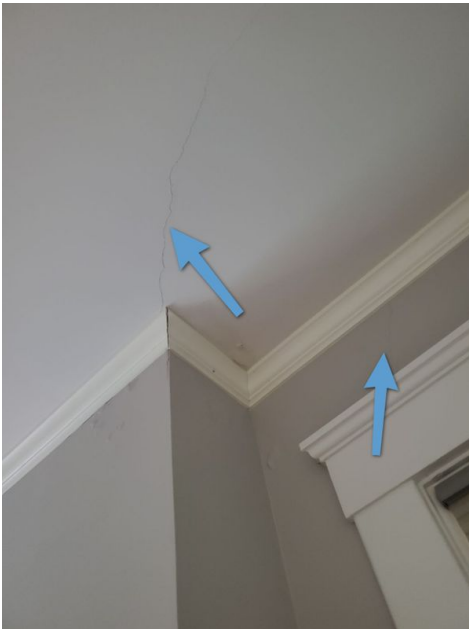
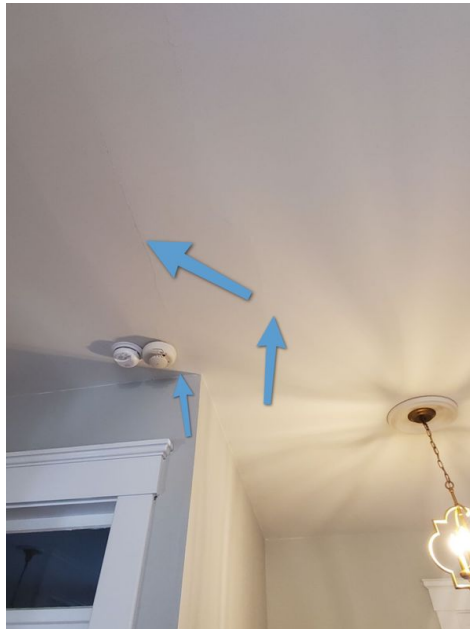
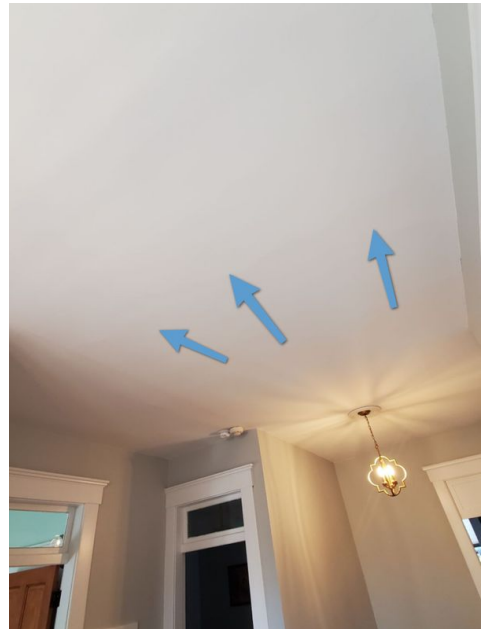
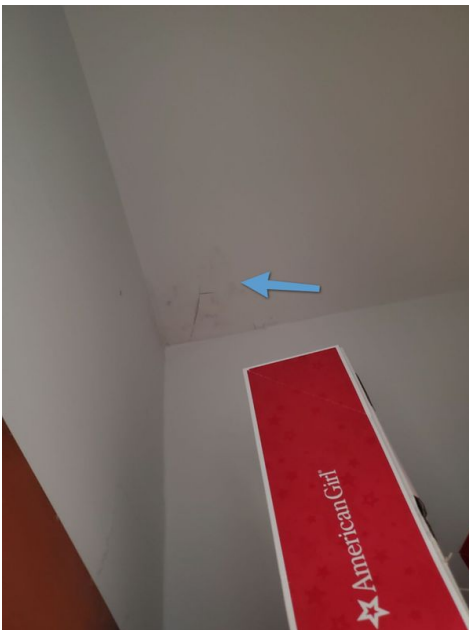
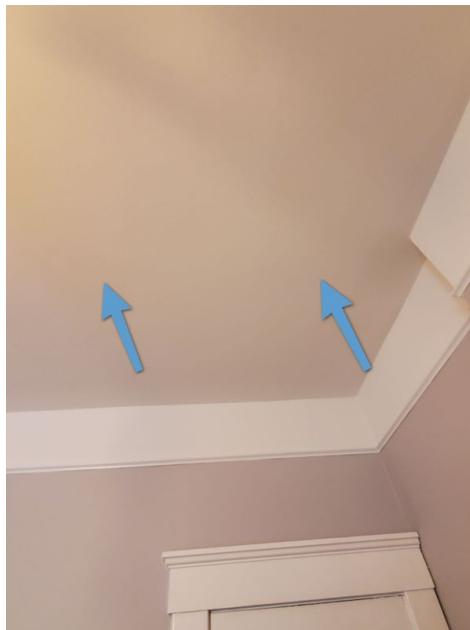
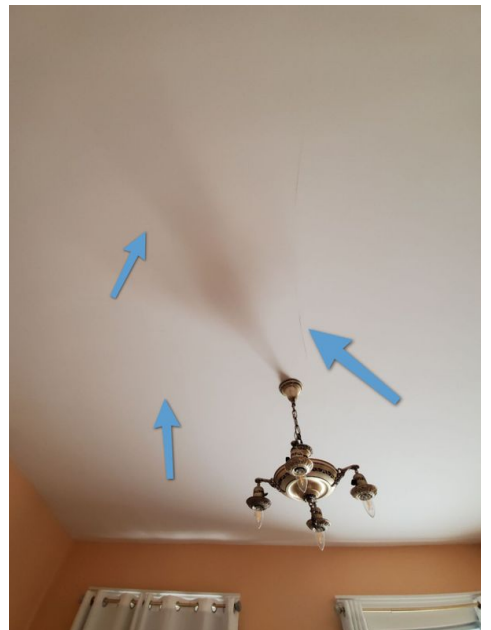
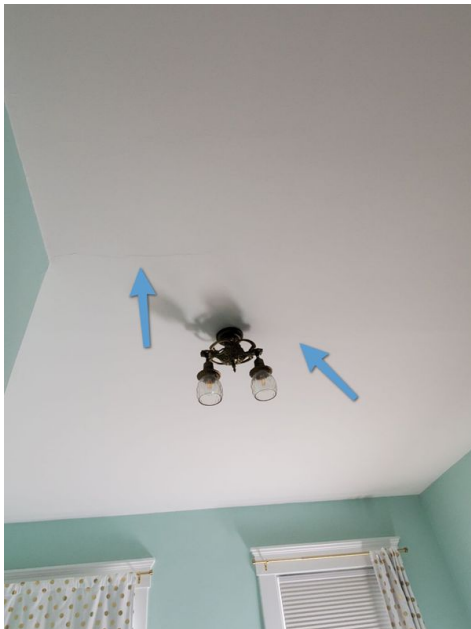
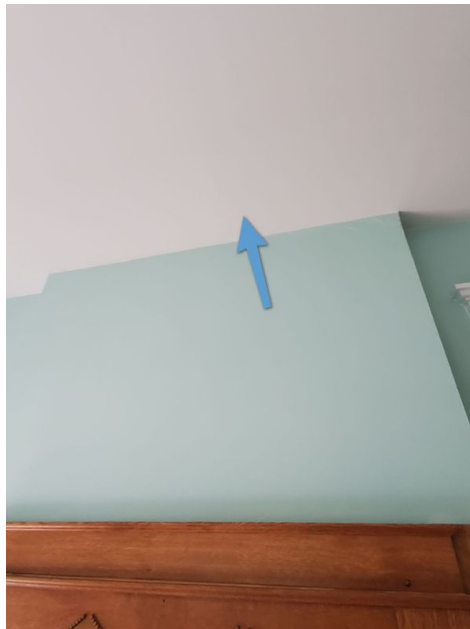
MINOR CRACKING

We observed minor cracks on interior surfaces which appeared to be the result of long-term settling. Some settling is not unusual in a home. These areas should be monitored to ensure that the cracks do not grow.

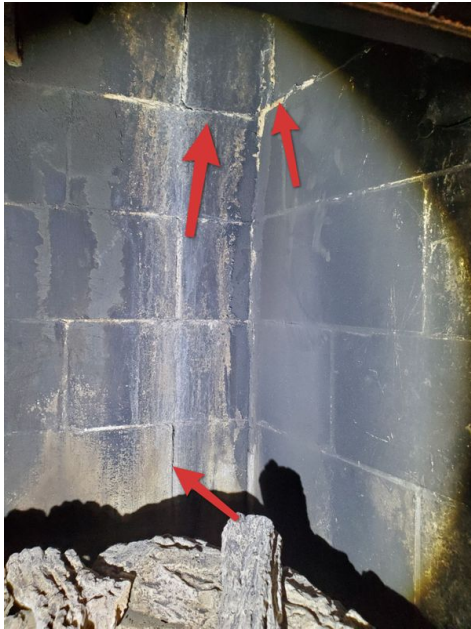
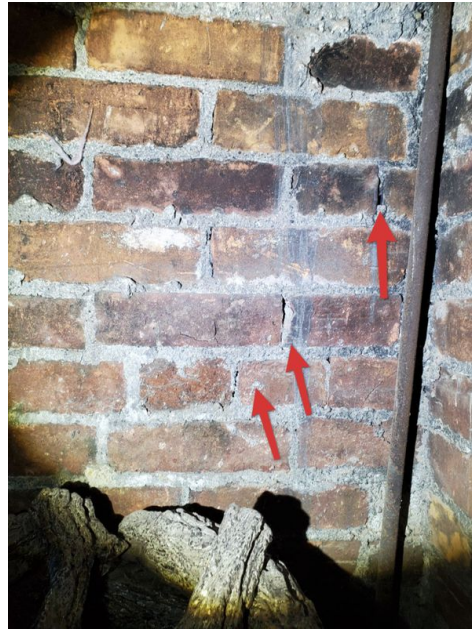
DEFECT IN INTERIOR CHAMBER

We observed a defect in the interior chamber of the firebox. If you plan to use these fireplaces, we highly recommend a fireplace & chimney inspection by a qualified specialist.

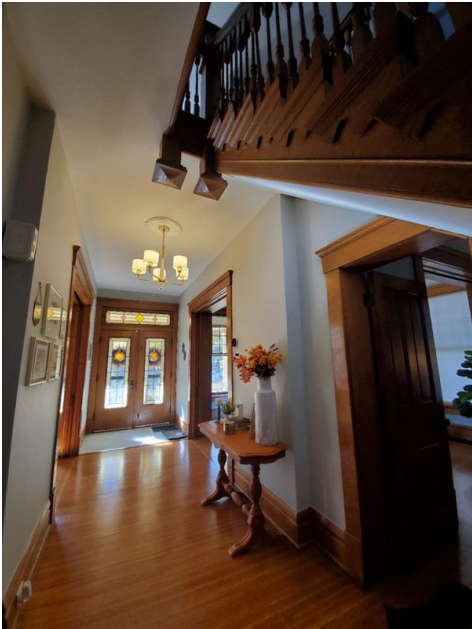
1st Floor

MISSING CO DETECTOR

We observed that a CO detector is missing from an area where it is recommended. A house with active natural gas or propane service should at least one on each floor of the house. This is a safety concern.

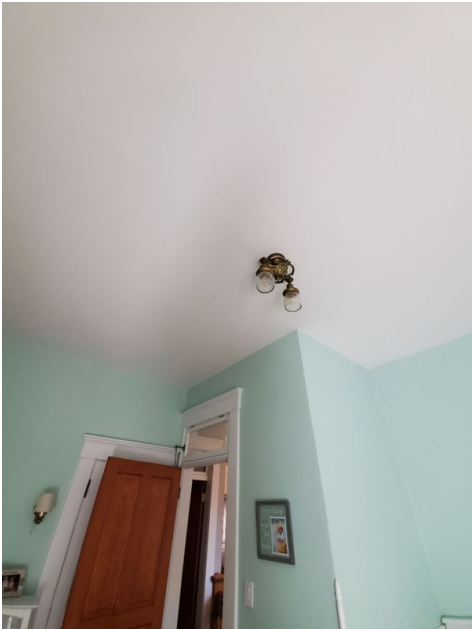
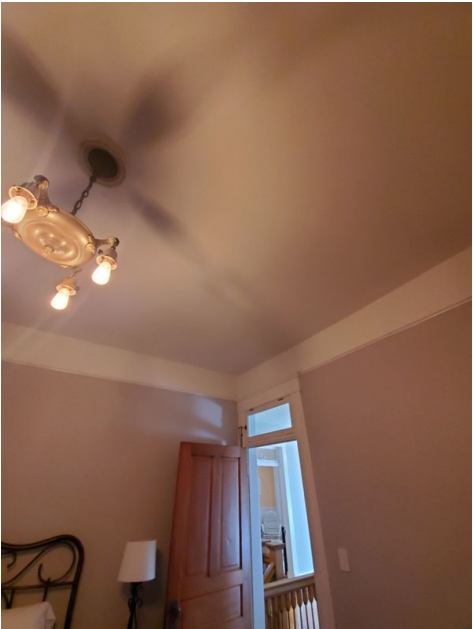
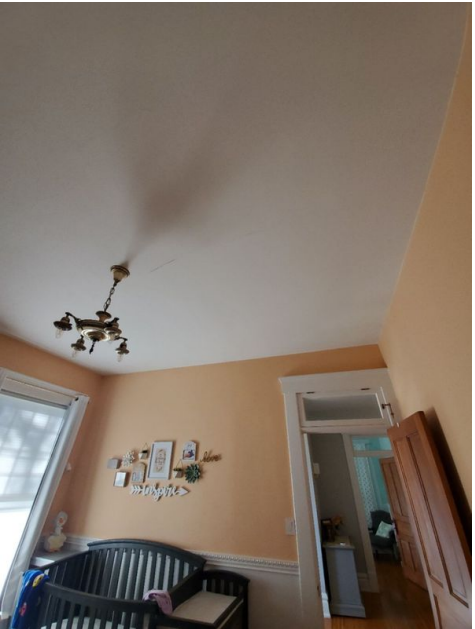
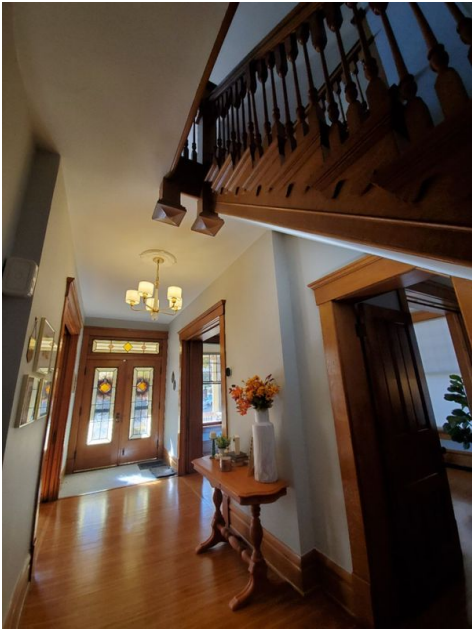
MISSING SMOKE DETECTOR

We observed that a smoke detector is missing from an area where it is recommended. Each bedroom should have a smoke detector and there should be at least one on each floor of the house. This is a safety concern.

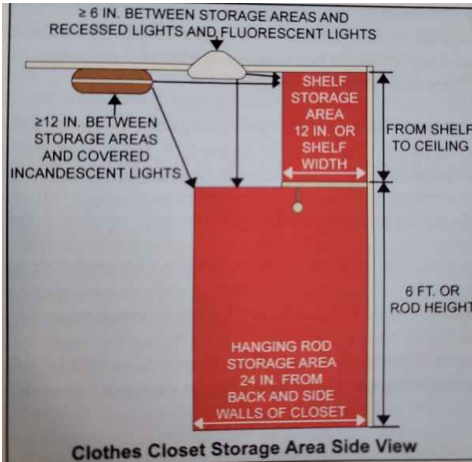
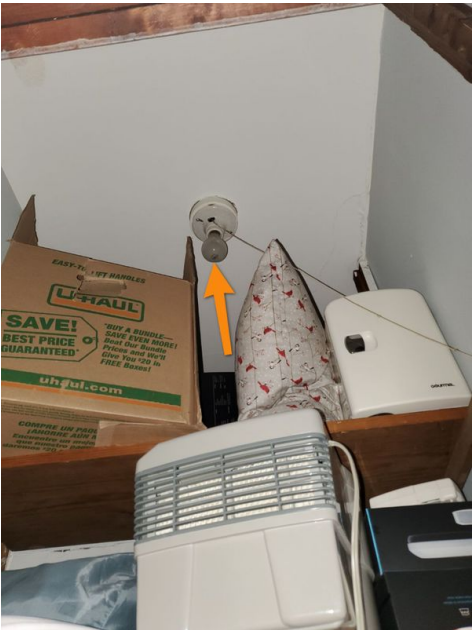
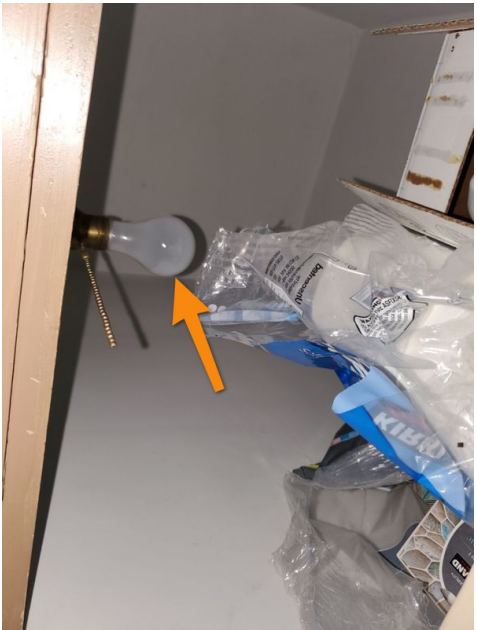
CLOSET LIGHT FIRE HAZARD

We observed a light fixture installed in a closet that is a potential fire hazard due to bulb type and/or location. We recommend you switch the incandescent bulb to an LED bulb.

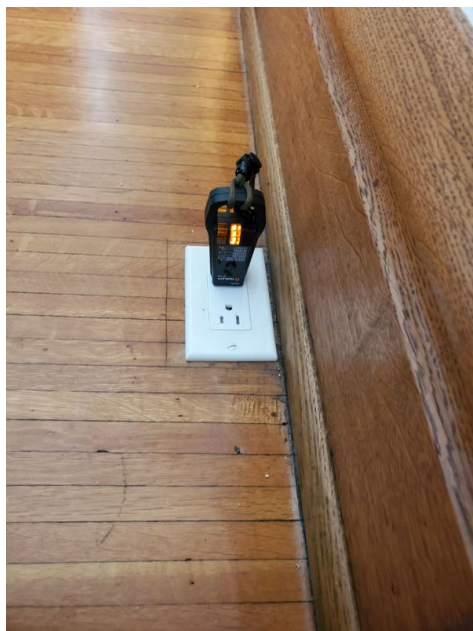
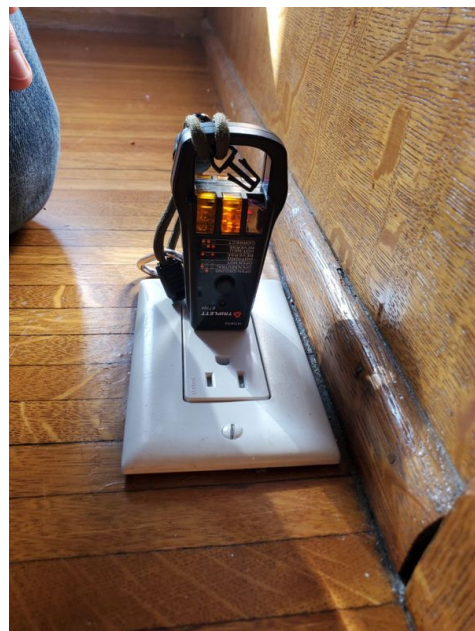
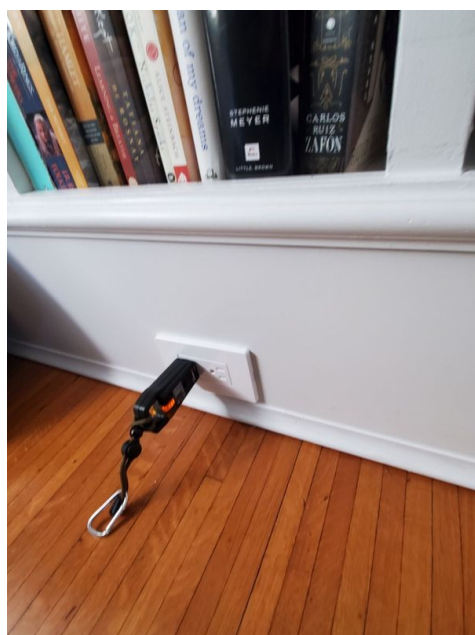
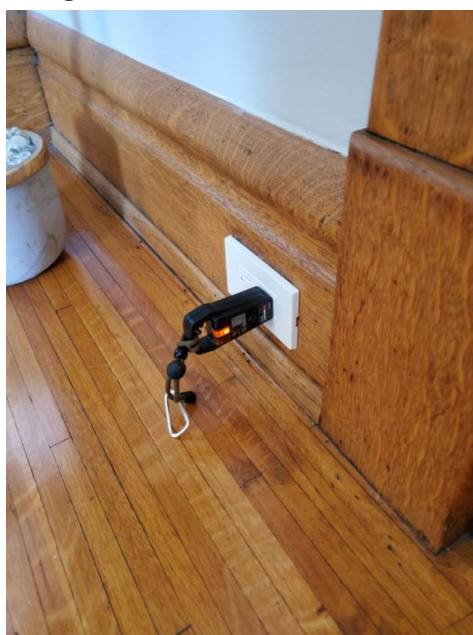
We observed a receptacle that when tested showed as having an open/missing ground at the time of the inspection. In older homes, sometimes old 2-slot ungrounded electrical outlets are replaced with newer 3-prong outlets for ease-of-use with modern plugs. This is incorrect unless the electrical wire was upgraded to current standards as well. This should be further evaluated and corrected by a qualified professional.

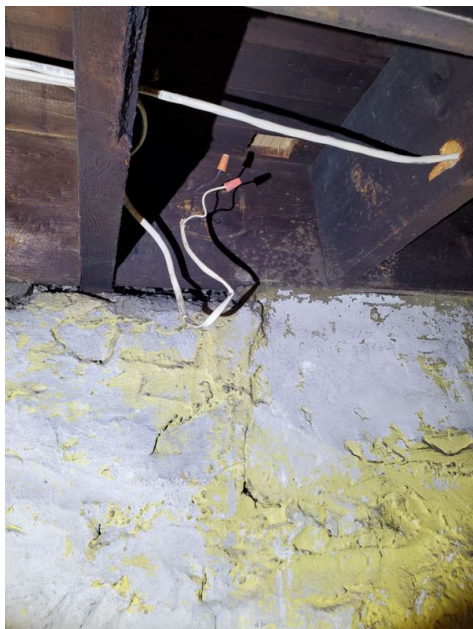
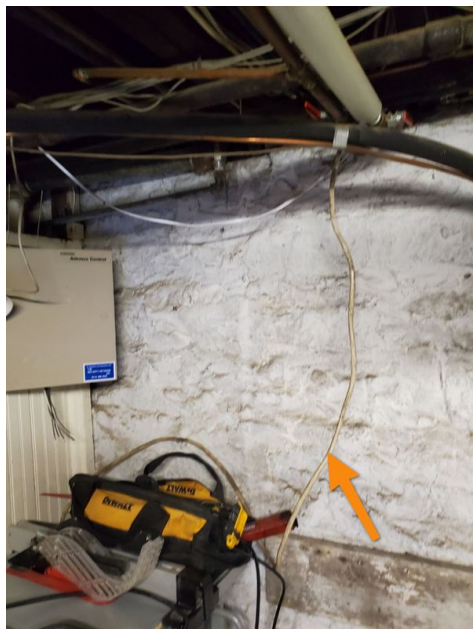
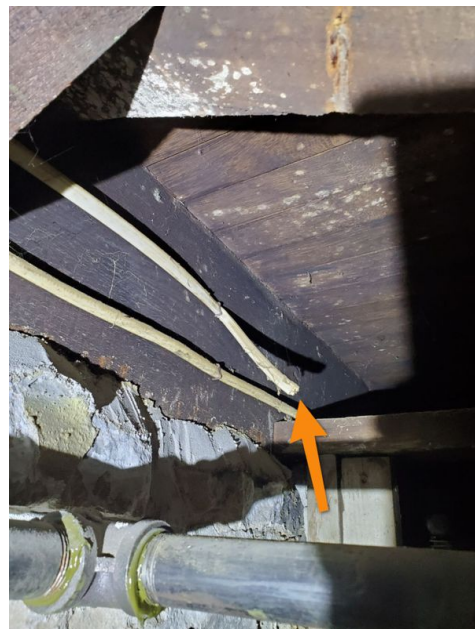
We observed electrical wiring that was loose and/or unprotected. This is a safety concern.

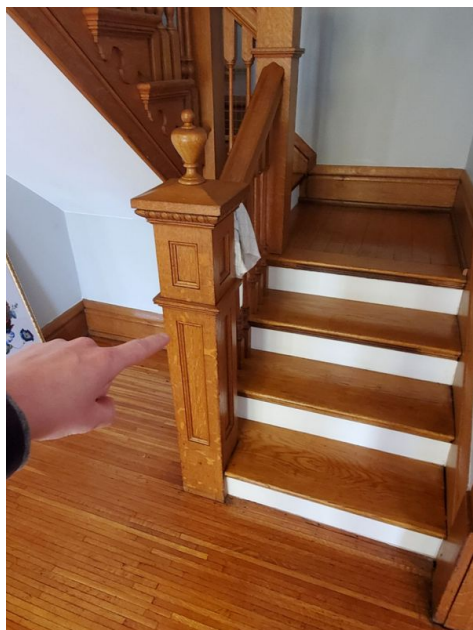
HANDRAIL LOOSE

We observed a loose handrail. This is a safety concern.

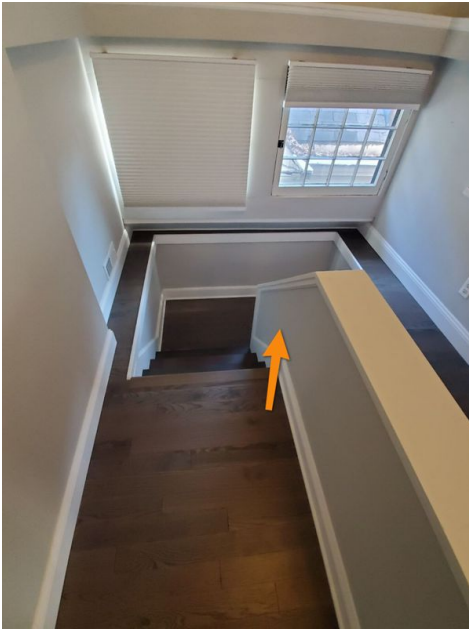
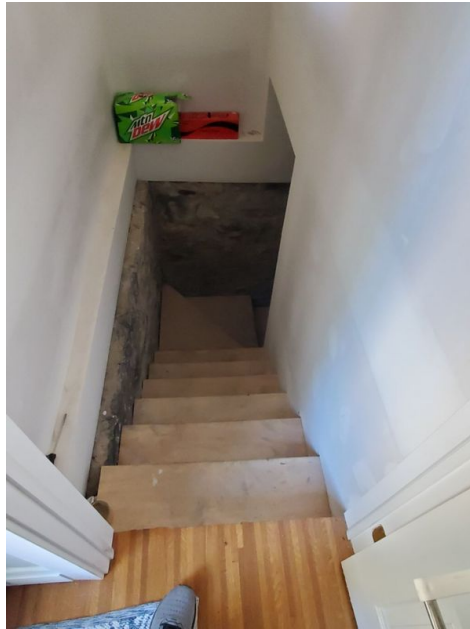
HANDRAIL MISSING

We observed a missing handrail at exterior steps. Steps with 4 or more risers require a handrail. This is a safety concern.

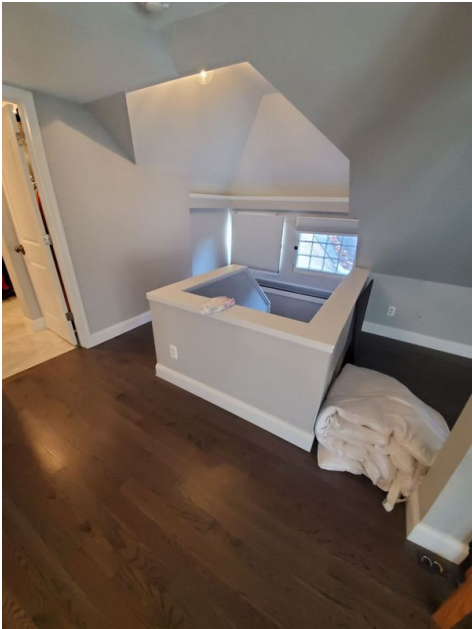
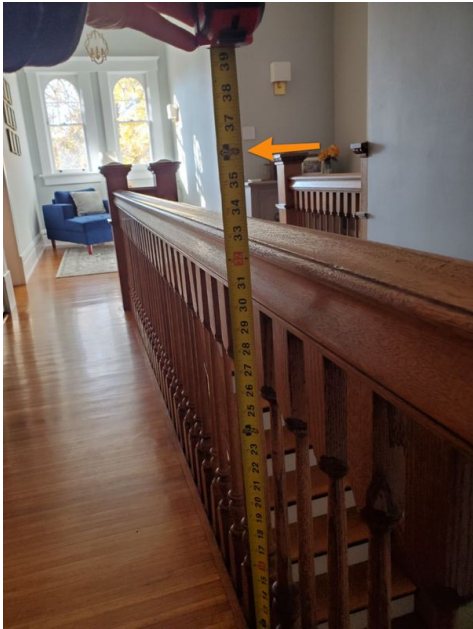
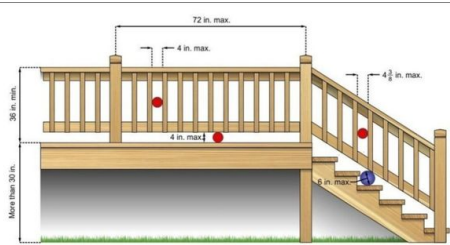
We observed that the guardrail is too short. Guardrails should be at least 36 inches tall. This is a safety concern.

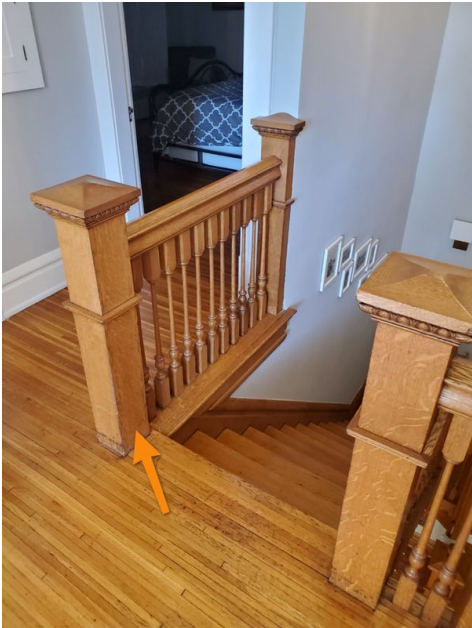
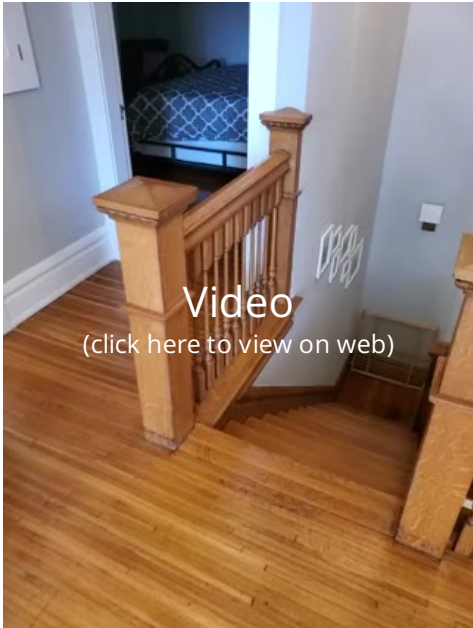
GUARD LOOSE

We observed a loose guardrail system. This is a safety concern.

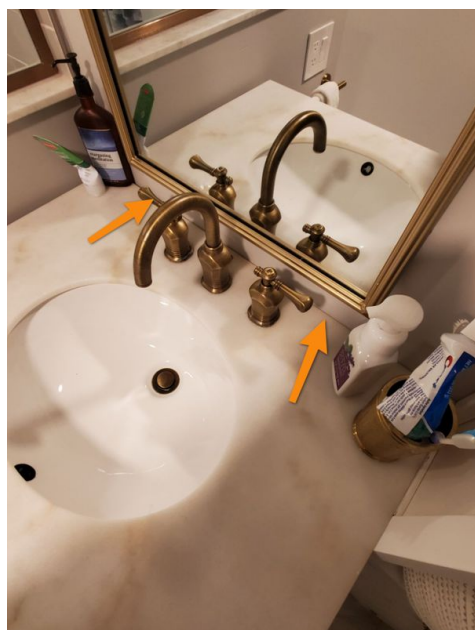
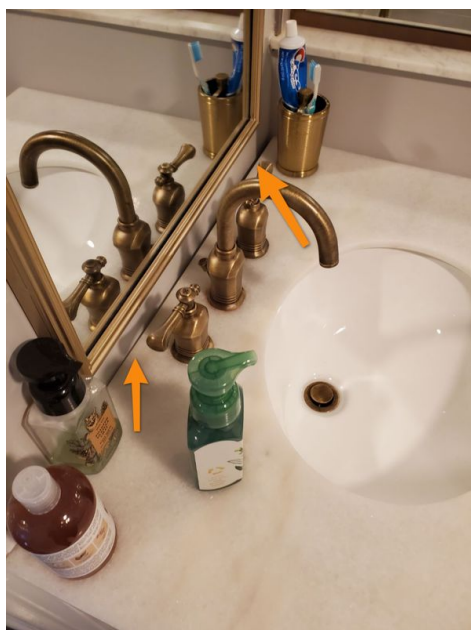
Master Bathroom

We observed missing or deteriorated caulk or grouting in the bathroom that may lead to water penetration.

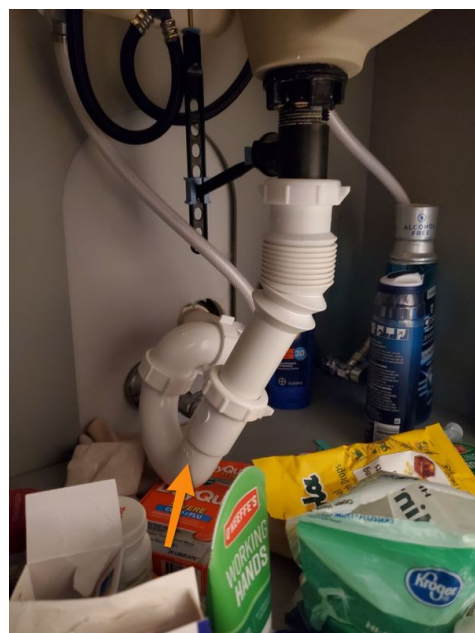
We observed that the plumbing trap was not level. It is more likely to lose its gas-blocking function if the water drains from the trap.

Recommend Repair

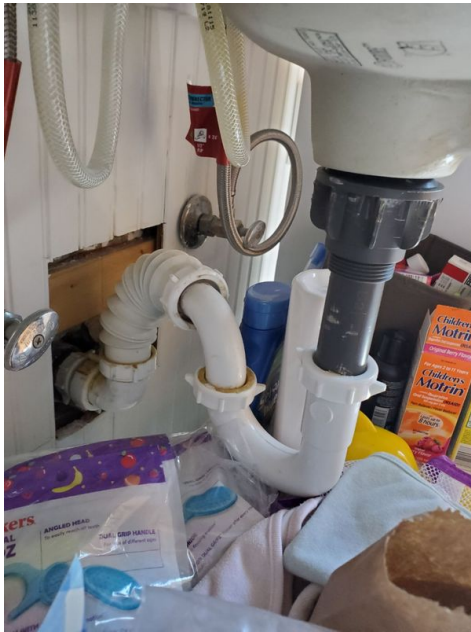
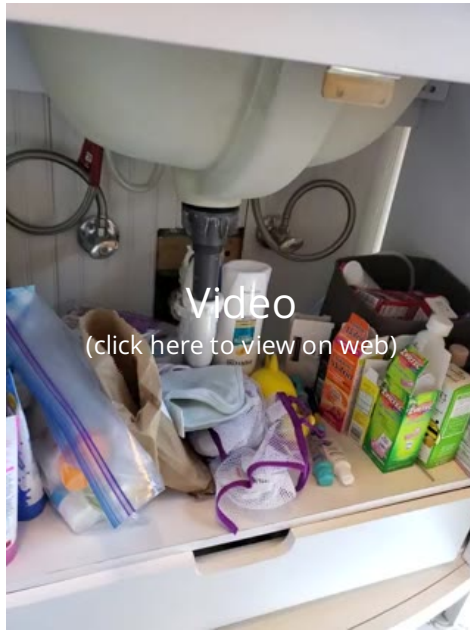
2nd Floor Bathroom

S TRAP

We observed presence of an S trap, which are no longer allowed. They are more likely to siphon water out of the trap and allow sewer gasses to escape. This should be replaced by a P trap.

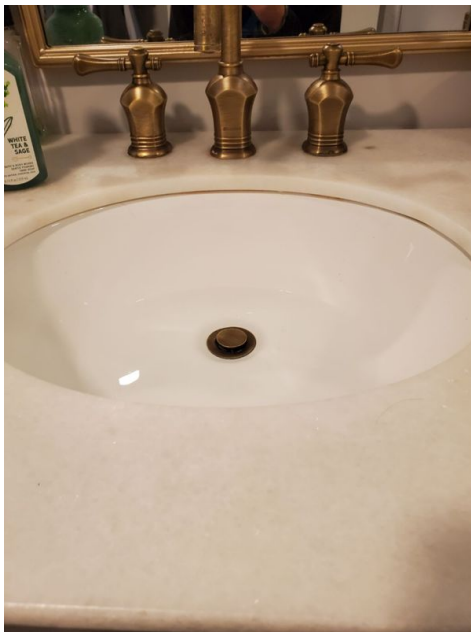
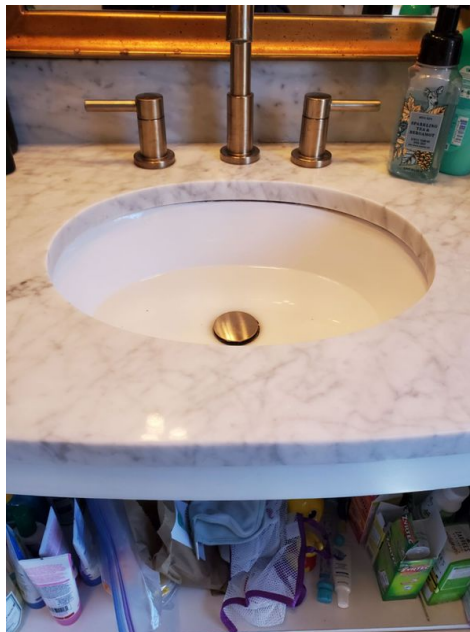
SINK DRAIN SLOW

We observed a slow drain at the sink, likely due to a clog.

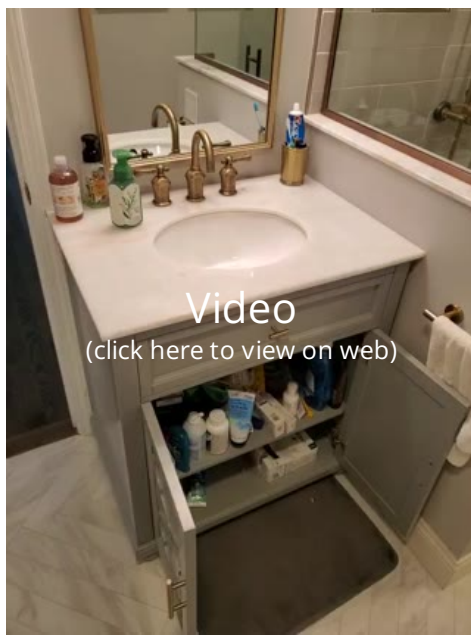
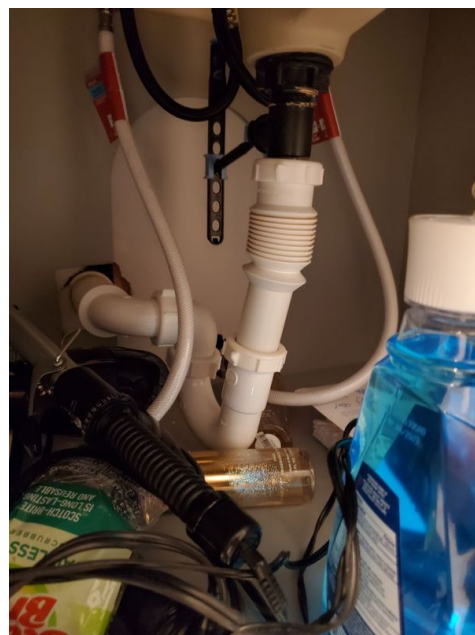
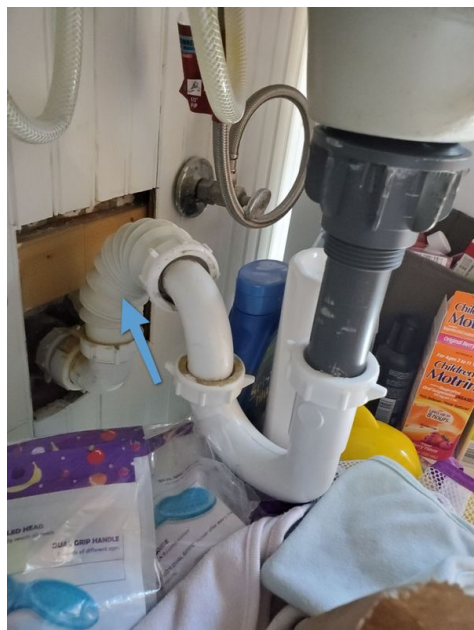
2nd Floor Bathroom

We observed improper installation of components at the bathroom plumbing system that may make it more likely to leak and/or fail to perform as intended. We recommend monitoring this area closely and correcting the issue.

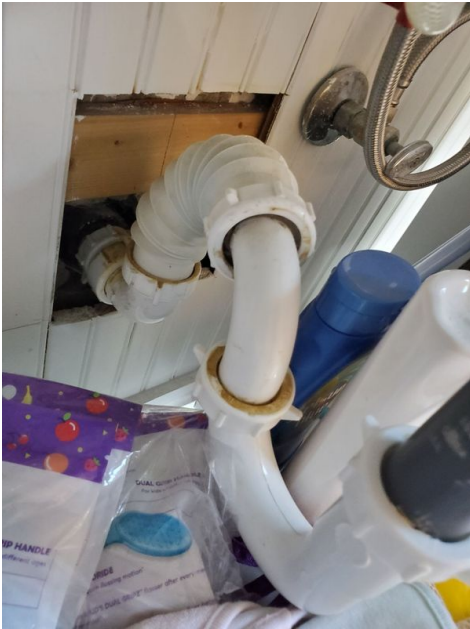
2nd Floor Bathroom

EVIDENCE OF PREVIOUS LEAK

We observed an area that appeared to have past water issues. We recommend asking the seller about this and monitor the area to make sure the issue is resolved.
