ELEVATE HOME INSPECTION

123 Curl Dr
Columbus, OH 43221

James DeGraw
NOVEMBER 8, 2021

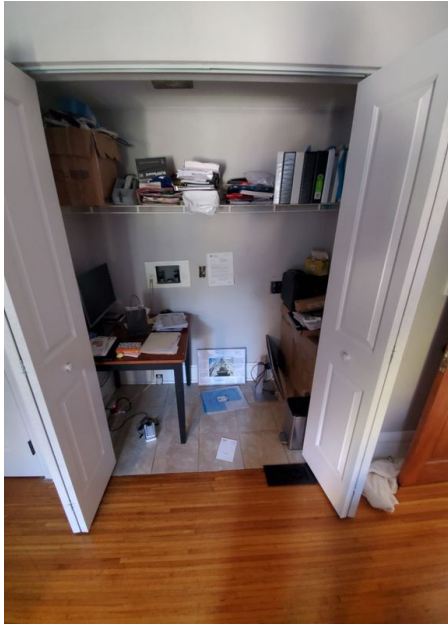
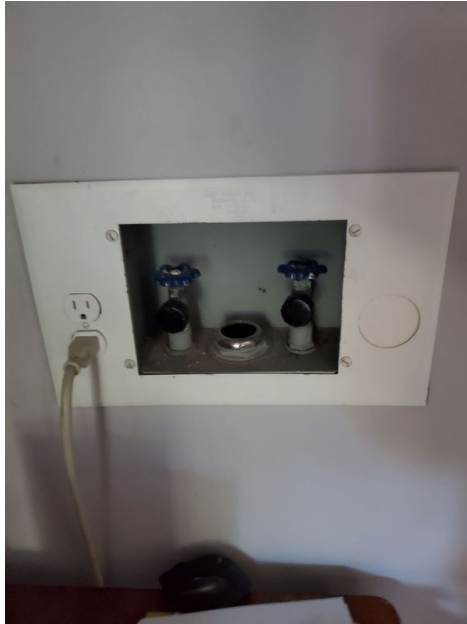
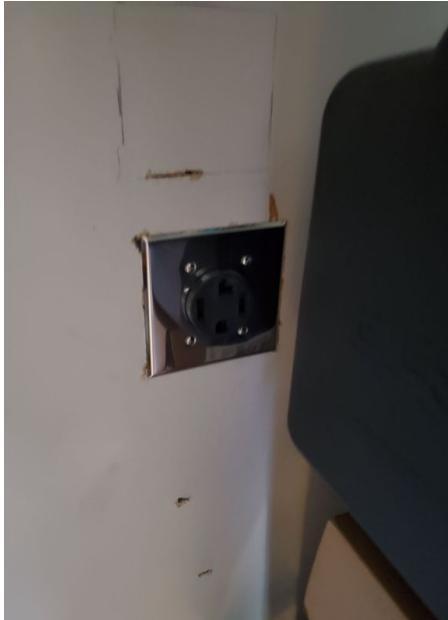
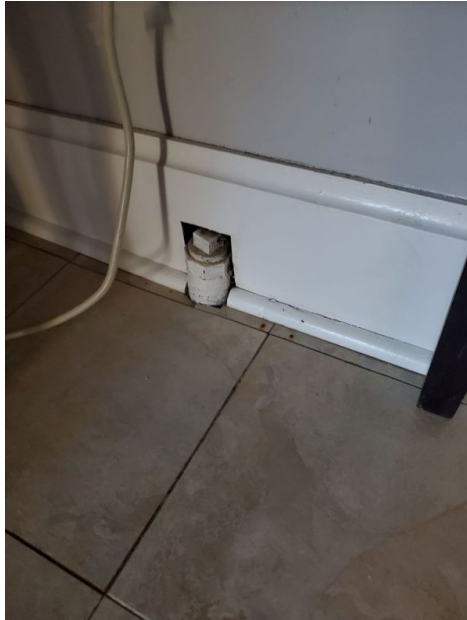
We observed an unused laundry area. The plumbing and electrical was turned off to this area at the time of inspection.

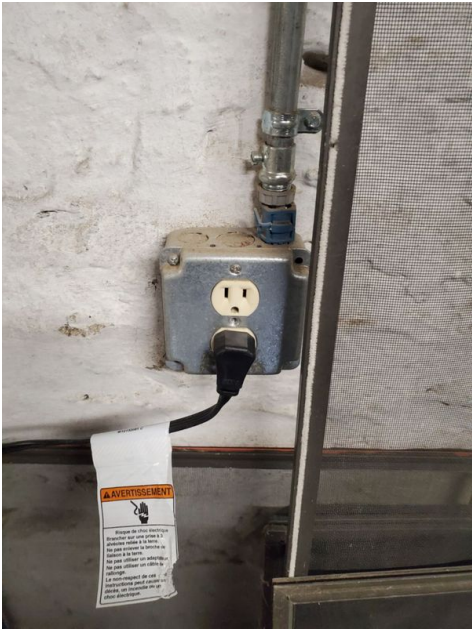
MISSING GFCI PROTECTION

We observed missing GFCI protection for one or more laundry receptacles. GFCI protection is required in laundry areas.

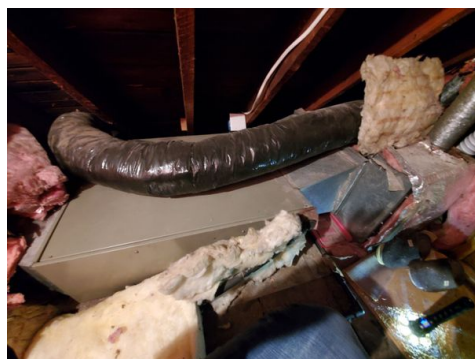
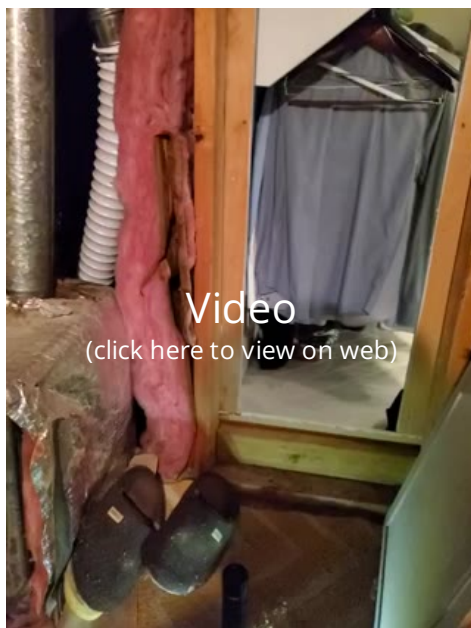
SYSTEM INACCESSIBLE

Part of the heating system was inaccessible. The inspection was restricted and limited. Further evaluation is recommended by a qualified professional.

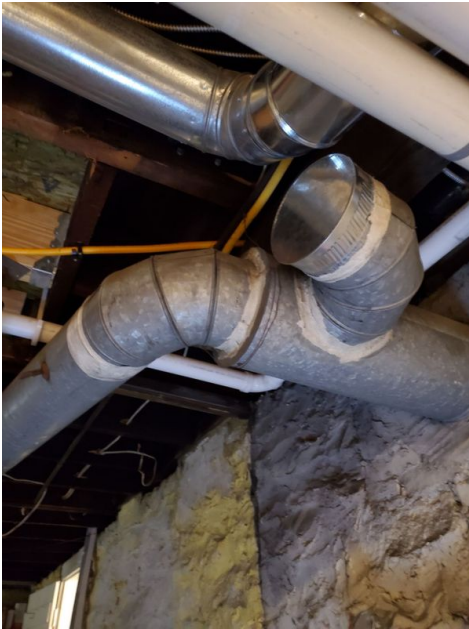
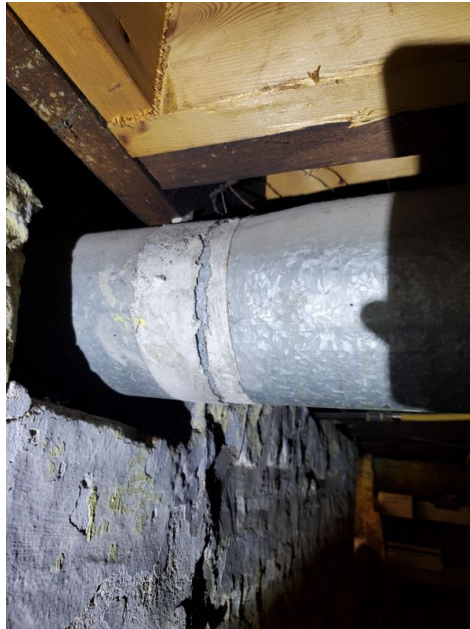
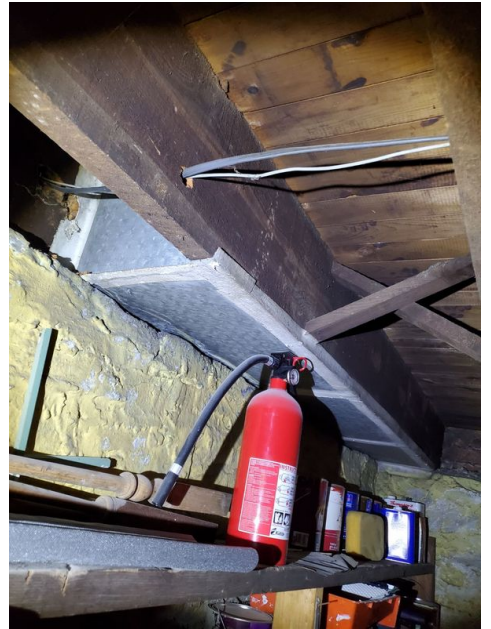
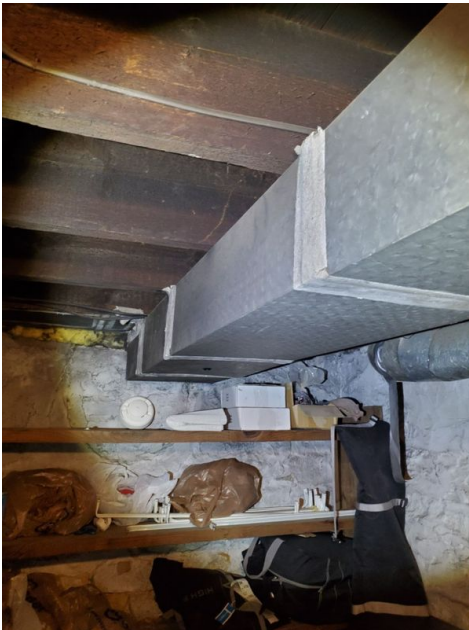
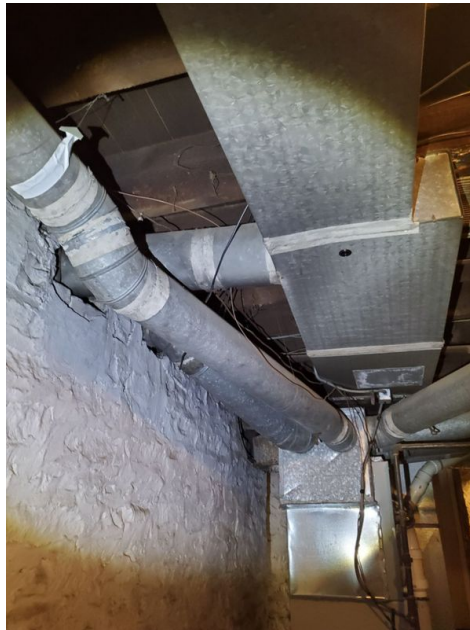
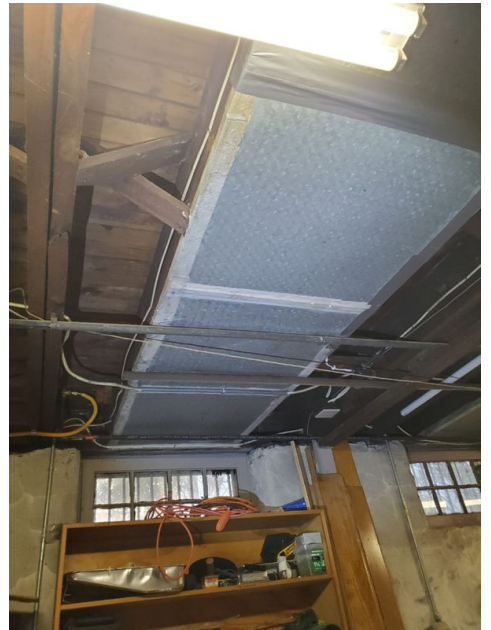
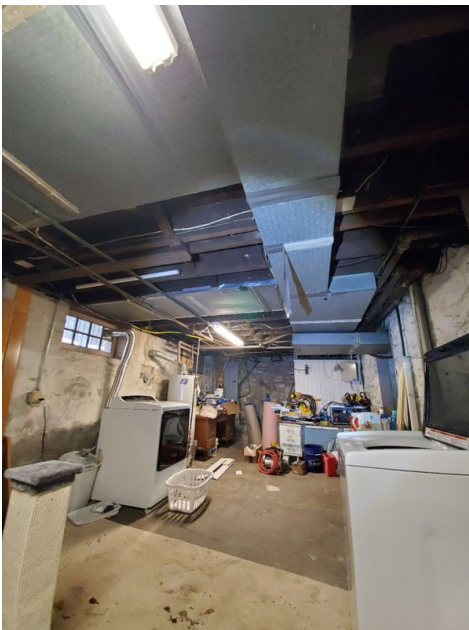
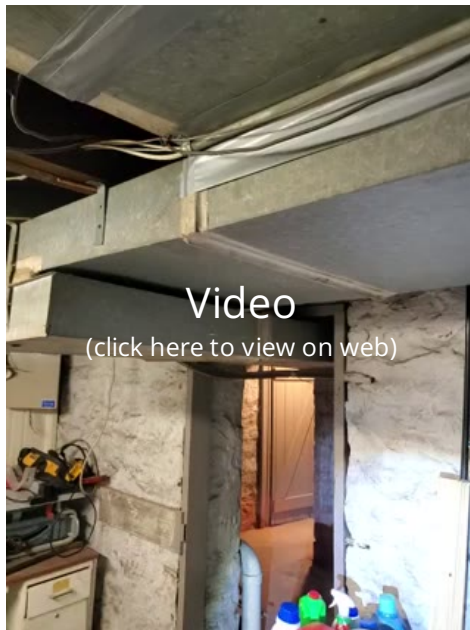
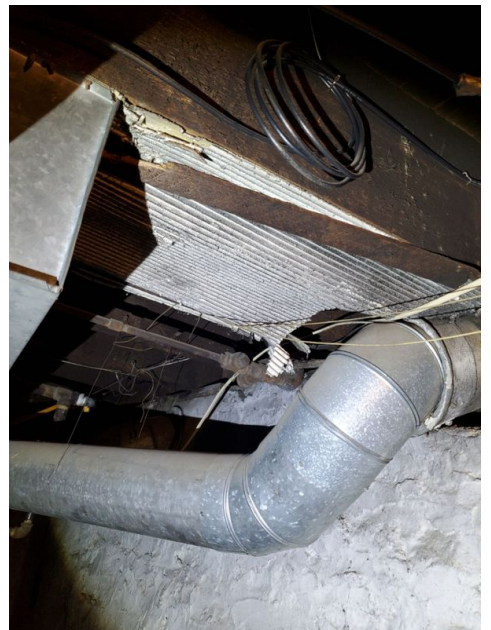
We observed materials that appear similar to those that may contain asbestos on the HVAC system and/or ductwork. This is a safety concern and should be further evaluated and corrected by a qualified professional.

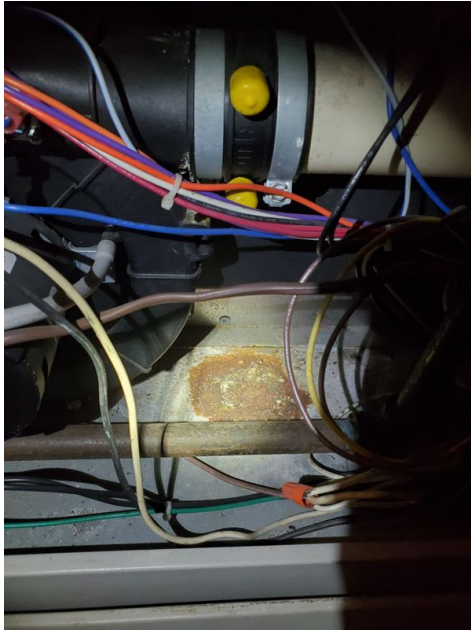
11.1.2 Heating & Ductwork

CORROSION & RUST

We observed areas of corrosion and rust at the heating system that may indicate its approaching the end of its service life. We recommend it is further evaluated by a qualified professional.

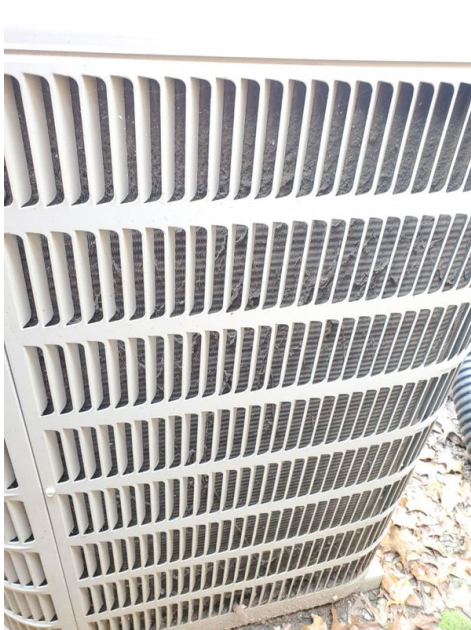
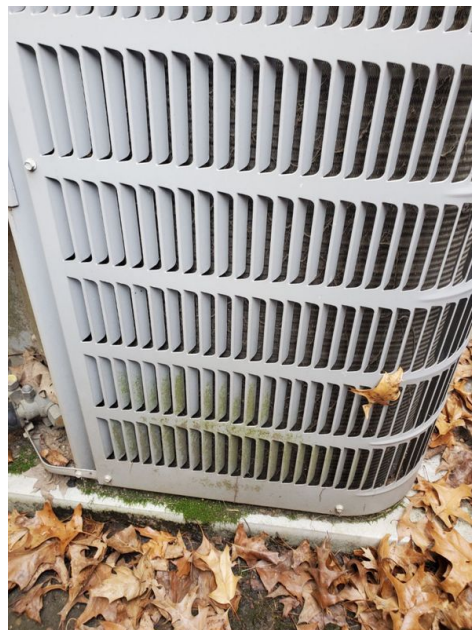
11.2.1 Cooling & Condensate

CONDENSER FINS DIRTY

We observed that the fins of the condensing unit were dirty. This can negatively impact the efficiency, performance, and service life of the system.

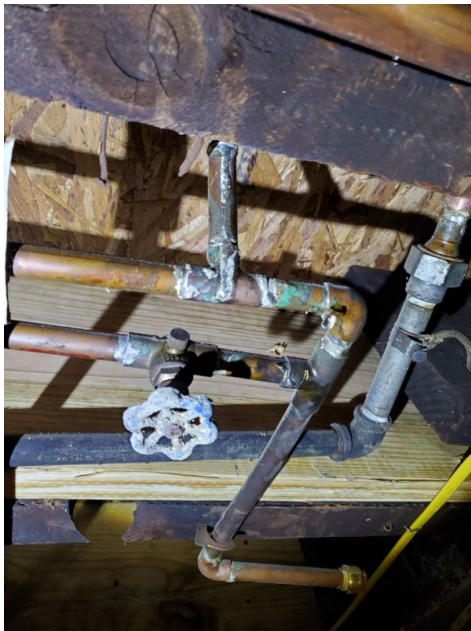
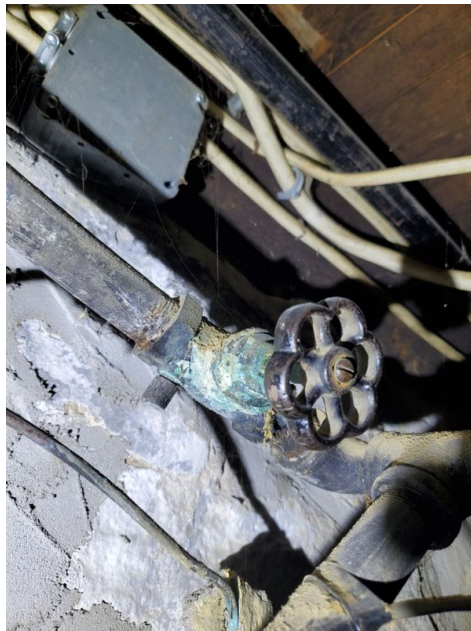
**CORROSION**

We observed more-than-expected corrosion at pipe fittings in one or more areas. Continued corrosion can cause leaks, but no active leaks were observed. We recommend this is further evaluated by a qualified professional.

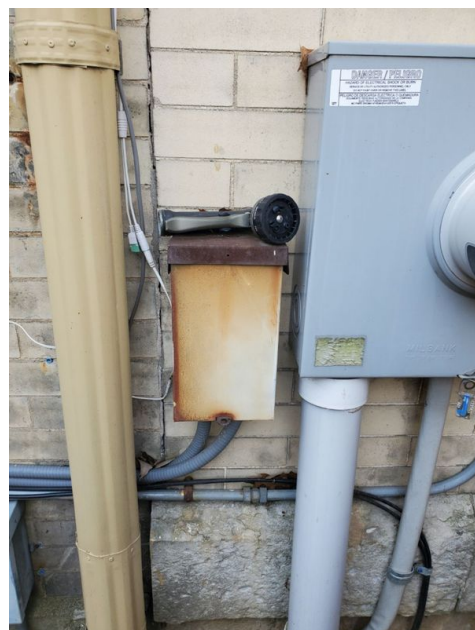
CORRODED EXTERIOR ELECTRICAL COMPONENT

We observed an electrical component that appears to be at the end of its service life.

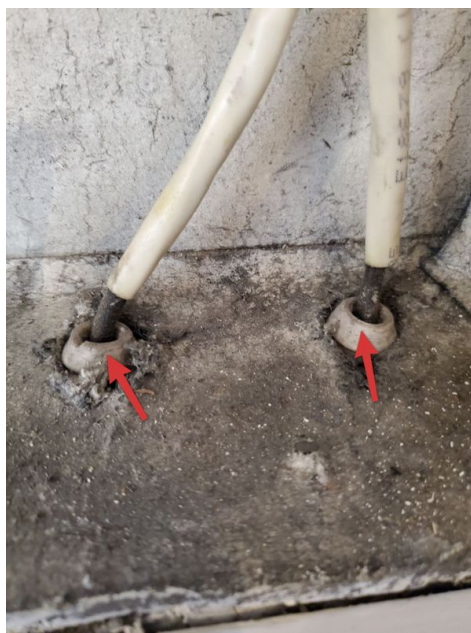
2nd Floor Hallway

We observed live knob & tube wiring in the home. Based on the age of this type of electrical, we considered it a hazard and replacement is recommended. Knob & tube wiring is not grounded, is susceptible to damage and deterioration, and certain types may contain asbestos in the wire insulation.

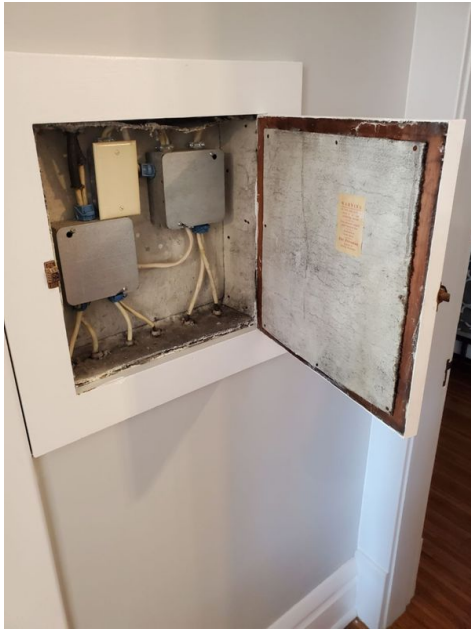
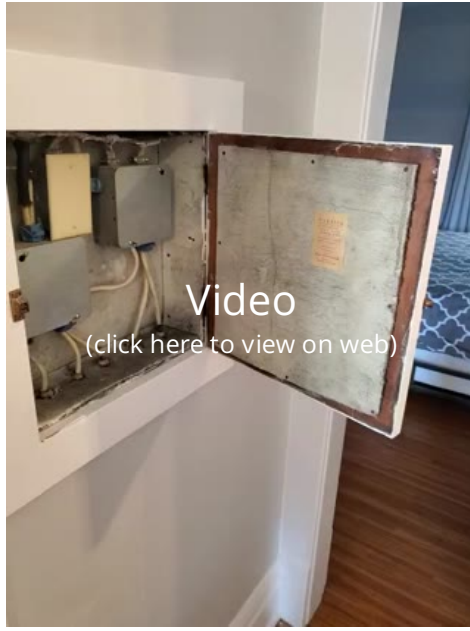
13.2.3 Disconnects, Panels, Breakers, & Wiring

SUSPECTED ACM

We observed materials that appear similar to those that may contain asbestos on the electrical system.

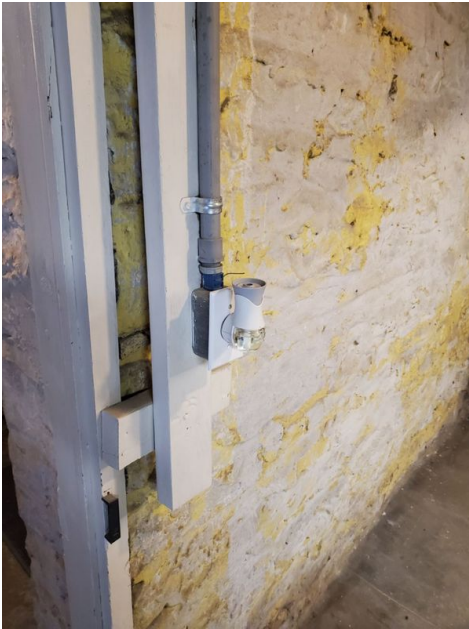
MISSING GFCI

We observed missing GFCI protection, which is required for all 15- and 20-amp receptacles in an unfinished basement.

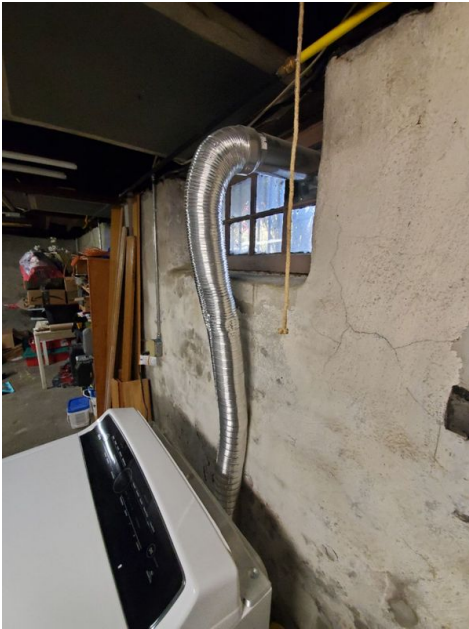
FOUNDATION WALL LEANING

We observed a leaning foundation wall. This is a potential structural issue, but is also relatively common among homes this age. We recommend further evaluation by a qualified specialist and/or structural engineer.

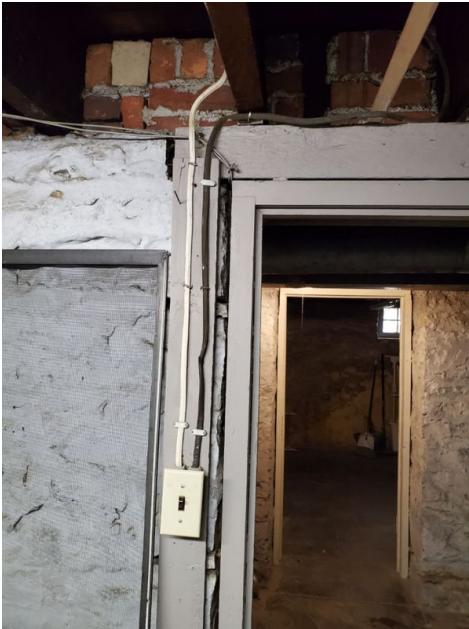
We observed electrical wiring that is subject to damage and should be protected inside a finished wall or a conduit. This is a safety concern.

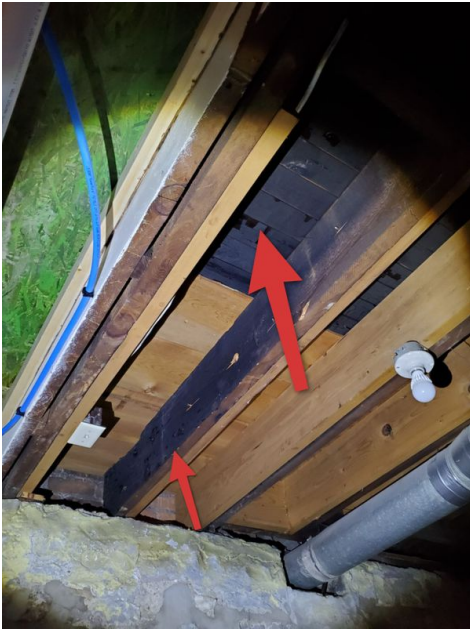
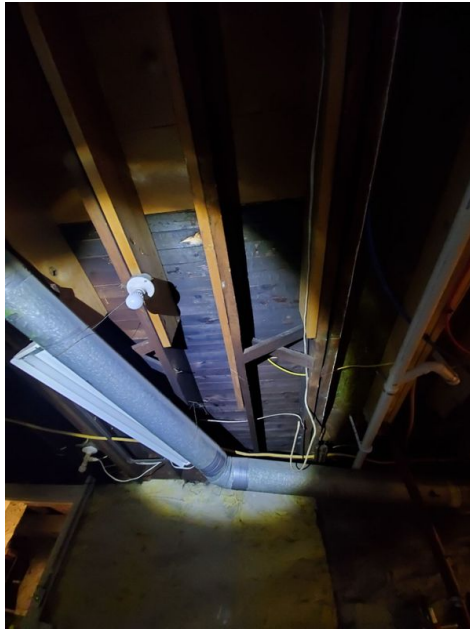
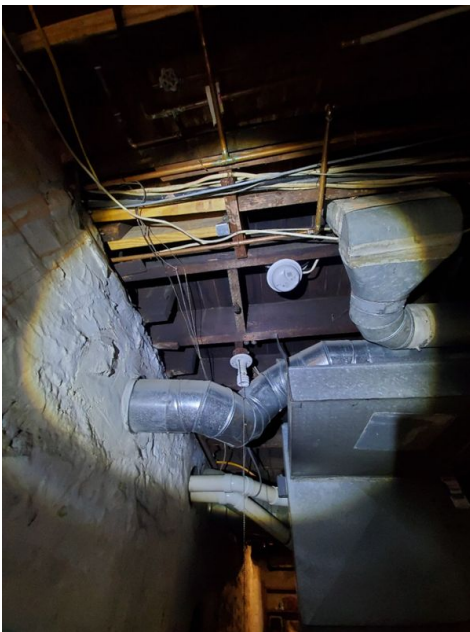
EVIDENCE OF FIRE DAMAGE

We observed indications that there may have been a fire in the house at some point. We recommend this is further evaluated by a qualified professional and/or structural engineer to determine that proper repairs were made.

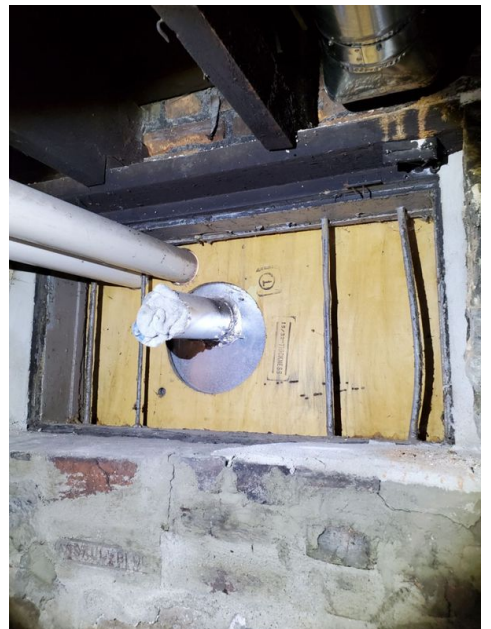
15.1.9 Basement

UNUSED VENT

We observed an unused vent that is not sealed. It may let in a lot of cold air in the winter.
