SCOTT HOME INSPECTION, LLC

## HOME INSPECTION REPORT

879 4th St  
Berthoud CO 80513

OCTOBER 30, 2018

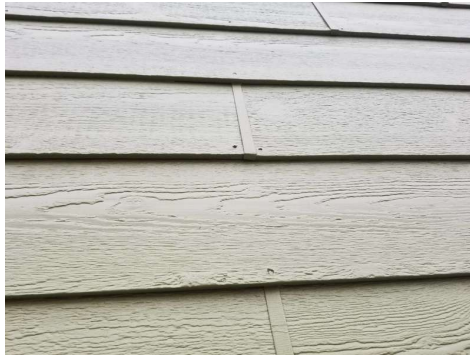
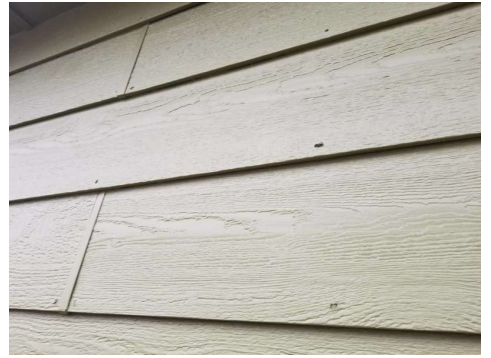
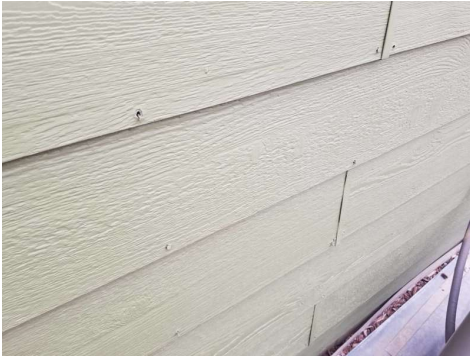
North

**NAIL/END CUT FAILURE**

The siding is failing at nail heads and end cuts in several areas. Water absorption is present and damage and deterioration are observed. It is recommended that a siding professional investigate and repair or replace the damaged siding as necessary.

Repair Recommendation

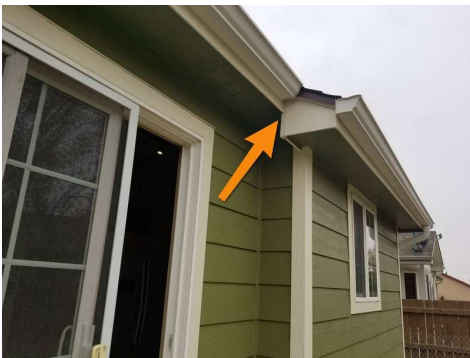
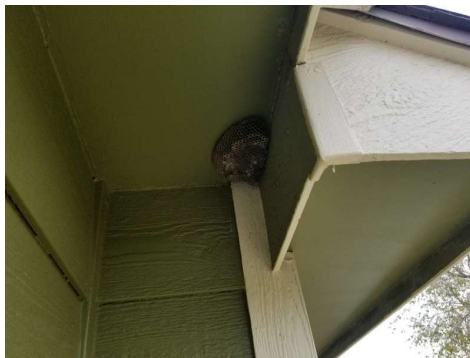
### 2.2.1 EAVES, SOFFITS AND FASCIAS

#### **WASPS NESTS**

Maintenance item

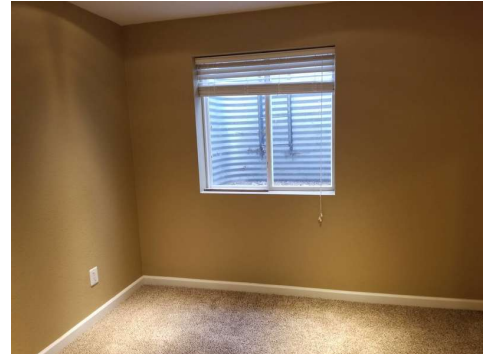
**MISSING SCREEN**

The screen is missing. A screen repair/replacement is needed.

Maintenance item

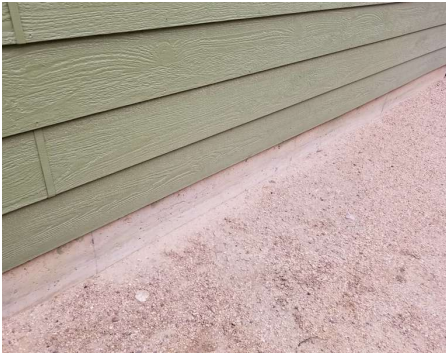
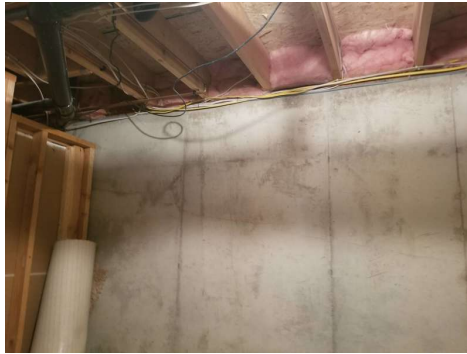
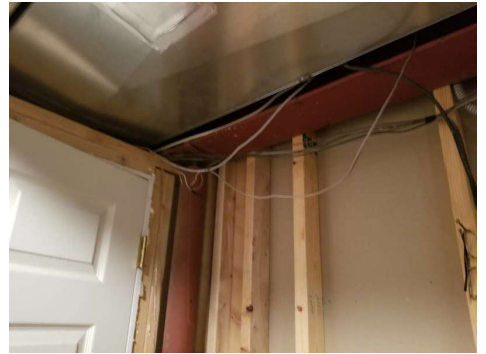
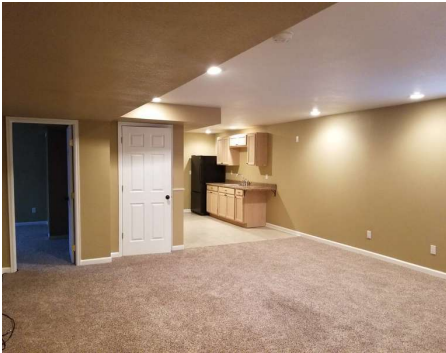
**FOUNDATIONS, BASEMENTS AND CRAWLSPACES: No Immediate Structural Concerns**

The structure and foundation of the home were visually inspected where readily accessible for signs of problems or concerns. The exterior and interior wall coverings were also inspected for indications of settling, movement, or cracking. No indications of significant structural concerns were observed at the time of the inspection.

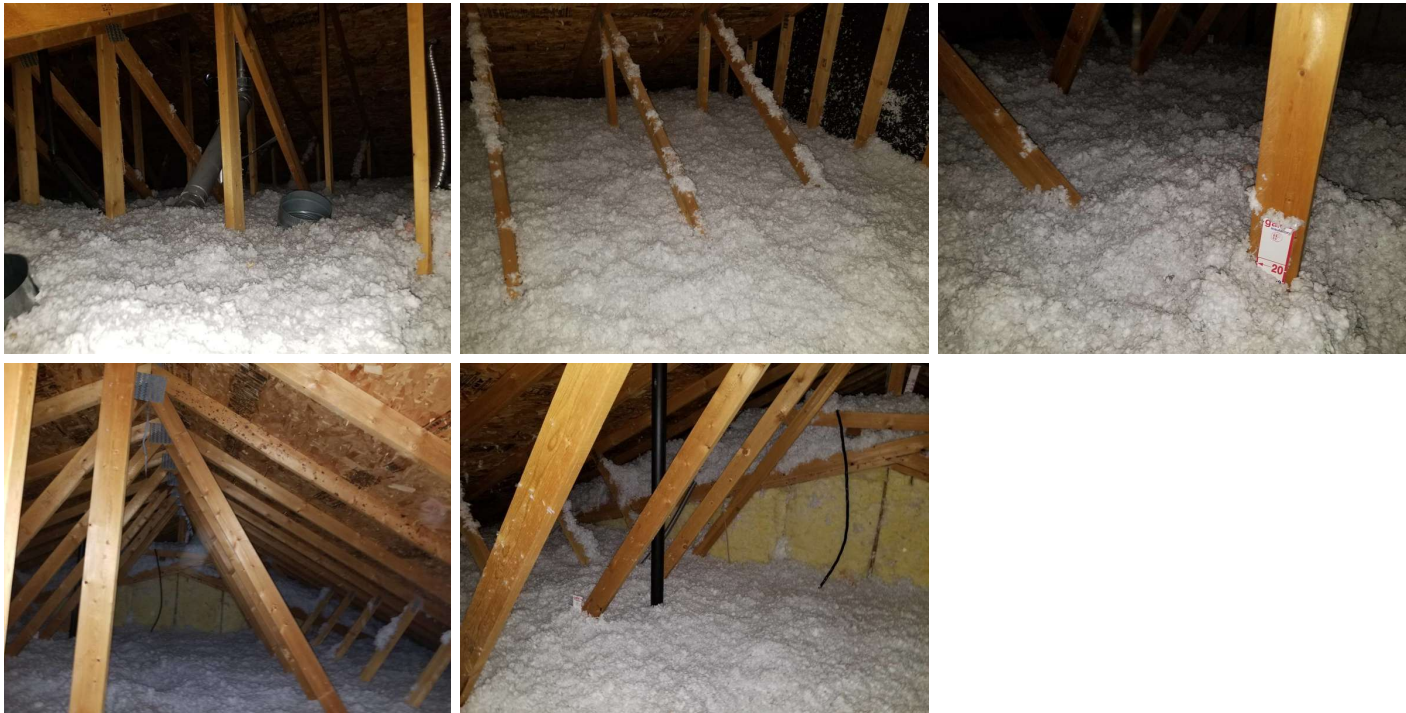
Attic

ATTIC INSULATION AND VAPOR RETARDERS: No immediate concerns noted

The attic was visually inspected and is properly insulated, with no structural or moisture concerns noted.

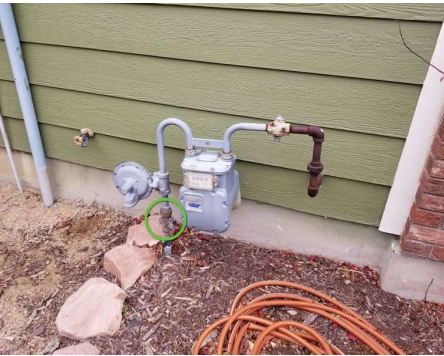
#### MAIN FUEL SHUT OFF LOCATION: At Gas Meter

The main fuel shut-off is at the gas meter outside. No visible concerns or odor of gas leaks were noted at this time. Note that we do not operate gas valves.

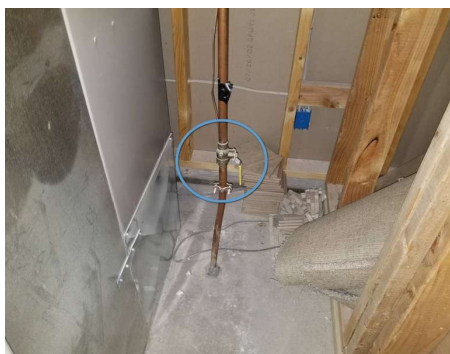
Basement Utility Room

**MAIN WATER SHUT-OFF LOCATION: Inspected - No Concerns Noted**

The main water shut-off was inspected, with no concerns noted. This can be used to turn all of the water off to the home in the event of a plumbing emergency or when plumbing repairs are needed.

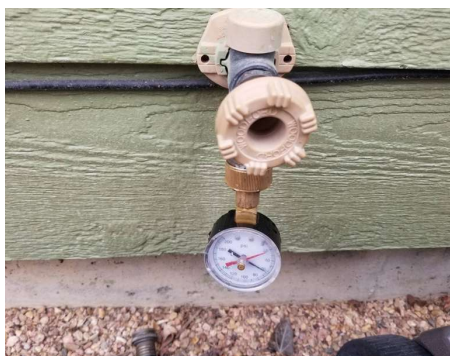
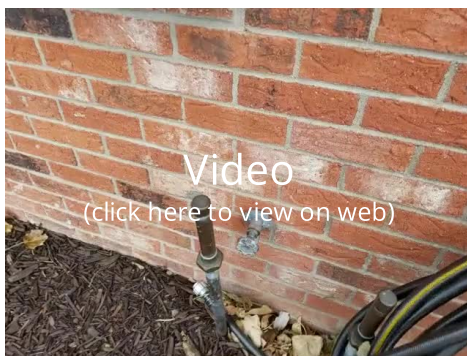
60 psi

**WATER PRESSURE MEASUREMENT: No Concerns Noted**

The water pressure was measured at an outside hose-bib and was in the normal expected range of 35-80 psi. This static measurement is what was measured on the day of the inspection, but this water pressure can vary at different times of the day depending on the pressure that is being delivered by the municipal water supplier.

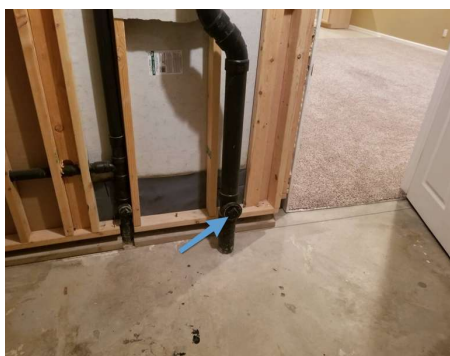
Basement Utility Room

**DRAIN, WASTE, AND VENT SYSTEMS: Clean out location**

There is a plumbing clean-out, which allows access to the waste drain, in the event of back-up or clogs. This item is noted for reference only, and for future maintenance consideration.

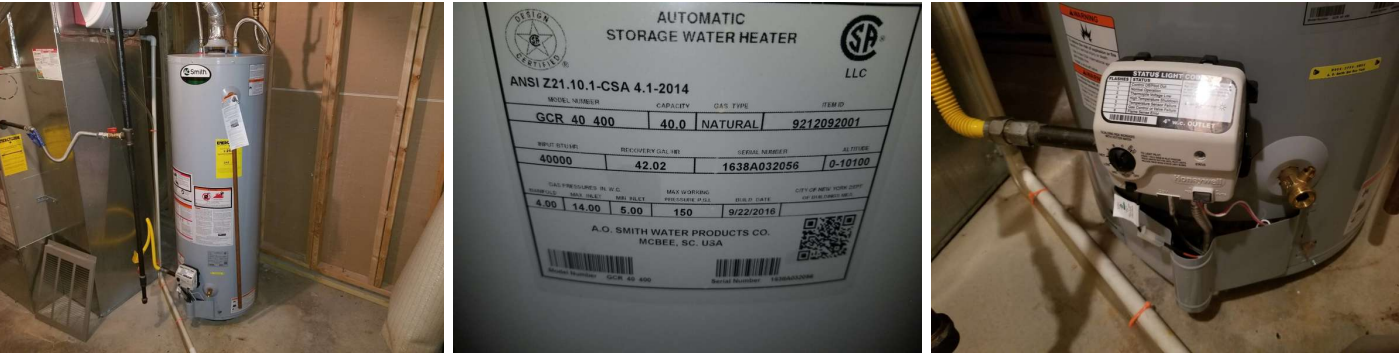
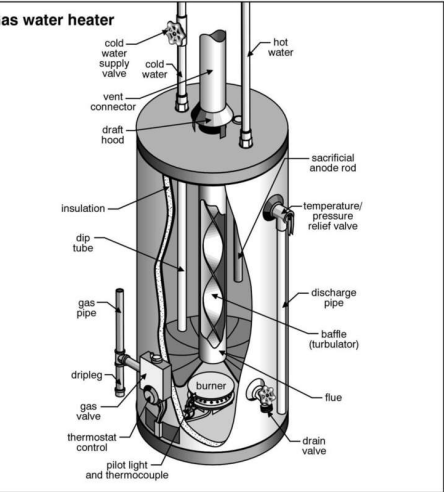
**HOT WATER SYSTEMS, CONTROLS, CHIMNEYS, FLUES AND VENTS: Gas Water Heater - No Concerns Noted**

The water heater was inspected, with no concerns noted and no significant rusting at this time. No action is needed.

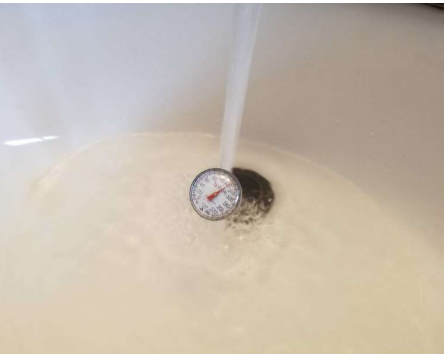
**TEMPERATURE OF HOT WATER (NOMINAL SETTING = 120 F): Temperature acceptable**

A thermometer was used to test the temperature of the hot water at a faucet in the home. This temperature was within the normally acceptable ranged of 120 to 130 degrees F. Temperatures over 130 F can present a scalding hazard. At the water heater, the temperature indicator dial was checked to verify that it corresponded with the temperature measured out of the tested faucet.

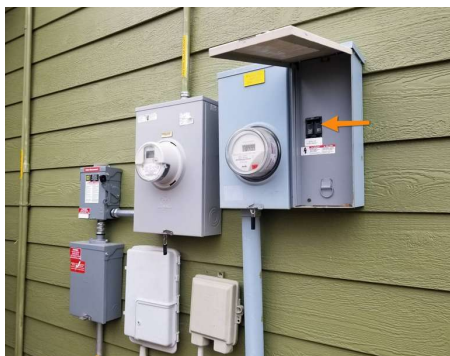
Main disconnect

**MAIN DISCONNECT DEVICE: Located and Inspected**

The main electrical service disconnect can be used to shut off all power to the home in the event of an electrical emergency or when electrical repairs are needed.

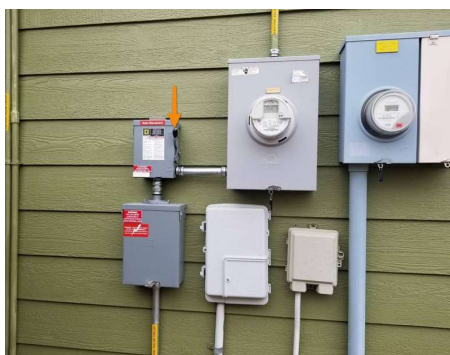
PV disconnect

**MAIN DISCONNECT DEVICE: Additional PV Solar Disconnect Present**

There is also a PV service disconnect. Both this and the main disconnect must be shut off in order to shut off all power to the home.

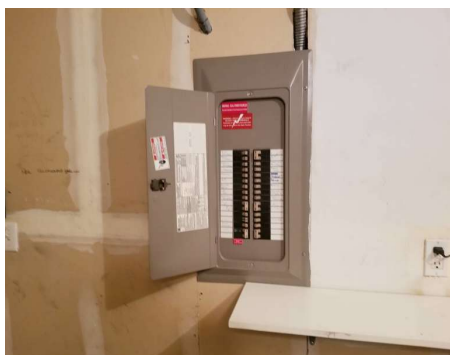
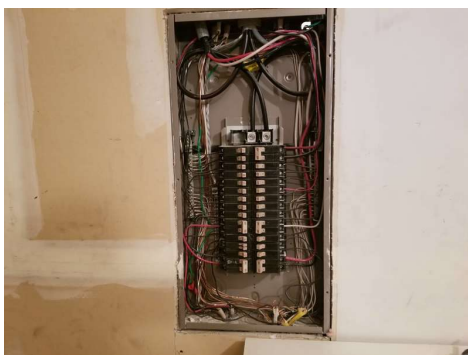
**MAIN & DISTRIBUTION PANELS, SERVICE AND GROUNDING EQUIPMENT: Panel Inspected - No Concerns Noted**

The interior of the main panel was inspected, with no concerns noted at this time.

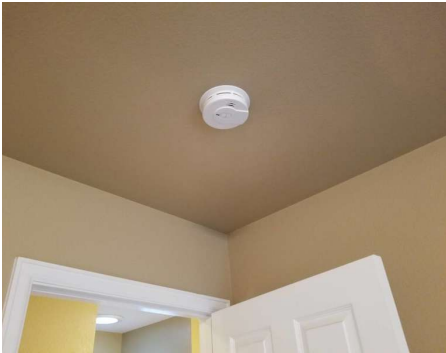
## SMOKE DETECTORS: Units Present In All Recommended Locations

Smoke detectors are present in the home, located on each floor and within each bedroom, as recommended. Monthly testing of the units is recommended, along with annual battery replacement. Additionally, replacement of the units is recommended once older than 10 years of age, according to the National Fire Protection Association. This helpful [resource](#) has important tips related to smoke alarm safety.

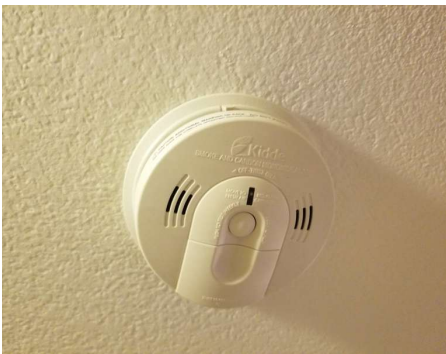
## CARBON MONOXIDE ALARMS: Units Present In All Recommended Locations

CO detectors are currently present in the proper locations.

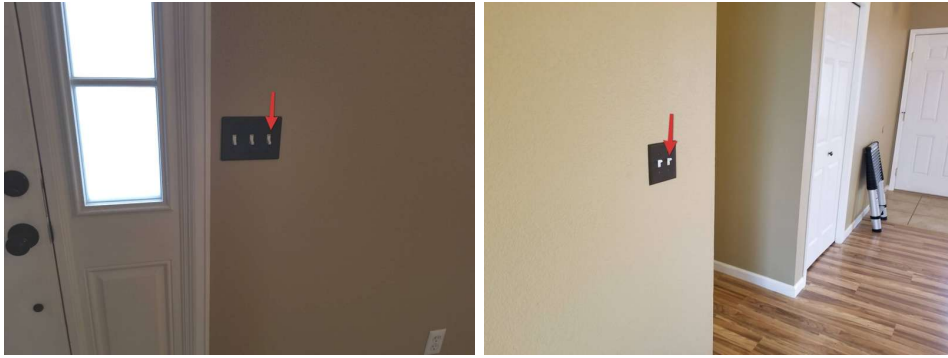
### 6.5.1 FIXTURES, SWITCHES AND CONNECTED DEVICES

Contact a qualified electrical contractor.

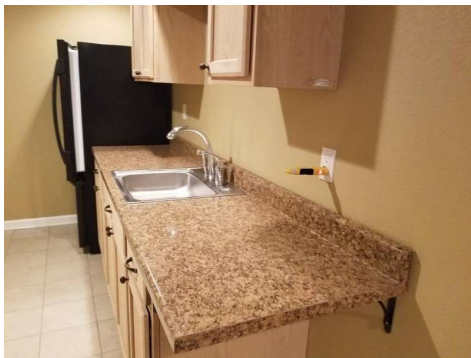
Kitchenette

### 6.6.1 RECEPTACLE OPERATION (POLARITY AND GROUNDING)

#### REVERSE POLARITY

Contact a qualified electrical contractor.

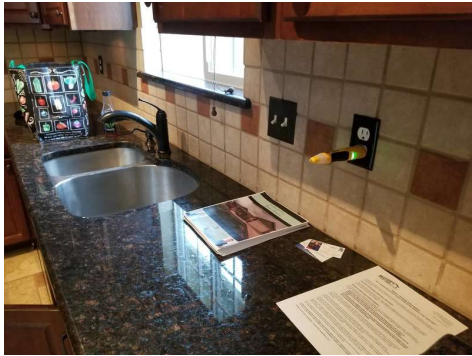
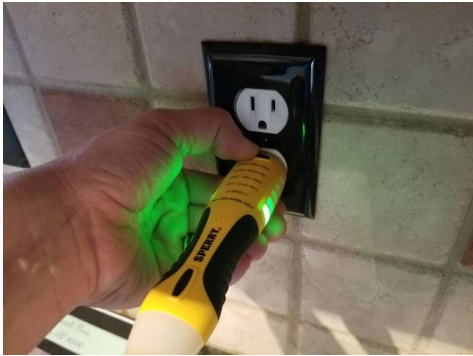
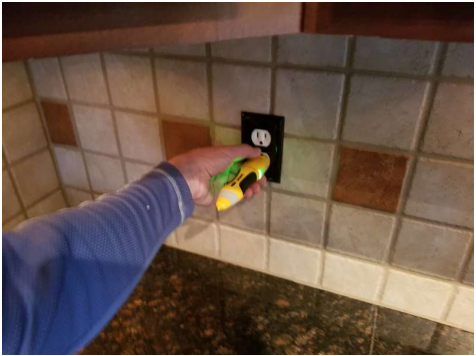
### 6.7.1 OPERATION OF GFCI (GROUND FAULT CIRCUIT INTERRUPTERS)

#### NO GFCI PROTECTION

Recommendation  
Contact a qualified electrical contractor.

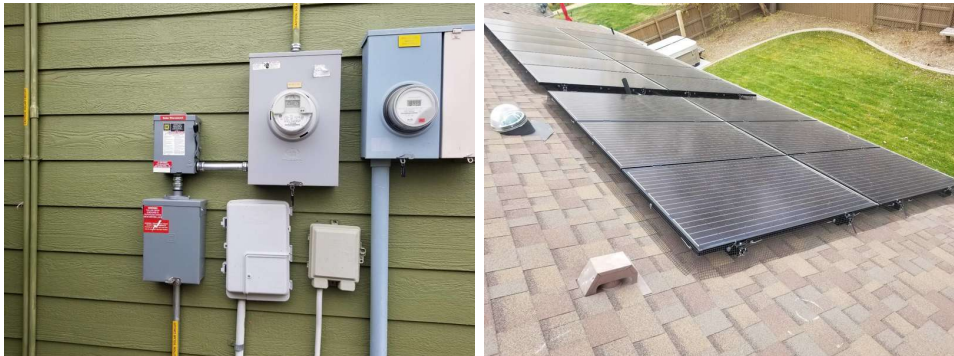
The home has a Photo-Voltaic (PV) solar system installed. This item is outside of the scope of a standard home inspection. However, the panels were visually inspected for concerns. The electric shut off was reviewed. And, the inverter was visually inspected. A complete evaluation and review of this system should be done with a specialist or the installer. No concerns were noted at this time.

Recommendation  
Contact a qualified professional.

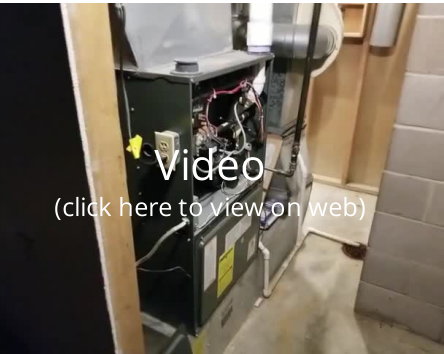
Basement Utility Room

The disposable filter for the HVAC system is clean. Regular furnace filter replacement is recommended every 3 months during the heating and cooling season.

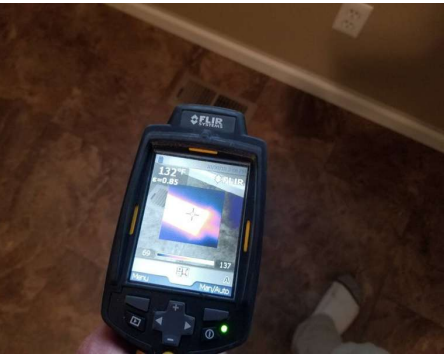
Temperature was measured at supply registers throughout the home while the heating system was operating, with no concerns noted

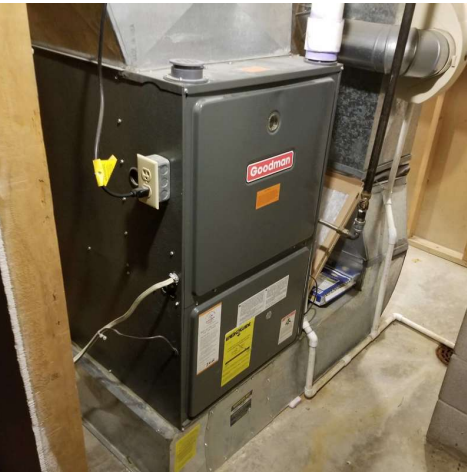
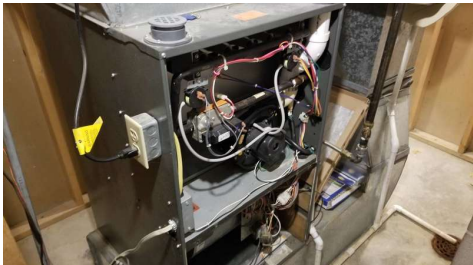
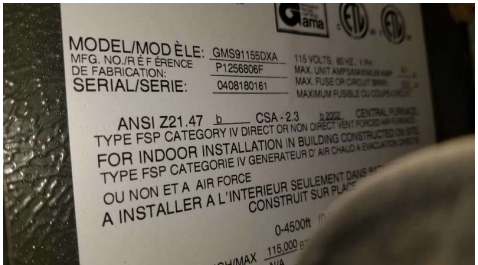
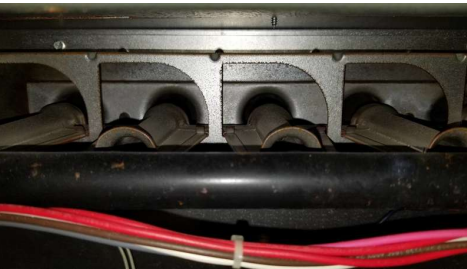
7.1.1 HEATING EQUIPMENT

The gas furnace is aging, but appears to be working properly at this time. The average life expectancy of a furnace is 15-20 years. No ambient Carbon-Monoxide (CO) emissions were detected from the unit. Based upon its age, the unit should be monitored for performance issues. It is recommended that an HVAC contractor service and fully evaluate the furnace at this time. Also, an annual servicing is recommended, to keep the unit in good working condition.

Recommend monitoring.

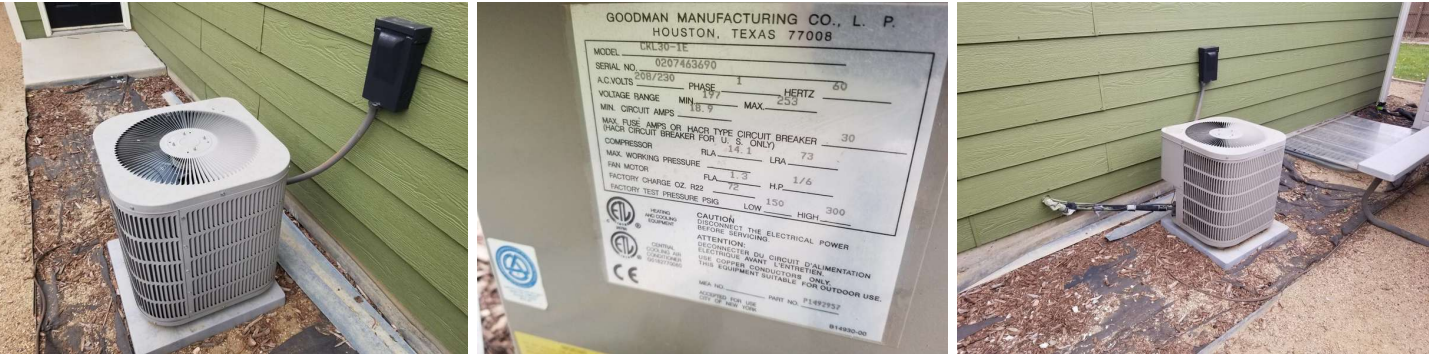
#### AC - TOO COLD TO TEST - AGE CONCERNS NOTED

The A/C was not tested for proper operation because the outside air temperature is 65 degrees or less. Damage to the unit can occur if operated below this temperature. Liquid can be in the compressor unit, and can damage the compressor if run. A limited visual inspection of the system and electrical service was conducted. The outside AC condenser unit is older and is at or nearing the end of its useful life. Units in this condition can fail during the seasonal change from mild to hot weather. When the unit can be run, the performance should be monitored, and replacement should be anticipated in the short term.

Contact a qualified heating and cooling contractor

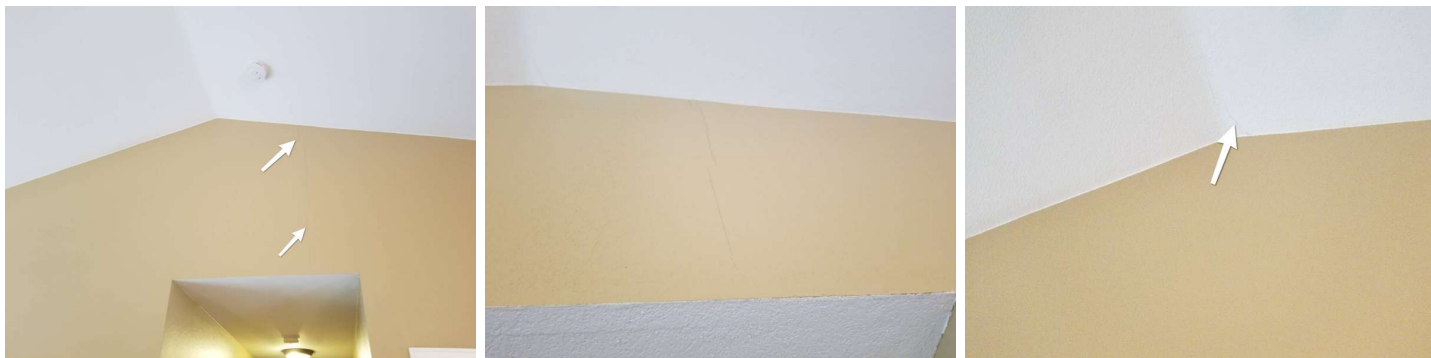
#### MINOR CRACK(S)

Minor cracking was noted. These types of cracks are typical of minor settling or shrinkage, and should be monitored for further movement, and patched and repaired as needed.

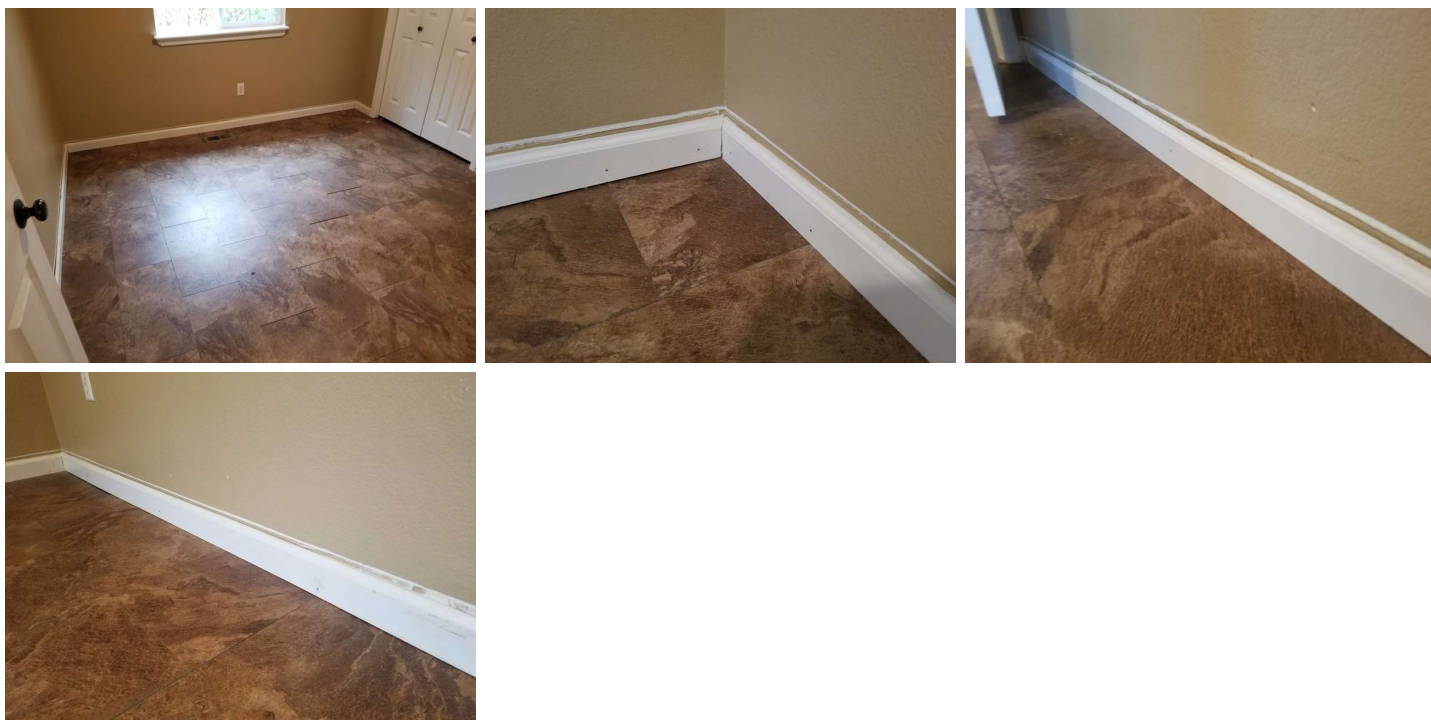
## 9.2.1 WALLS

**BASEBOARDS REMOVED**

The baseboards have been removed and reinstalled lower on the wall, likely because carpeting was removed in this room and replaced with the lower height vinyl flooring. This leaves a poorly finished line of caulking on the wall, and the baseboards have not been caulked and repainted. Consider having the baseboards replaced with a taller material, and caulked and repainted as needed.

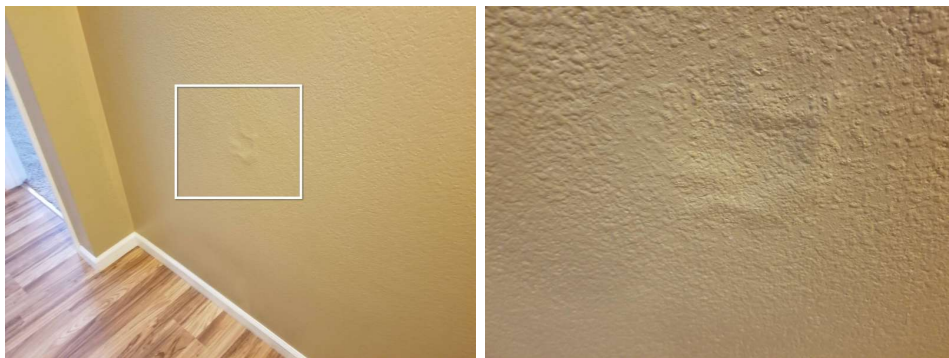
## 9.2.2 WALLS

**COSMETIC DEFECT**

A poorly finished and bubbled drywall patch is visible at the end of the hallway. A drywall professional can patch and repair as desired.

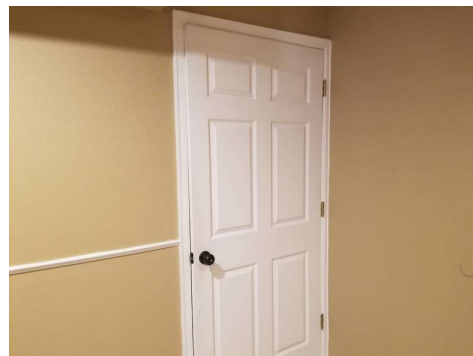
#### 9.4.1 DOORS

### **DOOR(S) RUBS AT JAMB**

The door(s) rubs at the jamb when closed. This door needs to be adjusted or repaired for proper operation.

Contact a qualified door repair/installation contractor.

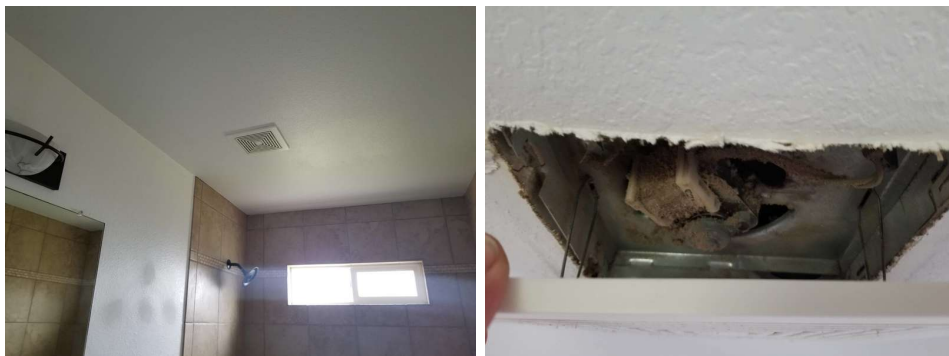
#### 9.8.1 VENTING SYSTEMS (KITCHENS, BATHS, AND LAUNDRY)

### **BATH FAN NOISY**

The bath fan operates noisily. This can indicate that the unit needs to be replaced, or can sometimes be remedied with a simple cleaning.

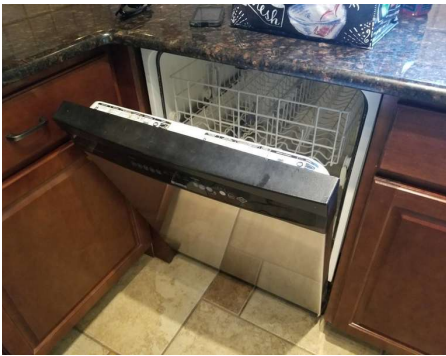
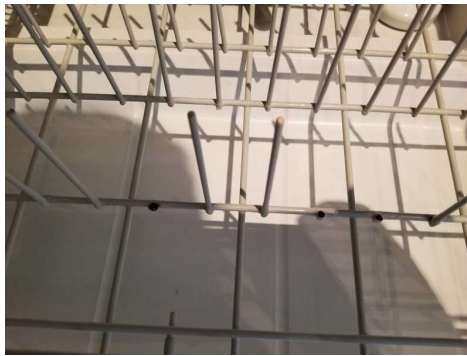
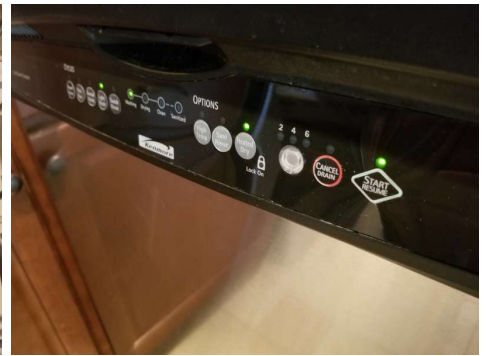
**DISHWASHER: Tested - Age Concerns Noted**

The dishwasher was visually inspected and was tested by running it through a brief cycle, to verify that no leaks were present and that it was running and draining properly. No concerns were noted with this limited functional test. However, the unit is older, and replacement with a new, Energy Star rated unit may be desired to improve efficiency.

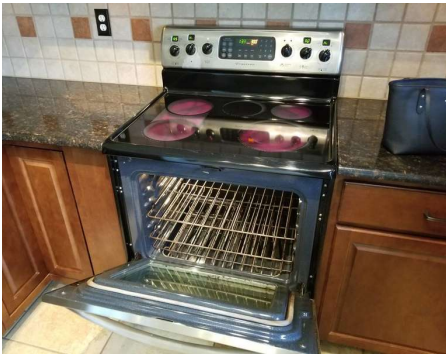
**RANGES / OVENS / COOKTOPS: Tested - Appears Functional**

A limited visual inspection was performed on the range and/or cook top and oven, to verify that the unit(s) is operating. The door seals are inspected, burners checked, and oven turned on to verify heat. No concerns were noted with this limited functional test. Some minor cosmetic damage and evidence of wear was noted at the unit.

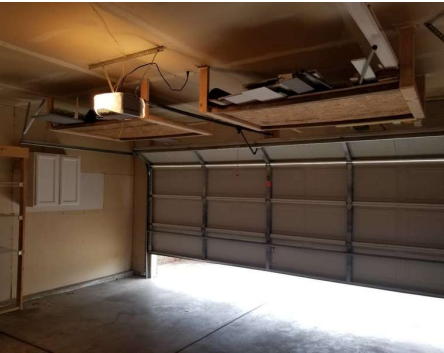
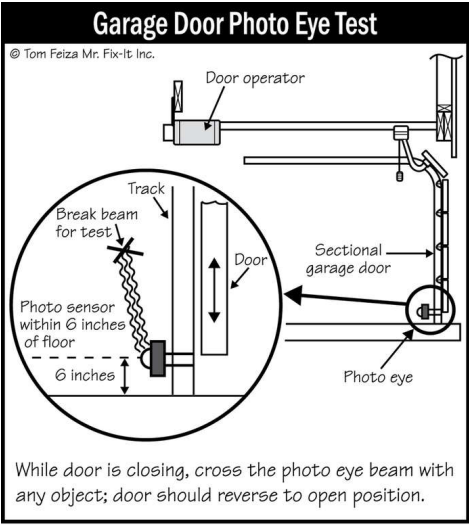
**GARAGE DOOR OPERATORS: Auto-Reverse Test Acceptable**

The garage door(s) reverse(s) when the photo-sensor beam is broken. This is a safety check performed, to test the safety feature of the door opener(s).

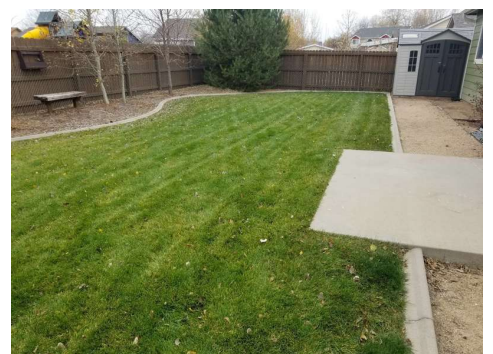
#### 12.1.1 SPRINKLER OPERATION

The sprinkler system was not tested due to the colder outside temperatures. The main shut off valve for the system was checked and is off at this time. A basic visual inspection of components was performed. The condition of the system is unknown, and it is unknown if proper winterizing was performed. Verify with the current owner that the system was blown-out or drained down and winterized properly. A full test should be done when the system can be de-winterized properly to verify operation.

Contact a qualified lawn care professional.

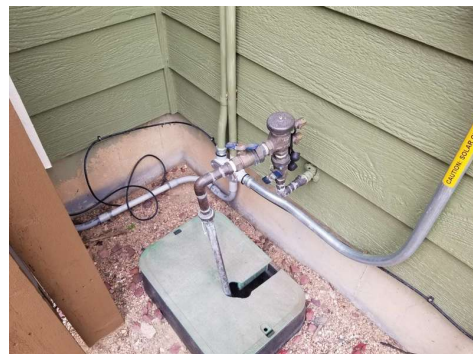
The backflow preventer for the lawn sprinkler system is located outside, and was visually inspected, with no concerns noted at this time. However the water to the system was not currently turned on, so the unit was not inspected for leaks or damage. A backflow preventer on a sprinkler supply ensures that water flow from the plumbing system flows out to the sprinkler, but is not allowed to be siphoned back into the drinking water system.

Contact a qualified lawn care professional.

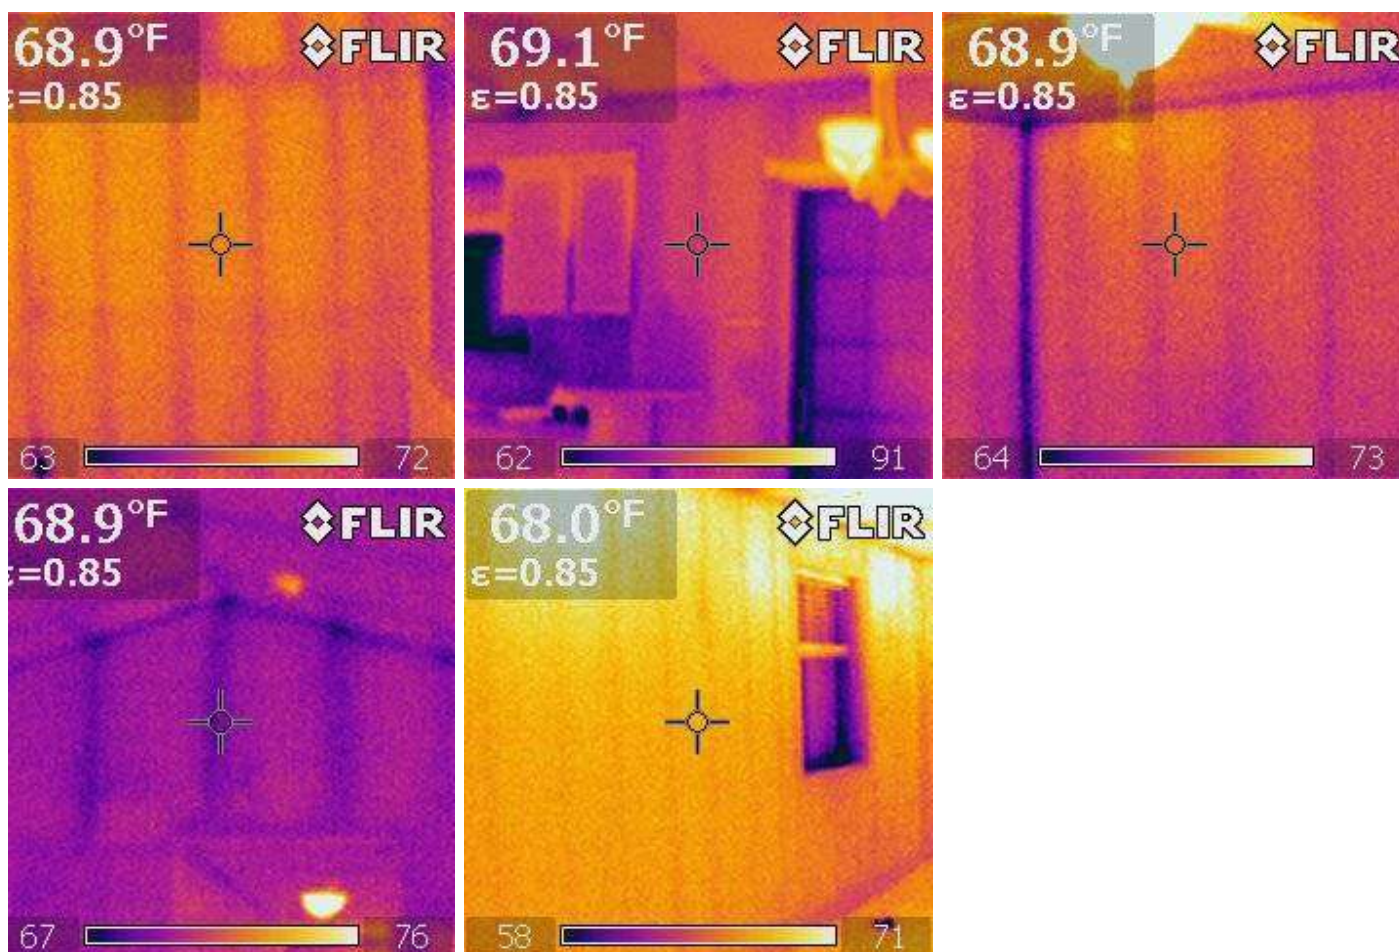
**Wall Insulation:** a basic inspection of the wall insulation was done using infra-red scans, and observing insulation levels behind outlet plates, where possible. This limited inspection showed that the walls appear to be insulated well at this time. No gaps, voids or missing areas were noted.

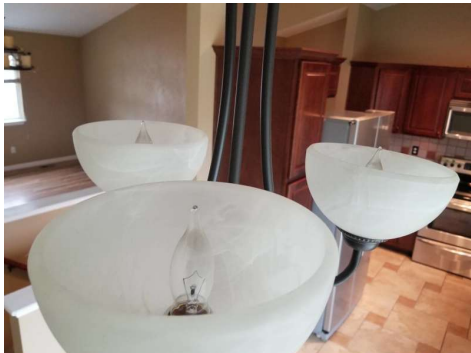
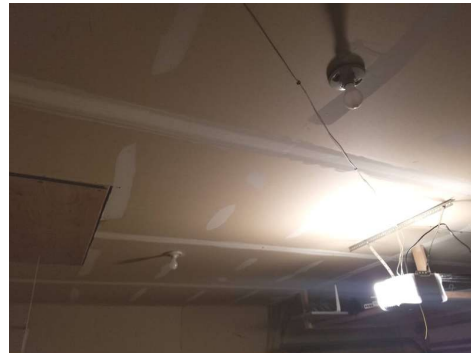
#### 14.6.1 LIGHTING-APPLIANCE RECOMMENDATIONS

##### ADD LED OR CFL BULBS

Contact a handyman or DIY project

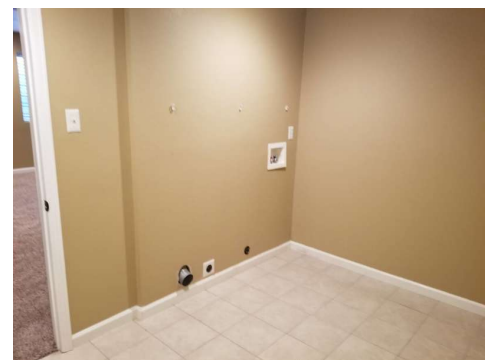
#### 14.6.2 LIGHTING-APPLIANCE RECOMMENDATIONS

##### WASH-DRYER NOT PRESENT

Recommended DIY Project

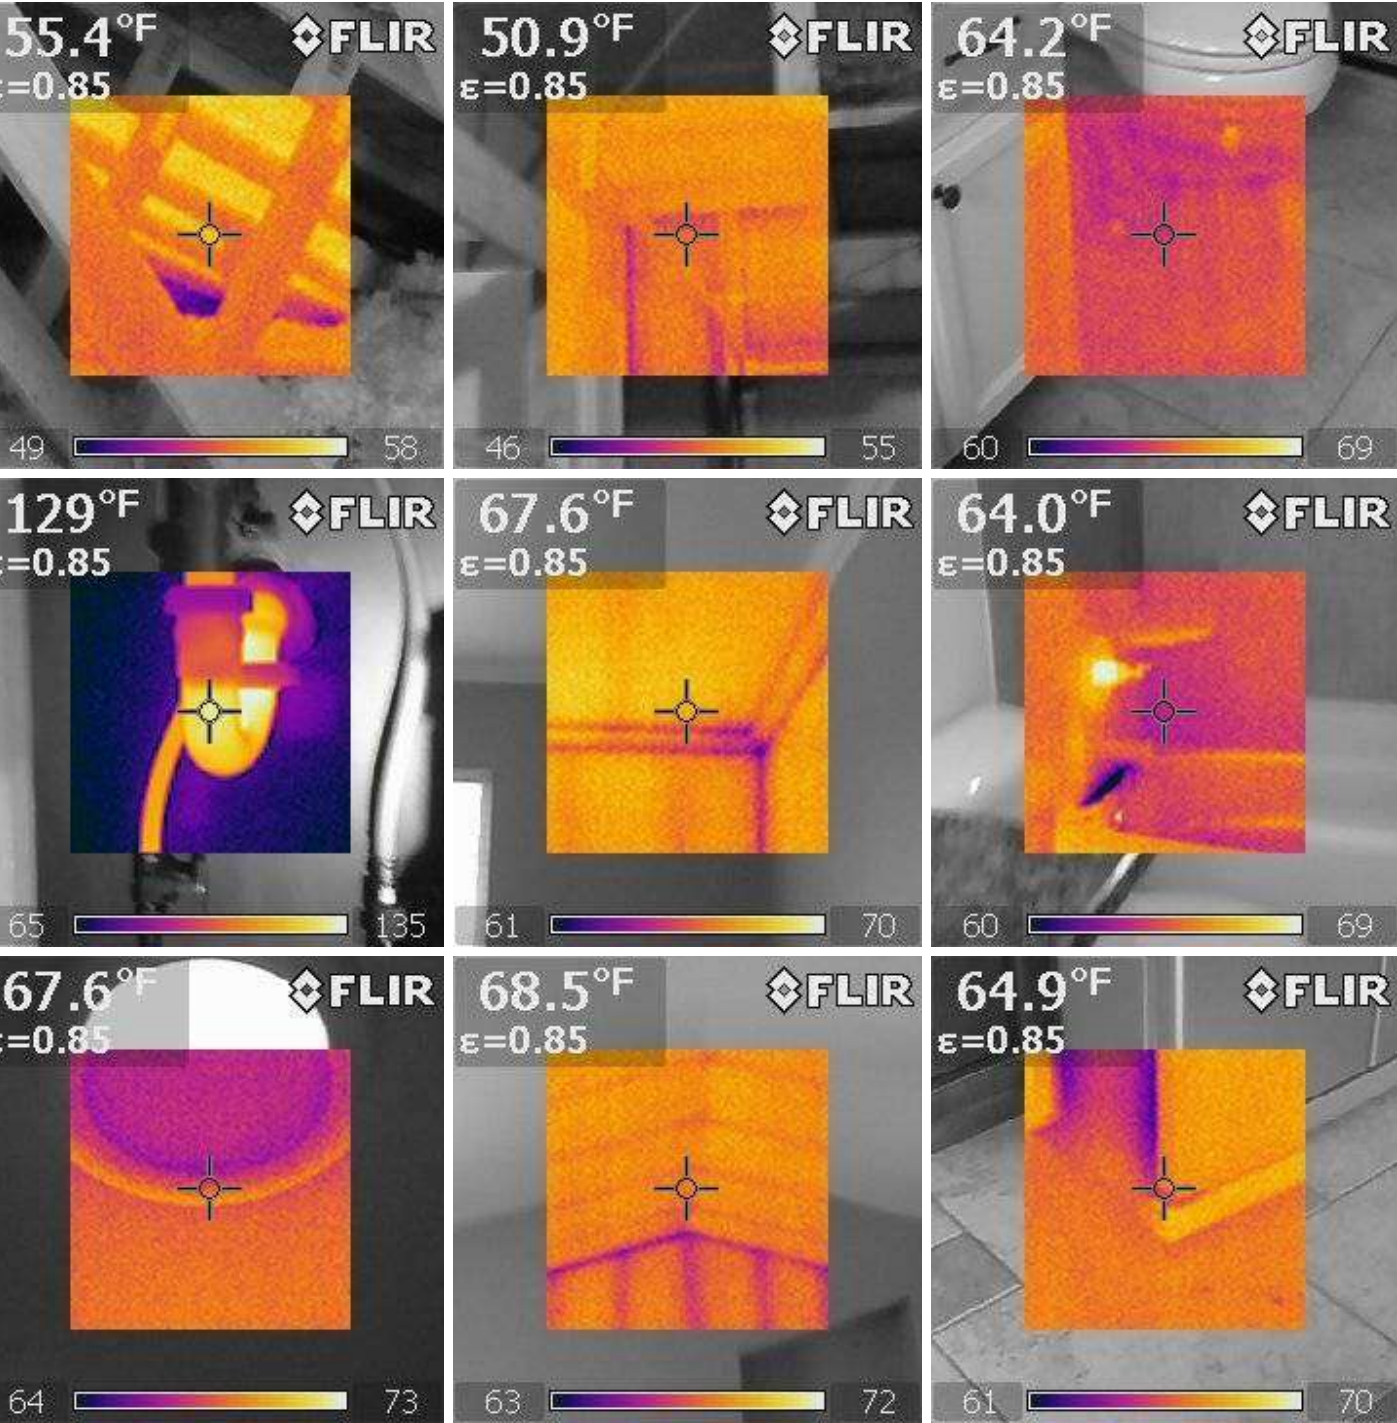
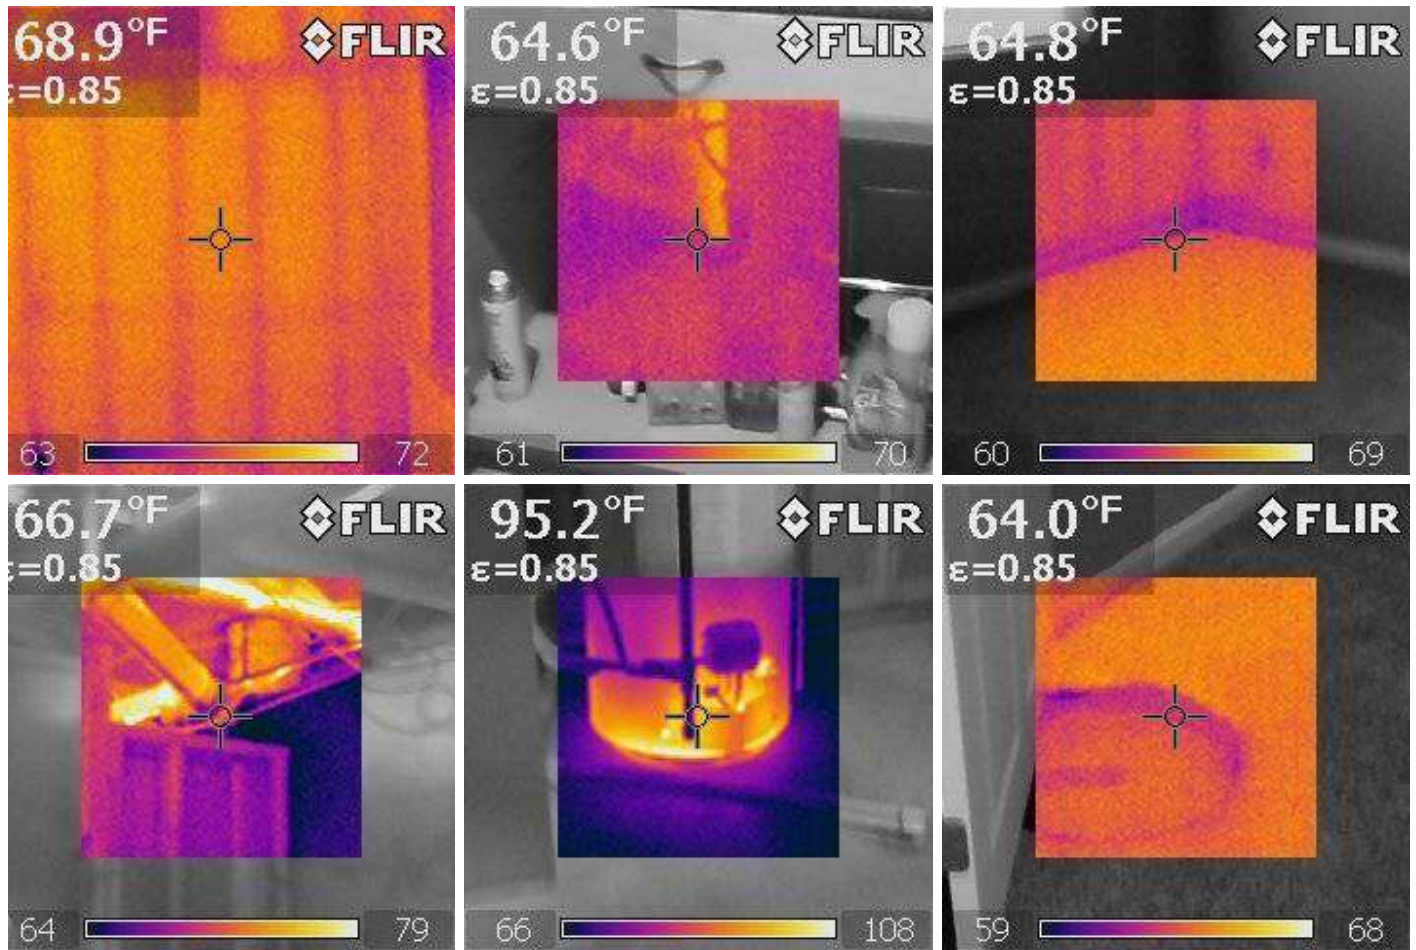
INFRA-RED (IR) SCANS: No Immediate Concerns Noted

Infrared scans were conducted throughout the home, to look for evidence of hidden moisture. Special attention was given to areas where potential moisture intrusion, plumbing or mechanical leaks, or roof leaks commonly occur. No evidence of the presence of moisture was noted or observed at the time of the inspection.

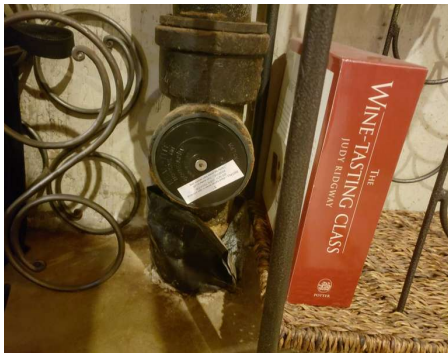
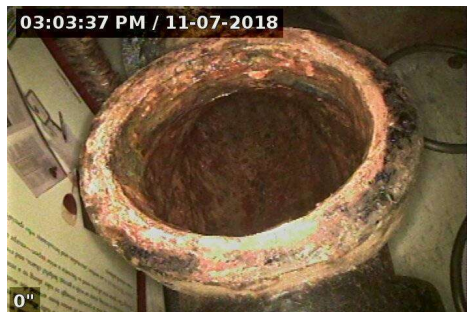
#### LOCATION OF CAMERA ENTRY: Basement Clean Out Present

A clean out was present in the basement. The camera inspection was performed through this location.

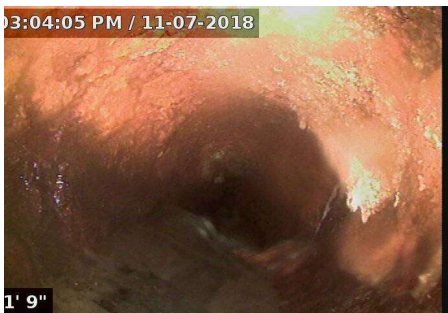
#### LENGTH OF SEWER LINE: Line Changes Material

The material of the sewer line changes type at 11 ft from cast iron to clay.

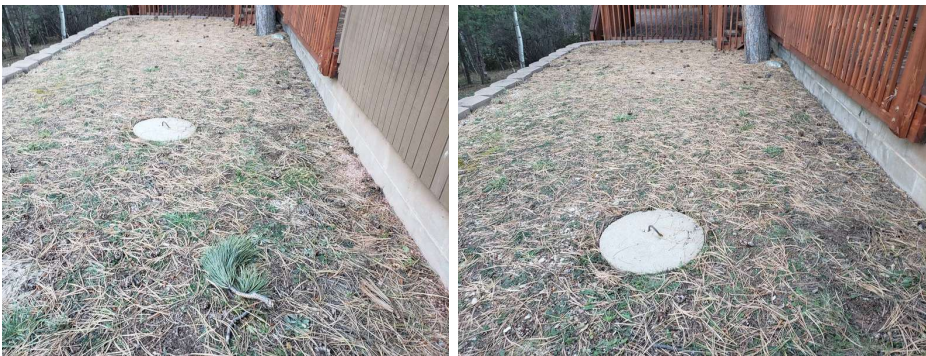
LOCATION OF AREA OF CONCERN: Location of Problem Area

The approximate location of the area of concern was determined using specialized locating equipment. The area was marked for future reference and for assistance in repair quotations. It is strongly recommended that this location be verified prior to excavating, as locating equipment can be affected by various factors, such as power lines, buried electrical lines and other items of interference, making the exact location difficult to determine.

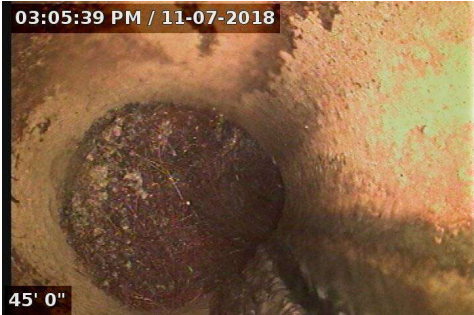
16.2.1 LENGTH OF SEWER LINE

The overall length of the sewer line from the entry point to the sewer main could not be found due to a root intrusion. Rooting and cleaning of the line is needed at this time. Then we recommend a re-inspection of the sewer line be done at that time to verify the condition. An associated re-inspection fee will apply for re-scope services.

Contact a qualified plumbing contractor.

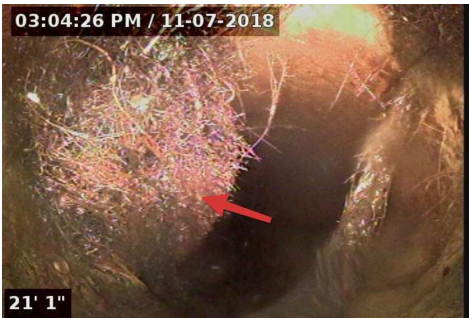
16.3.1 CONDITION OF SEWER LINE

Significant root intrusion was noted at the time of the sewer scope inspection. The roots prevented the camera from passing beyond this section. The camera inspection could not be completed, and the sewer line was not completely inspected. Repair is needed by a plumber or rooting company, to attempt to cut out the root intrusion present, allowing for complete inspection of the sewer line. Cracking or damage to the line can be present that is obstructed by the roots. After root cutting, a re-inspection of the line is strongly recommended to ensure all roots were removed from the line and to confirm the condition of the line. An associated re-inspection fee will apply for re-scope services.

Contact a qualified plumbing contractor.

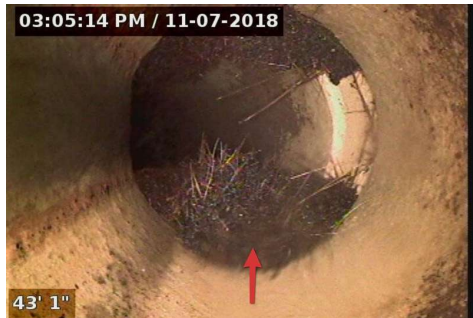
Root Intrusion

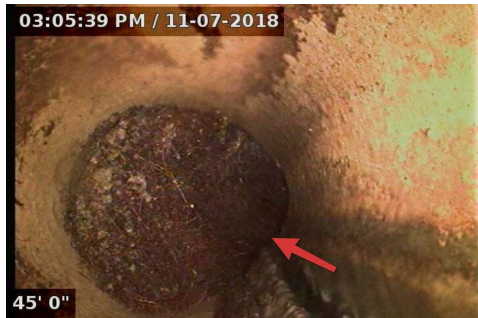
Root Intrusion

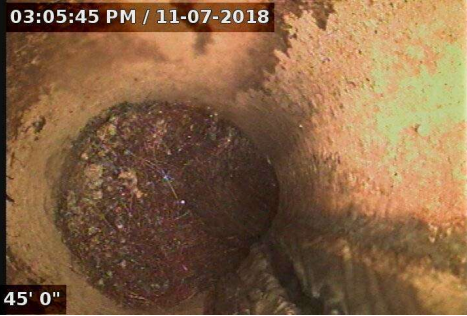
Significant Root Intrusion

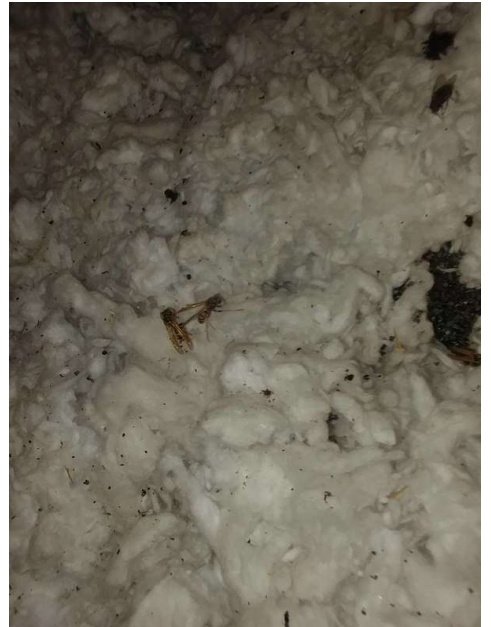
Dead wasps and evidence of wasp nesting were noted at the attic space. It appears likely that there is an ongoing pest intrusion concern. It is recommended to have remediation by a qualified pest control professional, to remove all pests and to seal any potential points of entry.

Contact a qualified pest control specialist.

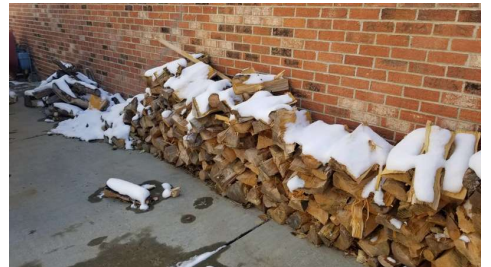
### 17.3.1 RECOMMENDATIONS FOR PREVENTATIVE ACTION

Fire-wood is being stored against the exterior of the home, which can promote insect and pest infestation in and around the structure. It is recommended that the fire-wood be stored away from the home, and that the areas currently obstructed be evaluated when the wood has been removed.

Contact a handyman or DIY project
