SCOTT HOME INSPECTION, LLC

## HOME INSPECTION REPORT

879 4th St  
Berthoud CO 80513

OCTOBER 30, 2018

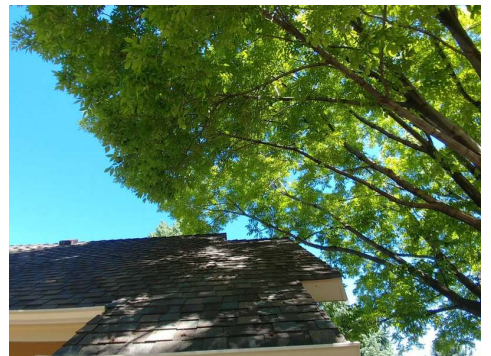
### 17.3.2 RECOMMENDATIONS FOR PREVENTATIVE ACTION

Tree branches are in contact with the exterior of the home and/or roof in areas, which can promote insect and pest access and infestation in and around the structure. It is recommended that these limbs be trimmed away from the home.

Contact a qualified tree service company.

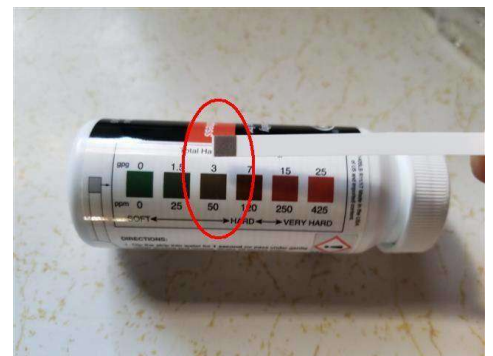
19.5.1 TOTAL HARDNESS - Measured in ppm

### WATER SOFTENER RECOMMENDED

This falls into the **Hard** category on the hardness scale. The term "hardness" was originally used to describe water that is hard to wash in, as hard water will waste a lot of soap and make it difficult to form lathering. This can result in laundry coming out stiff, and dishes/glassware can show spottiness from excessive mineral deposits. When showering or bathing with hard water, you may also experience dry, itchy skin or unmanageable hair. For the house plumbing system, it can result in scale deposits at sinks, tubs, fixtures, and appliances in the home. It is recommended that you consider installing a whole house filtration and water softener system. See this [useful link](#) for more info on water softener systems. Consult with a plumber or filtration system expert for options and costs.

Contact a qualified plumbing contractor.
