HOME INSPECTION

119 Wahane Ln
Bastrop TX 78602

PROPERTY INSPECTION REPORT

Concerning: 119 Wahane Ln, Bastrop TX 78602

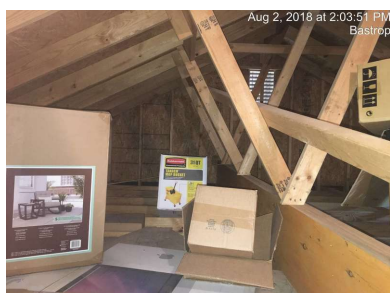
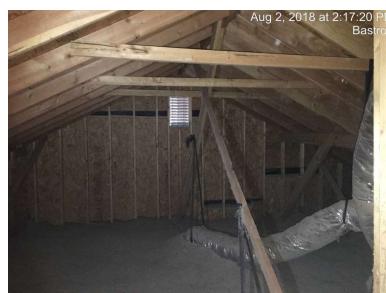
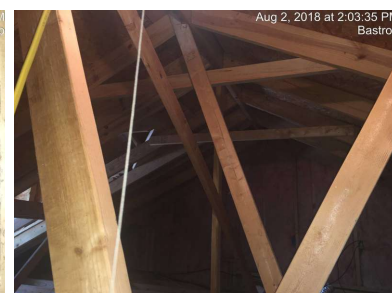
Comments: Hand-Framed Structure:

Attic structure is constructed with hand-framed 2 x wood rafters and ceiling joist. Proper bracing is in place as required. All structural components have been installed according to industry standards and all areas are performing as intended. Service decking has been installed to allow for access to all equipment located in attic space.

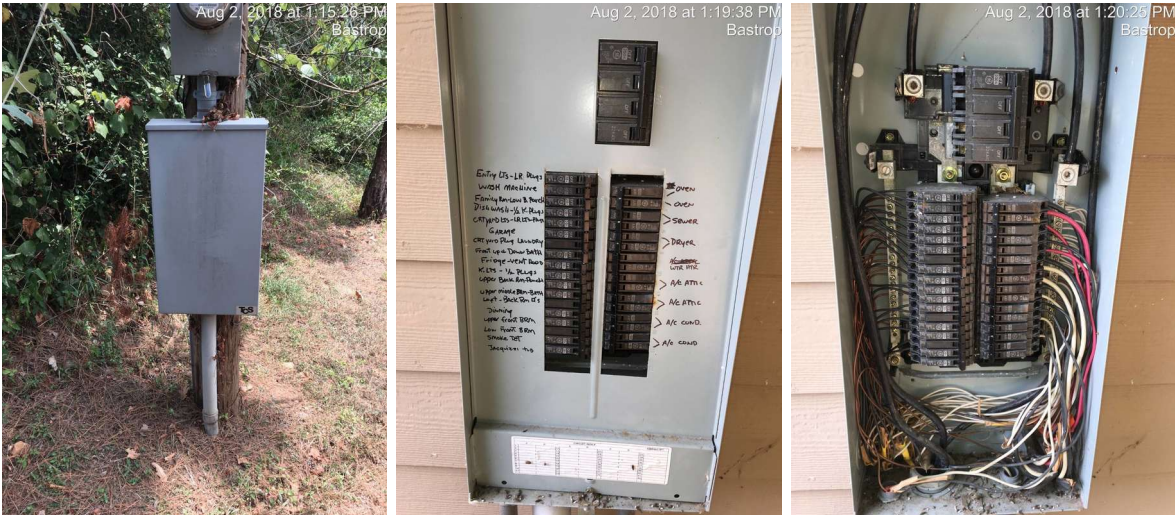
Comments: Incoming Electrical Service:

Electrical service is coming in from a utility pole located to the left of the home. There is a service panel with only a disconnect for the 200-amp service. Incoming service wiring is copper and all connections look good and professionally installed. Sub-panel is located on the exterior wall of the home on the right side. All circuits are clearly labeled, panel is clean and professionally installed.

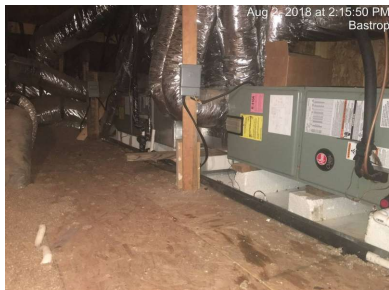
Heating units were inspected but not operated since the ambient outside temperature exceeded 65 degrees.

1: Recommend Servicing/Cleaning

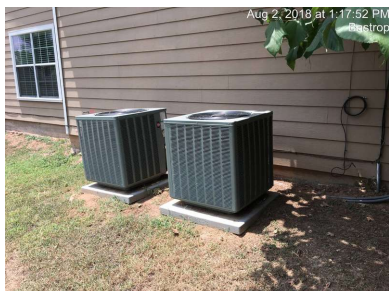
1: Unit Not Level

🔴 Recommendation

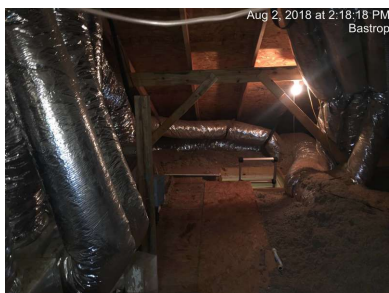
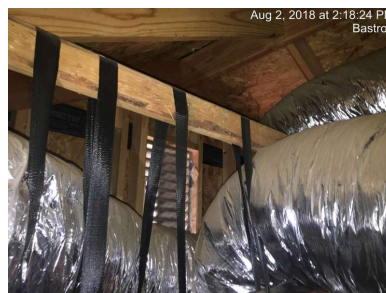
A/C ducts were located in attic space, all A/C ducts that were accessible were checked for air leakage and none was found. Ducts were installed correctly and were performing as intended.

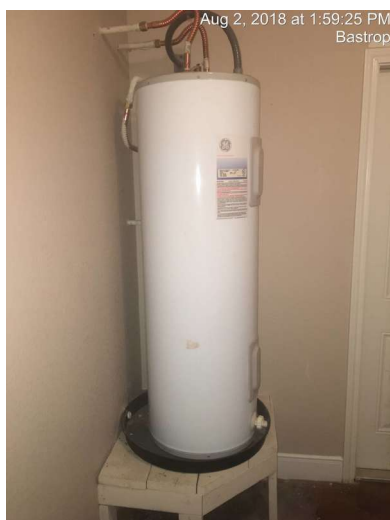
Comments- Electric Unit:

All supply, drain, and electric lines were installed correctly and unit was performing as intended.
