# PROPERTY INSPECTION REPORT

Concerning: 123 Lucky Loop, Round Rock, Texas 78665

By: Josh Molleur - License # 23872

11/19/2019 8:30 am

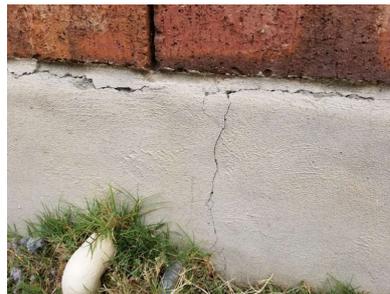
South Side

### 2: Cracking of skim coat

Cracks were observed in the cosmetic skim coat covering the concrete perimeter beam of the foundation. Cracks in the cosmetic skim coat should be repaired as this allows moisture penetration, can create conducive conditions for wood destroying insects and allow further deterioration of the cosmetic skim coat. This should be closely monitored and repaired as needed.

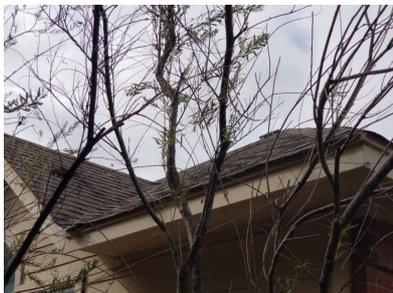
Northeast Side

Foliage was observed touching or in close proximity to the roof covering material. Foliage should be trimmed away from the roof covering material at all times as this can easily damage the roof covering material and exterior wall veneer.

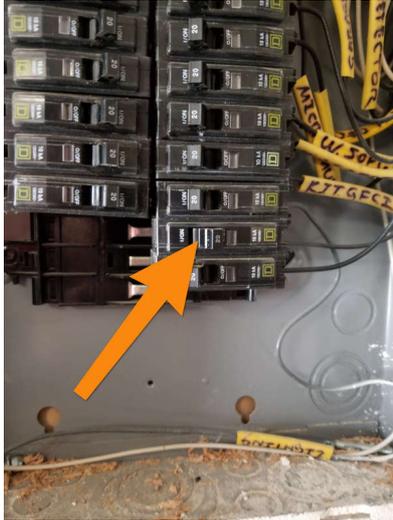
Subpanel

*NOTE - One or more breaker was off:*

One or more of the breakers were in the off position at the time of the inspection.

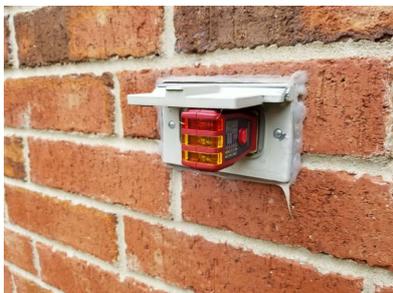
North Side

➔ Further Evaluation Recommended

One or more electrical receptacle was found to not function. It is recommended to have a qualified licensed electrician further investigate and repair or replace as needed.

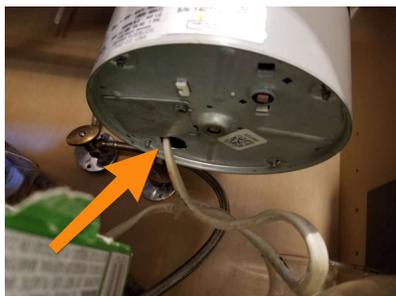
The electrical conductor entering the food waste disposer was found to not be properly protected. A bushing with a clamp should be installed to help minimize the food waste disposers housing from cutting the electrical conductor.

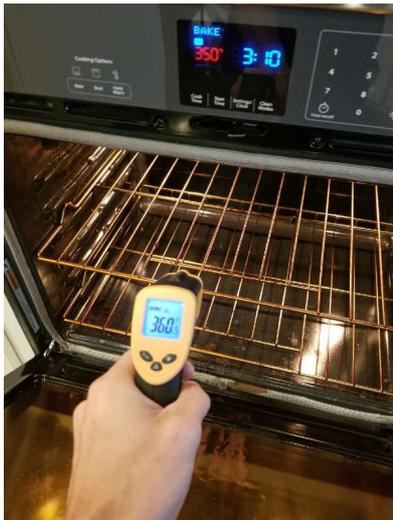
*Oven temperature reading: 360 -*

The recommended temperature differential is +/- 25 degrees when set to 350 degrees. At the time of the inspection the oven reading was within the recommended range.

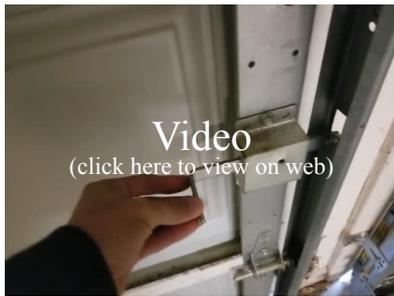
The manual locks for the garage door were found to not be disabled. When an automatic garage door opener is installed, the manual door locks should either be disabled or removed. This is to prevent damage to the garage door, garage door hardware and automatic garage door opener in the event that the door was locked and the garage door opener engaged.

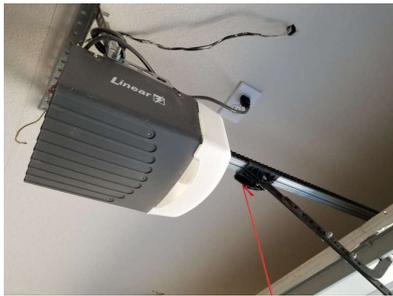
Left Garage Door

The automatic garage door openers light was found to be inoperative. This condition may need a bulb replacement, fixture repair or a fixture replacement.

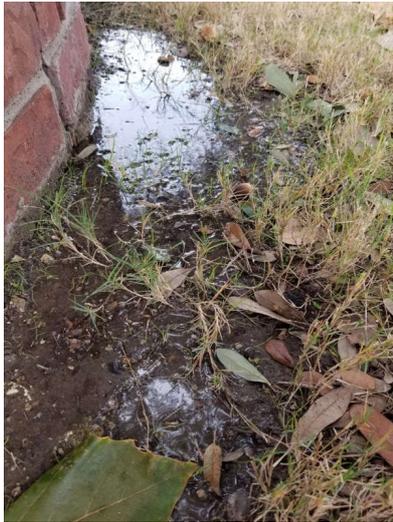
Zone 2 at Flowerbed

A damaged sprinkler head was found in zone 2. It is recommended that an irrigation specialist repair of the affected heads.

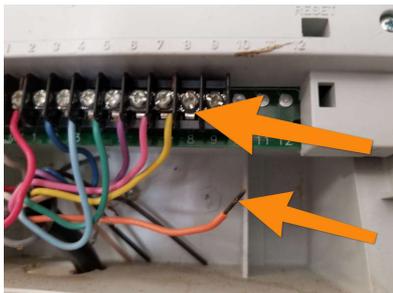
**2: Zone 8 not connected**

Zone 8 was found to not be connected to the controller and was found to not operate at the time of the inspection.
