DDP RECON REPORT COPY

Sample Recon Report - 691 San Marcos St
Giddings, TX 78942

APRIL 29, 2021

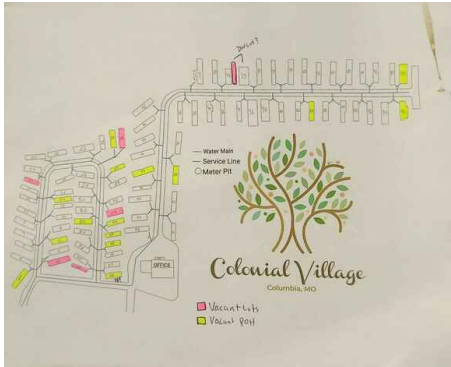
Total lots:132
Number of vacant lots:3
Number of lost lots: **4**
Number of single wide: 109
Number of double wide: 2
Number of RVs: 22

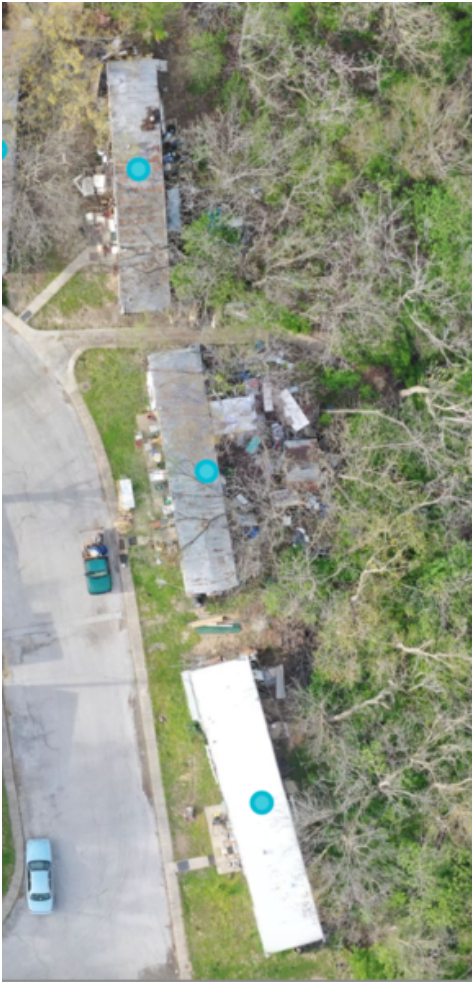
2.1.1 Lot Usability

The hillside that runs to the river behind is eroding. Lots 20, 21, 22. To correct, dozens of trees will need to be removed and a retention wall will need to be built at least ten foot from the home to provide a setback - so that homes do not fall off the cliff.

Estimated Cost
\$20,000 - \$60,000

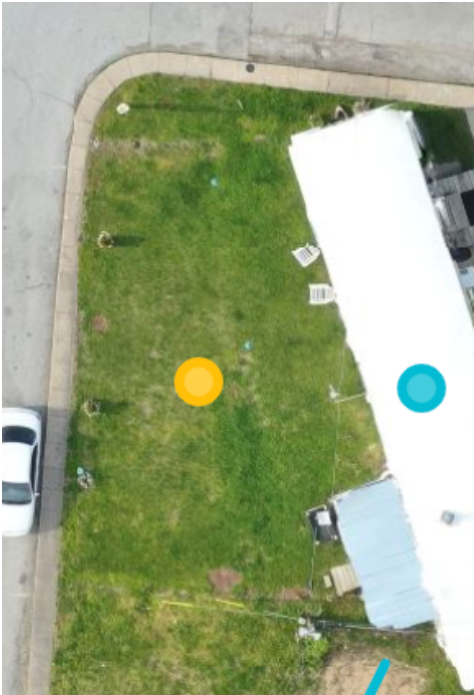
2.1.2 Lot Usability

LOST LOT (SHORT/NARROW)

MEDIUM: 10K ~ 50K Est.

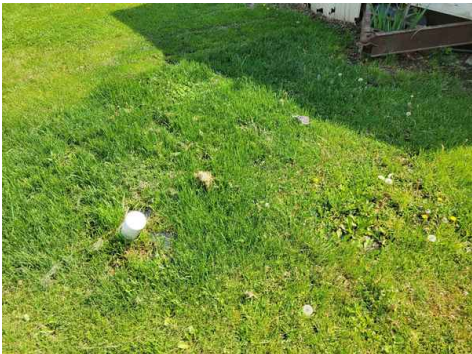
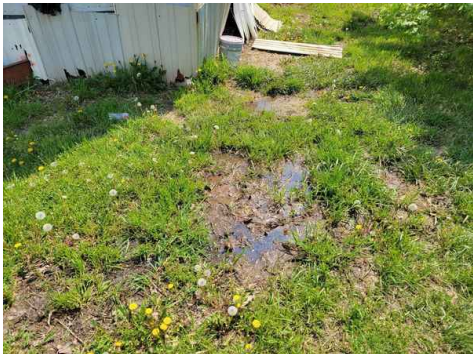
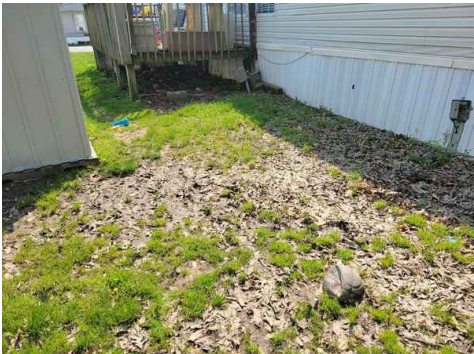
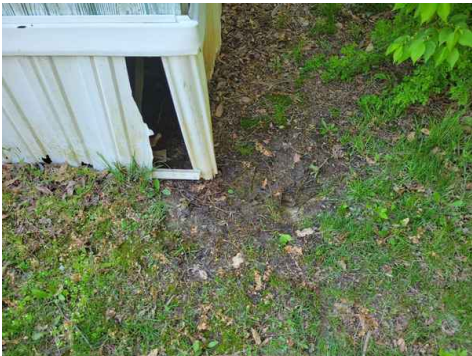
7.1.2 Conditions

GROUND DISCHARGE

\$50 - \$250

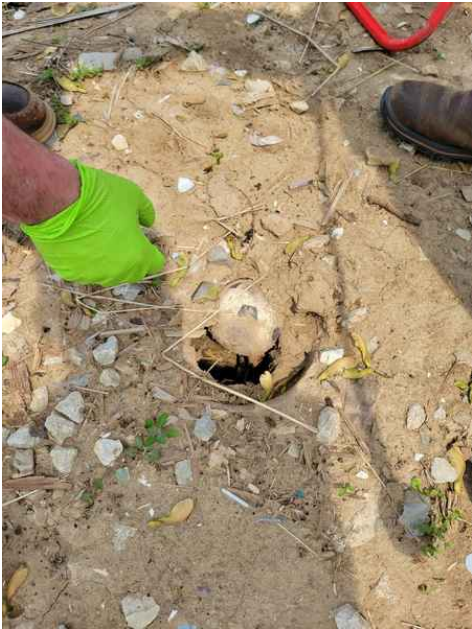
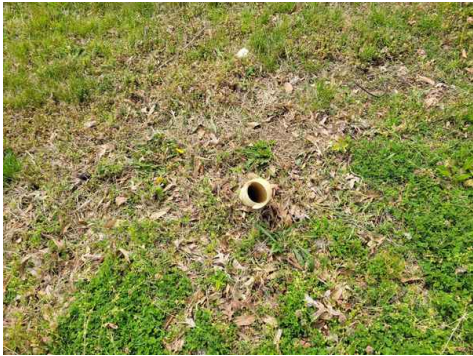
Amount of cleanouts observed open: 2

Non capped cleanouts can result in lines becoming corroded, broken, and filled requiring maintenance or replacement.

This is considered a low cost maintenance item. Remove any debris found and cap all cleanouts.

Jetting is recommended to flush out debris. Hydro jetting industry average: \$350 (small job) to \$2,000 (over 100 lot park). Note, hydro jetting is a temporary fix if debris has caused damage to the lines.

Estimated Cost
\$350 - \$2,000

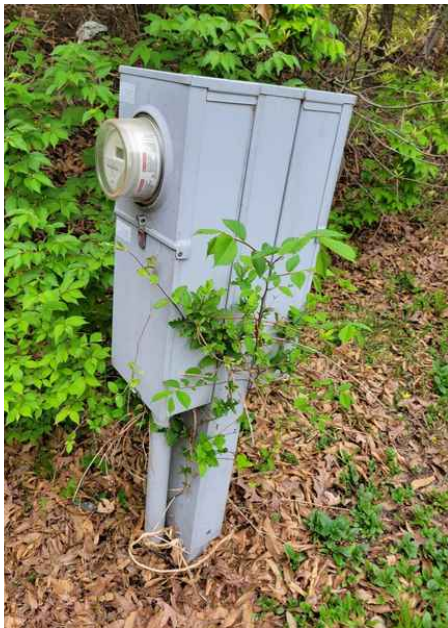
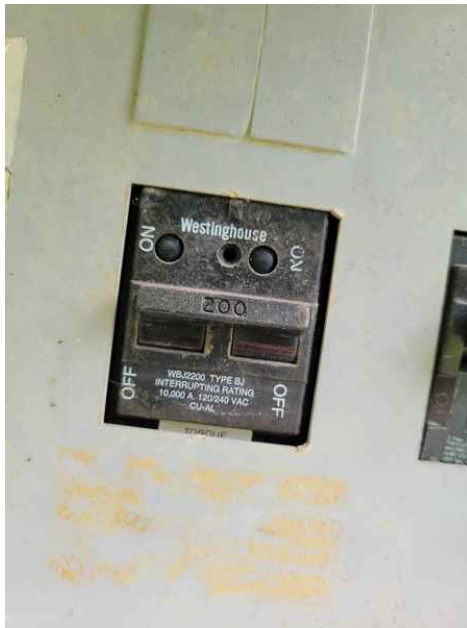
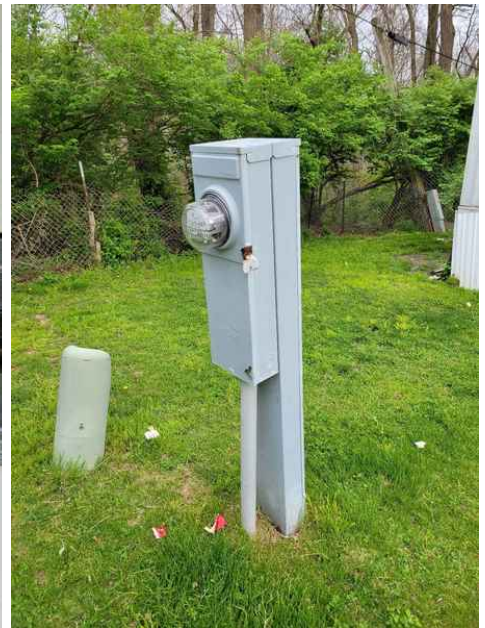
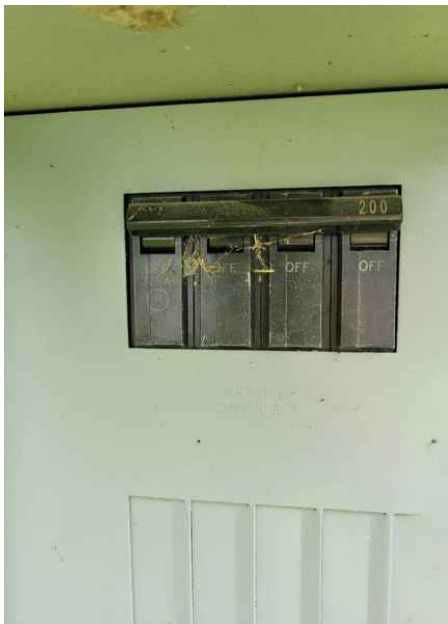
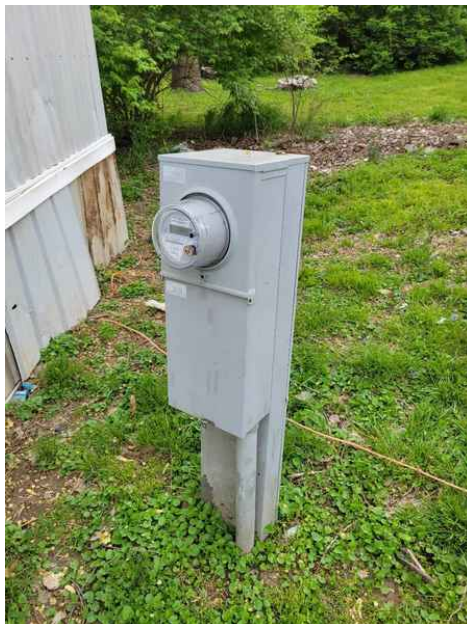
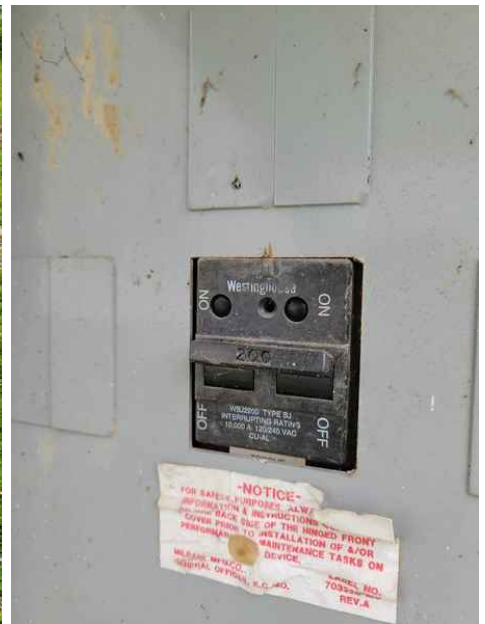
Summary: The park had fair electrical overall. The north circular portion of the park was 90% 100 amp and 10% 200 amp. The south portion of the park (L shaped) was 90% 200 amp and 10% 100 amp. The condition of the pedestals and boxes were 85% good condition and 15% bad condition. Most of the 200 amp were new, however there were ~4 bad pedestals that were bent or leaning. The 100 amp pedestals were older and constituted most of the bad boxes.

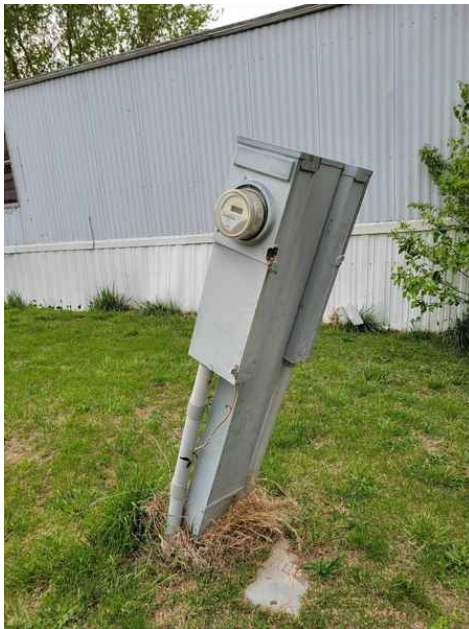
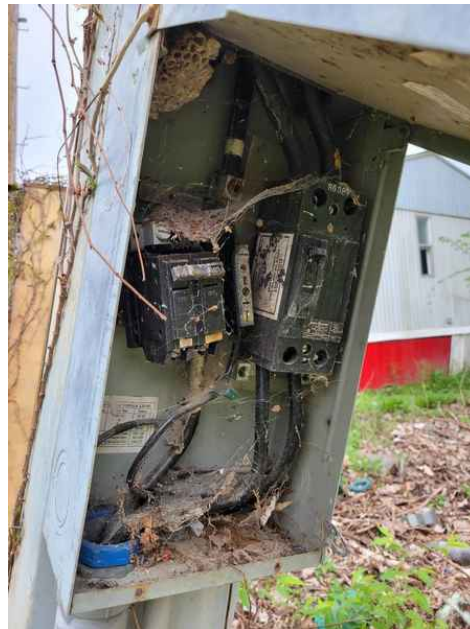
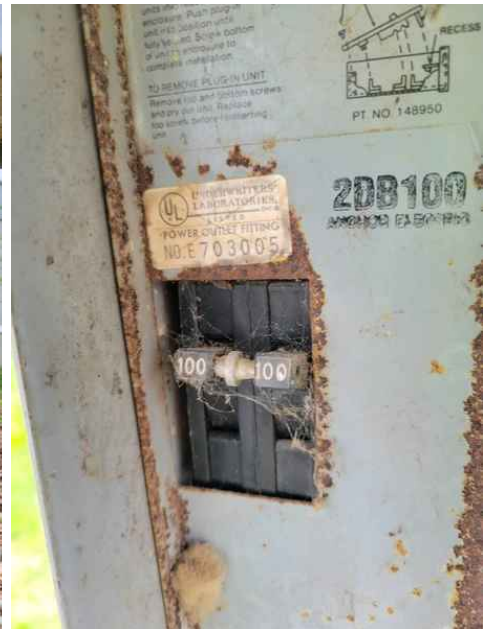
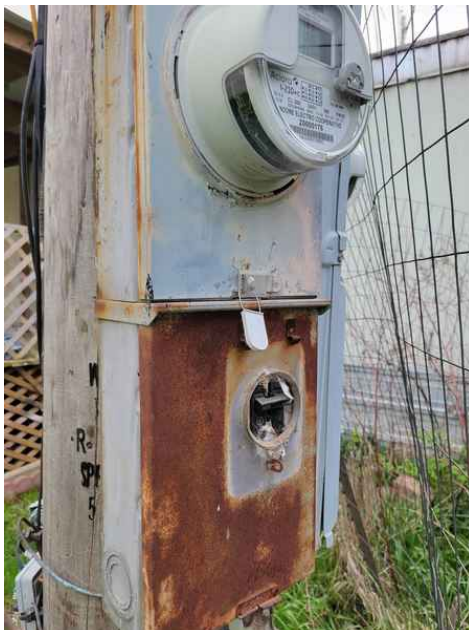
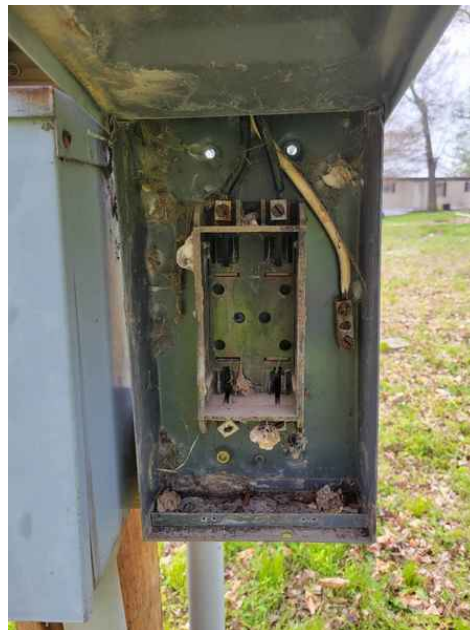
**BAD BOX(ES): HAZARD OR OTHER**

This many bad boxes were observed overall. **About: 15%.** Reference 'vacant lot audit' for any vacant lot electric conditions.

\$1,000 - \$2,500

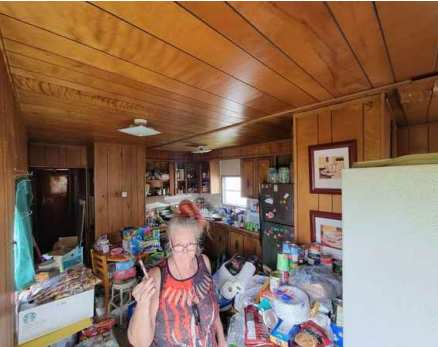
LOT 3, Occupied: Interior

Description
Bad Condition, Smell/Odor,
Hoarder

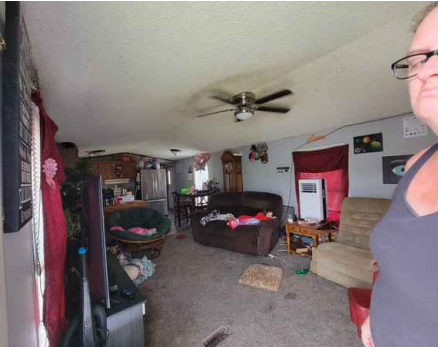
LOT 74, Occupied: Interior

Description
Average Condition

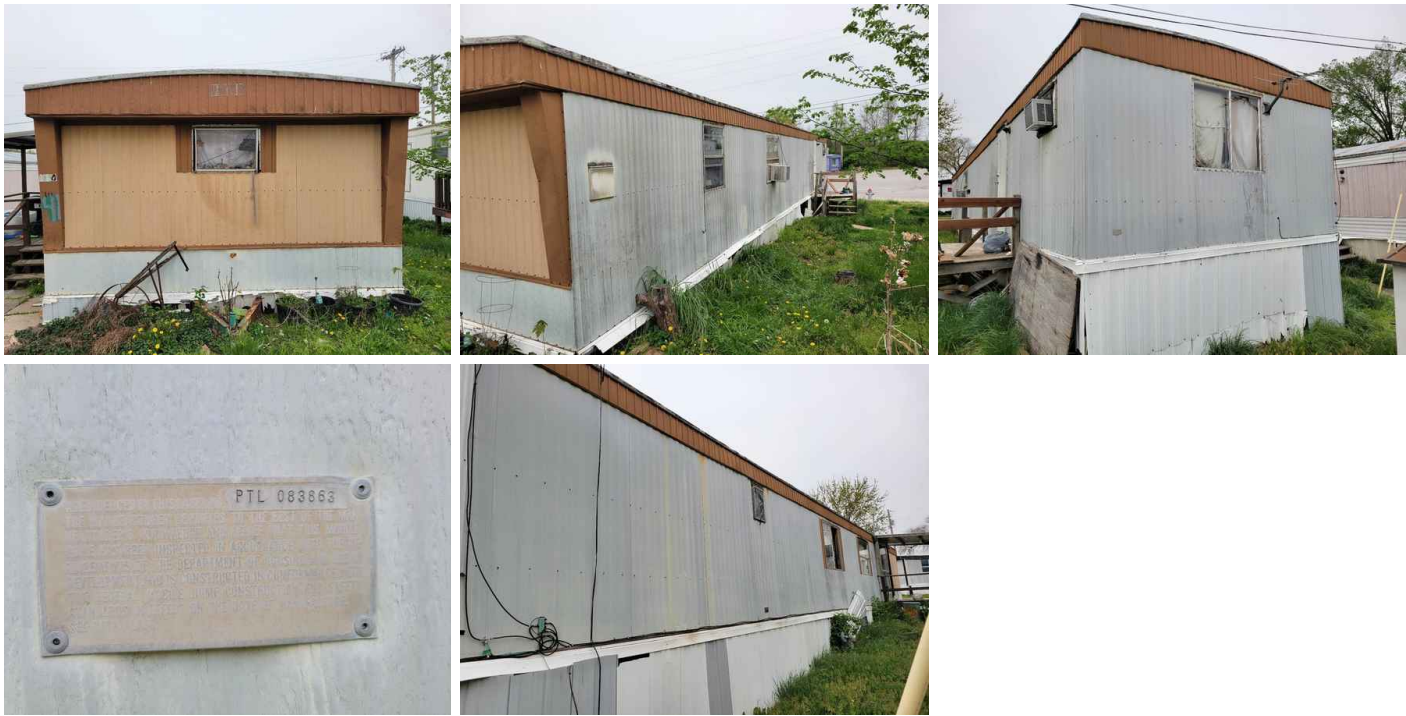
LOT 41, Occupied: Exterior Description
Poor Condition, Window Units, HUD Label Visible

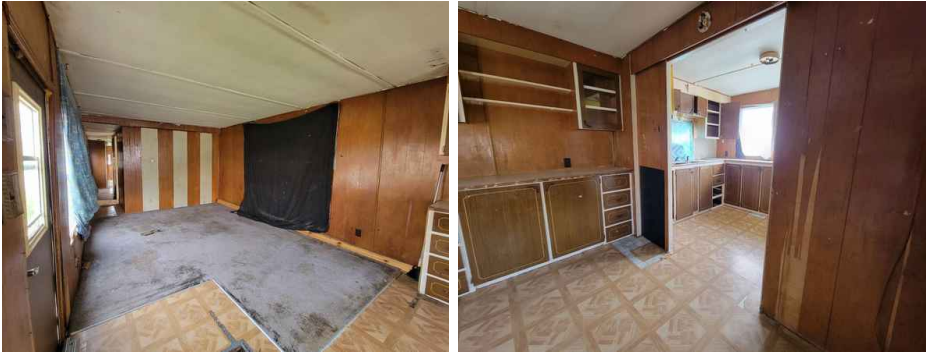
LOT 6, Vacant: Interior Description
Bad Condition, Smell/Odor, No Entry

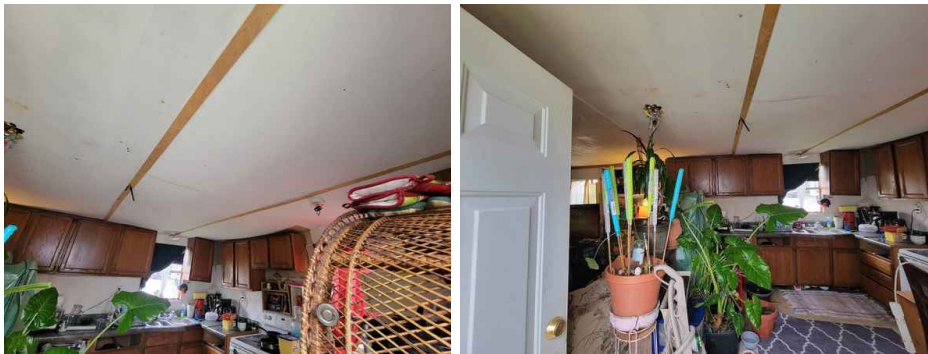
LOT 71, Occupied: Interior Description
Average Condition

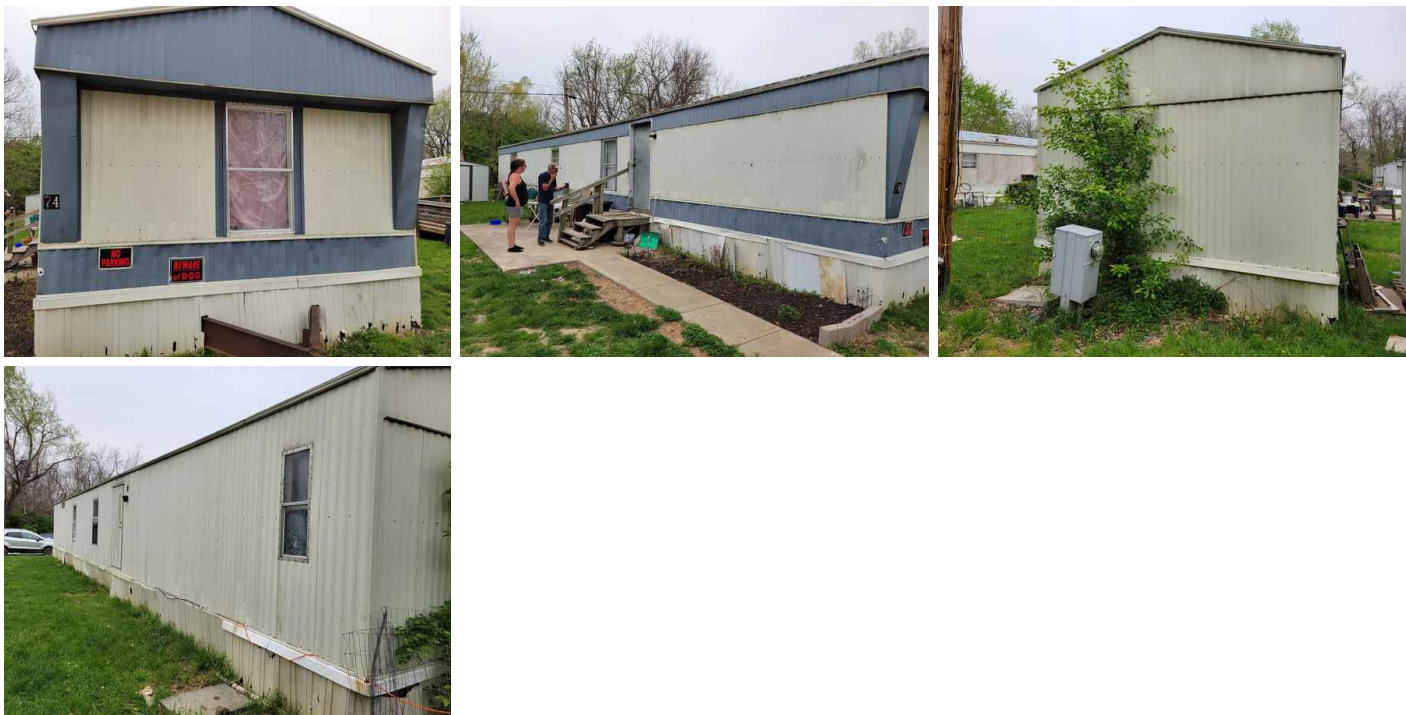
LOT 74, Occupied: Exterior Description
Average Condition

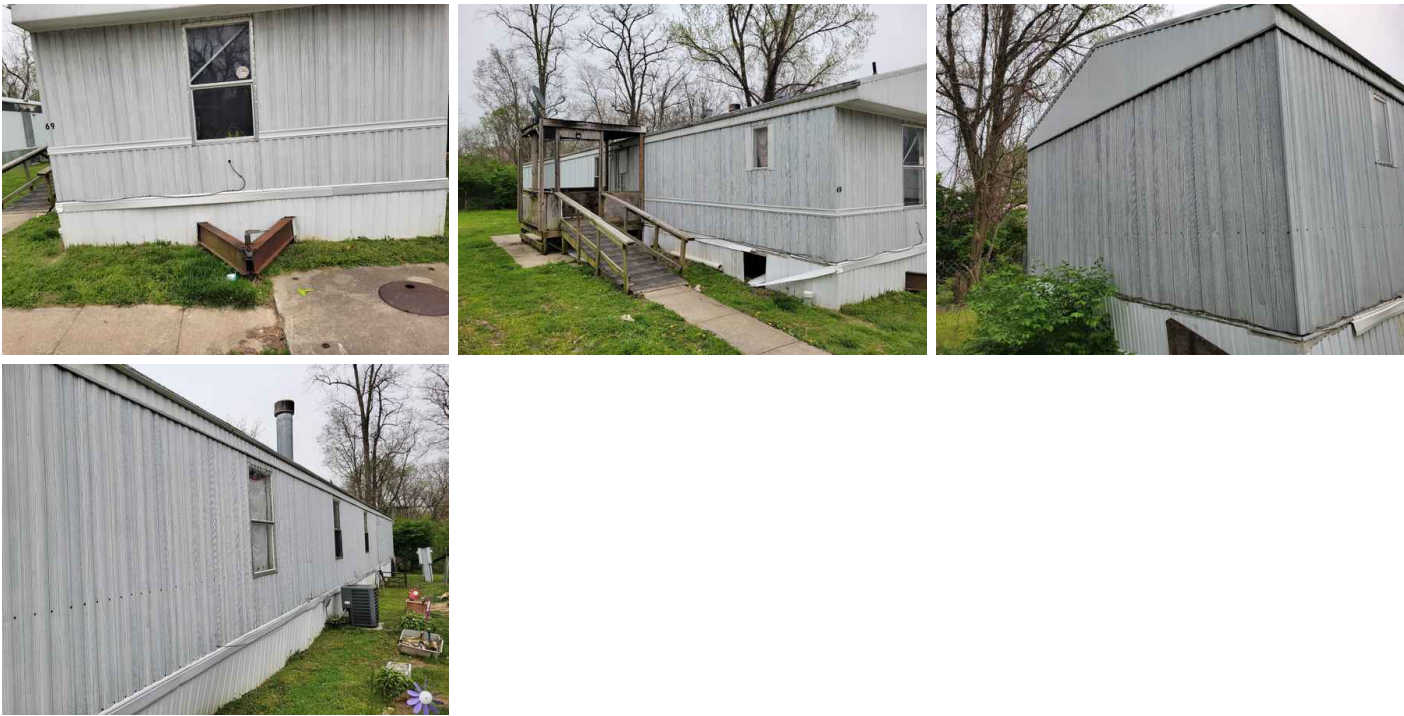
LOT 69, Occupied: Exterior Description
Average Condition

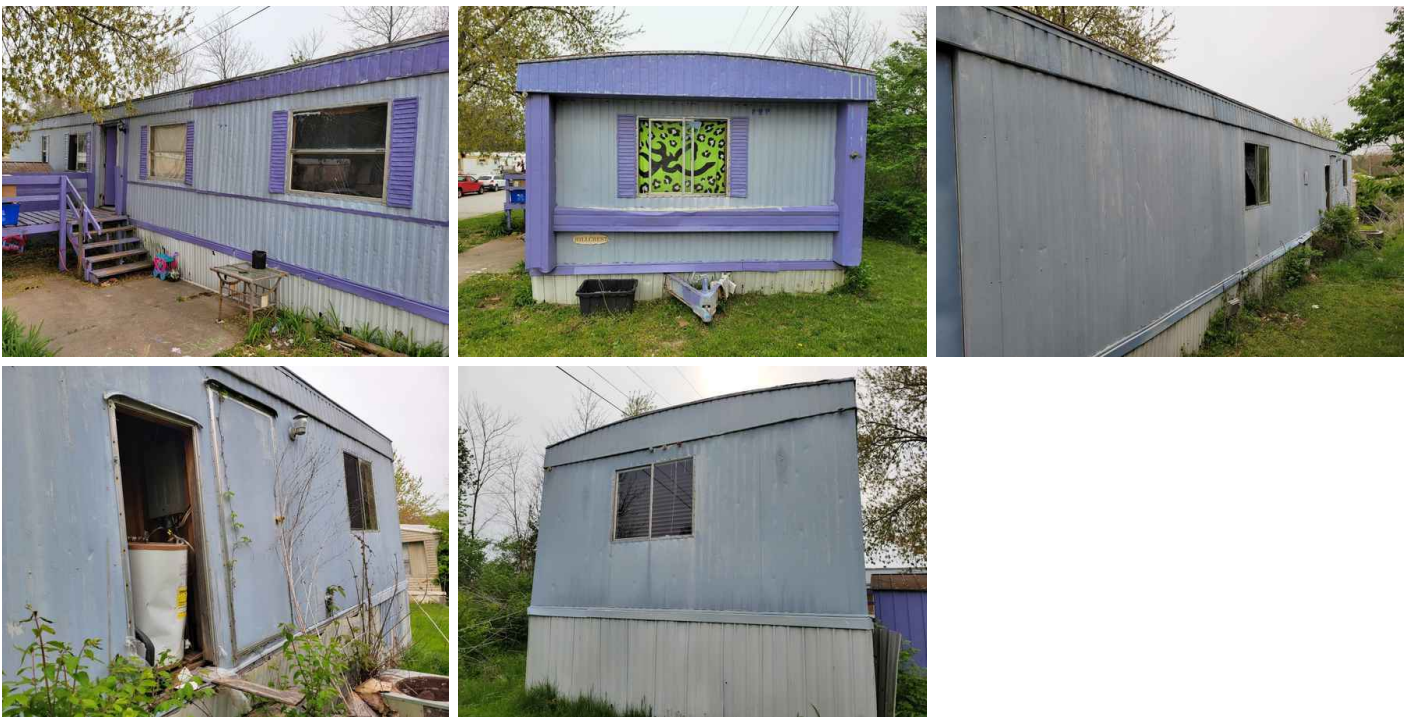
LOT 62, Occupied: Exterior Description
Average Condition

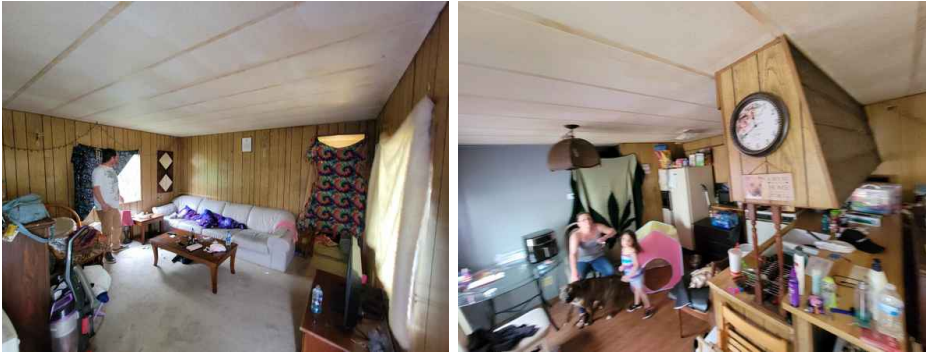
LOT 62, Occupied: Interior Description

Average Condition, Smell/Odor

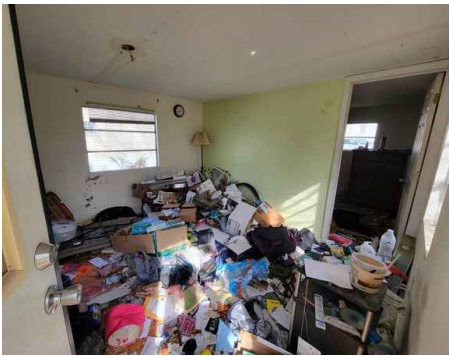
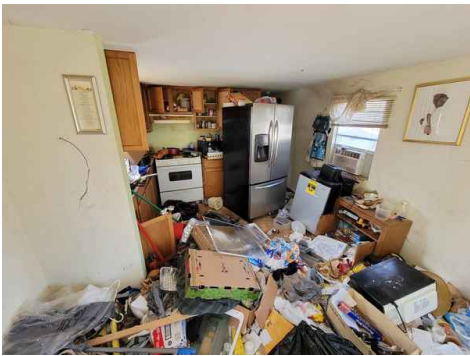
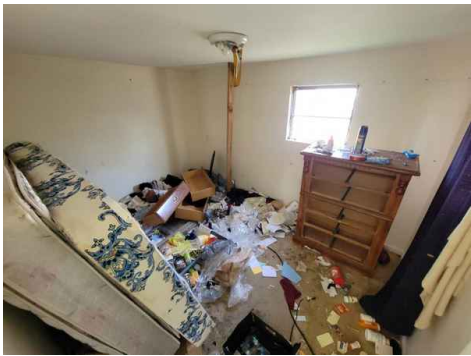
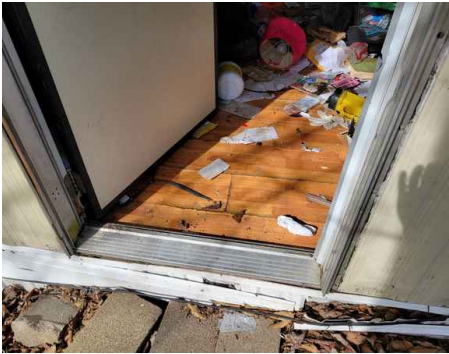
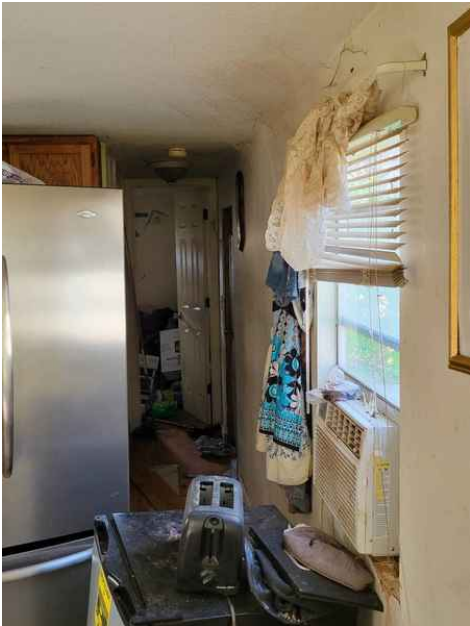
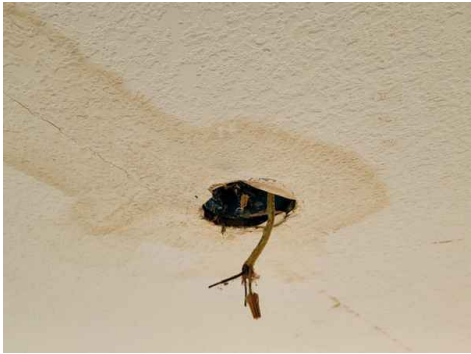
LOT 27, Vacant: Interior Description
Bad Condition, Smell/Odor, Hoarder

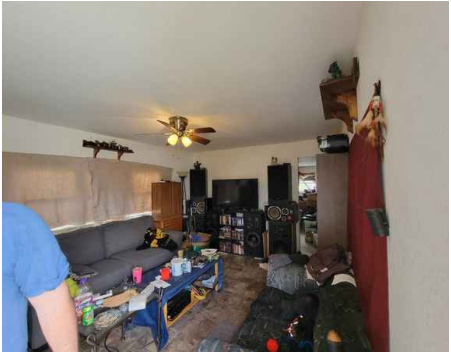
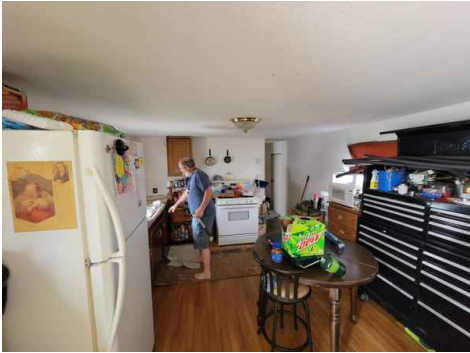
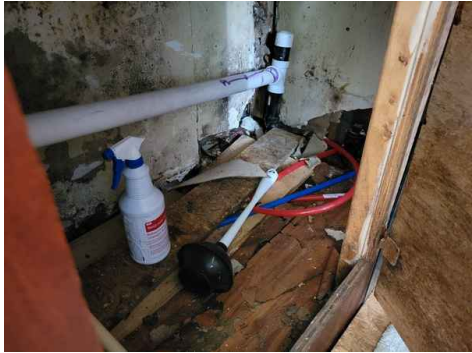
LOT 30, Occupied: Interior Description
Average Condition, Smell/Odor

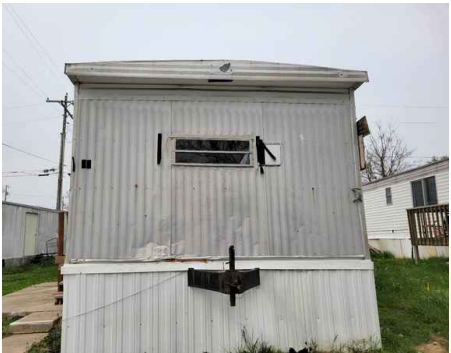
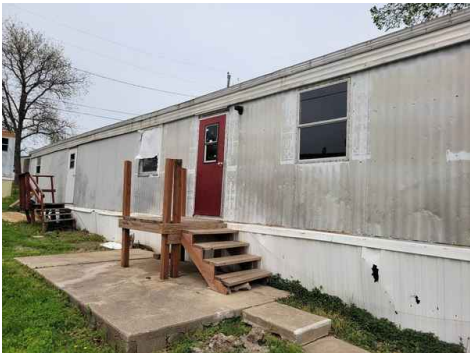
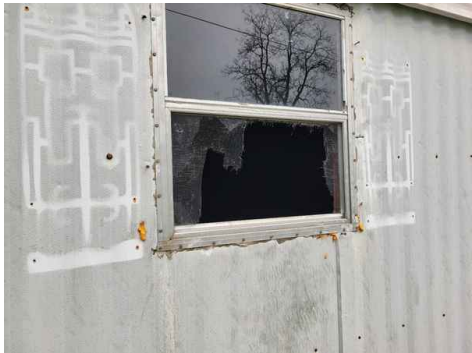
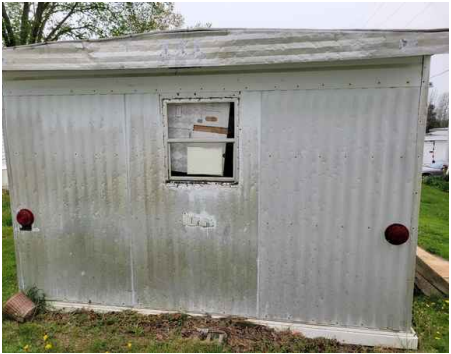
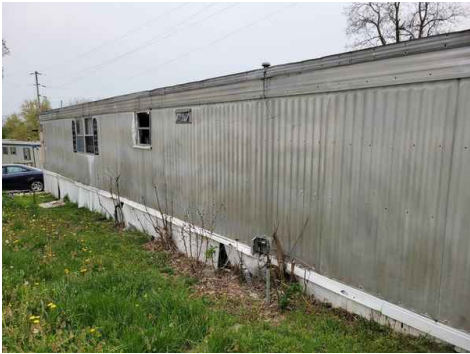
LOT 34, Vacant: Exterior Description
Poor Condition

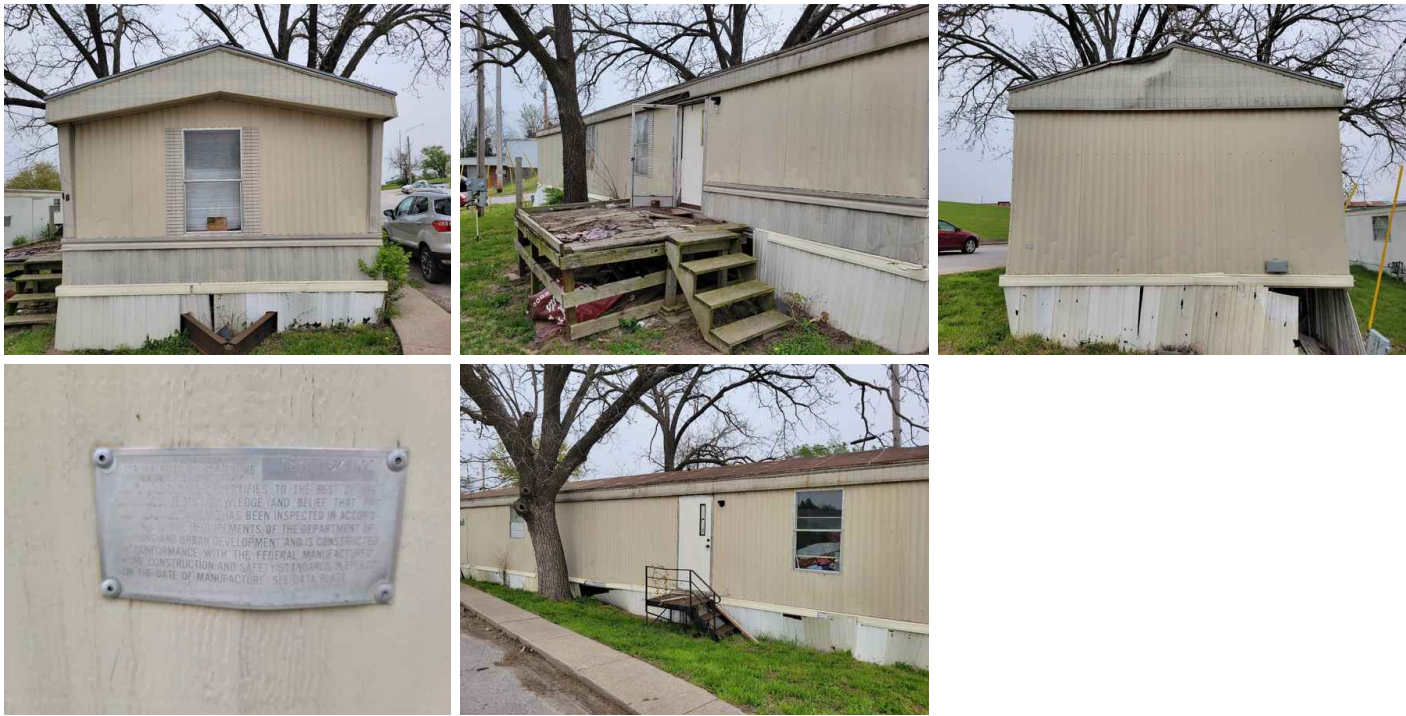
LOT 44, Vacant: Exterior Description
Average Condition, HUD Label Visible

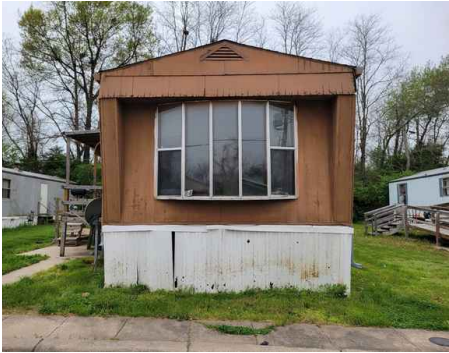
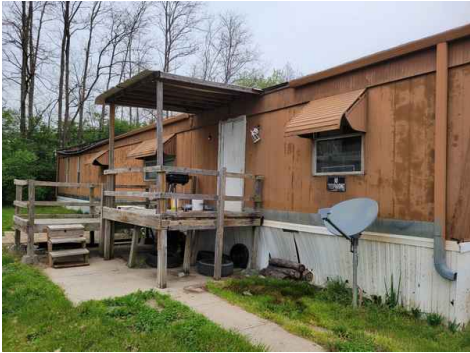
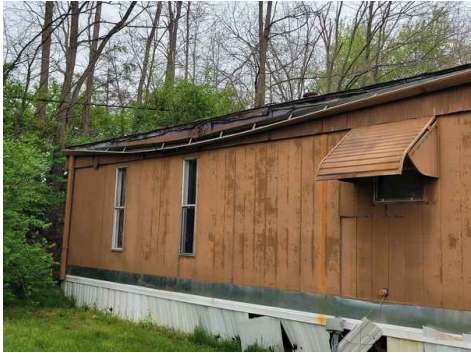
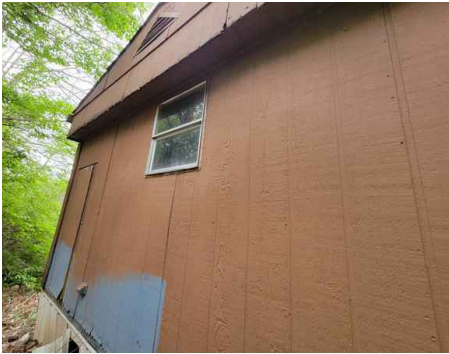
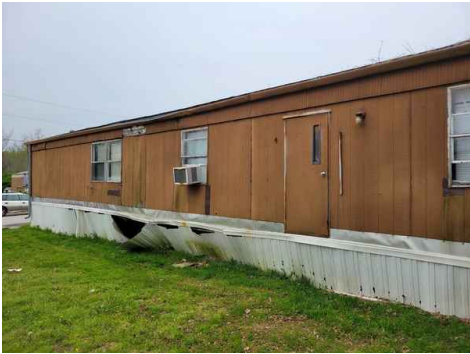
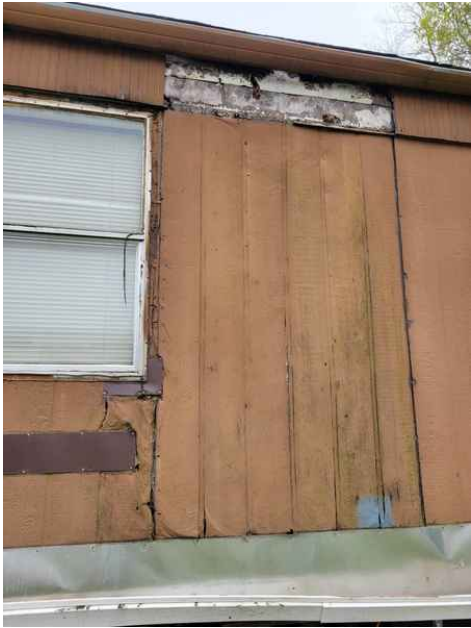
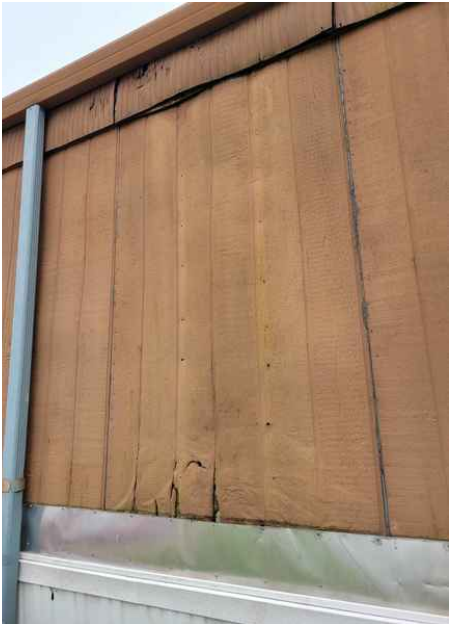
LOT 84, Vacant: Exterior Description
Poor Condition

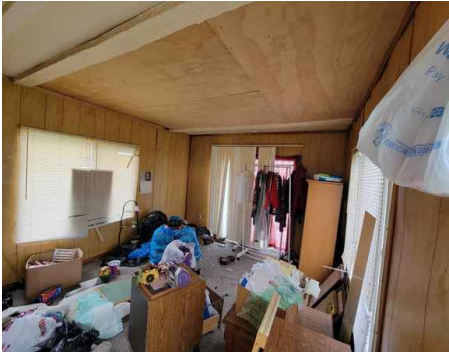
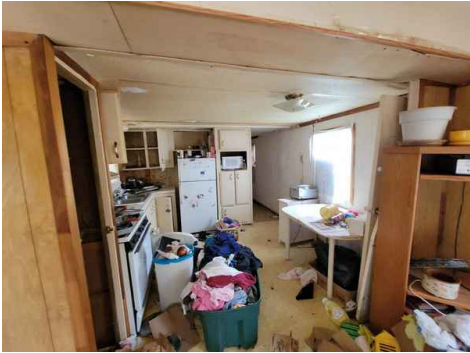
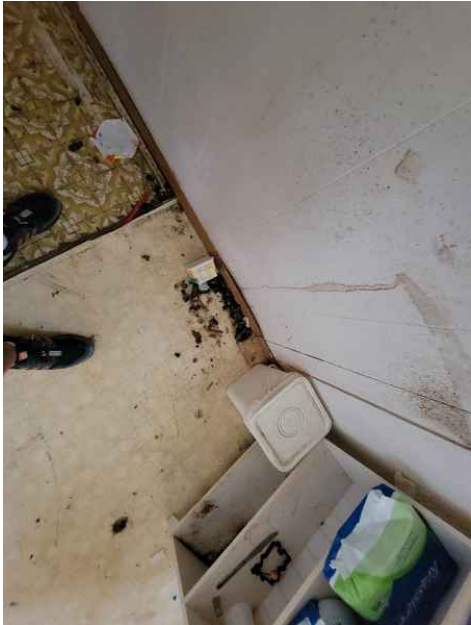
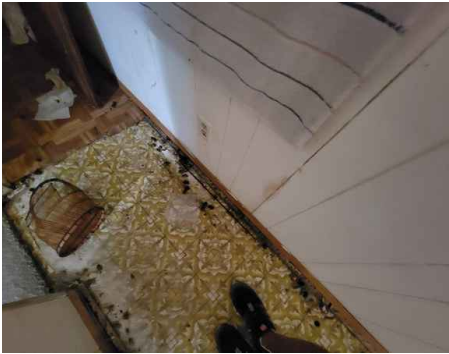
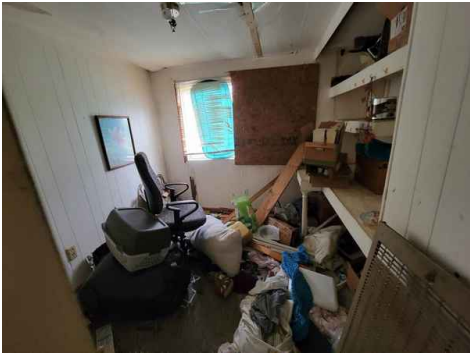
LOT 96, Vacant: Interior Description
Bad Condition, Smell/Odor

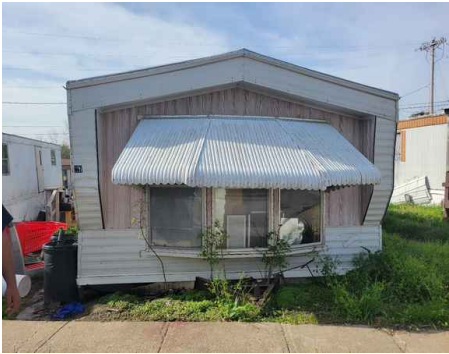
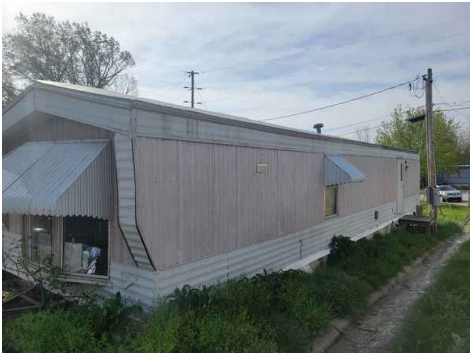
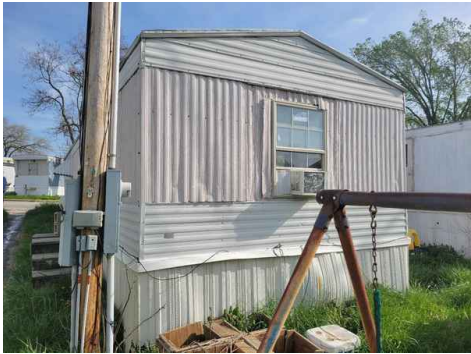
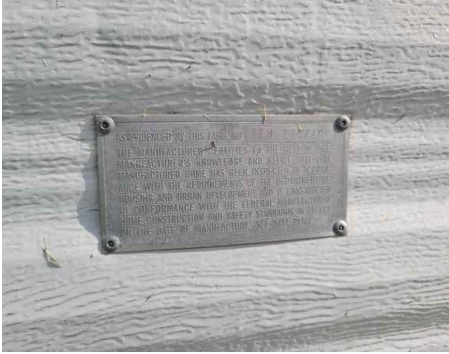
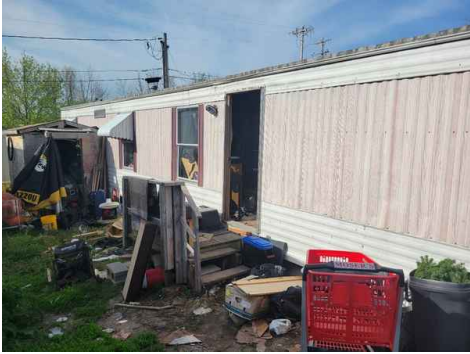
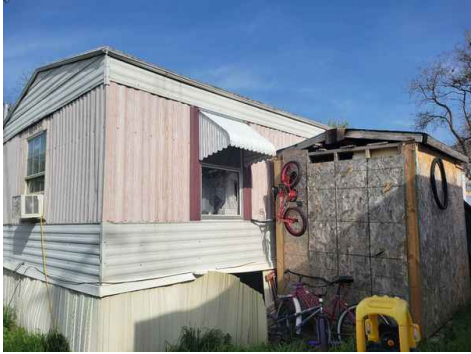
LOT 39, Vacant: Exterior Description
Poor Condition, HUD Label Visible

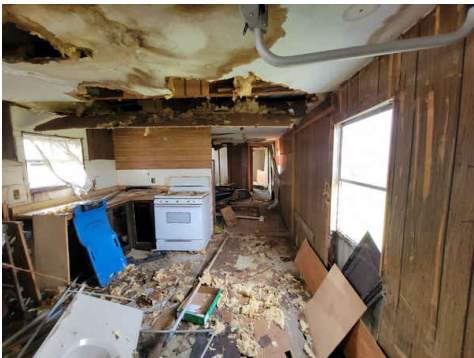
INT/EXT: LEAK OR MOLD

Leak or mold was observed. Seek a qualified vendor to determine severity and estimate.

LOW: Under 10K Est.

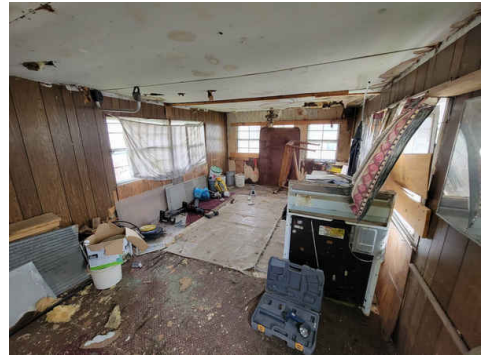
10.2.2 LOT 1, Vacant

INT: FLOORING PROBLEM

Flooring problem was observed. See 'Standards of Practice' for industry average details (per square foot).

LOW: Under 10K Est.

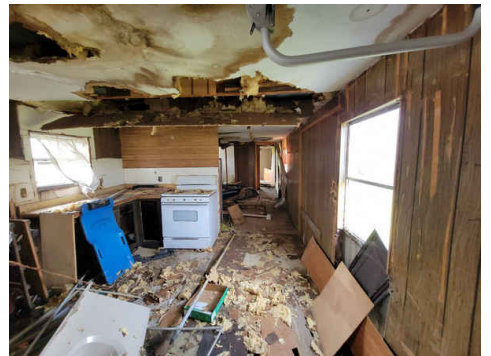
10.2.3 LOT 1, Vacant

INT: WALL OR CEILING

Wall or ceiling problem was observed. Seek qualified rehabber for estimate.

LOW: Under 10K Est.

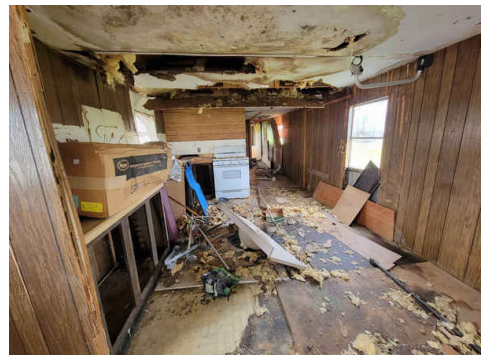
10.2.4 LOT 1, Vacant

INT: MISSING APPLIANCES

Appliances were missing. See 'Standards of Practice' for average appliance costs.

LOW: Under 10K Est.

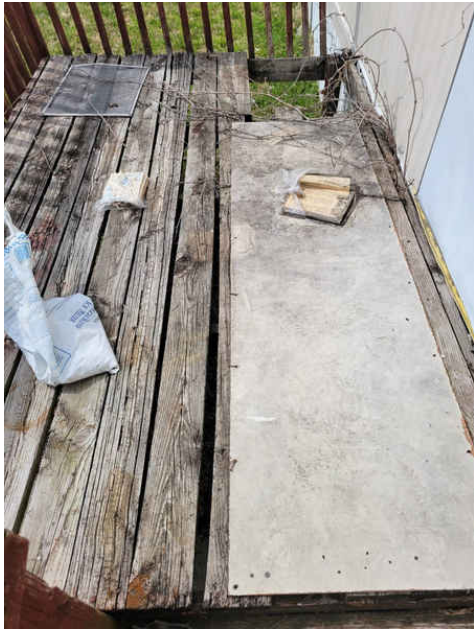
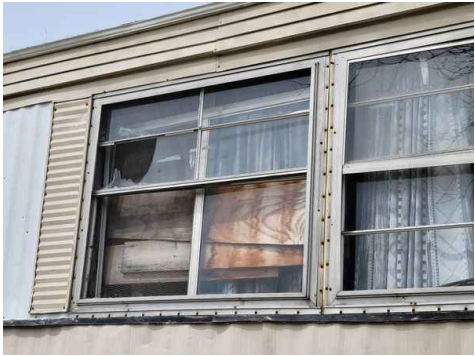
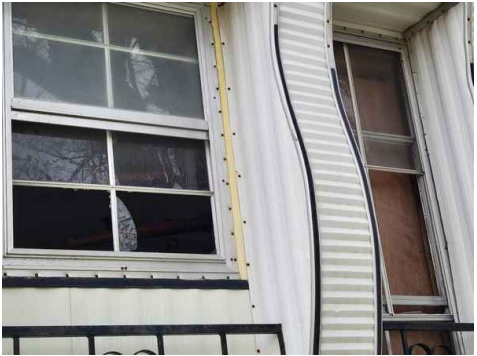
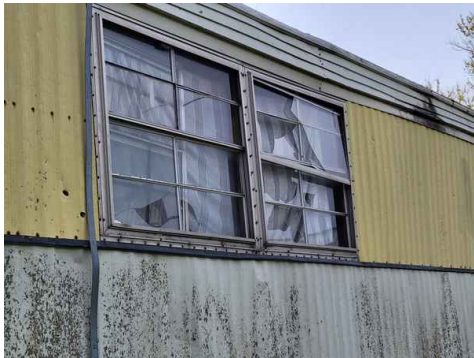
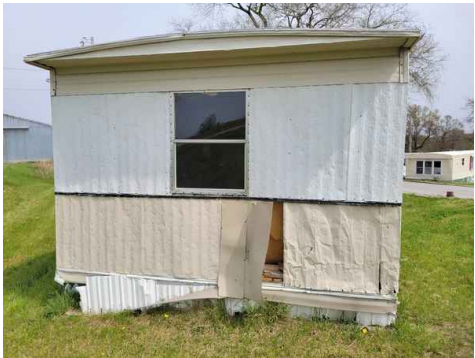
10.2.5 LOT 1, Vacant

EXT: BROKEN DOOR/WINDOW/DECK

A broken window, door, or deck was observed. Average replacement cost:

LOW: Under 10K Est.

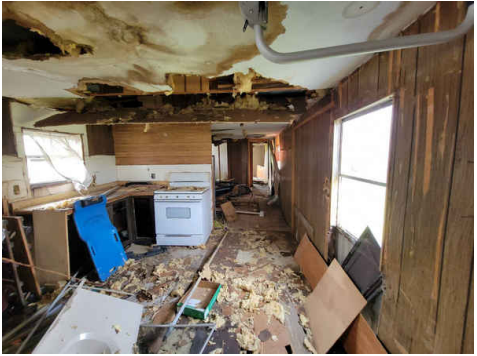
10.2.6 LOT 1, Vacant

SCRAP HOME

This home is considered to be 'scrap' condition. Cost amount assumes that a value was given to home for home to be usable/habitable. Possible costs may include home removal and home purchasing.

MEDIUM: 10K ~ 50K Est.

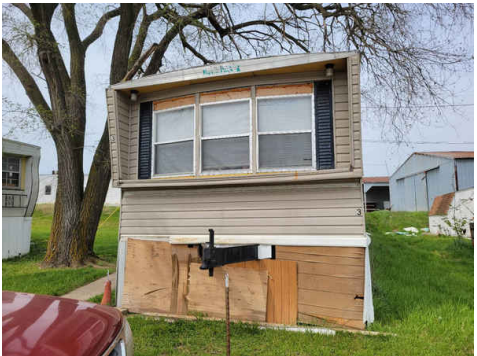
10.3.1 LOT 3, Occupied

EXT: BAD/MISSING SKIRTING(OVER 10%)

Note, it is not rare to see a single panel missing due to maintenance/meter access. Bad skirting or more than one panel missing was observed.

LOW: Under 10K Est.

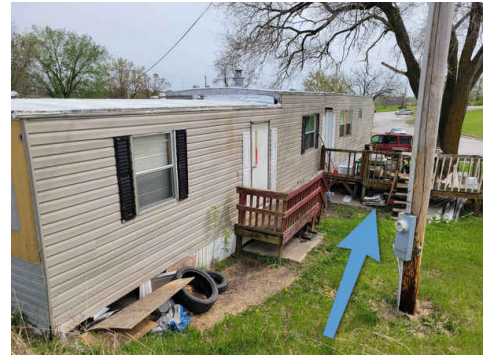
10.3.2 LOT 3, Occupied

**EXT: BROKEN
DOOR/WINDOW/DECK**

A broken window, door, or deck was observed. Average replacement cost:

- Door: \$478-956
- Window: \$175-\$650
- Decks: \$15-\$30 p/sq/ft: 10 x 10: \$1,500 - \$3,000

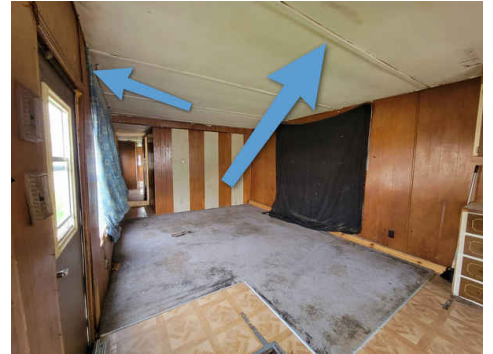
10.5.1 LOT 6, Vacant

INT/EXT: LEAK OR MOLD

Leak or mold was observed. Seek a qualified vendor to determine severity and estimate.

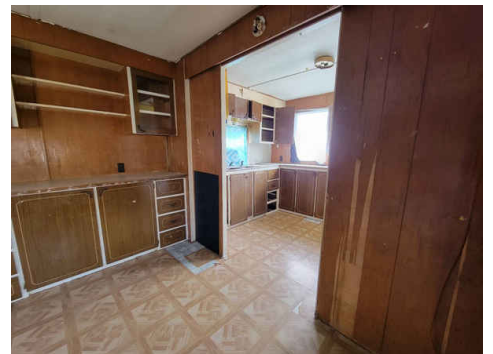
10.5.2 LOT 6, Vacant

INT: MISSING APPLIANCES

Appliances were missing. See 'Standards of Practice' for average appliance costs.

Estimated Cost
\$1,735 - \$3,470

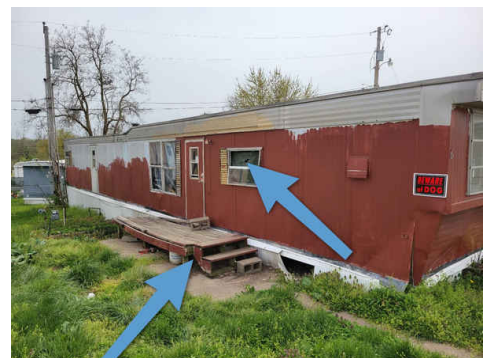
10.5.3 LOT 6, Vacant

**EXT: BROKEN
DOOR/WINDOW/DECK**

A broken window, door, or deck was observed. Average replacement cost:

- Door: \$478-956
- Window: \$175-\$650
- Decks: \$15-\$30 p/sq/ft: 10 x 10: \$1,500 - \$3,000

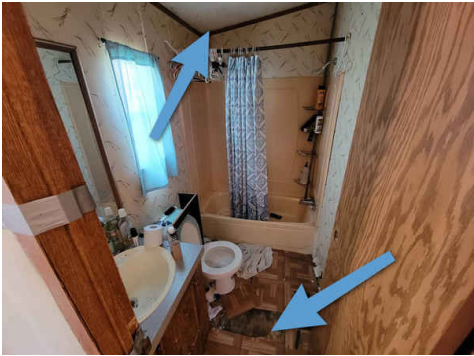
10.6.1 LOT 94, Occupied

INT/EXT: LEAK OR MOLD

Leak or mold was observed. Seek a qualified vendor to determine severity and estimate.

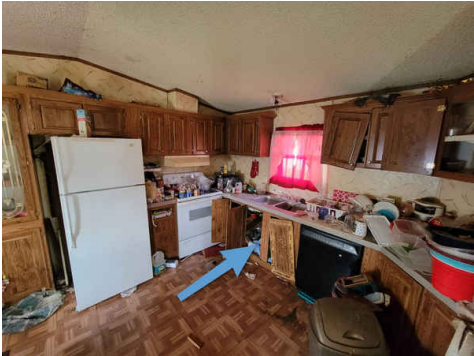
10.6.2 LOT 94, Occupied

INT: BUG/RODENT INFESTED

Bug/rodent infestation was observed. Seek a qualified vendor to determine severity and estimate.

LOW: Under 10K Est.

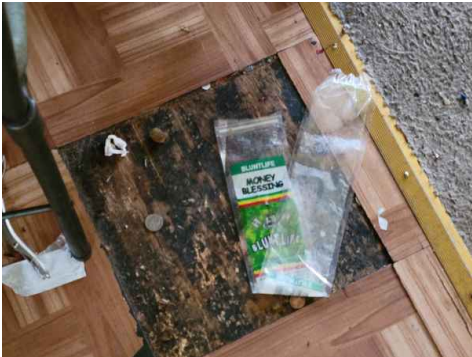
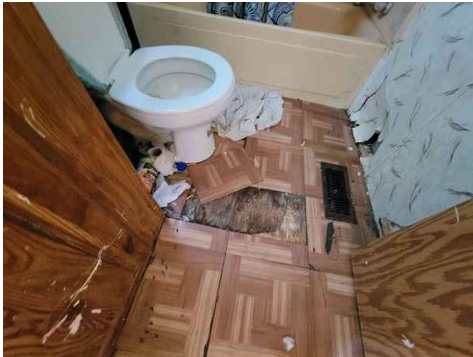
10.6.3 LOT 94, Occupied

INT: FLOORING PROBLEM

Flooring problem was observed. See 'Standards of Practice' for industry average details (per square foot).

LOW: Under 10K Est.

Estimated Cost
\$7 - \$15

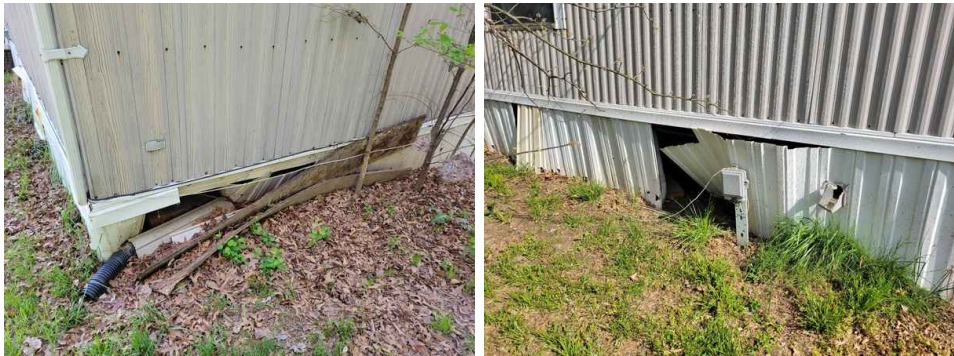
10.6.4 LOT 94, Occupied

EXT: BAD/MISSING SKIRTING(OVER 10%)

Note, it is not rare to see a single panel missing due to maintenance/meter access. Bad skirting or more than one panel missing was observed.

Estimated Cost
\$400 - \$4,000

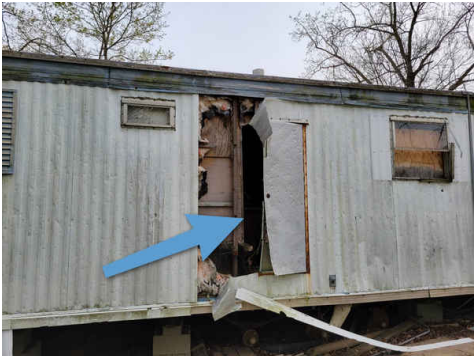
INT/EXT: LEAK OR MOLD

LOW: Under 10K Est.

Leak or mold was observed. Seek a qualified vendor to determine severity and estimate.

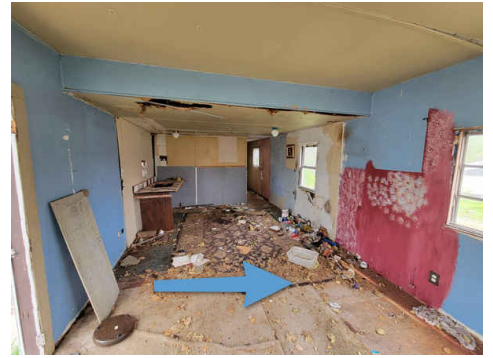
10.7.2 LOT 24, Vacant

Flooring problem was observed. See 'Standards of Practice' for industry average details (per square foot).

Estimated Cost

\$7 - \$15
