DDP RECON REPORT COPY

Sample Recon Report - 691 San Marcos St
Giddings, TX 78942

APRIL 29, 2021

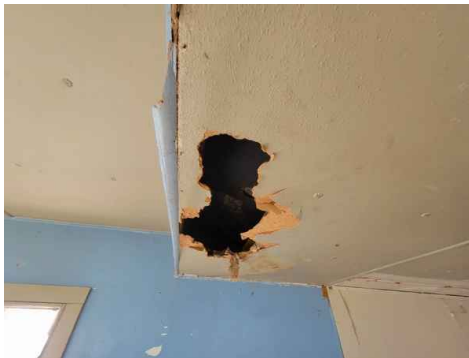
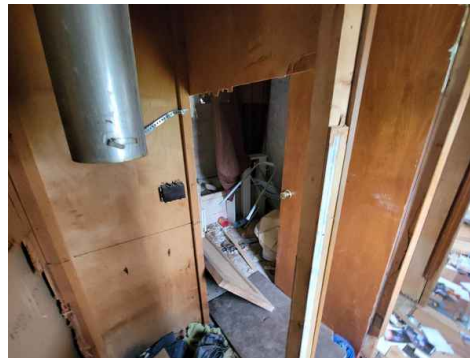
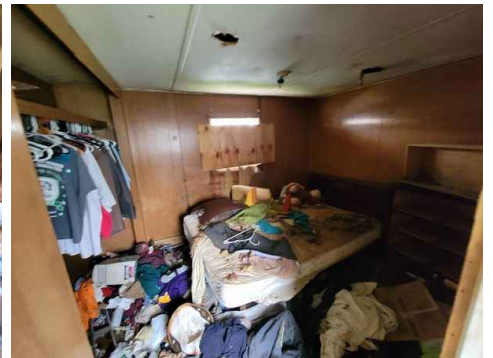
INT: WALL OR CEILING

Wall or ceiling problem was observed. Seek qualified rehabber for estimate.

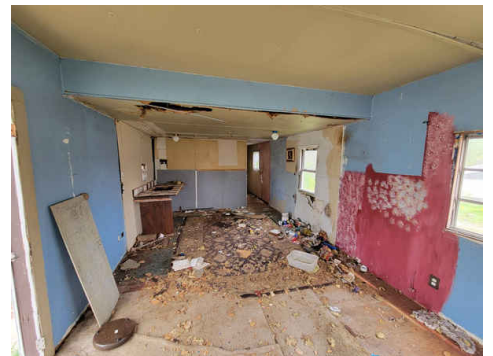
10.7.4 LOT 24, Vacant

INT: MISSING APPLIANCES

Appliances were missing. See 'Standards of Practice' for average appliance costs.

\$1,735 - \$3,470

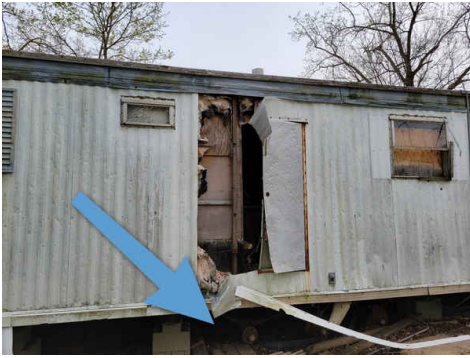
10.7.5 LOT 24, Vacant

EXT: BAD/MISSING SKIRTING(OVER 10%)

Note, it is not rare to see a single panel missing due to maintenance/meter access. Bad skirting or more than one panel missing was observed.

\$400 - \$4,000

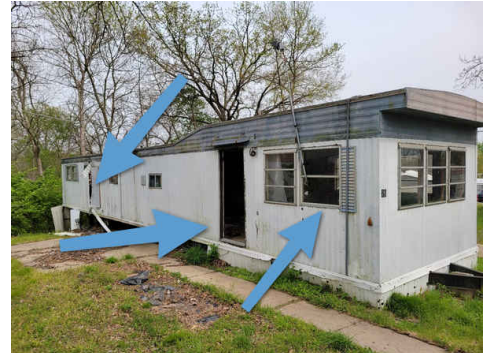
10.7.6 LOT 24, Vacant

EXT: BROKEN DOOR/WINDOW/DECK

A broken window, door, or deck was observed. Average replacement cost:

LOW: Under 10K Est.

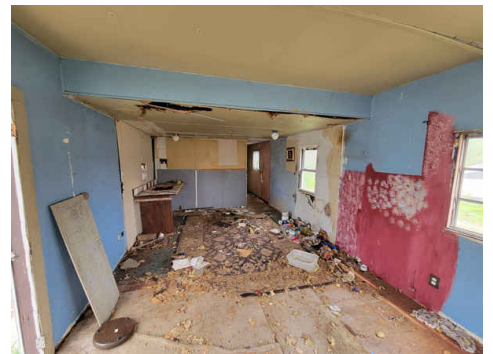
10.7.7 LOT 24, Vacant

SCRAP HOME

This home is considered to be 'scrap' condition. Cost amount assumes that a value was given to home for home to be usable/habitable. Possible costs may include home removal and home purchasing.

MEDIUM: 10K ~ 50K Est.

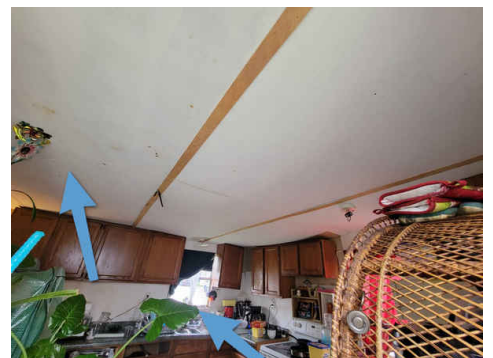
10.8.1 LOT 71, Occupied

INT/EXT: LEAK OR MOLD

Leak or mold was observed. Seek a qualified vendor to determine severity and estimate.

LOW: Under 10K Est.

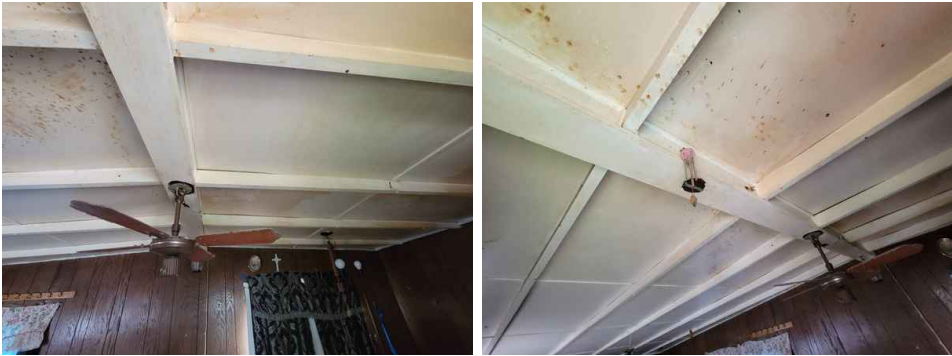
10.9.1 LOT 14, Vacant

INT/EXT: LEAK OR MOLD

Leak or mold was observed. Seek a qualified vendor to determine severity and estimate.

LOW: Under 10K Est.

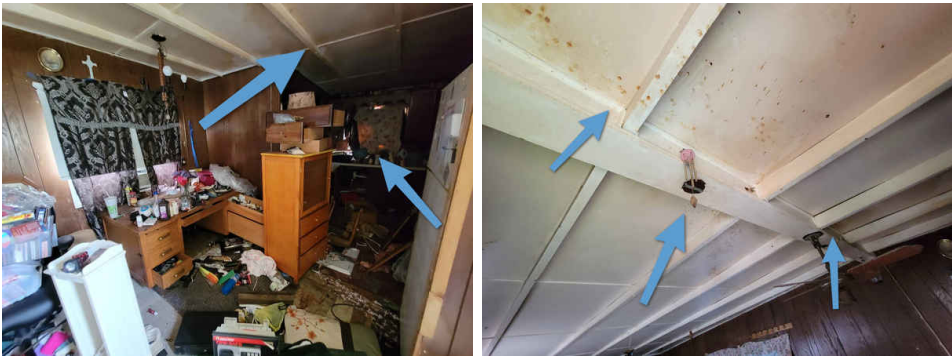
10.9.2 LOT 14, Vacant

INT: WALL OR CEILING

Wall or ceiling problem was observed. Seek qualified rehabber for estimate.

LOW: Under 10K Est.

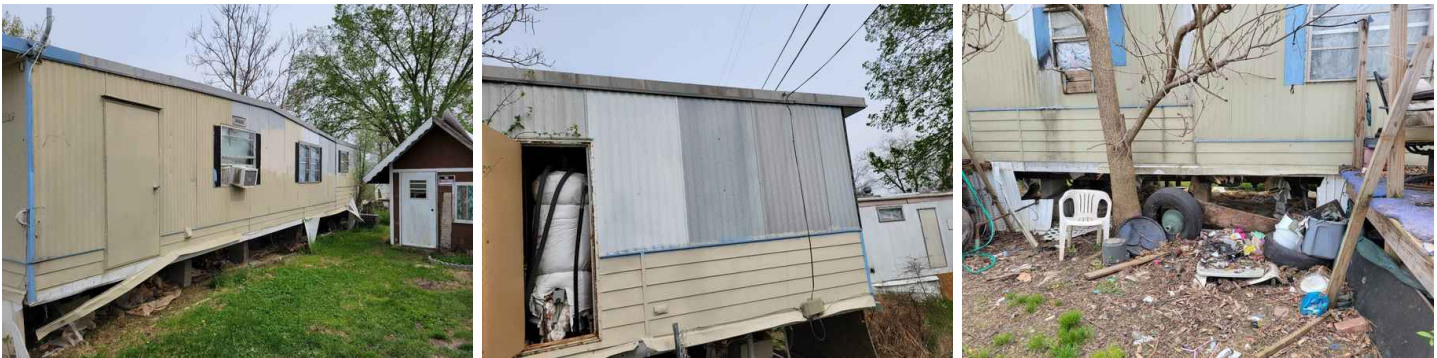
10.9.3 LOT 14, Vacant

EXT: BAD/MISSING SKIRTING(OVER 10%)

Note, it is not rare to see a single panel missing due to maintenance/meter access. Bad skirting or more than one panel missing was observed.

LOW: Under 10K Est.

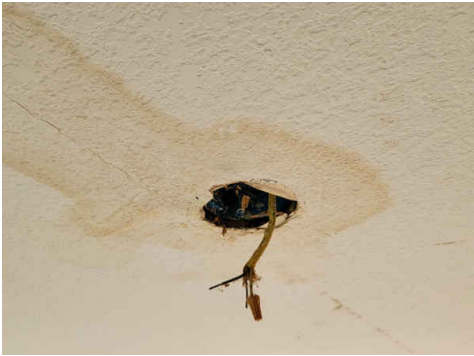
INT/EXT: LEAK OR MOLD

Leak or mold was observed. Seek a qualified vendor to determine severity and estimate.

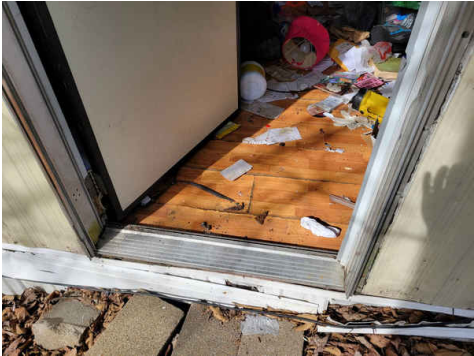
10.13.2 LOT 27, Vacant

INT: FLOORING PROBLEM

Flooring problem was observed. See 'Standards of Practice' for industry average details (per square foot).

- soft spot (y/n):
- missing flooring (y/n):
- deteriorated (y/n):

LOW: Under 10K Est.

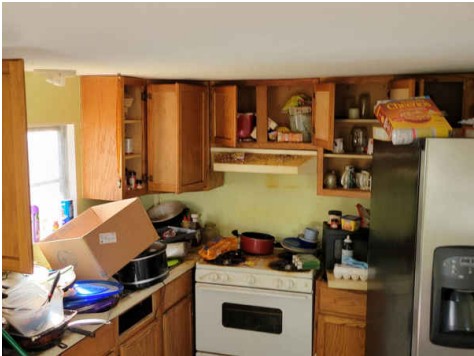
INT: MISSING APPLIANCES

Appliances were missing. See 'Standards of Practice' for average appliance costs.

LOW: Under 10K Est.

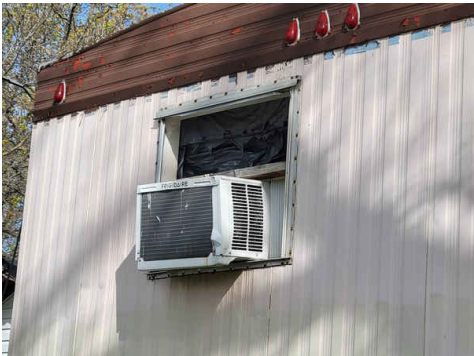
EXT: BROKEN
DOOR/WINDOW/DECK

A broken window, door, or deck was observed. Average replacement cost:

- Door: \$478-956
- Window: \$175-\$650
- Decks: \$15-\$30 p/sq/ft: 10 x 10: \$1,500 - \$3,000

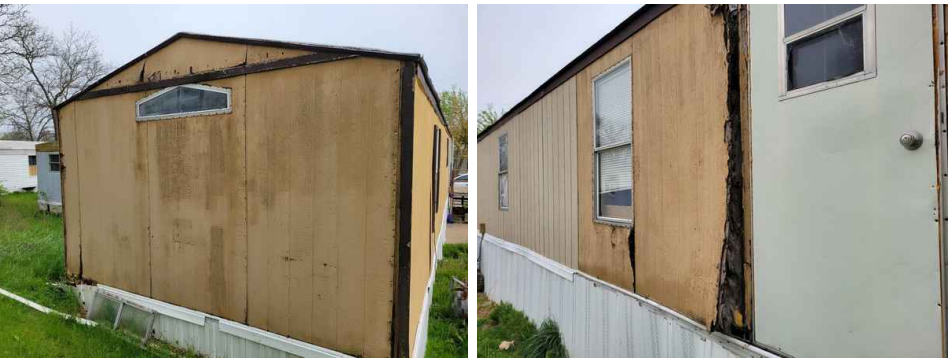
INT/EXT: LEAK OR MOLD

Leak or mold was observed. Seek a qualified vendor to determine severity and estimate.

LOW: Under 10K Est.

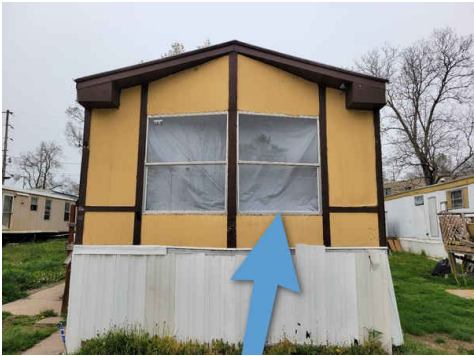
10.14.2 LOT 55, Occupied

EXT: BROKEN
DOOR/WINDOW/DECK

A broken window, door, or deck was observed. Average replacement cost:

- Door: \$478-956
- Window: \$175-\$650
- Decks: \$15-\$30 p/sq/ft: 10 x 10: \$1,500 - \$3,000

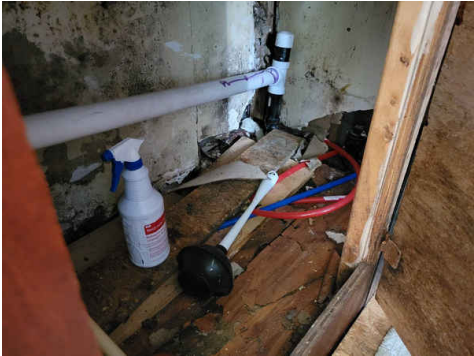
10.15.1 LOT 30, Occupied

INT/EXT: LEAK OR MOLD

Leak or mold was observed. Seek a qualified vendor to determine severity and estimate.

LOW: Under 10K Est.

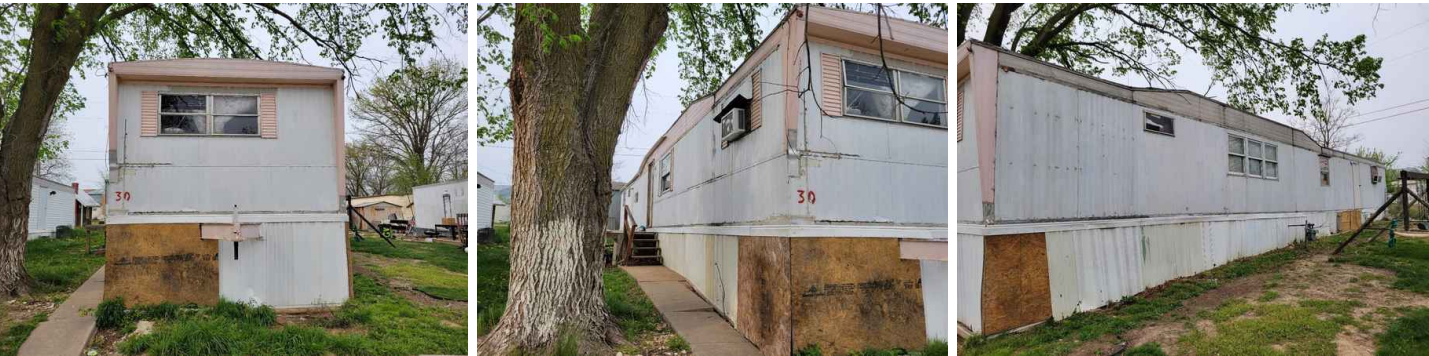
10.15.2 LOT 30, Occupied

EXT: BAD/MISSING SKIRTING(OVER 10%)

Note, it is not rare to see a single panel missing due to maintenance/meter access. Bad skirting or more than one panel missing was observed.

LOW: Under 10K Est.

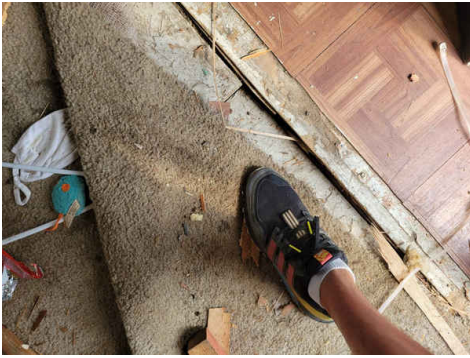
10.16.1 LOT 34, Vacant

INT: FLOORING PROBLEM

Flooring problem was observed. See 'Standards of Practice' for industry average details (per square foot).

LOW: Under 10K Est.

Estimated Cost
\$7 - \$15

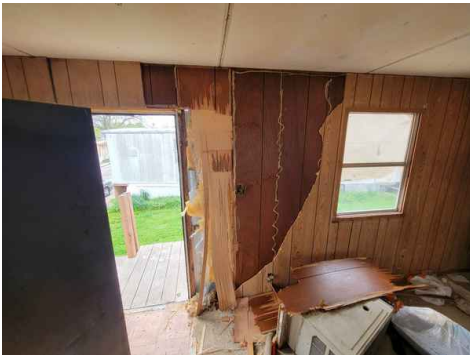
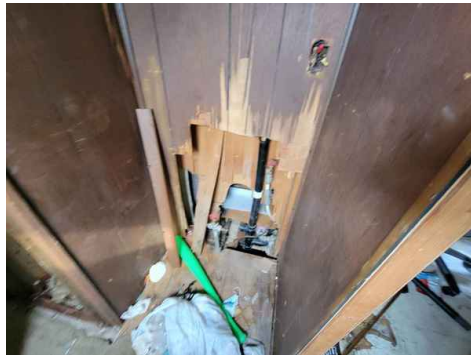
10.16.2 LOT 34, Vacant

INT: WALL OR CEILING

Wall or ceiling problem was observed. Seek qualified rehabber for estimate.

LOW: Under 10K Est.

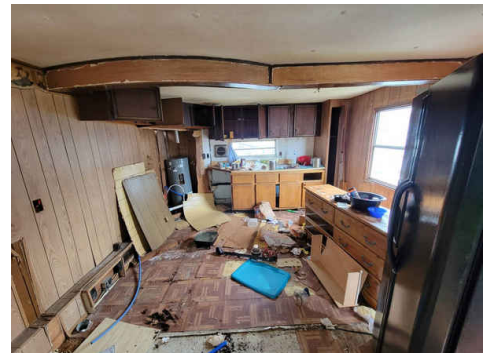
10.16.3 LOT 34, Vacant

INT: MISSING APPLIANCES

Appliances were missing. See 'Standards of Practice' for average appliance costs.

LOW: Under 10K Est.

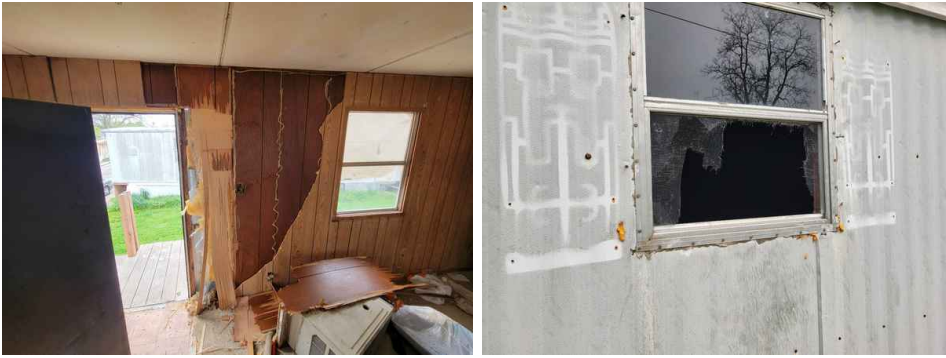
10.16.4 LOT 34, Vacant

EXT: BROKEN DOOR/WINDOW/DECK

A broken window, door, or deck was observed. Average replacement cost:

LOW: Under 10K Est.

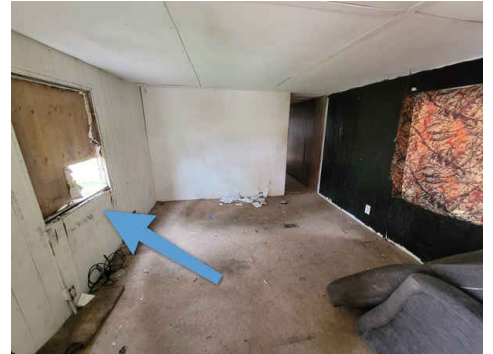
10.17.1 LOT 35, Vacant

INT/EXT: LEAK OR MOLD

Leak or mold was observed. Seek a qualified vendor to determine severity and estimate.

LOW: Under 10K Est.

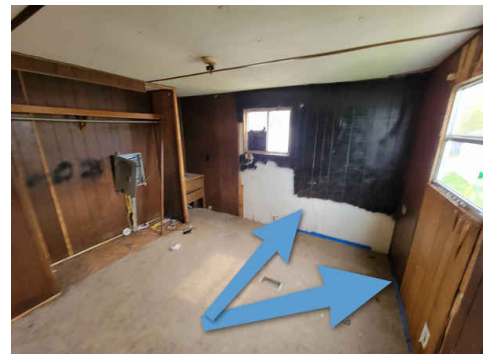
10.17.2 LOT 35, Vacant

INT: WALL OR CEILING

Wall or ceiling problem was observed. Seek qualified rehabber for estimate.

LOW: Under 10K Est.

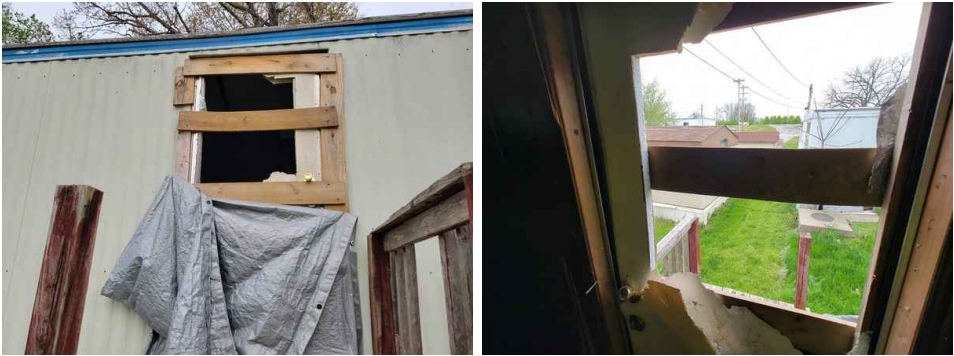
10.17.3 LOT 35, Vacant

EXT: BROKEN DOOR/WINDOW/DECK

A broken window, door, or deck was observed. Average replacement cost:

LOW: Under 10K Est.

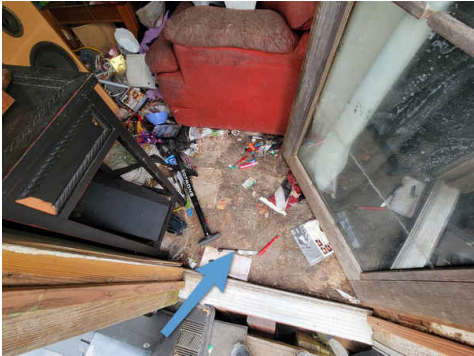
10.18.1 LOT 37, Vacant

INT/EXT: LEAK OR MOLD

Leak or mold was observed. Seek a qualified vendor to determine severity and estimate.

LOW: Under 10K Est.

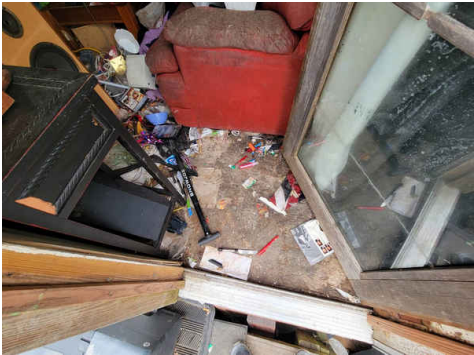
10.18.2 LOT 37, Vacant

INT: FLOORING PROBLEM

Flooring problem was observed. See 'Standards of Practice' for industry average details (per square foot).

- soft spot (y/n):
- missing flooring (y/n):
- deteriorated (y/n):

LOW: Under 10K Est.

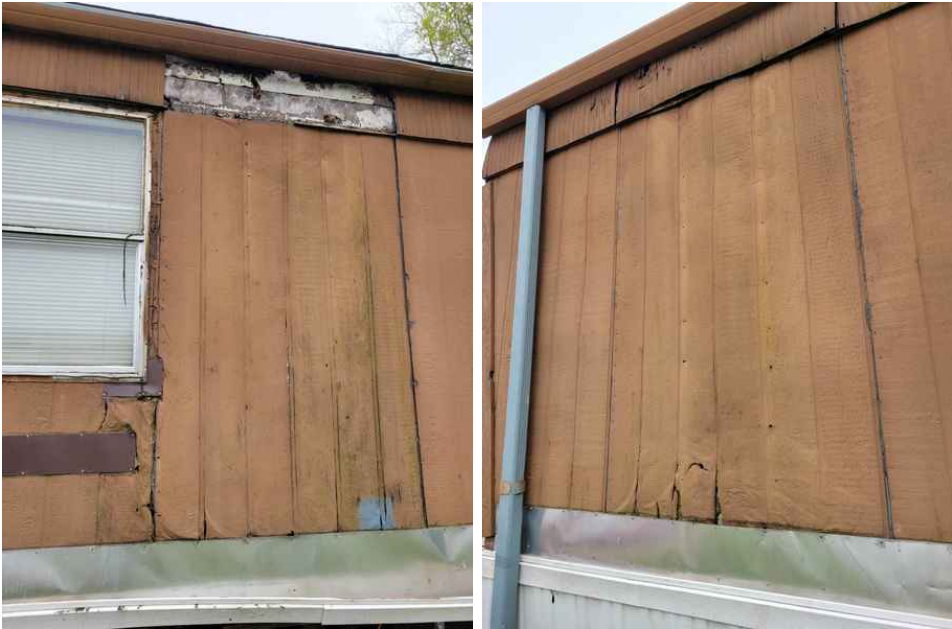
10.20.1 LOT 84, Vacant

INT/EXT: LEAK OR MOLD

Leak or mold was observed. Seek a qualified vendor to determine severity and estimate.

LOW: Under 10K Est.

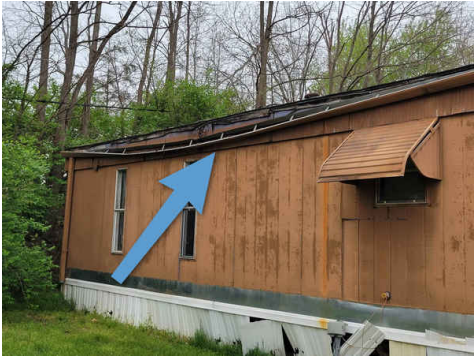
10.20.2 LOT 84, Vacant

EXT: ROOF HOLES/BROKEN

Bad roof area observed. Average cost per square foot for asphalt shingles.

LOW: Under 10K Est.

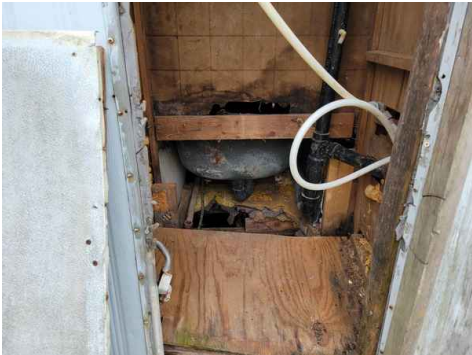
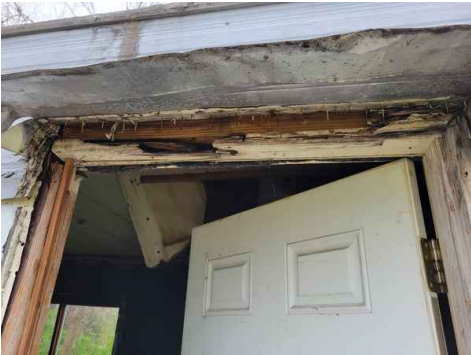
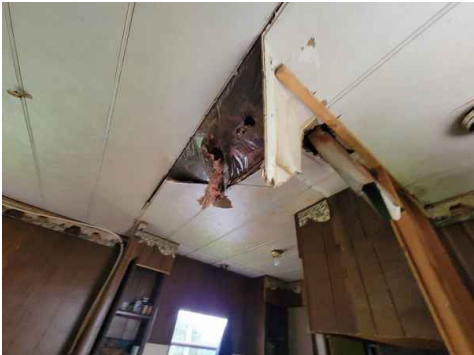
10.21.1 LOT 95, Vacant

INT/EXT: LEAK OR MOLD

Leak or mold was observed. Seek a qualified vendor to determine severity and estimate.

LOW: Under 10K Est.

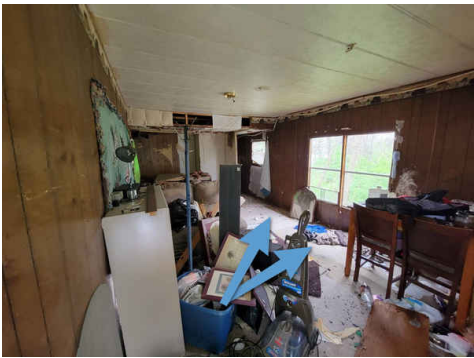
10.21.2 LOT 95, Vacant

INT: FLOORING PROBLEM

Flooring problem was observed. See 'Standards of Practice' for industry average details (per square foot).

- soft spot (y/n):
- missing flooring (y/n):
- deteriorated (y/n):

Estimated Cost
\$7 - \$15

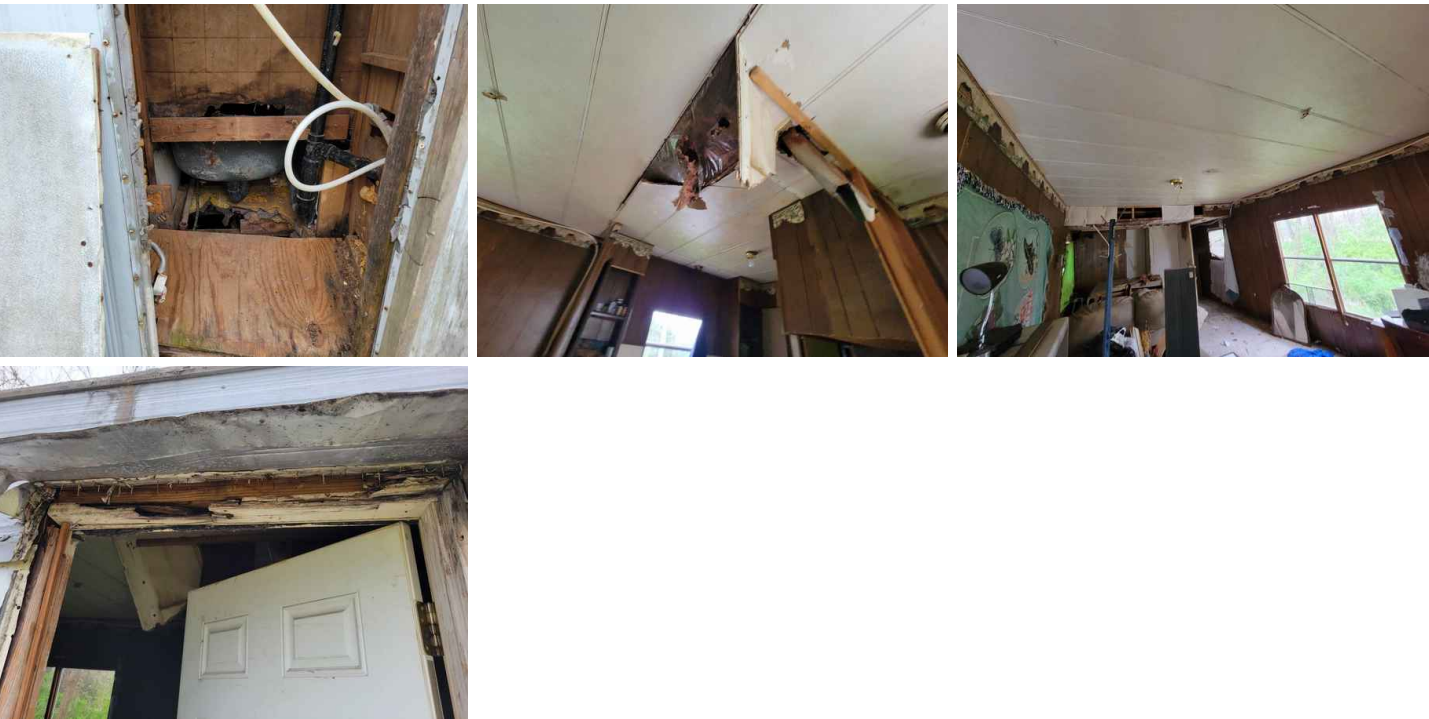
10.21.3 LOT 95, Vacant

INT: WALL OR CEILING

LOW: Under 10K Est.

Wall or ceiling problem was observed. Seek qualified rehabber for estimate.

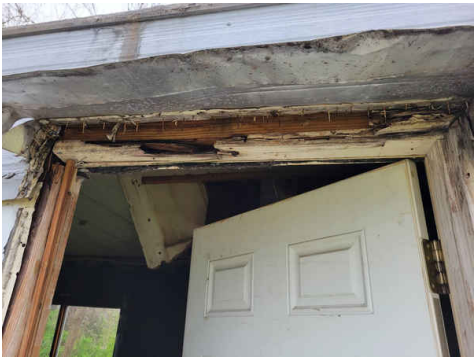
10.21.4 LOT 95, Vacant

**EXT: BROKEN
DOOR/WINDOW/DECK**

A broken window, door, or deck was observed. Average replacement cost:

- Door: \$478-956
- Window: \$175-\$650
- Decks: \$15-\$30 p/sq/ft: 10 x 10: \$1,500 - \$3,000

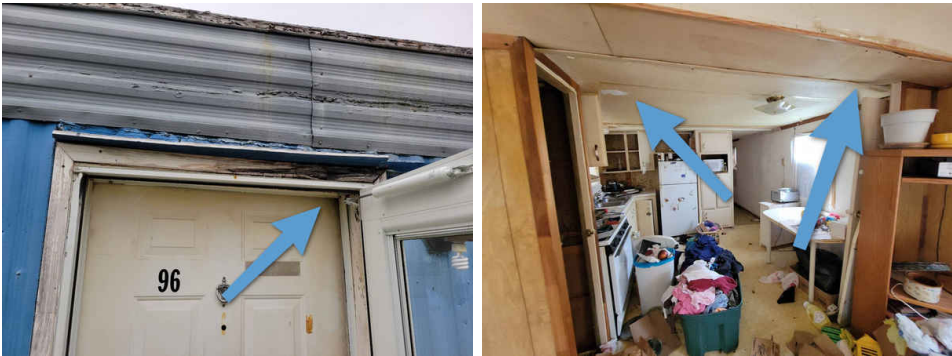
10.22.1 LOT 96, Vacant

INT/EXT: LEAK OR MOLD

LOW: Under 10K Est.

Leak or mold was observed. Seek a qualified vendor to determine severity and estimate.

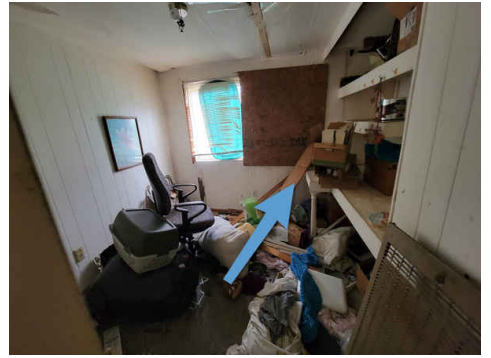
**EXT: BROKEN
DOOR/WINDOW/DECK**

A broken window, door, or deck was observed. Average replacement cost:

- Door: \$478-956
- Window: \$175-\$650
- Decks: \$15-\$30 p/sq/ft: 10 x 10: \$1,500 - \$3,000

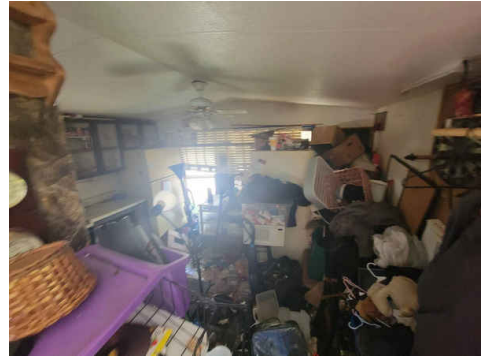
10.23.1 LOT 39, Vacant

INT/EXT: LEAK OR MOLD

Leak or mold was observed. Seek a qualified vendor to determine severity and estimate.

LOW: Under 10K Est.

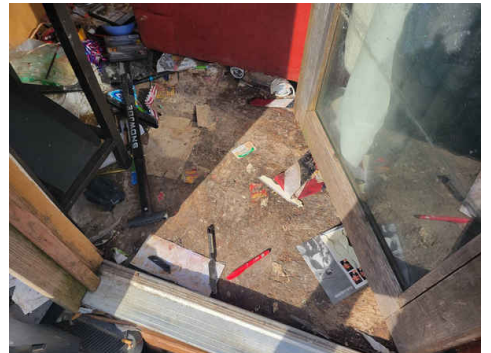
10.23.3 LOT 39, Vacant

INT: FLOORING PROBLEM

Flooring problem was observed. See 'Standards of Practice' for industry average details (per square foot).

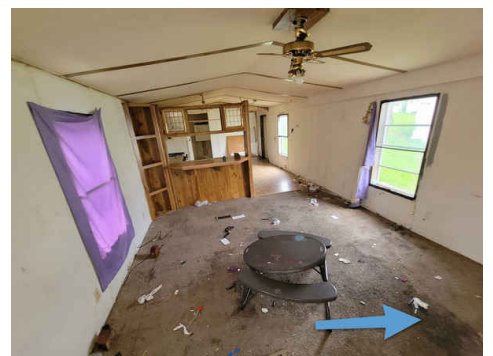
10.24.2 LOT 57, Vacant

INT: FLOORING PROBLEM

Flooring problem was observed. See 'Standards of Practice' for industry average details (per square foot).

Type of floor problem:

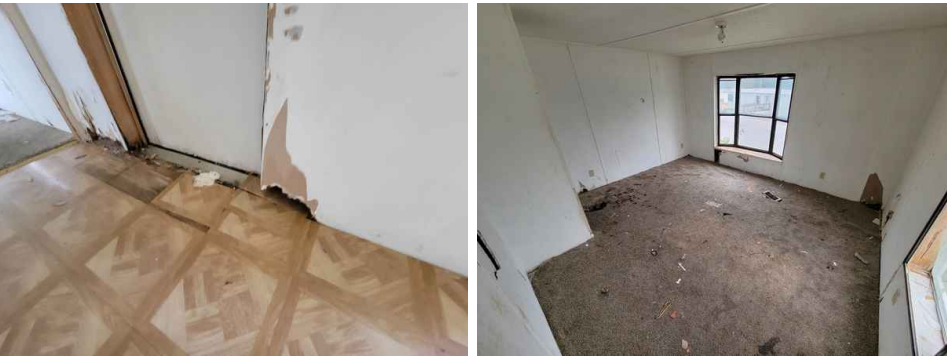
10.24.3 LOT 57, Vacant

Wall or ceiling problem was observed. Seek qualified rehabber for estimate.

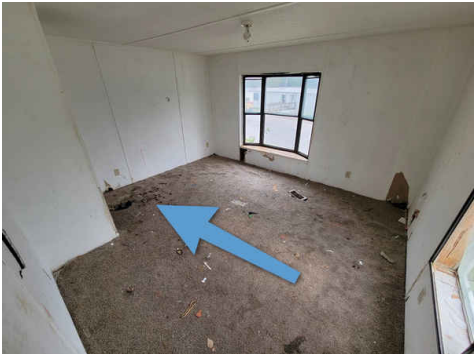
10.24.4 LOT 57, Vacant

INT: ANIMAL ALERT

Animal noticed. Note, approval per lot is unknown. Pictures are taken (if possible) of animal because animal may not be approved and/or causing damage. It will be noted if there appears to be a 'service animal' epidemic.

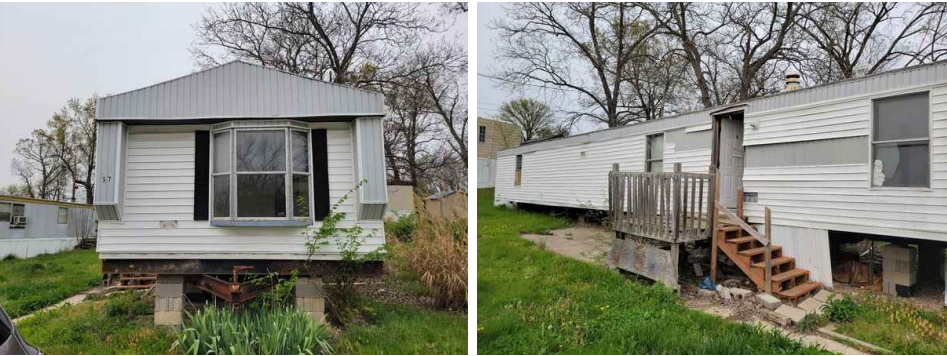
10.24.5 LOT 57, Vacant

EXT: BAD/MISSING SKIRTING(OVER 10%)

Note, it is not rare to see a single panel missing due to maintenance/meter access. Bad skirting or more than one panel missing was observed.

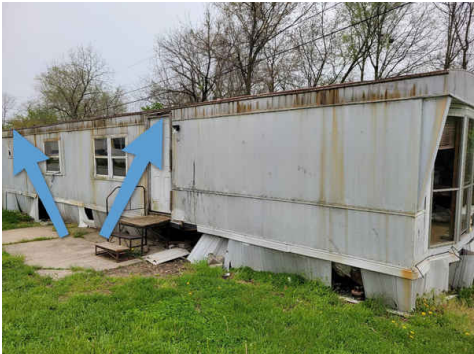
10.25.5 LOT 64, Vacant

EXT: ROOF HOLES/BROKEN

Bad roof area observed. Average cost per square foot for asphalt shingles.

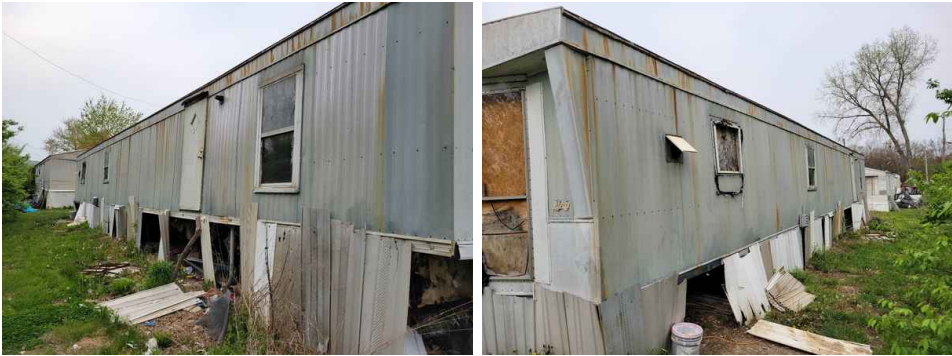
10.25.6 LOT 64, Vacant

EXT: BAD/MISSING SKIRTING(OVER 10%)

Note, it is not rare to see a single panel missing due to maintenance/meter access. Bad skirting or more than one panel missing was observed.

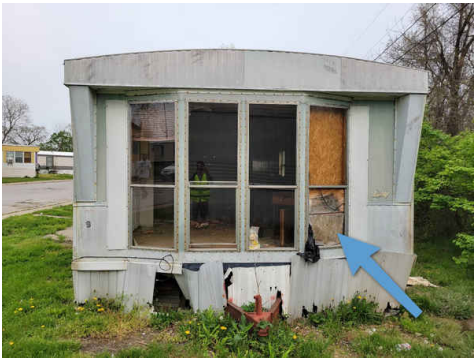
10.25.7 LOT 64, Vacant

**EXT: BROKEN
DOOR/WINDOW/DECK**

A broken window, door, or deck was observed. Average replacement cost:

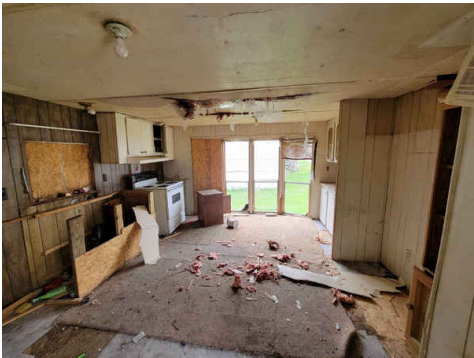
10.25.8 LOT 64, Vacant

This home is considered to be 'scrap' condition. Cost amount assumes that a value was given to home for home to be usable/habitable. Possible costs may include home removal and home purchasing.

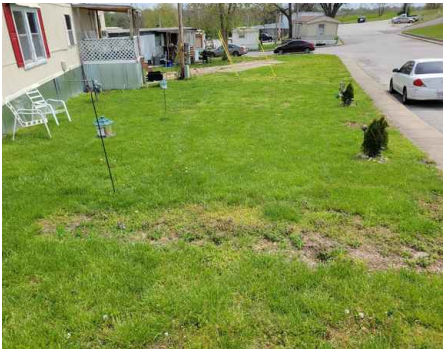
Lot # 2: Lot Condition
No Pad

Lot # 2: Connections Found
Water: Not Found, Sewer: Not Found, Electric: Not Found

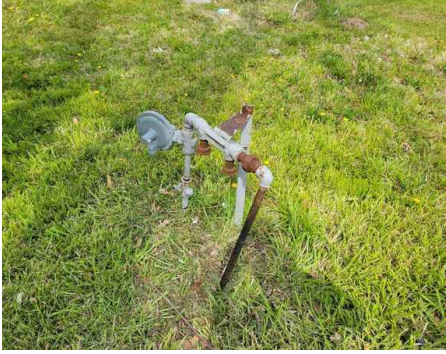
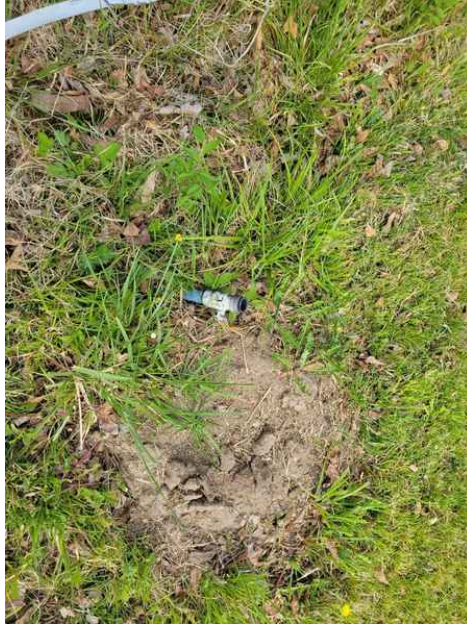
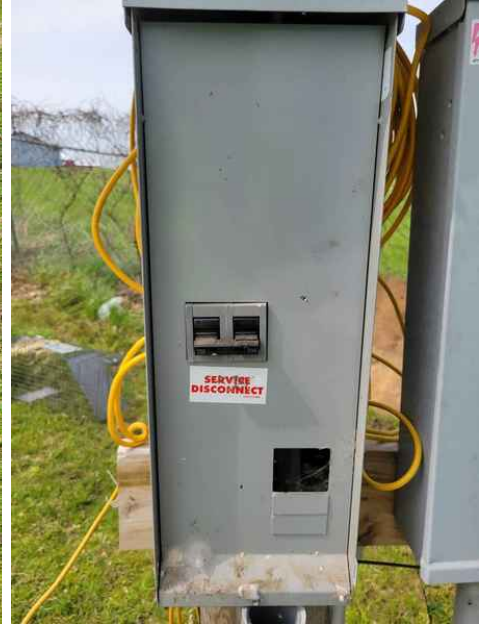
Lot # 17: Connections Found

Water: Good, Sewer: Not Found, Electric: 200 amp, Gas Connection

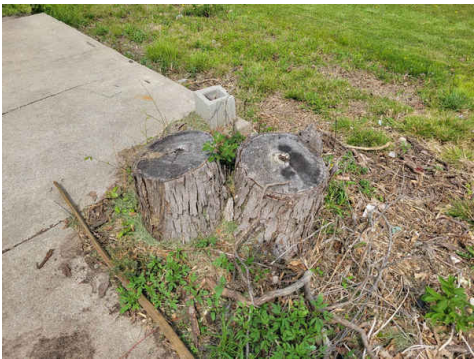
11.2.1 Lot # 17

TREE OR BRUSH REMOVAL

This deferred maintenance item is ONLY noted if it prevents lot from being used - blocking a home from moving in. Note, large diameter trees over 50 foot may cost significantly more.

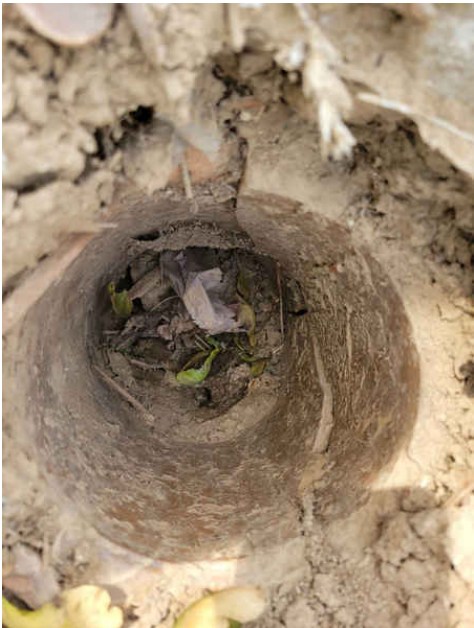
11.5.1 Lot # 42

FIX SEWER CONNECTION

Bad sewer connection. 'Bad connection': corroded or broken requiring replacement. Note, repair cost may be significantly less if the only broken item found (when fixing line) is an area cracked at the surface.

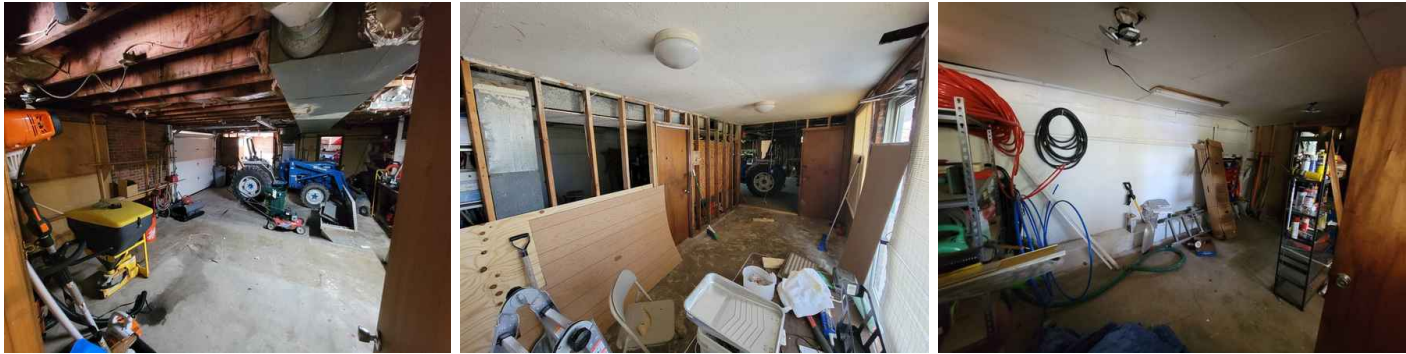
12.1.1 Condition of Structure(s)

DEFECTS OBSERVED

Unfinished wall areas, evidence of roof leaks, sagging roof areas in warehouse, and unfinished floor areas.

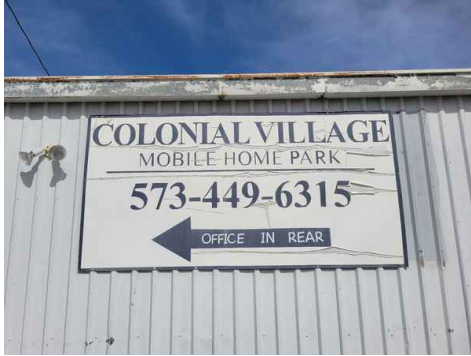
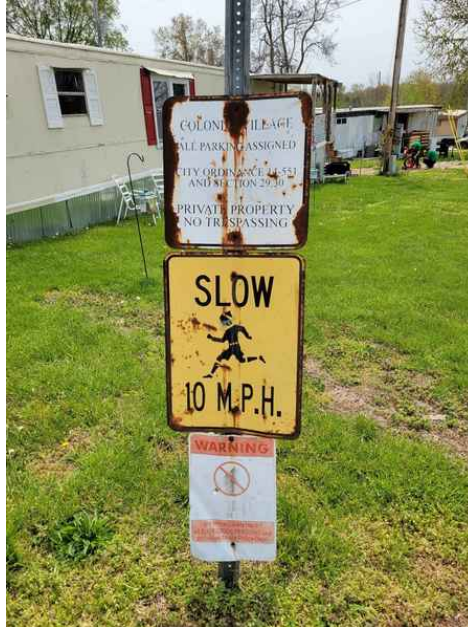
13.1.1 Condition of Signs

'Bad' condition: worn, deteriorated or broken needing replacement. Average includes materials and installation. Main sign may also be considered 'bad' if it is located in a non-visible place and/or missing phone number (ineffective).

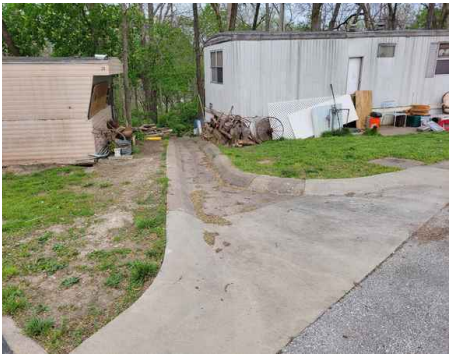
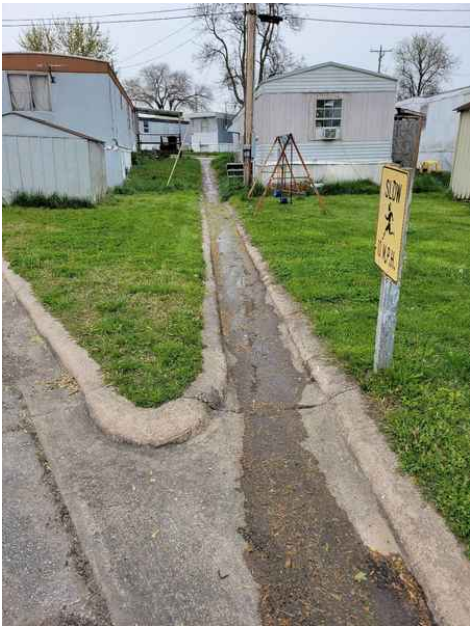
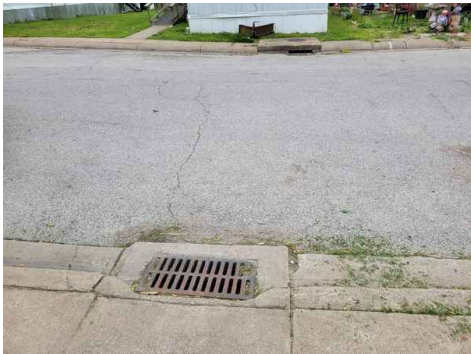
Drainage observations: While the drainage for the park was good overall there was a problem found when talking to some of the residents. Around lots 69-76 there is drainage that is not sufficient when a large rainstorm comes through. The area floods 3-5 inches and saturates the ground around the homes and sheds. **Please see the images.**

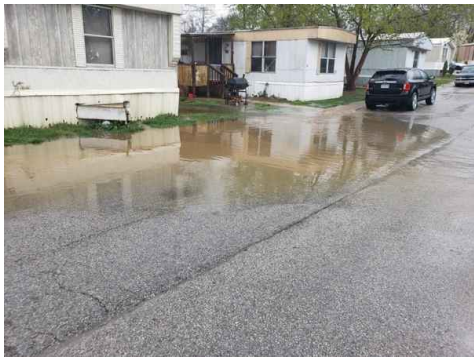
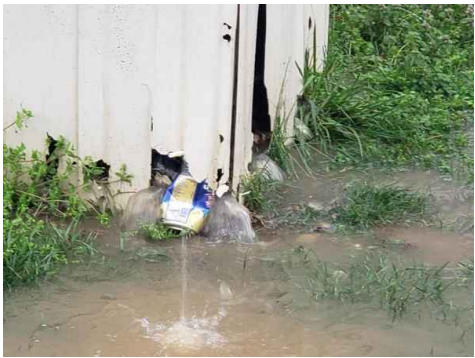
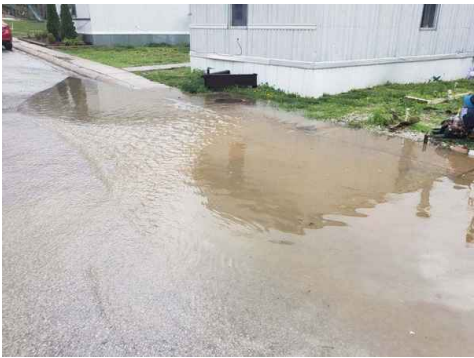
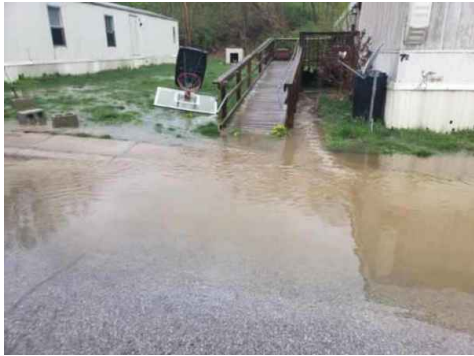
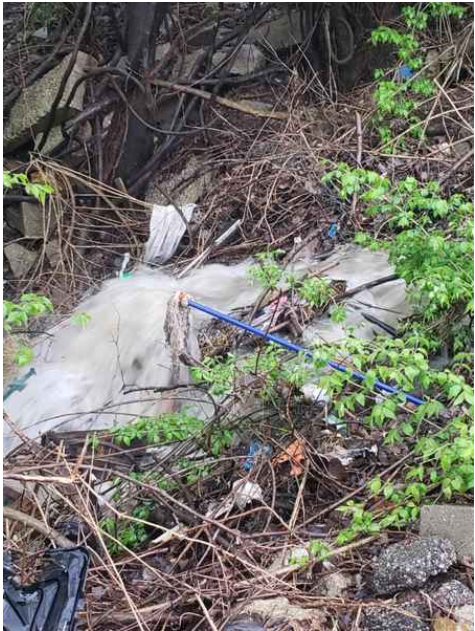
14.1.1 Condition

FLOODING - MISSING DRAINAGE

HIGH: 50K+ Est.

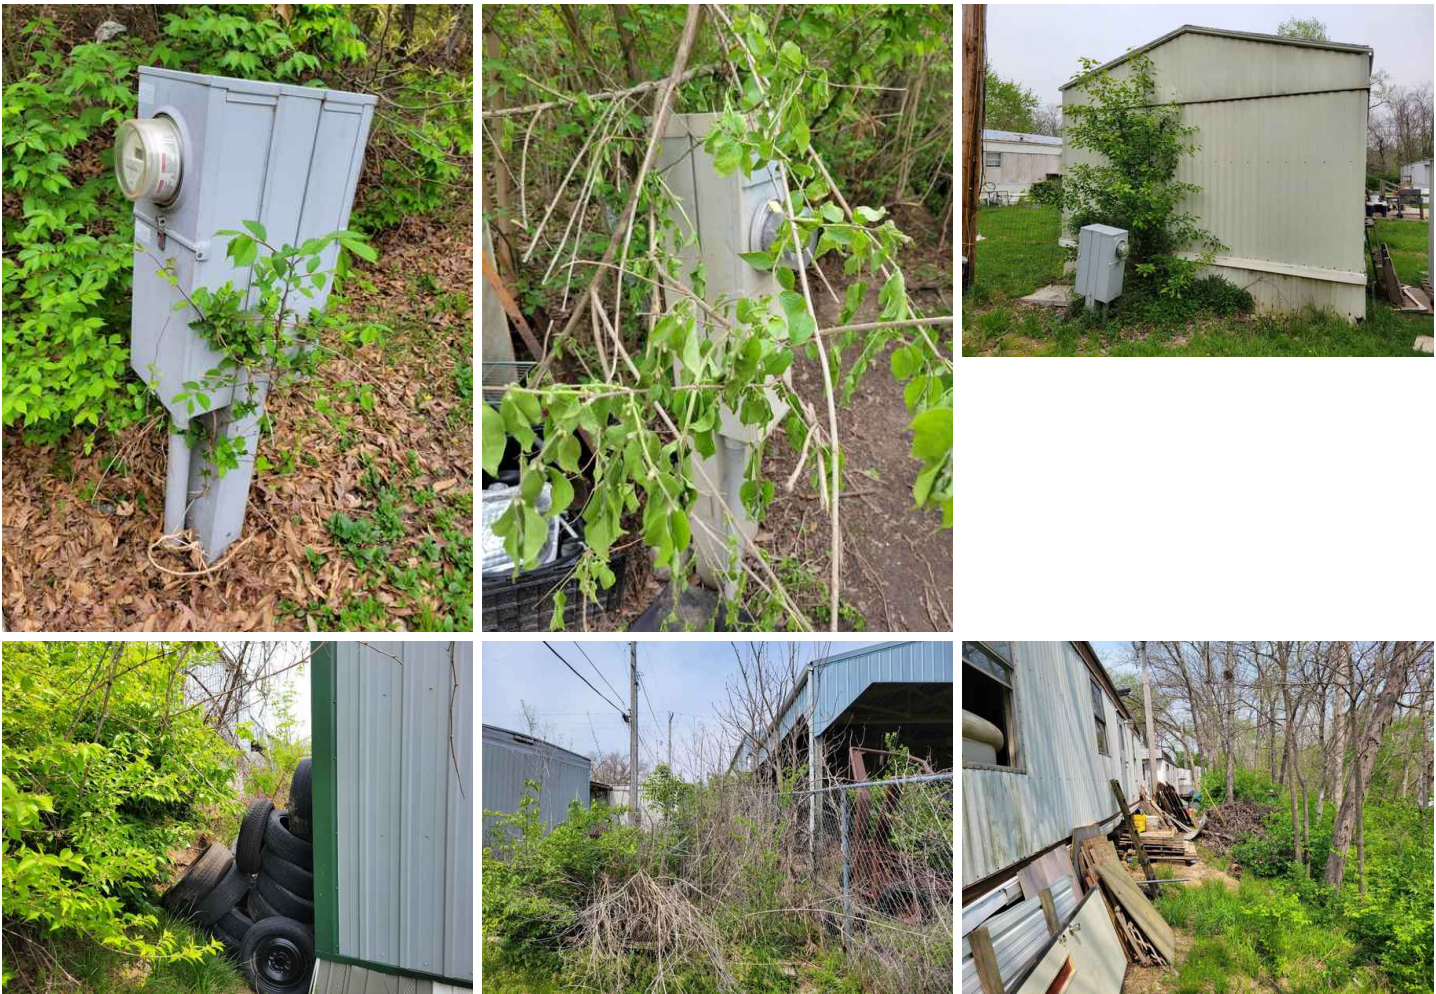
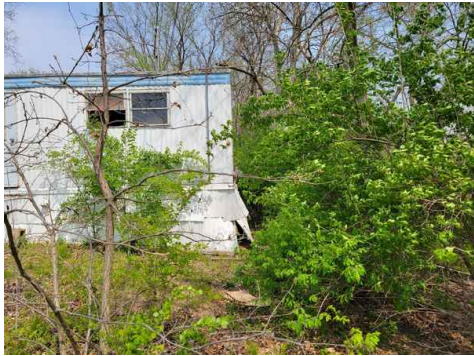
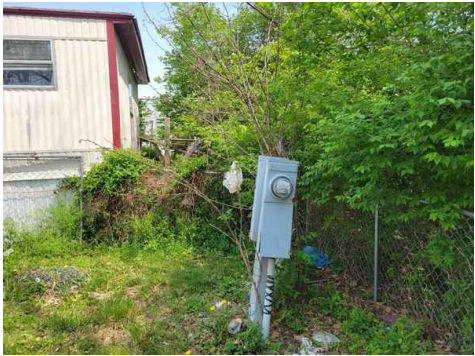
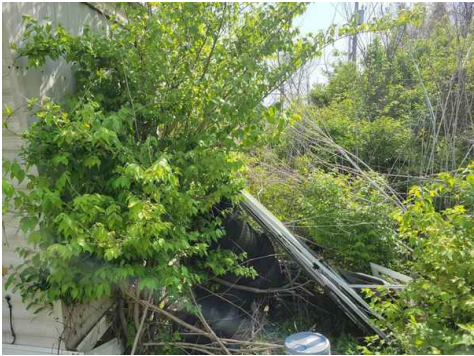
15.1.1 Size, Average Quantity, & Condition

Overall tree conditions observed (sizes, density, if touching homes): There are large trees throughout the park and >1,000 around the perimeter of the property. There are >5 trees making contact with homes within the park.

MEDIUM: 10K ~ 50K Est.

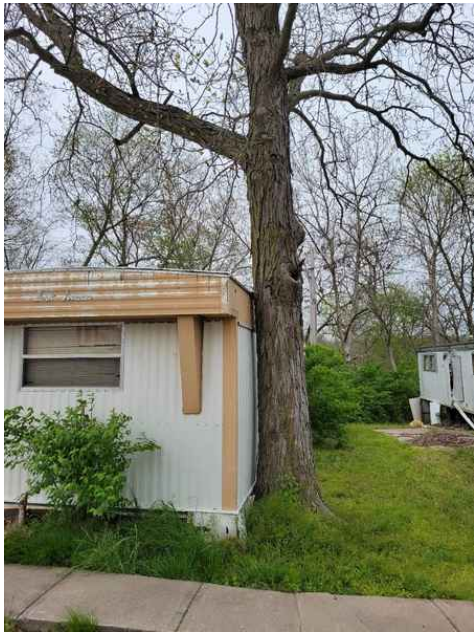
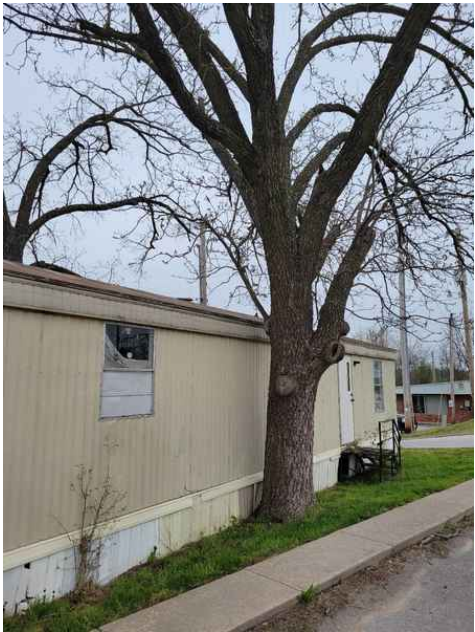
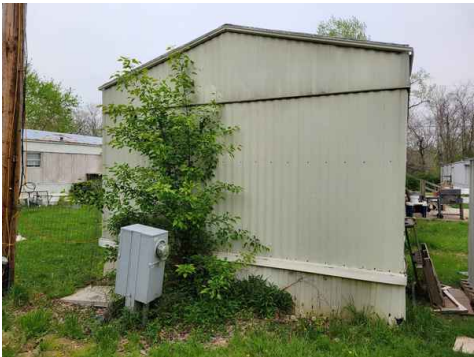
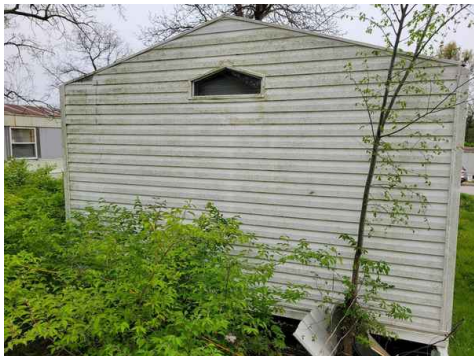
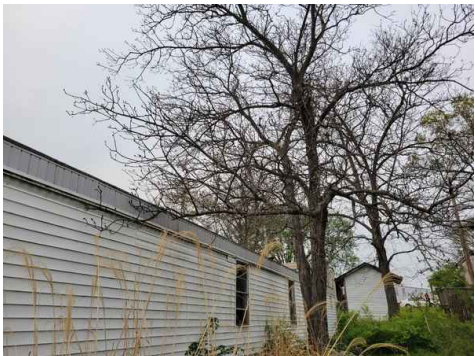
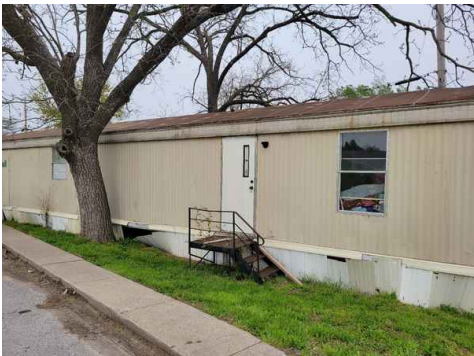
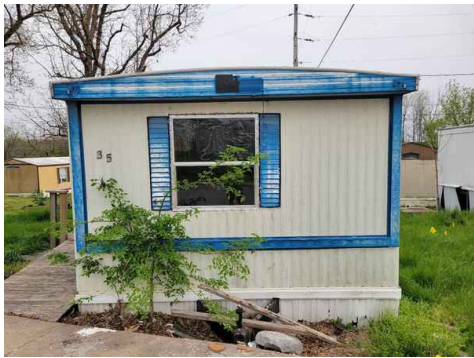
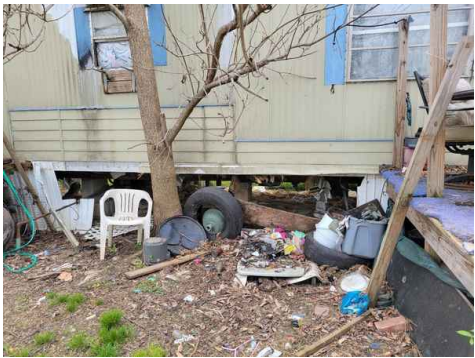
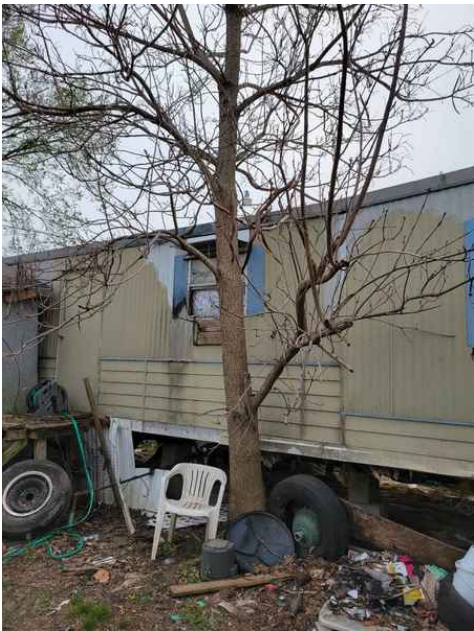
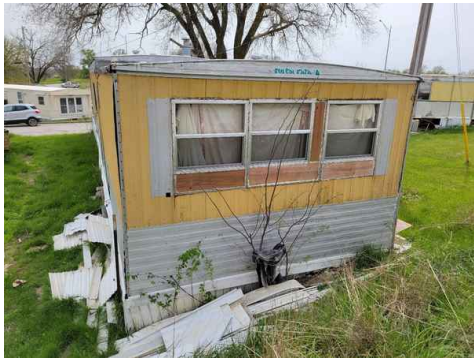
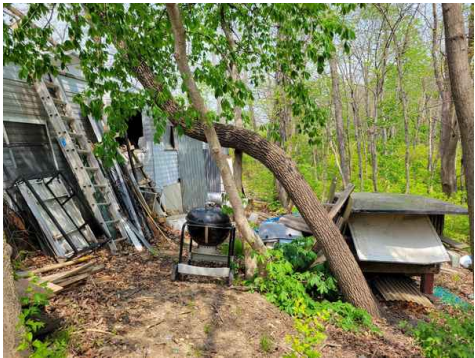
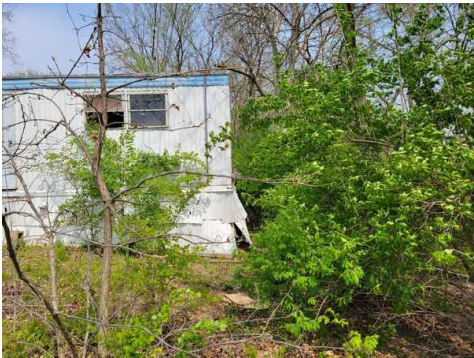
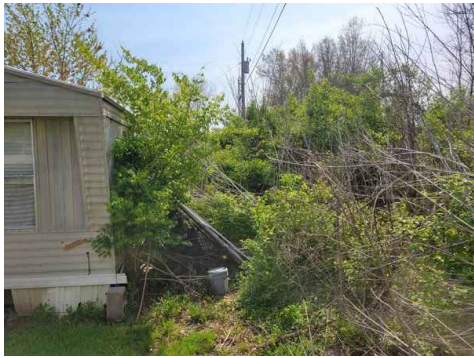
15.1.2 Size, Average Quantity, & Condition
TREE(S) TOUCHING OR ON HOMES
Estimated Cost
\$350 - \$1

LOW: Under 10K Est.
