DDP RECON REPORT COPY

Sample Recon Report - 691 San Marcos St
Giddings, TX 78942

APRIL 29, 2021

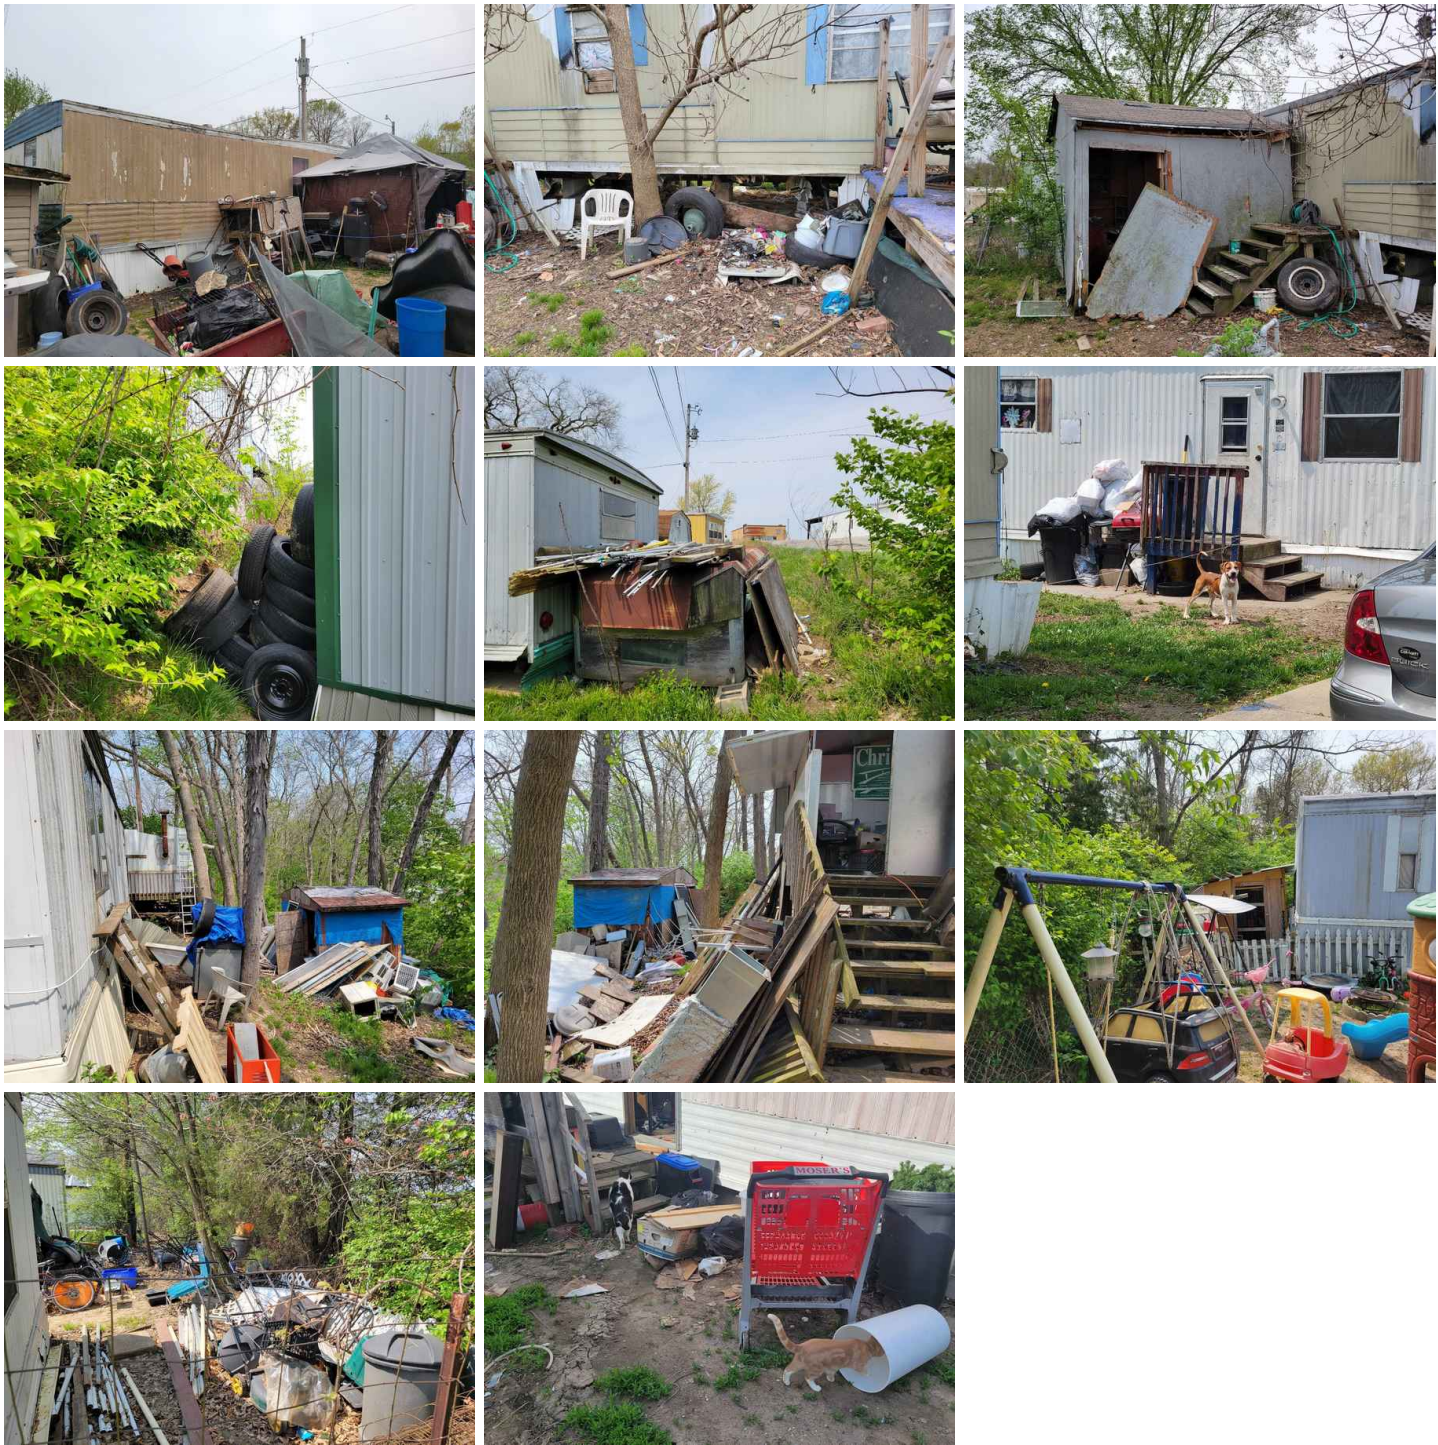
16.1.2 Items Observed

DEBRIS (MORE THAN 10% OF LOTS)

LOW: Under 10K Est.

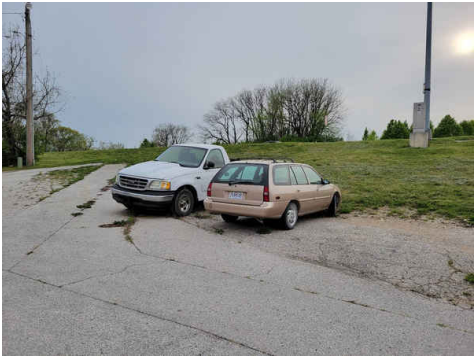
16.1.3 Items Observed

BROKEN VEHICLES (MORE THAN 5% OF LOTS)

LOW: Under 10K Est.

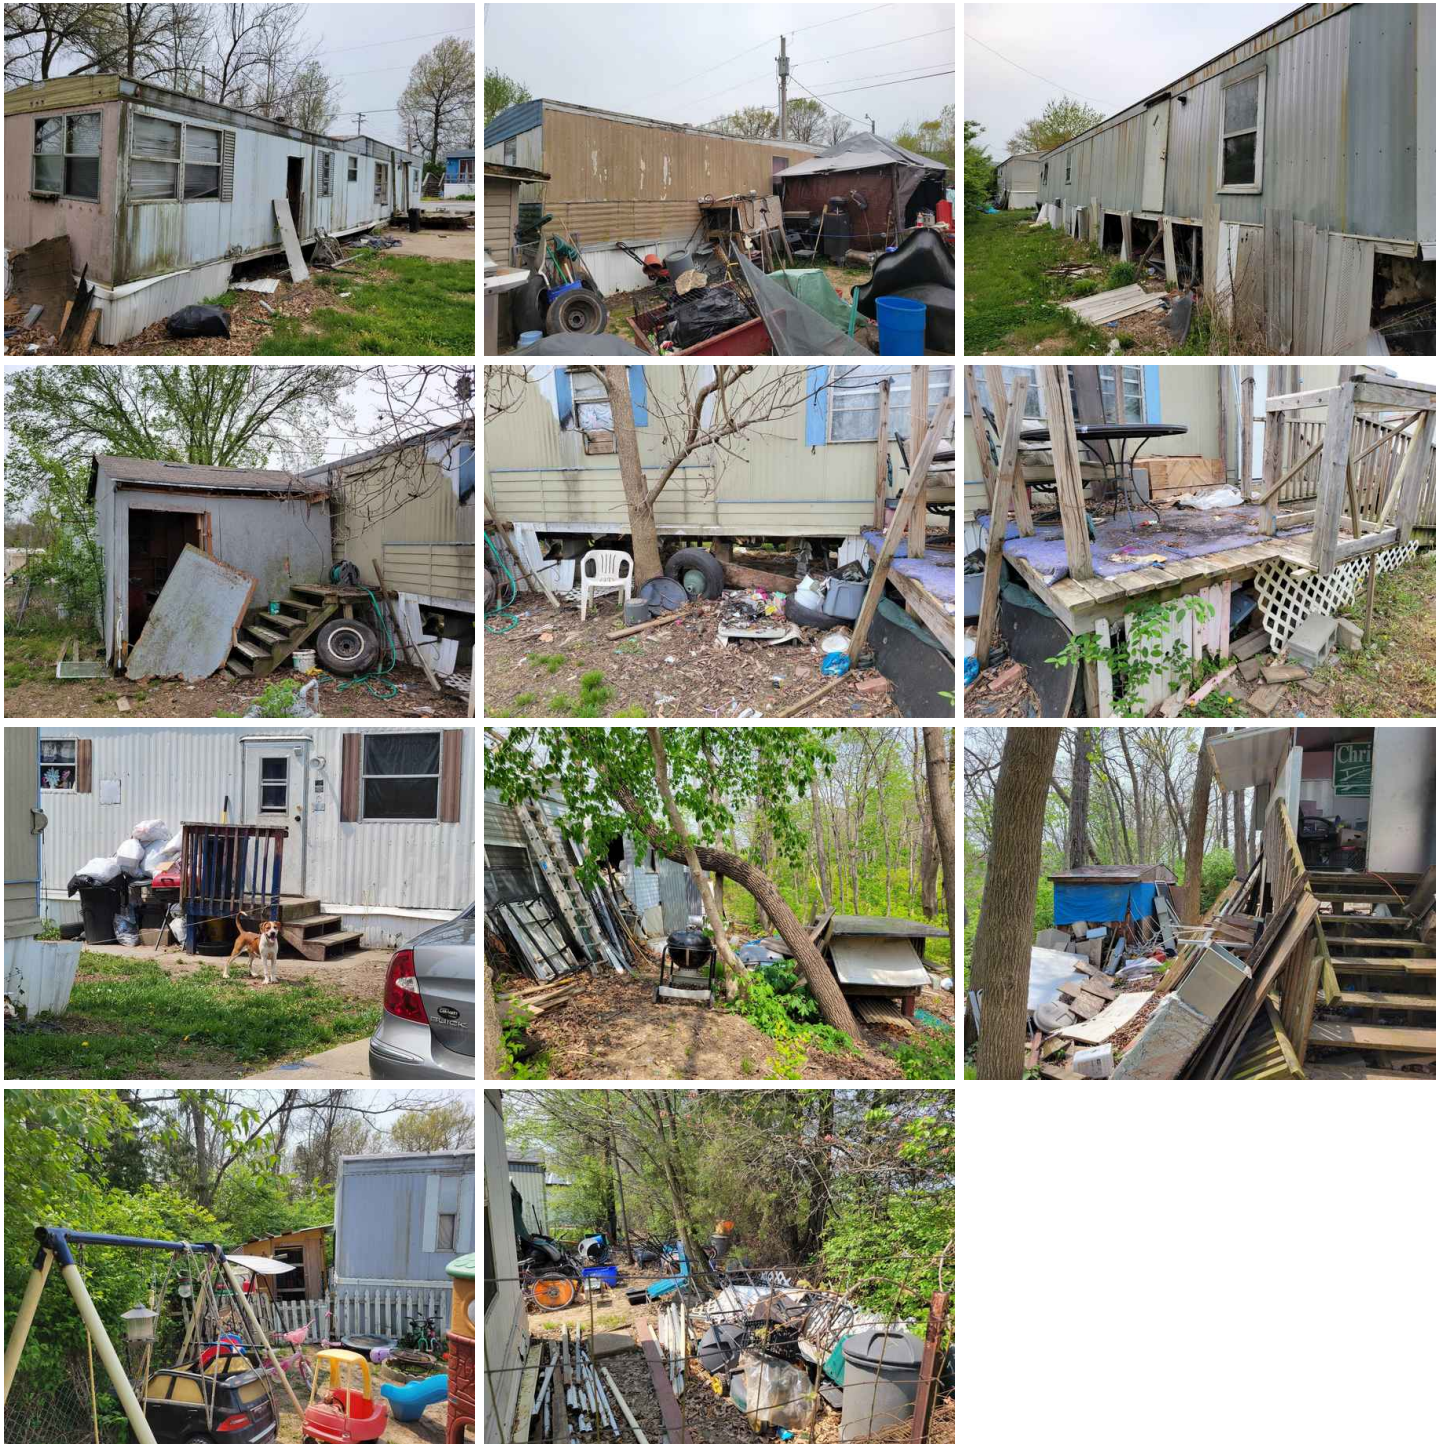
16.1.4 Items Observed

TERRIBLE CONDITION TENANT HOMES (MORE THAN 10%)

No cost estimate assumes that tenant will be required to make repairs.

LOW: Under 10K Est.

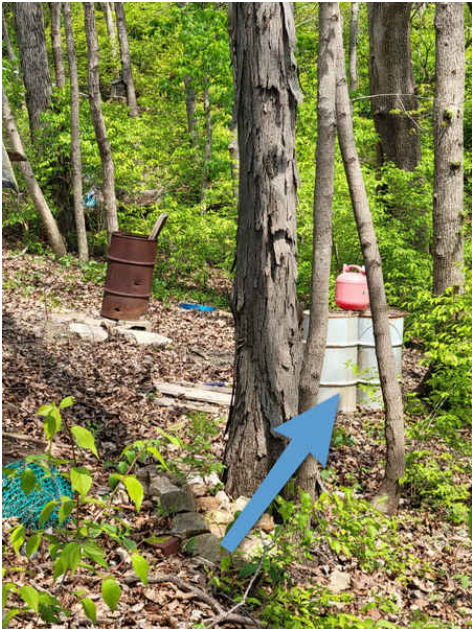
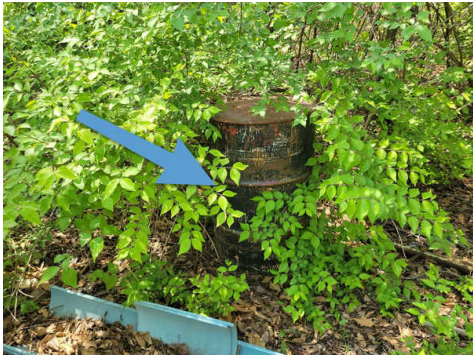
16.1.8 Items Observed
CHEMICAL HAZARD

Chemical hazard may include oil/chemical canisters/drums, chemical spills, and odor. No cost, assuming tenant removal.

LOW: Under 10K Est.

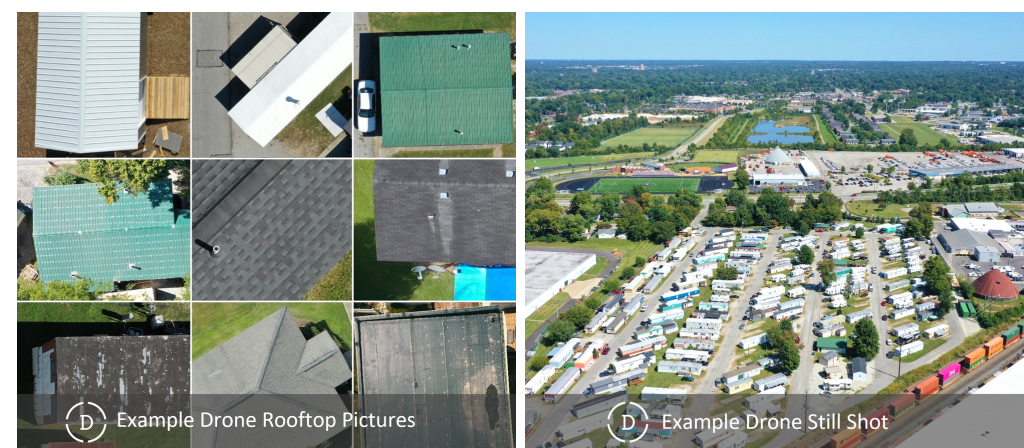
Example of Rooftop and Still Pictures

Conditions observed for roof tops were: Fair, the roof on the office / commercial space did not show any holes or obvious issues other than age.
