Sample Report
TX 12345

PROPERTY INSPECTION REPORT

Concerning: Sample Report, TX 12345
(Address or Other Identification of Inspected Property)

By: Junior Darsan - Professional Home Inspector TREC #25023 09/17/2021 10:00
(Name and License Number of Inspector) am (Date)

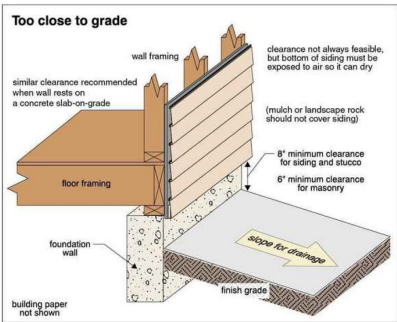
1: High Soil

➡Recommendation

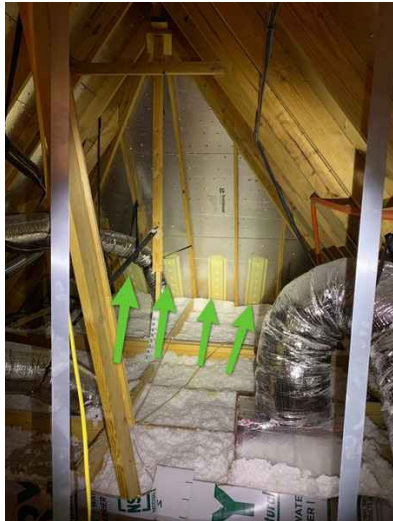
Baffles in attic

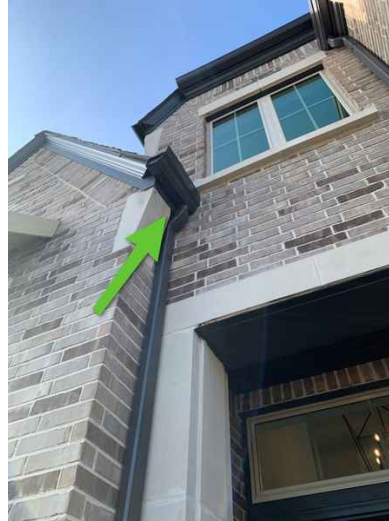
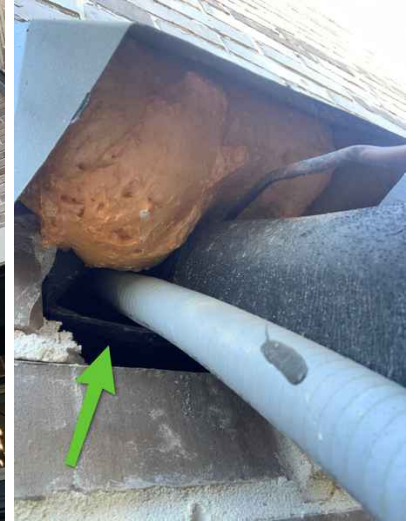
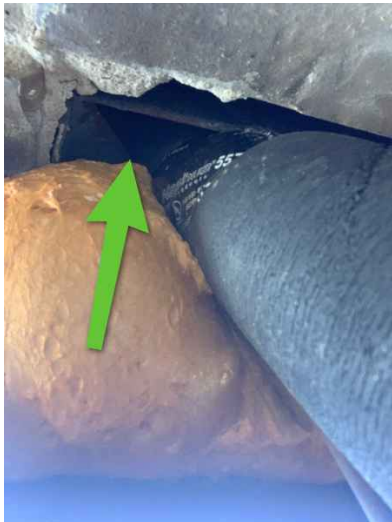
A/C line penetrations into home

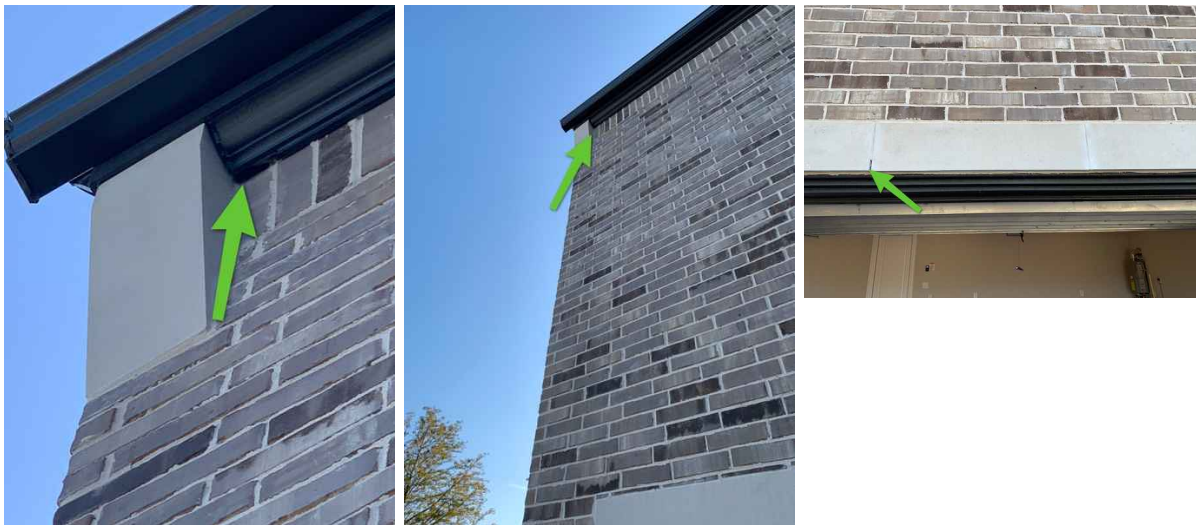
Roof over single car garage

There are several areas with missing or gaps in caulking. Recommend repair by a qualified contractor.

Recommendation: Contact a qualified professional.

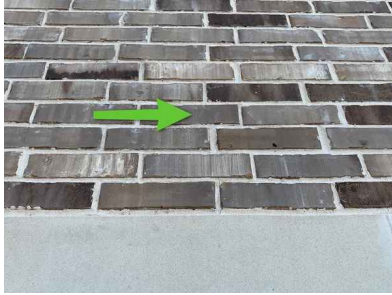
Above Garage Door

5: Grout Missing

Recommend repair by a qualified contractor.

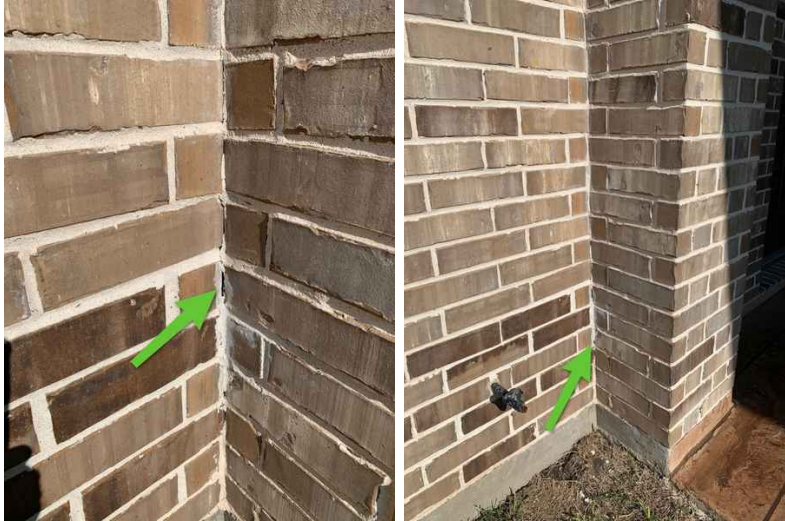
Corner wall at rear patio

6: Pest Infestation

Recommend a qualified pest professional evaluate and remedy.

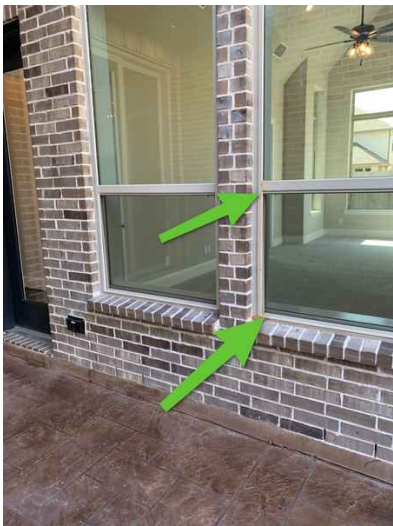
Right side patio

2: Inadequate Window Caulking
🔴Recommendation

Recommend repair by a qualified contractor.

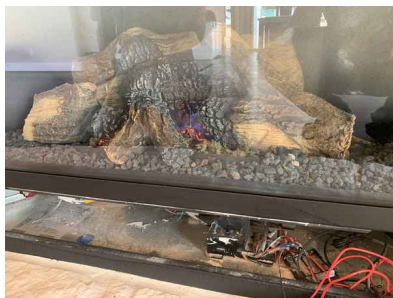
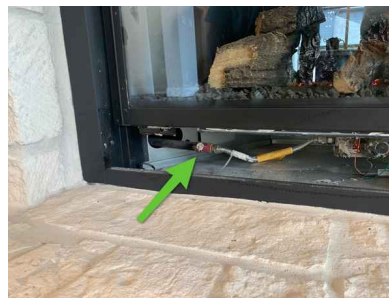
Gas Shut-off for Fireplace

House had a Natural Gas Fireplace which was functional at the time of the inspection.

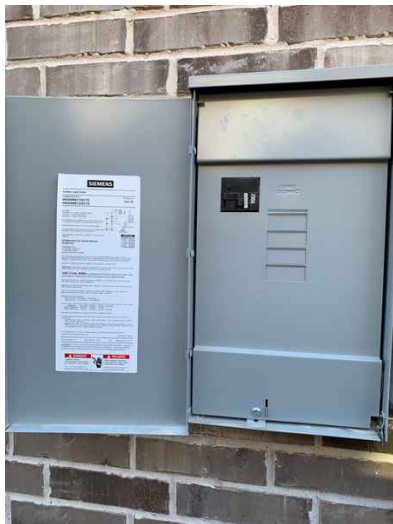
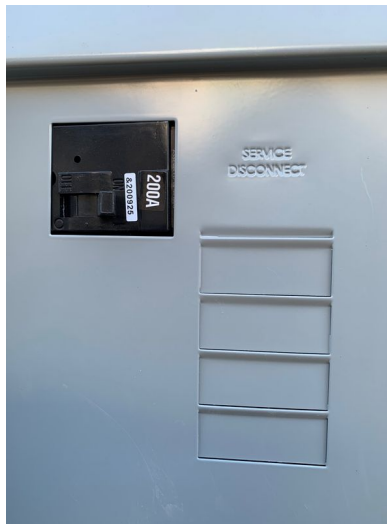
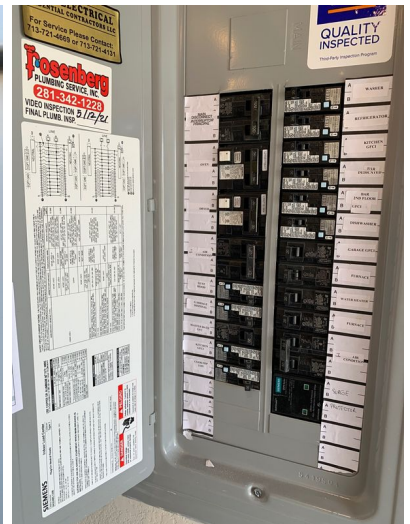
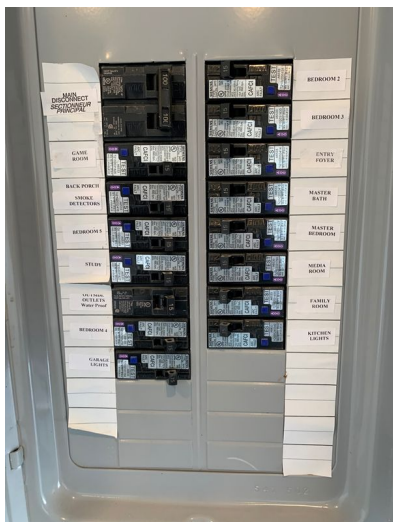
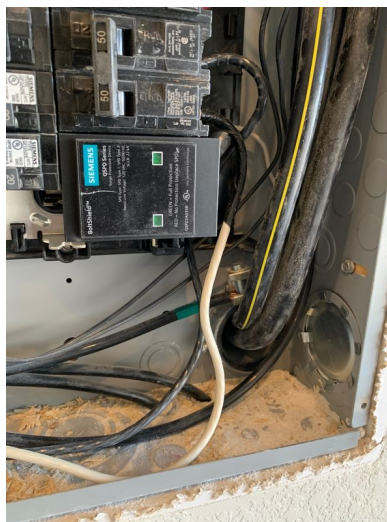
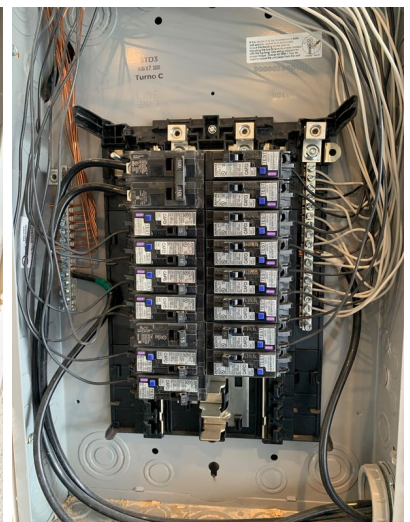
1: No Antioxidant Grease on Aluminium Wires

Aluminium wiring should be installed with anti-oxidant grease to prevent oxidation of the wires and loosening at the terminals.

Recommendation: Contact a qualified professional.

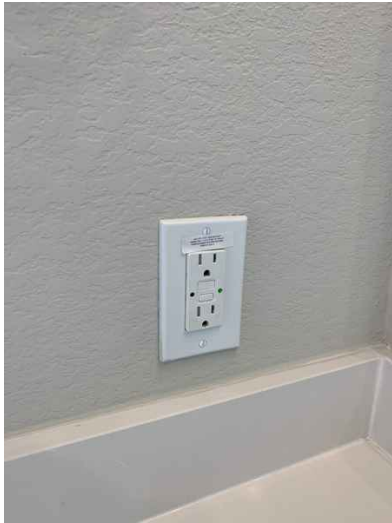
GFCI reset switch located in master bathroom

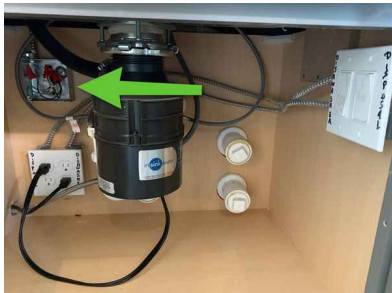
1: Open Junction Box

Open junction box observed under the kitchen sink. This is a possible electrocution and fire risk. A cover should be immediately installed over this box.

Recommendation: Contact a qualified electrical contractor.

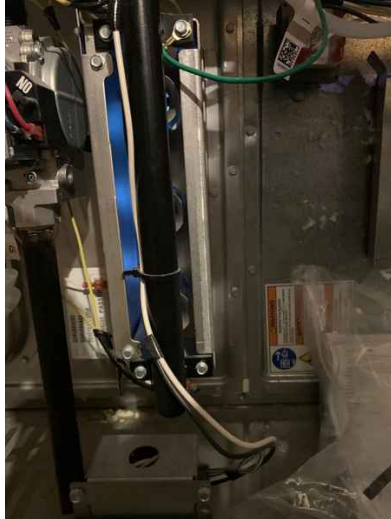
Right Unit

Both heating units were functional at the time of the inspection.

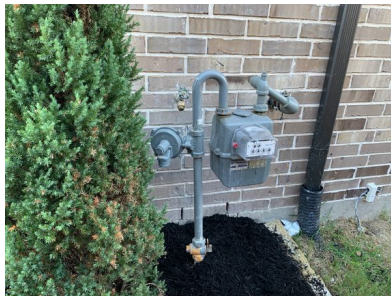
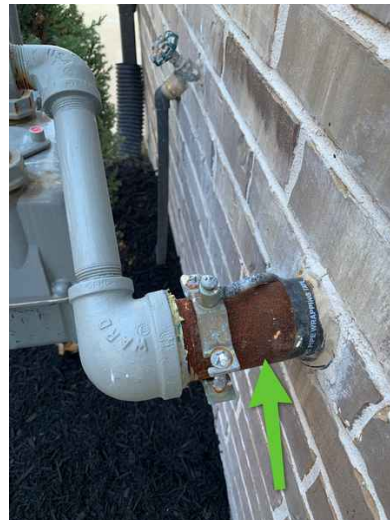
Right side exterior wall

Gas Meter is located on the right exterior wall. Gas entry line into house appears to be rusting and should be painted with a rust resistant paint.

A section of the main gas line entering the home is rusted. This should be cleaned and painted with anti-corrosion or rust inhibiting paint.

Recommendation: Contact a qualified professional.

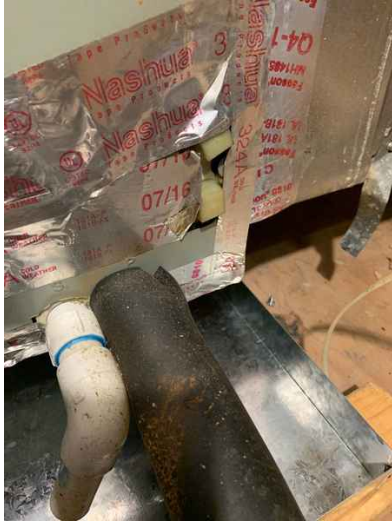
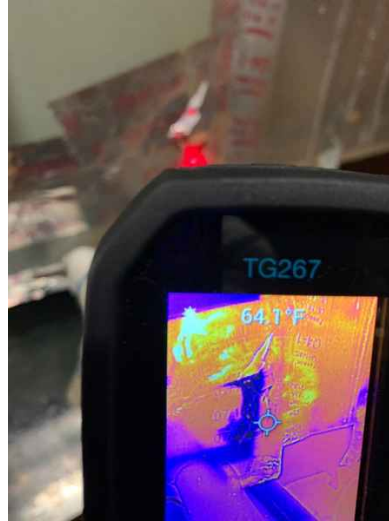
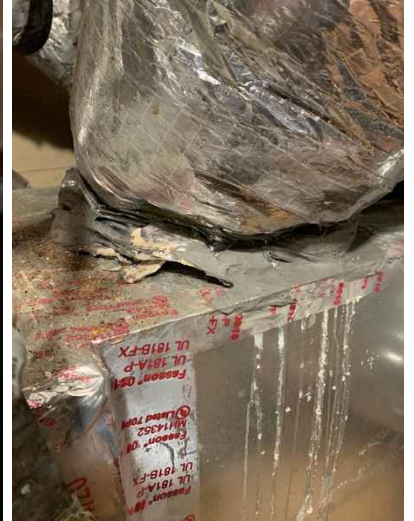
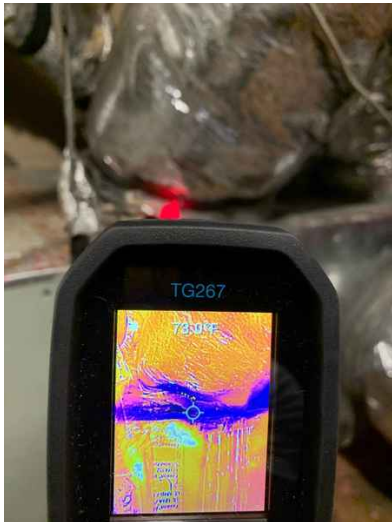
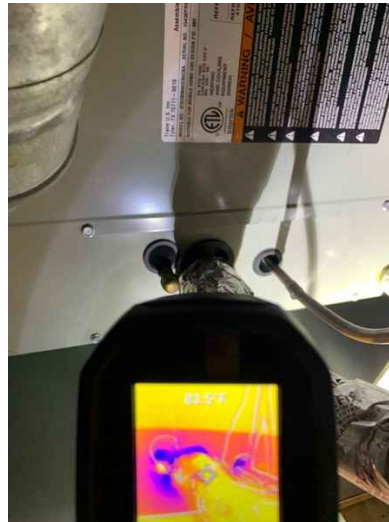
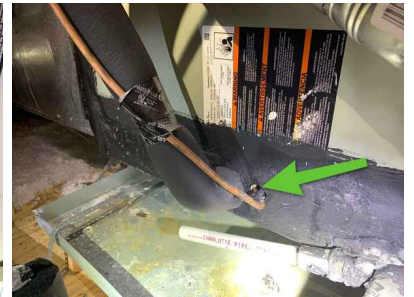
2: Leaking Air

Air was observed to be leaking from the lie penetration points on the left A/C attic unit. Recommend evaluation and repair by a qualified HVAC contractor.

Recommendation: Contact a qualified professional.

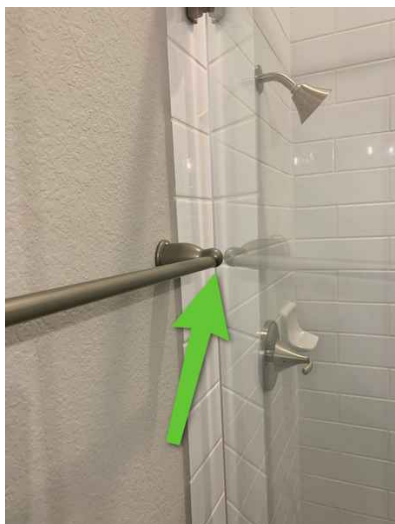
1: Bathroom Enclosure Door Hazard

Bathroom door is in close proximity to the towel rack in the right front first floor bathroom. i recommend either a door stop to prevent to glass shower door hitting the towel rack, or relocating the towel rack.

Recommendation: Contact a qualified professional.

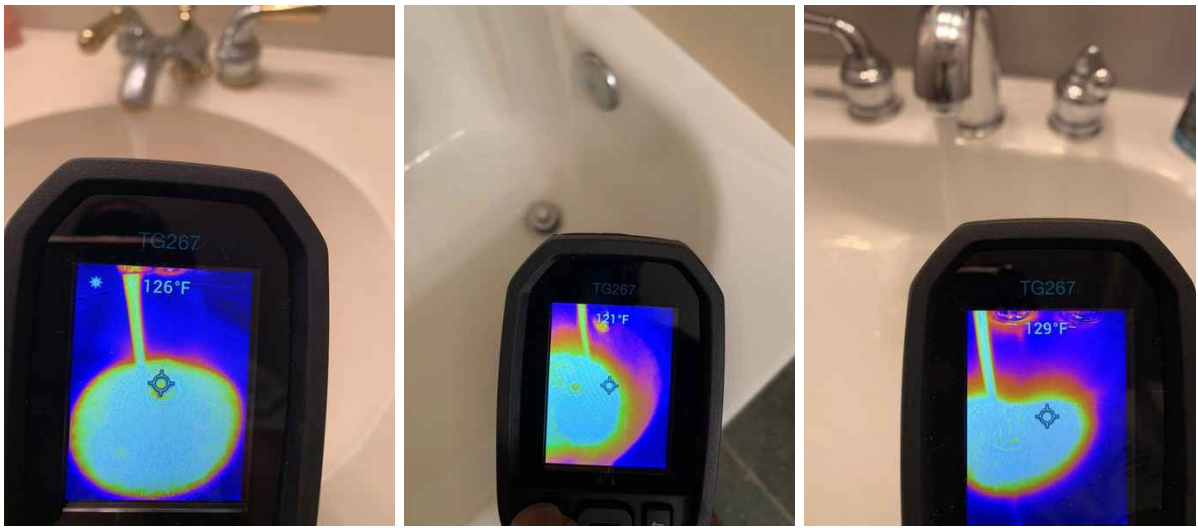
The water heating equipment was functional at the time of the inspection. Hot water temperatures ranged from to 121 to 129 degrees F. This was above the recommended temperature of 120 Degrees F. High hot water temperatures can cause scolding and burns particularly in small children. I recommend lowering the temperature setting on the water heater.

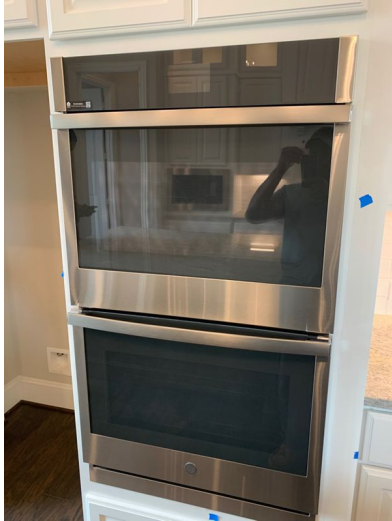
1: Electrical Oven Malfunction

Both ovens tripped the 50Amp Breaker. Recommend immediate evaluation and repair by a qualified professional.

Recommendation: Contact a qualified professional.

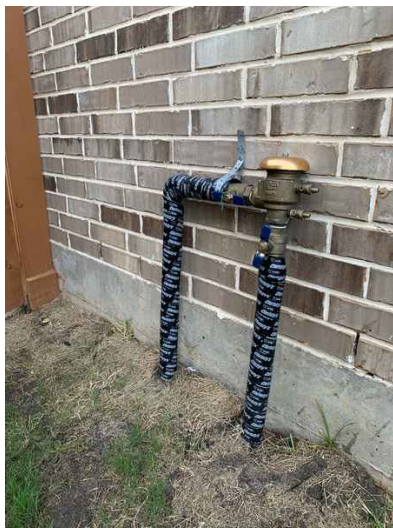
Left side wall

1: Sprinkler Head Adjustment

Several sprinkler heads were spraying excessively onto walkways, fences and the exterior walls. Recommend repair by an irrigation contractor.

Recommendation: Contact a qualified professional.
