AVALON PRE-DRYWALL INSPECTION

1206 Coldwater Ct
Griffin GA 30224

MARCH 9, 2021

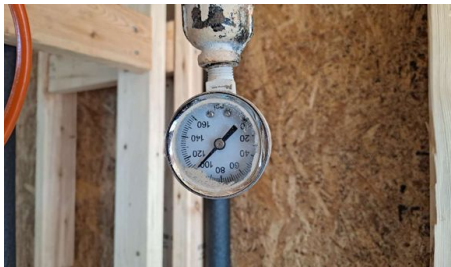
Water pressure Test

A pressurized water line test was conducted on the plumbing water supply system to detect any leaking in the water system. None were observed at the time of the inspection.

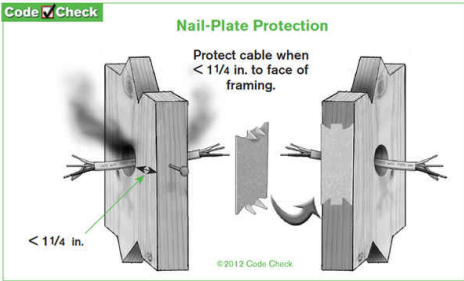
Electrical Nail Guard Diagram

Nail Guards were missing in various locations at the time of inspection. Provided a few reference photos. Builder should inspect entire home and install as per code requirements.

Recommendation
Contact your builder.
